Testing Polysulfide Sealant Deformation on Vises

Reprinted from
Adhesives Age
Volume 28, No. 5, May 1985
p. 18-22
(DBR Paper No. 1340)

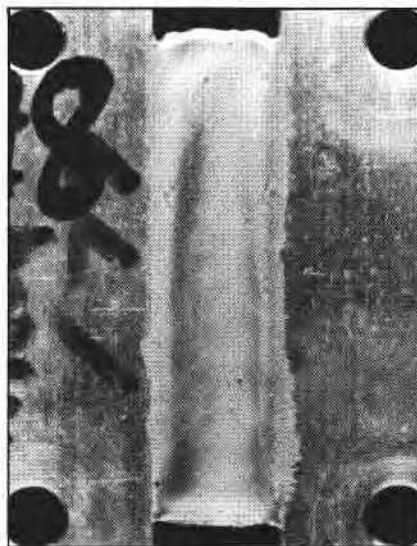
Figures 7a (left) and 7b (right). Stage 1 of permanent deformation (exposure past one winter), north exposure, top at preparation. 7a: $\pm 45\%$; 7b: $\pm 55\%$.

After each winter and summer, the amount of movement for each stage was determined; it could be estimated within about a 5% step. For example, after three winters the greatest amount of movement without permanent deformation was $\pm 25\%$, as shown in Figures 3 and 4. At $\pm 35\%$ there was permanent deformation (Figures 5 and 6), while at $\pm 30\%$ it was less well defined. The Stage 1 limit for two winters was $\pm 30\%$ - $\pm 35\%$ (not shown); for one winter it was $\pm 45\%$ - $\pm 50\%$ (see Figure 7, where 7a is a specimen at its limit, and 7b is a specimen at the next higher movement).

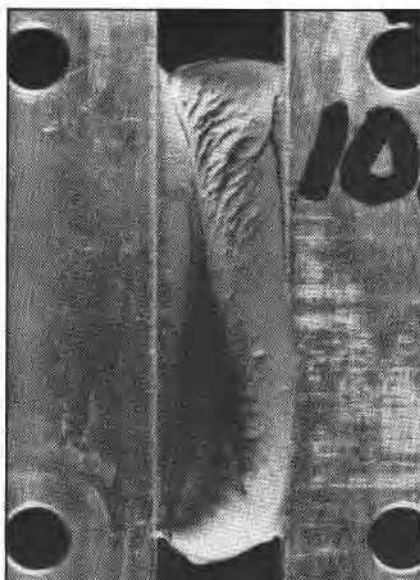
Figure 9 (left). Stage 2 of permanent deformation (exposure past one winter); south exposure, underside at preparation, $\pm 65\%$.

As the amplitude of the yearly movement increases, Stage 2 of the progressive permanent deformation occurs, consisting of bulges and a thinned portion of material folded under the bulges. Photographs of specimens that have reached Stage 2 after one, two, and three winters on the exposure rack are shown in Figures 9, 10, and 11, respectively. The folds are usually single, but in some cases are multiple, as in Figure 11a. A single bulge is shown in Figure 11b, while 11c shows the opposite side of the same specimen with the thinned section protruding. The range of movement in which Stage 2 is reached can be seen in Figure 8. With movements between the two stages, the depression increases (as in Figures 5a and 5b), but there is no folding under.

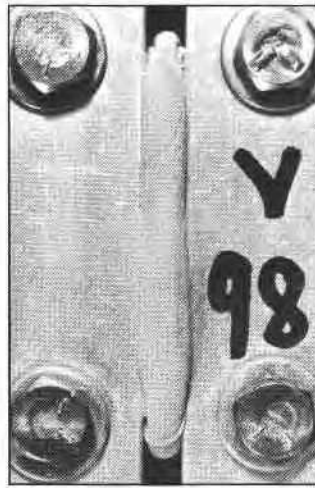
Figures 13a (left) and 13b (right). 13a: south exposure, underside at preparation; 13b: side facing rack, top at preparation.

The progress of permanent deformation during exposure can be followed on a specimen subjected to $\pm 55\%$ movement. When the horizontal line corresponding to this movement is followed from left to right in Figure 8, one can see that the specimen is just above Stage 1 after the first winter; i.e., permanent deformation has just started, as illustrated by Figure 8b. (This is the top of the specimen; the underside showed no change at that time.) As the horizontal line is followed, Stage 2 is reached at its lower limit (point A in Figure 8); the corresponding specimen is shown in Figure 10 (at intermediate extension). After the third winter the specimen is at the upper limit of Stage 2 (point B) and is shown in Figure 11 (b and c), front and back (at original width). The same specimen is at maximum extension during the third winter (Figure 12). Comparison with the previous figures shows that the sealant bead folds along the thinner section as the joint width diminishes and the bulge protrudes on one side (Figure 11b); the thin section does the same on the other side (Figure 11c). On compression, this process continues and the groove disappears (Figure 13a and 13b).

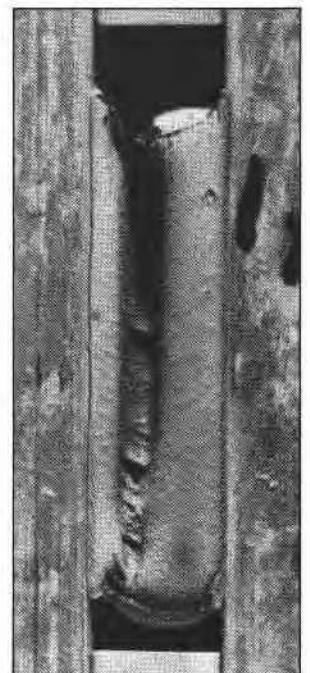
Figures 16a (left) and 16b (right). Three-year exposure on strain-cycling rack at $\pm 30\%$ maximum yearly movement. 16a: south exposure, top at preparation; 16b: north exposure, underside at preparation.

Strain-Cycling Rack Exposures. As reported earlier(1), the $\frac{1}{2}$ -in.-wide specimens were exposed on the strain-cycling rack in the fall at the yearly average temperature. The movements on the rack ranged from $\pm 14\%$ – $\pm 30\%$ yearly. In Stages 1 and 2, permanent deformation also was observed, occurring at $\pm 16\%$ and $\pm 30\%$ yearly movements, respectively, the latter shown in Figure 16. This behavior is similar to that illustrated in Figure 11 at $\pm 50\%$ movement. Stages 1 and 2 on the strain-cycling rack are located approximately in Figure 8, represented by a sinusoidal line marked SCR 1 and SCR 2, respectively, at the approximate time in which they occurred. They develop at lower movements than in specimens exposed on vises. This is understandable when it is recalled that every day the specimens undergo a cyclic movement that is about one fifth of the yearly movement. Because the permanent deformations are
