### **Vacuum insulation panels (VIPs) arrive in northern Canada : institutional building pilot retrofit in Yukon**

**Institutional Building Pilot Retrofit in Yukon**

10<sup>th</sup> International Vacuum Insulation Symposium 15 – 16 2011  
Ottawa, Ontario

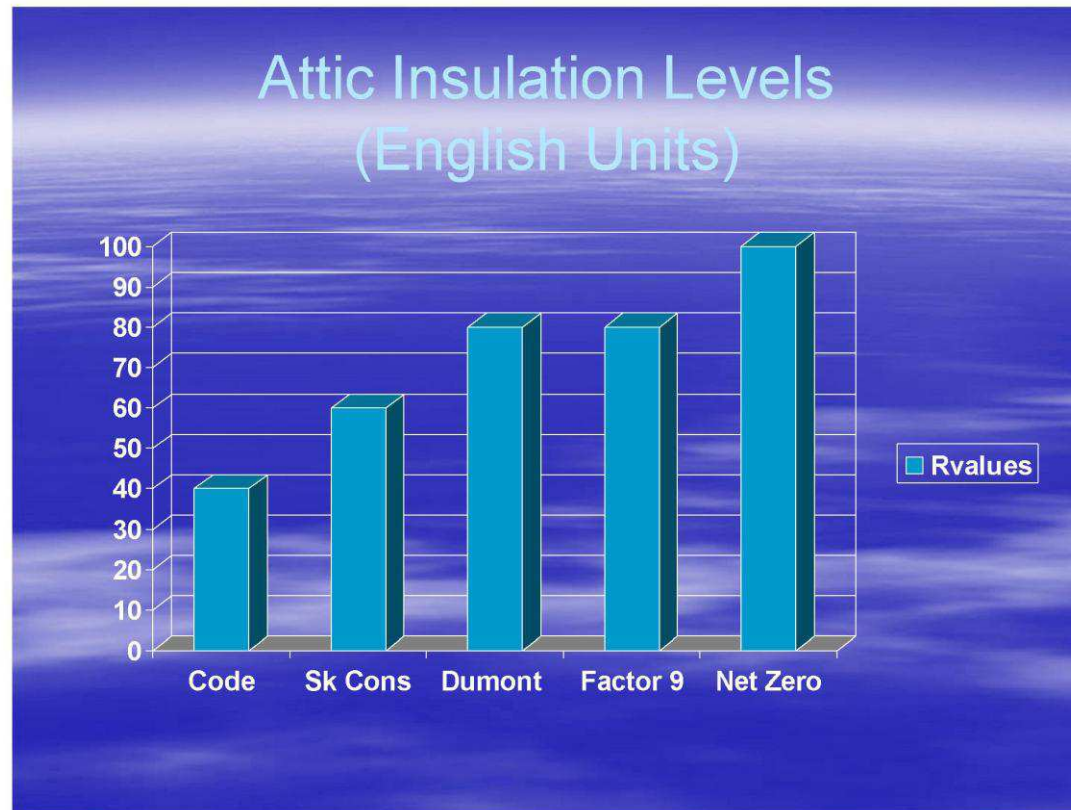
## Economic Insulation Level

Minimum recommended insulation levels are increasing.

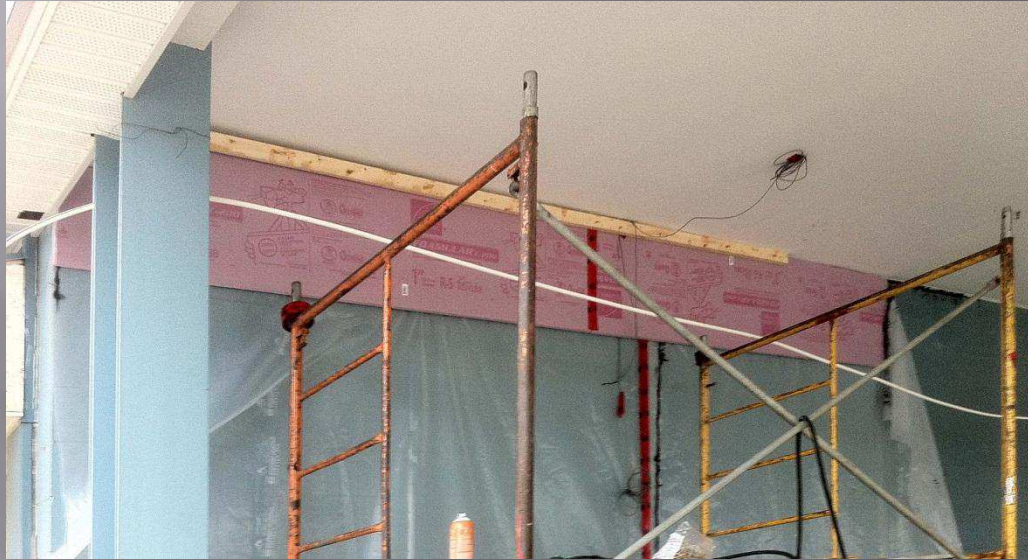
- ▣ Installation of the air/vapour/moisture barrier proceeded smoothly as was expected, as such construction is routine.
- ▣ Similarly, installation of the 25 mm (1") polystyrene foam board layer over the air/vapour/moisture barrier also proceeded without incident.

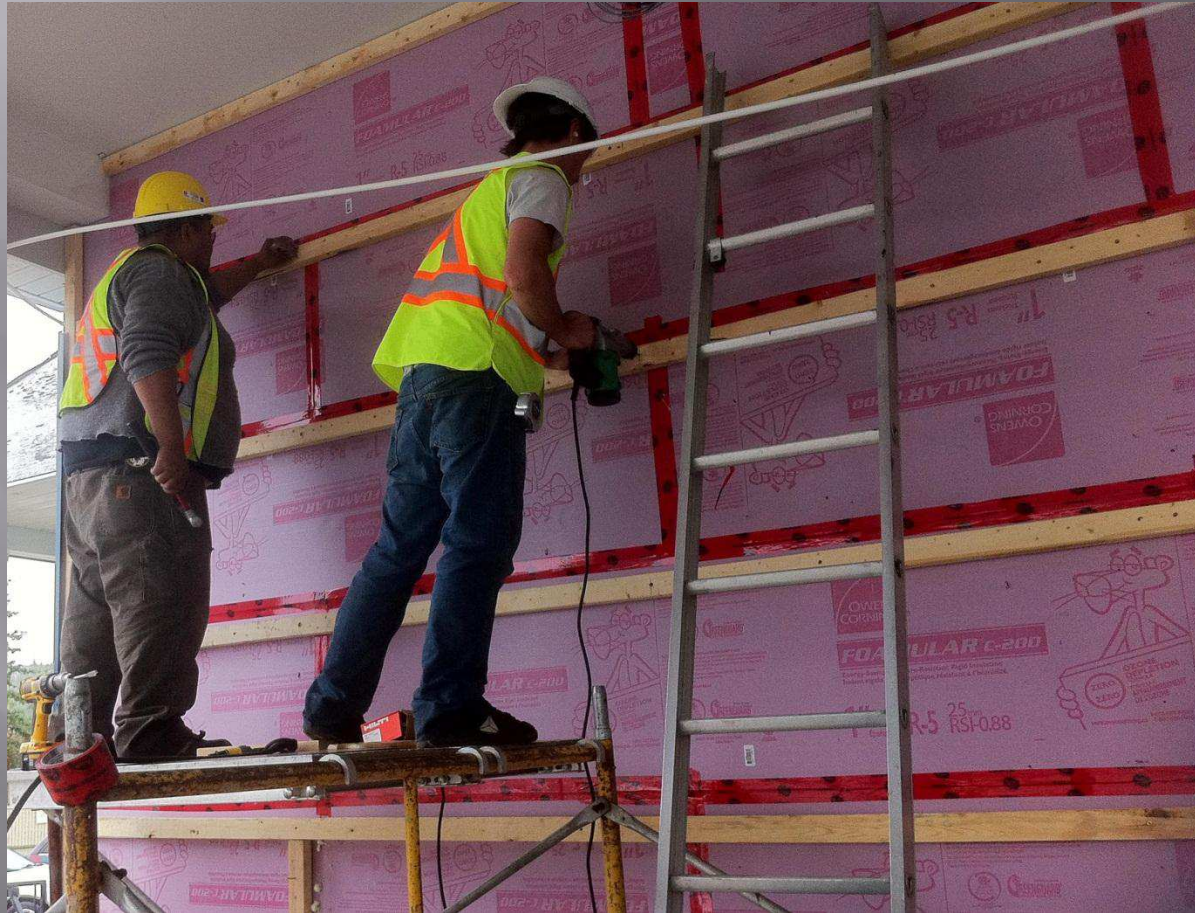
Installation of the 50 x 75 (2 x 3s) proceeded almost flawlessly.

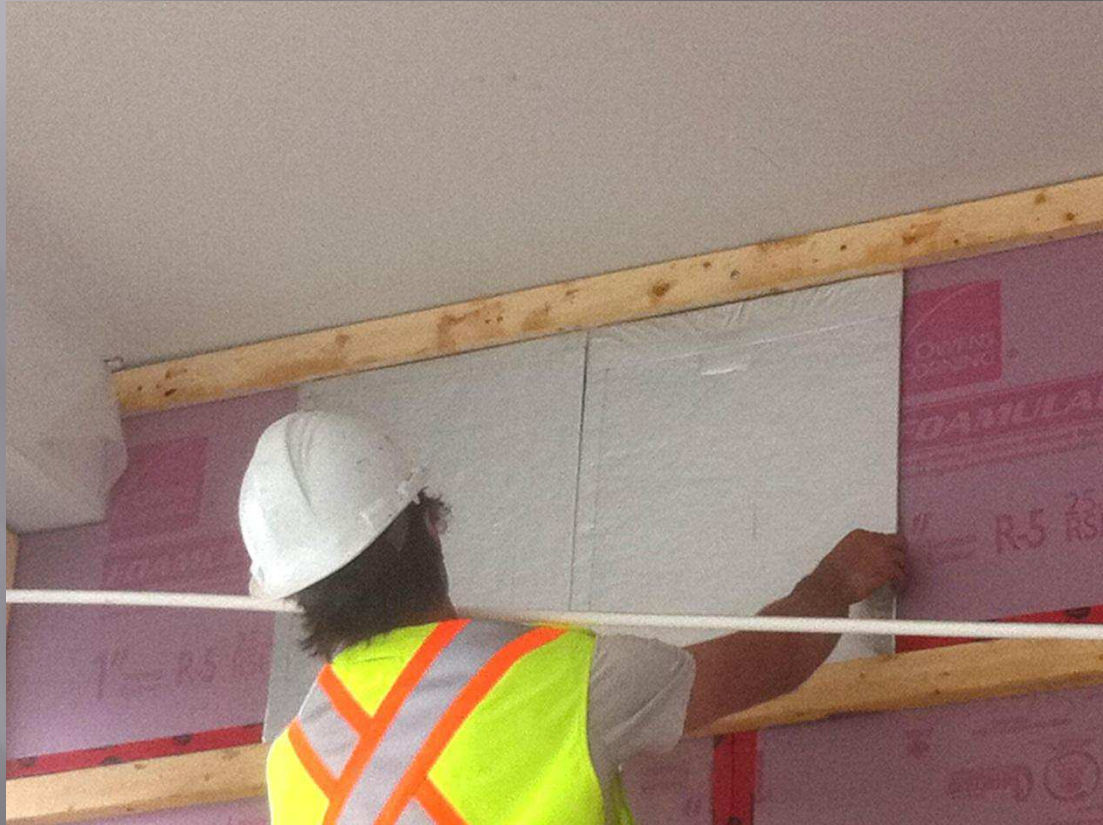
Installation of the VIPs proceeded quickly.

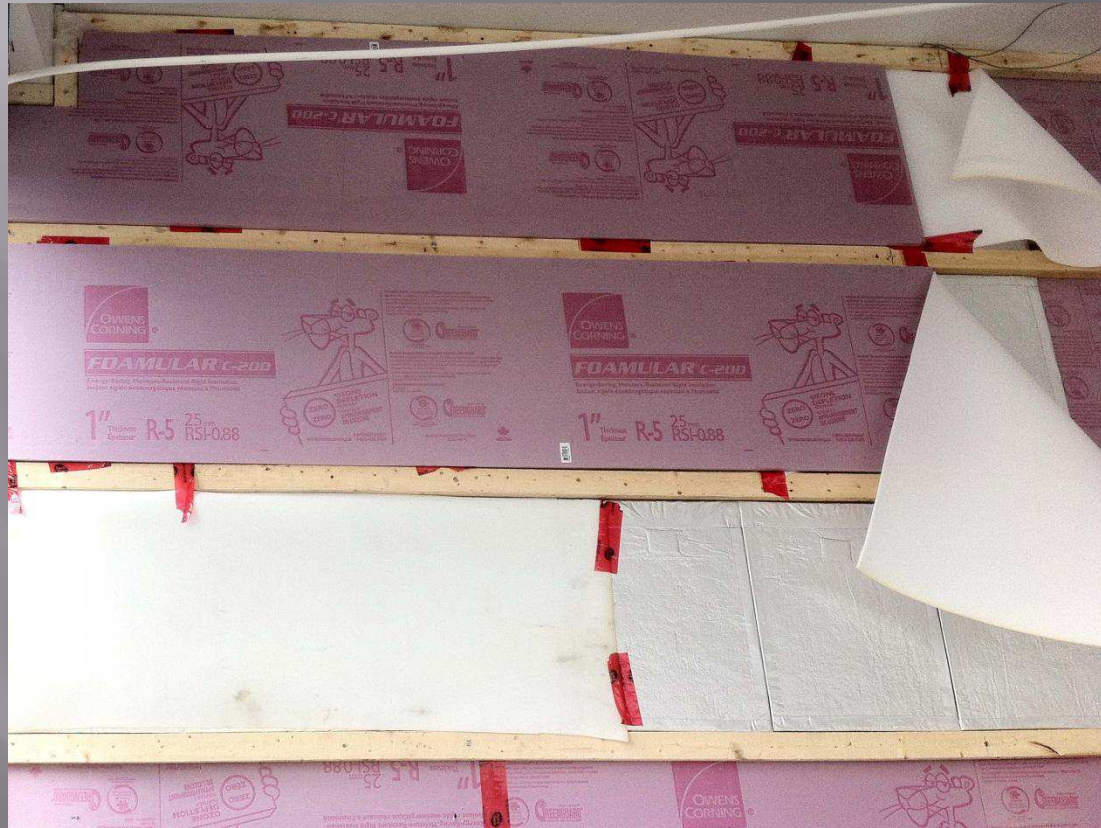
Installation of the flexible foam layer proceeded smoothly.

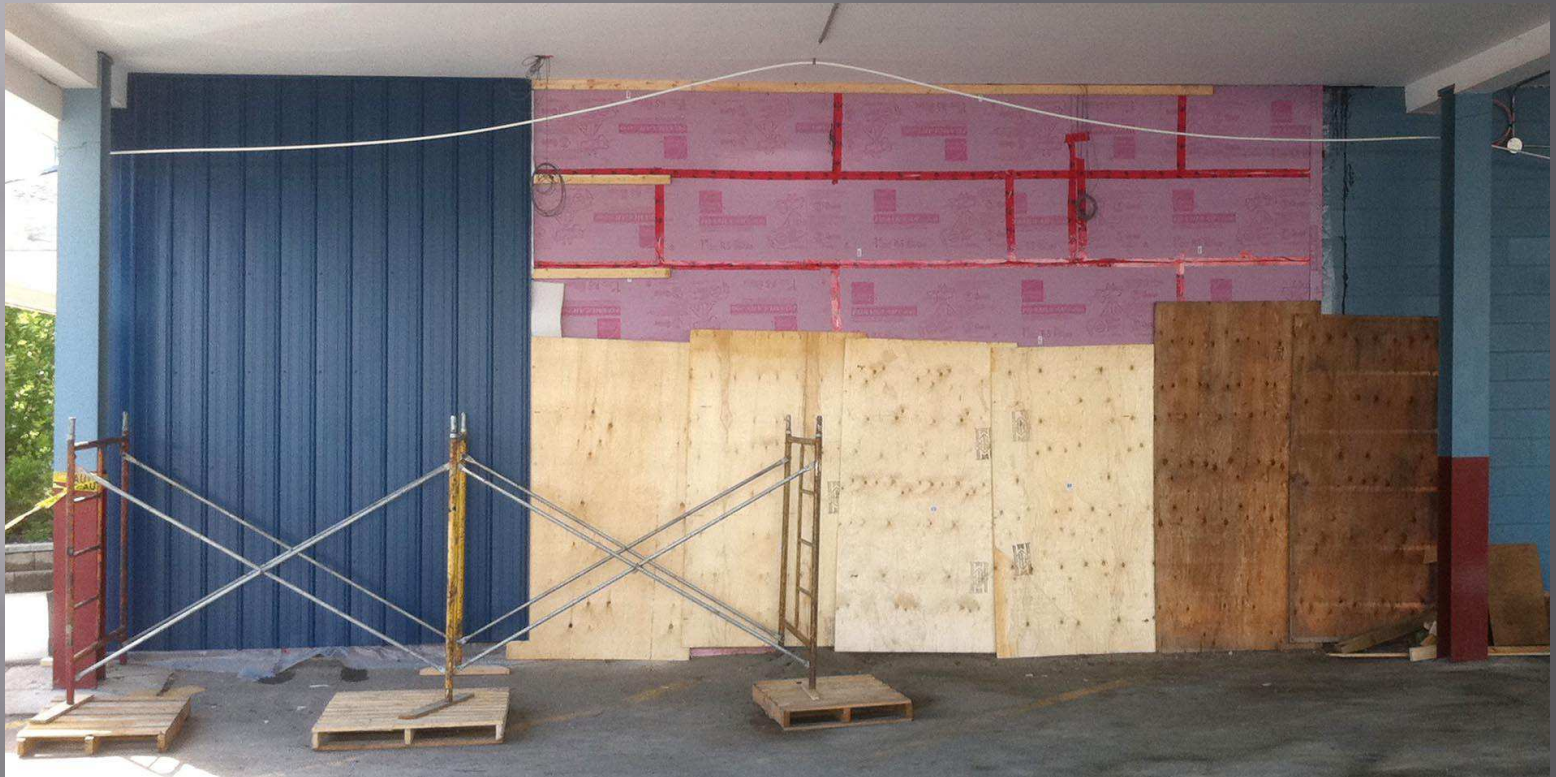
- ▣ Installation of the second layer of 25 mm (1") foam board also proceeded smoothly.

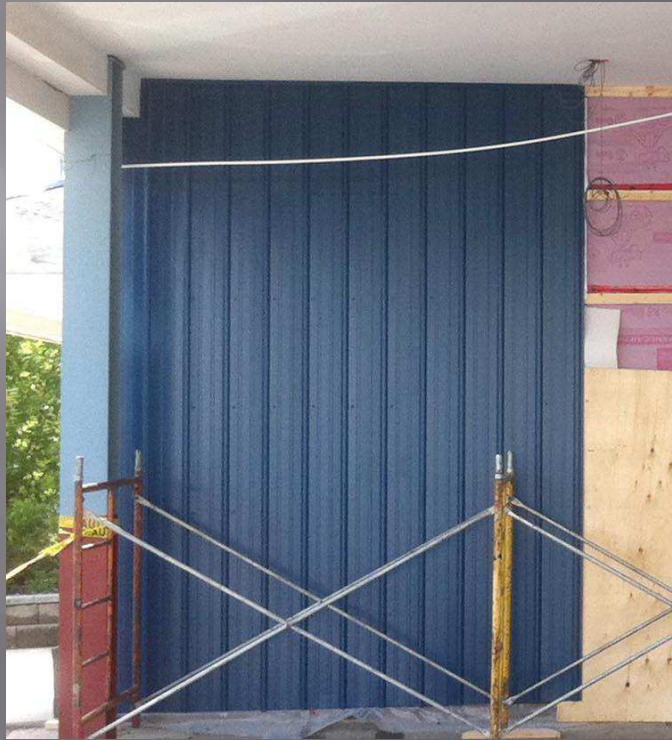
## Siding Installation

- Pre-drilling siding was very effective.

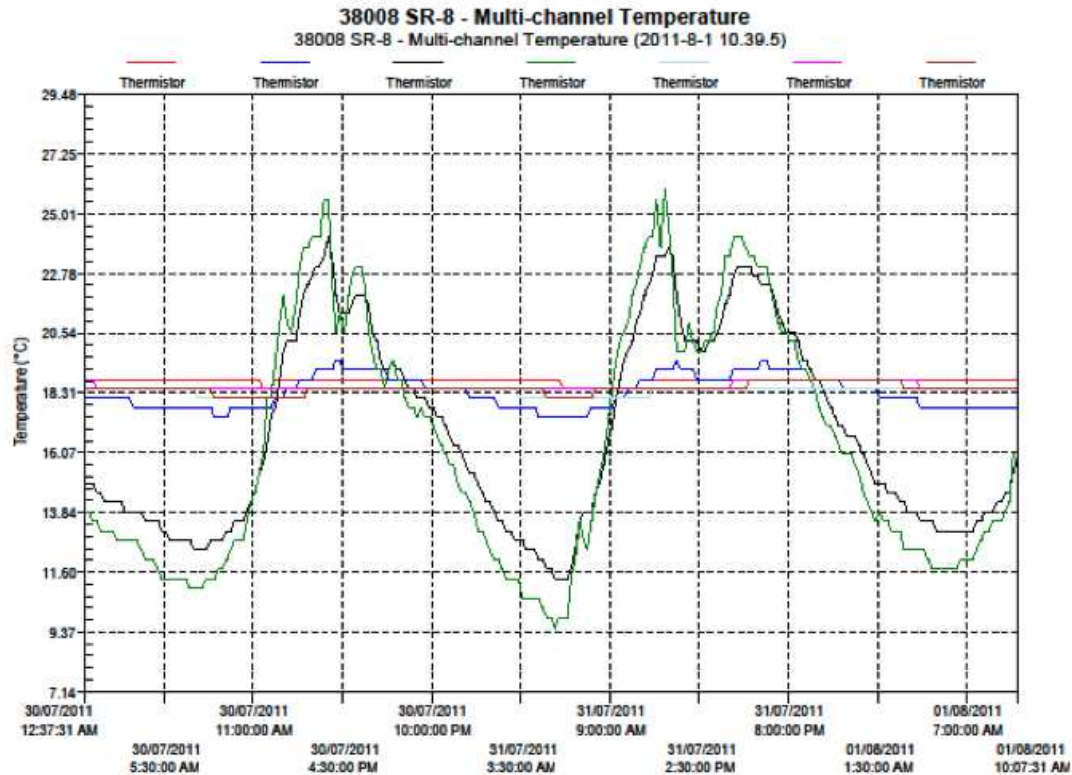
- Initial results were consistent with expectations.
