Understanding low-sloped roofs under Hurricane Charley from field to practice

Understanding low-sloped roofs under hurricane Charley from field to practice

Understanding Flat Roofs Under Hurricane Charley From Field to Practice

A. Baskaran¹, S.Molleti² and D. Roodvoets³

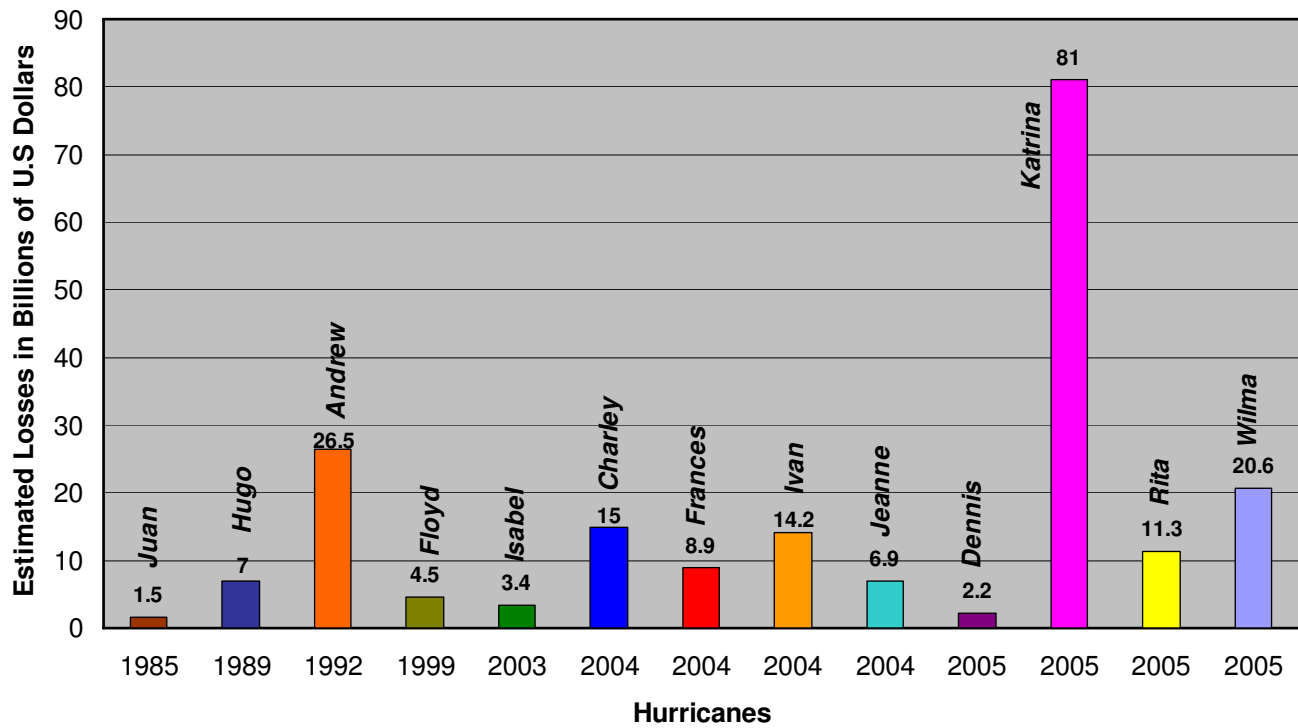
Figure 1: Approximate cost of hurricanes (Source: NOAA)

Natural wind hazards such as typhoons and hurricanes have been dramatic in recent years, incurring losses of life and property damages. Figure 1 shows the trend of the damage amounts of the most costly hurricanes in the United States. As shown in the Figure 1 [National Oceanic and Atmospheric Administration (NOAA), 2007] the years 2004 and 2005 can be considered as the worst hurricane disaster years incurring total losses of 45 and 115 billion U.S. dollars respectively (not adjusted for inflation). Of these, Hurricane Charley, in the year 2004 was a category 4 event. (Categories range from 1-5 with 5 having the highest wind speeds and severe damage expected) incurring losses of \$15 billion U.S dollars across the areas of Florida and South Carolina. In contrast to Hurricane Katrina, where the damages were a combination of water and wind induced failures, nearly all damages from Hurricane Charley were wind-induced failure. Wind induced failure is one of the major contributors to insurance claims, and it is rising. Therefore, understanding as how to prevent wind damages by establishing engineering standards, or standard practices will allow designer to design roofs that can stay during high winds.

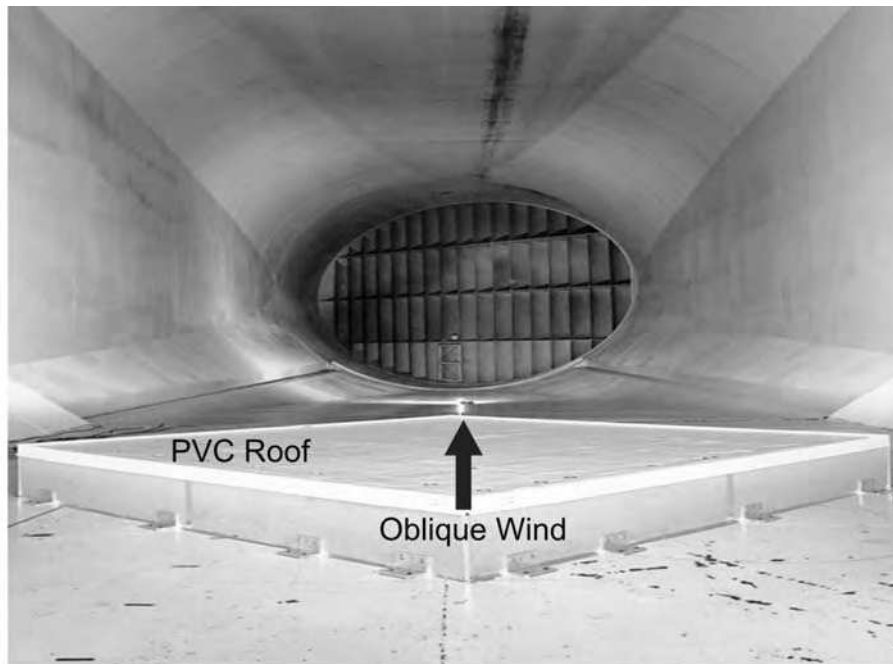
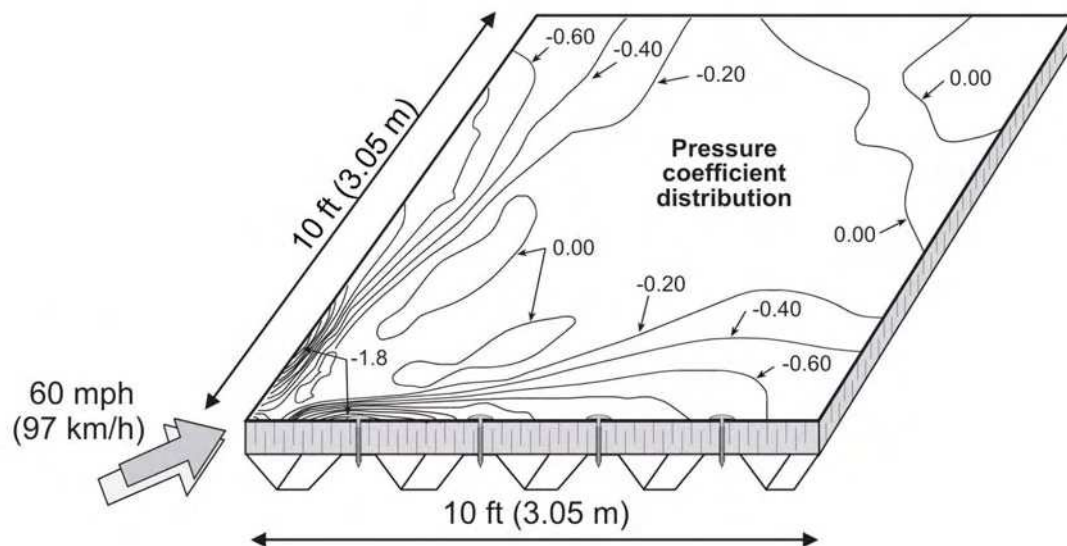
**Figure 2: Wind tunnel model and wind induced pressure distribution over a roof assembly
(Savage et. al, 1994))**

As mentioned before, wind pressure distribution varies spatially over a roof and it can have high suction at the corner and perimeter, due to vortex flow and separations. This science is clearly displayed in Figure 2, which represents pressure variation on a building roof taken from a wind tunnel study at National Research Council of Canada (NRC) (Savage et.al., 1994). The wind tunnel tests were carried out in the 30 ft x 30 ft (9 m x 9 m) NRC wind tunnel. These tests used full-scale roofing components 10 ft x 10 ft (3 x 3 m in size) having different heights. For wind directions perpendicular to a building face (normal wind) and at 45 degrees to a face (oblique wind) measurements were made in smooth wind and turbulent wind conditions for five wind speeds, ranging from 30 to 60 mph (13.4 m/s to 26.8 m/s). As shown in the Figure 2, PVC (Polyvinyl Chloride) roofing system was tested with 81 pressure taps fitted on the single ply membrane to measure the unsteady pressure loads on the roof (Savage et al., 1994). In total, 30 configurations were tested in this wind tunnel study. Wind induced corner suctions are evident from the Figure 2 with maximum measured mean pressure coefficient (C_p) of 1.8 on corners. Pressure coefficients (C_p) are the non-dimensional ratios of wind-induced pressures on

a building to the dynamic pressure (velocity pressure) of the wind at the reference height, which is the roof eave height.

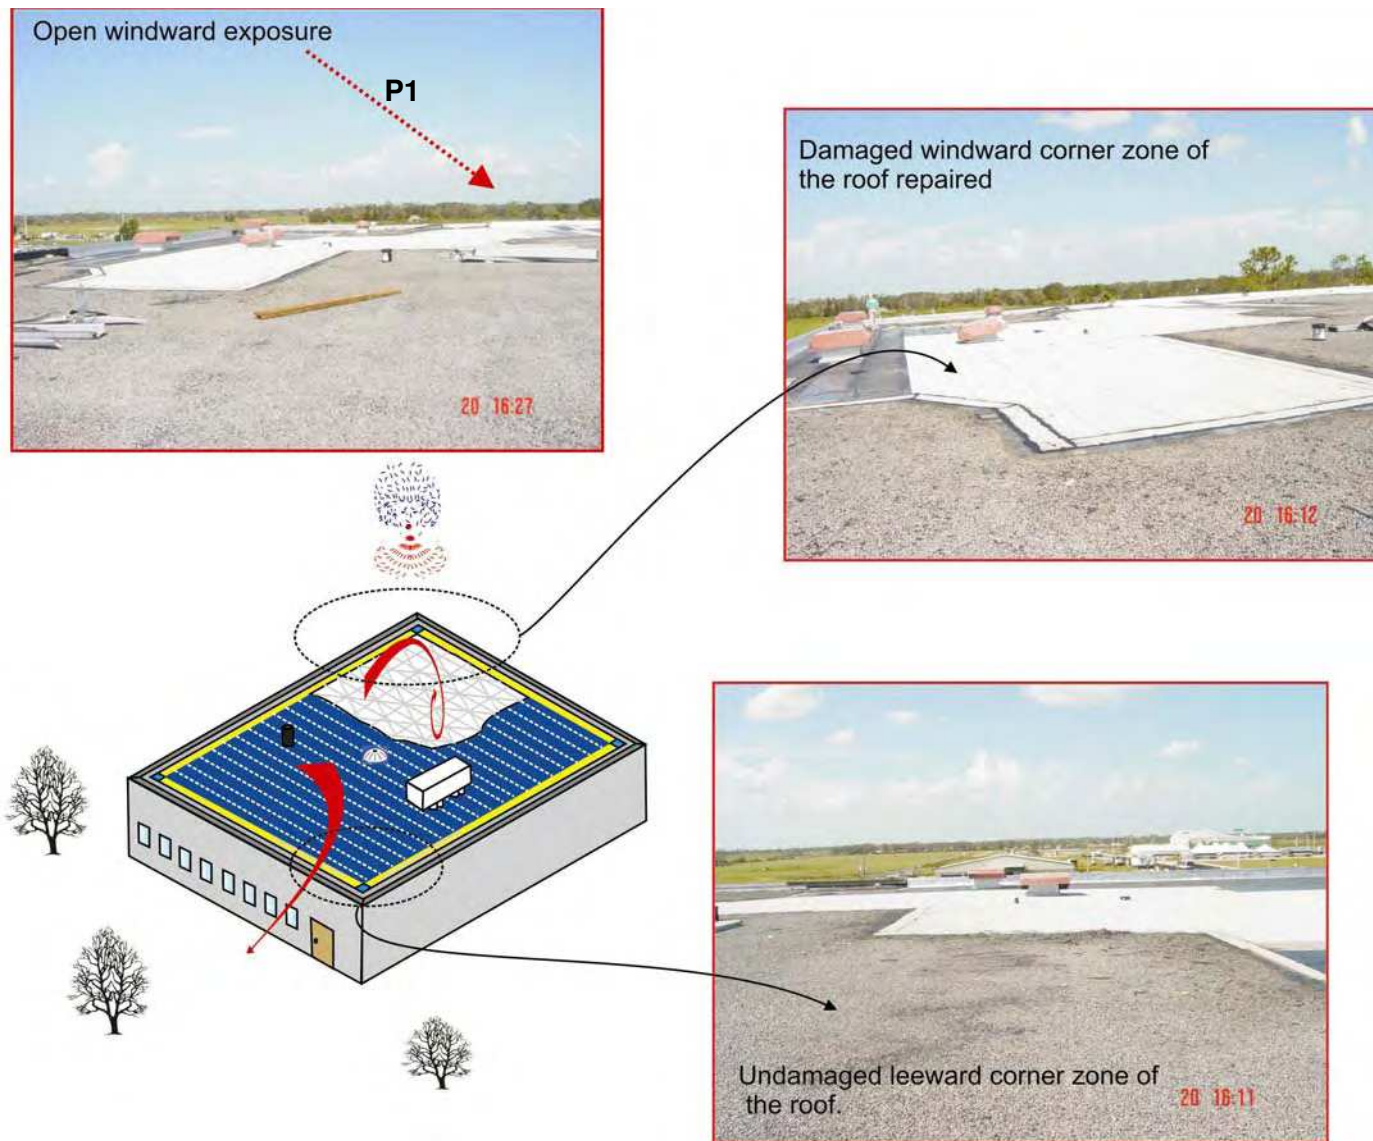
Figure 3 shows the failure investigation of a school roof in which the above discussed scientific data have been correlated to the field observation. All the photographs shown in the Figure 3 are taken from the top of the roof under investigation. P1 shows the prevailing windward exposure condition. According to the American codes standards of practice (American Society of Civil Engineers, ASCE 7-05), this can be classified as Exposure C where as the Canadian building code (National Building Code of Canada, NBCC 2005) classifies it as Open country exposure. Even though there is variation in the terminologies, both of them define that “*open terrain with scattered obstruction having flat open country, grasslands and water surface as the criteria for this exposure condition*”.

The building under investigation was a 40 ft (12 m) high concrete walled gymnasium. It is part of a school used as a shelter during hurricane Charlie, although it was not designated as a shelter. The building is of substantial construction with concrete walls and a lightweight concrete deck. There was only one exterior fire escape door that led to the outside. It was reported as closed during the storm. Primary access was through the corridors of the adjacent building. The entire complex with several roof areas totalled more than 140,000 sq. ft (13,000 sq. m). The damaged roof area section was about 40000 sq. ft. (3700 sq. m) and had a stone surface 4-ply BUR (Built-up Roofing). The membrane was attached to a lightweight concrete deck mechanical fastener. A large section of the gymnasium roof (over 40% of the membrane) blew off during the storm when about 400 people were inside. This released a large volume of water that spread across most of the school complex. Other than some limited edge metal damage, there was no damage to about 100,000 sq.ft (9300 sq. m) of roof on adjacent parts of the structure. These sections were all BUR membrane roofs appearing to be of the same construction as the sections that were blown off.

The gymnasium roof structure did not appear to fail because of pressurization below the deck; the cause appears to have been purely suction force. The school roof was the highest point in several miles, so it took the brunt of the hurricane's force. The low 2 ft (0.7 m) parapet in the

upwind corner did not help to reduce the maximum uplift (also refer to discussion of Figure 4 and 5). The roof failure pattern was typical of the uplift forces that would be present in a cornering wind with an L-shaped area. As temporary repairs had been made, it was not possible to determine the sequence of failure. It is interesting to correlate the failure shape with the wind pressure distribution diagram of the Figure 2 where the roof corner experiences high suction. This was the similar phenomenon in the case of the school roof, where those high suction pressures on the corner of the roof caused the failure of the roof.

Figure 3: Roof assembly failure due to high suctions caused by cornering wind (Not to scale)

Corner wind can cause high wind suction and use of high parapet can mitigate those high suctions. Wind flow aerodynamics over a roof area has been modified based on the presence of parapet and its height. These modifications affect the wind-induced suctions on the roof assembly. Measured data show that high parapets on tall building show beneficial effect in suction reduction. Therefore, in hurricane prone regions use of parapets over 3 ft (1 m) high are recommended.

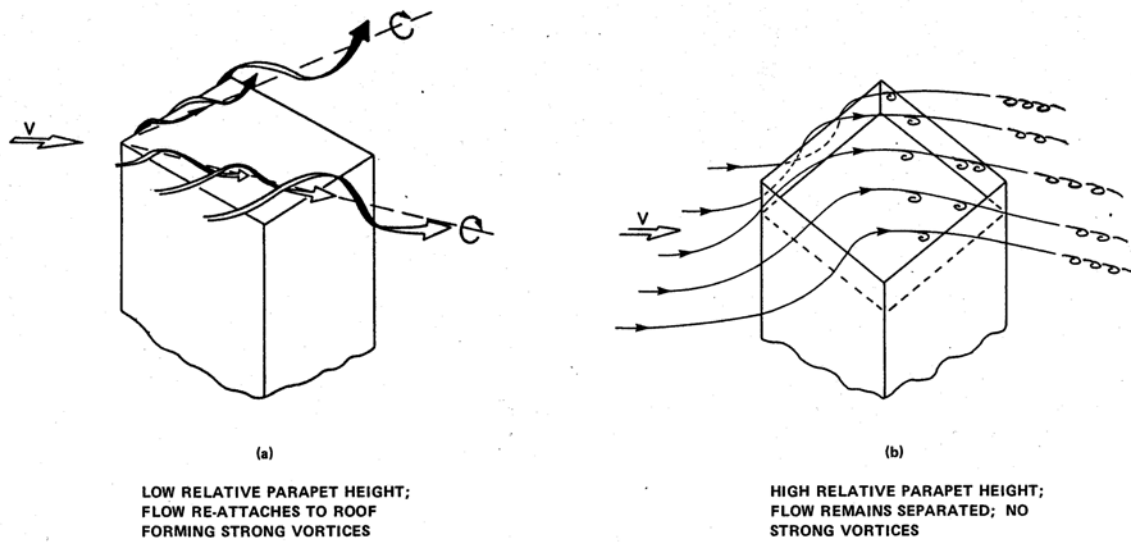
Most flat roofs have a parapet. It is the low wall built along one side of, or, all around the perimeter of a flat roof, where it may modify the wind flow over the roof so that the pressure on it is more uniformly distributed. It also provides a measure of safety in that no objects (gravel, for example) are so easily blown into the street below. Parapets have been of research interest from early 1970's and several wind studies are being carried out to quantify the influence of parapet on roof wind loads (Baskaran, 1986, Baskaran and Stathopoulos, 1988, Kopp et al 2005). Figure 4 shows a typical wind flow over roofs with parapet. According to Kind et. al., (1977 to 1987) increased parapet height generally resulted in more favourable pressure distributions. That is, maximum suctions were reduced and suction peaks were broadened so that pressure are less non- uniform and monotonic, there was no 'worst' non – zero parapet height. Parapets are also effective in preventing stone blow off from the buildings having ballasted roof systems. However limitations do exist regarding the effectiveness of the parapet height in providing resistance to the phenomenon of stone blow-off [Kind et. al.1977, Single Ply Roofing Industry (SPRI), 2002]. Field observation on a gravel roof with low parapet confirms these scientific theories (Figure 5).

Figure 4: Effect of parapet height on wind flow over roofs, (Kind, Savage and Wardlaw, 1987)

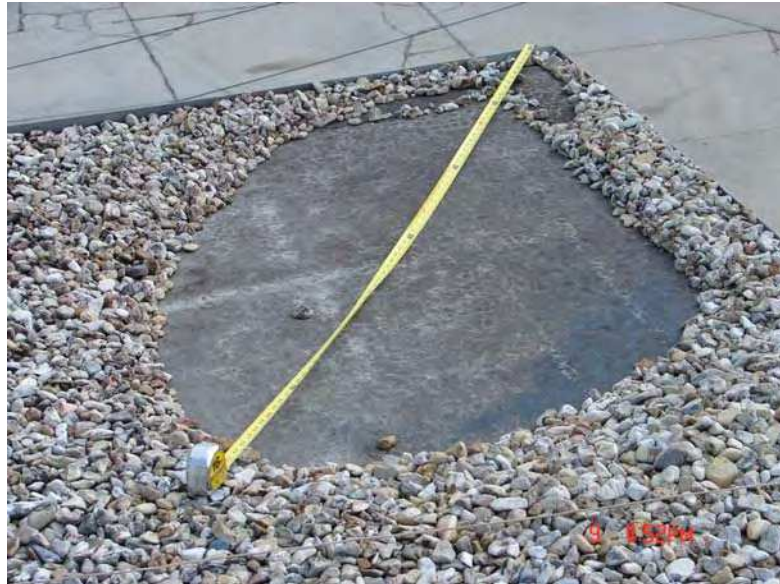
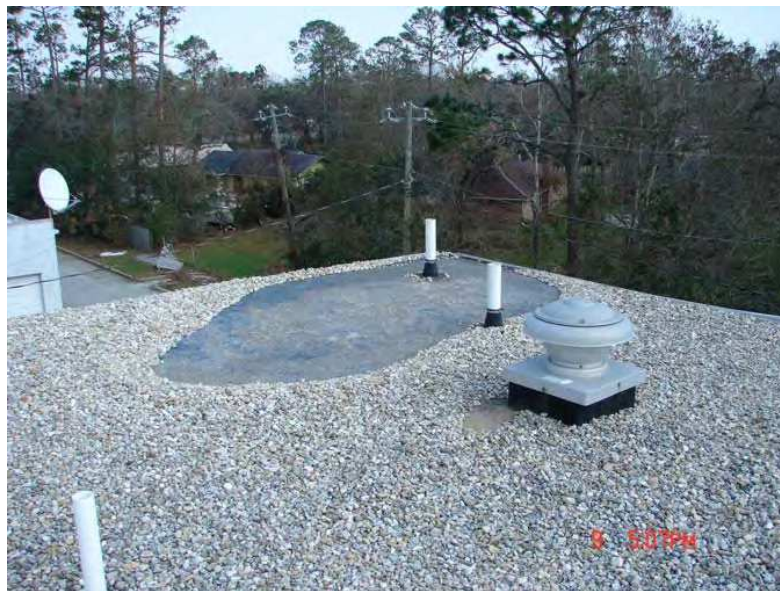
Figure 5: Wind vortex formation on gravel roofs due to low parapet.

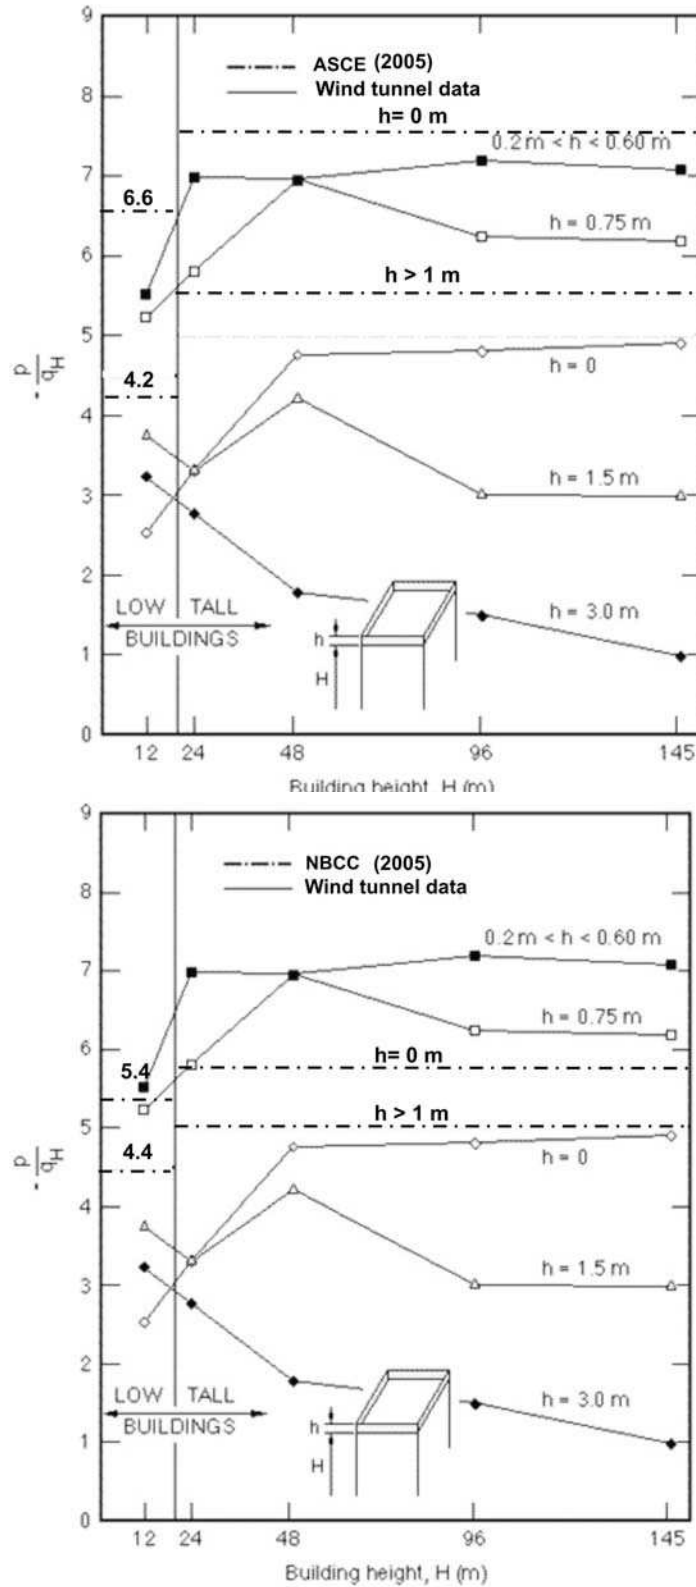
- At corner regions (Figure 6), low parapets tend to increase both the mean and peak pressure coefficients. In fact, with winds approaching a roof obliquely (at 45°), 1 ft to 1.2 ft (0.3 to 0.4 m) high parapets can roughly double the pressure coefficients at the corner regions of a roof of both low and tall buildings. Parapets of 3 ft (1 m) or higher, however, reduce the pressure coefficients of roof corners of tall buildings significantly, but only marginally on low buildings

Figure 6: Relationship of code specifications {NBC (2005) and ASCE (2005)} to measured data (Baskaran, 1986) regarding pressure coefficients on roof corners with parapet

Based on the wind tunnel measurements building codes recommends reduction in roof wind uplift design loads for tall building. Refer Figures I-9, I-15 and Figures 6.11 and 6.17 respectively in the NBCC 2005 and ASCE 7 –2005.

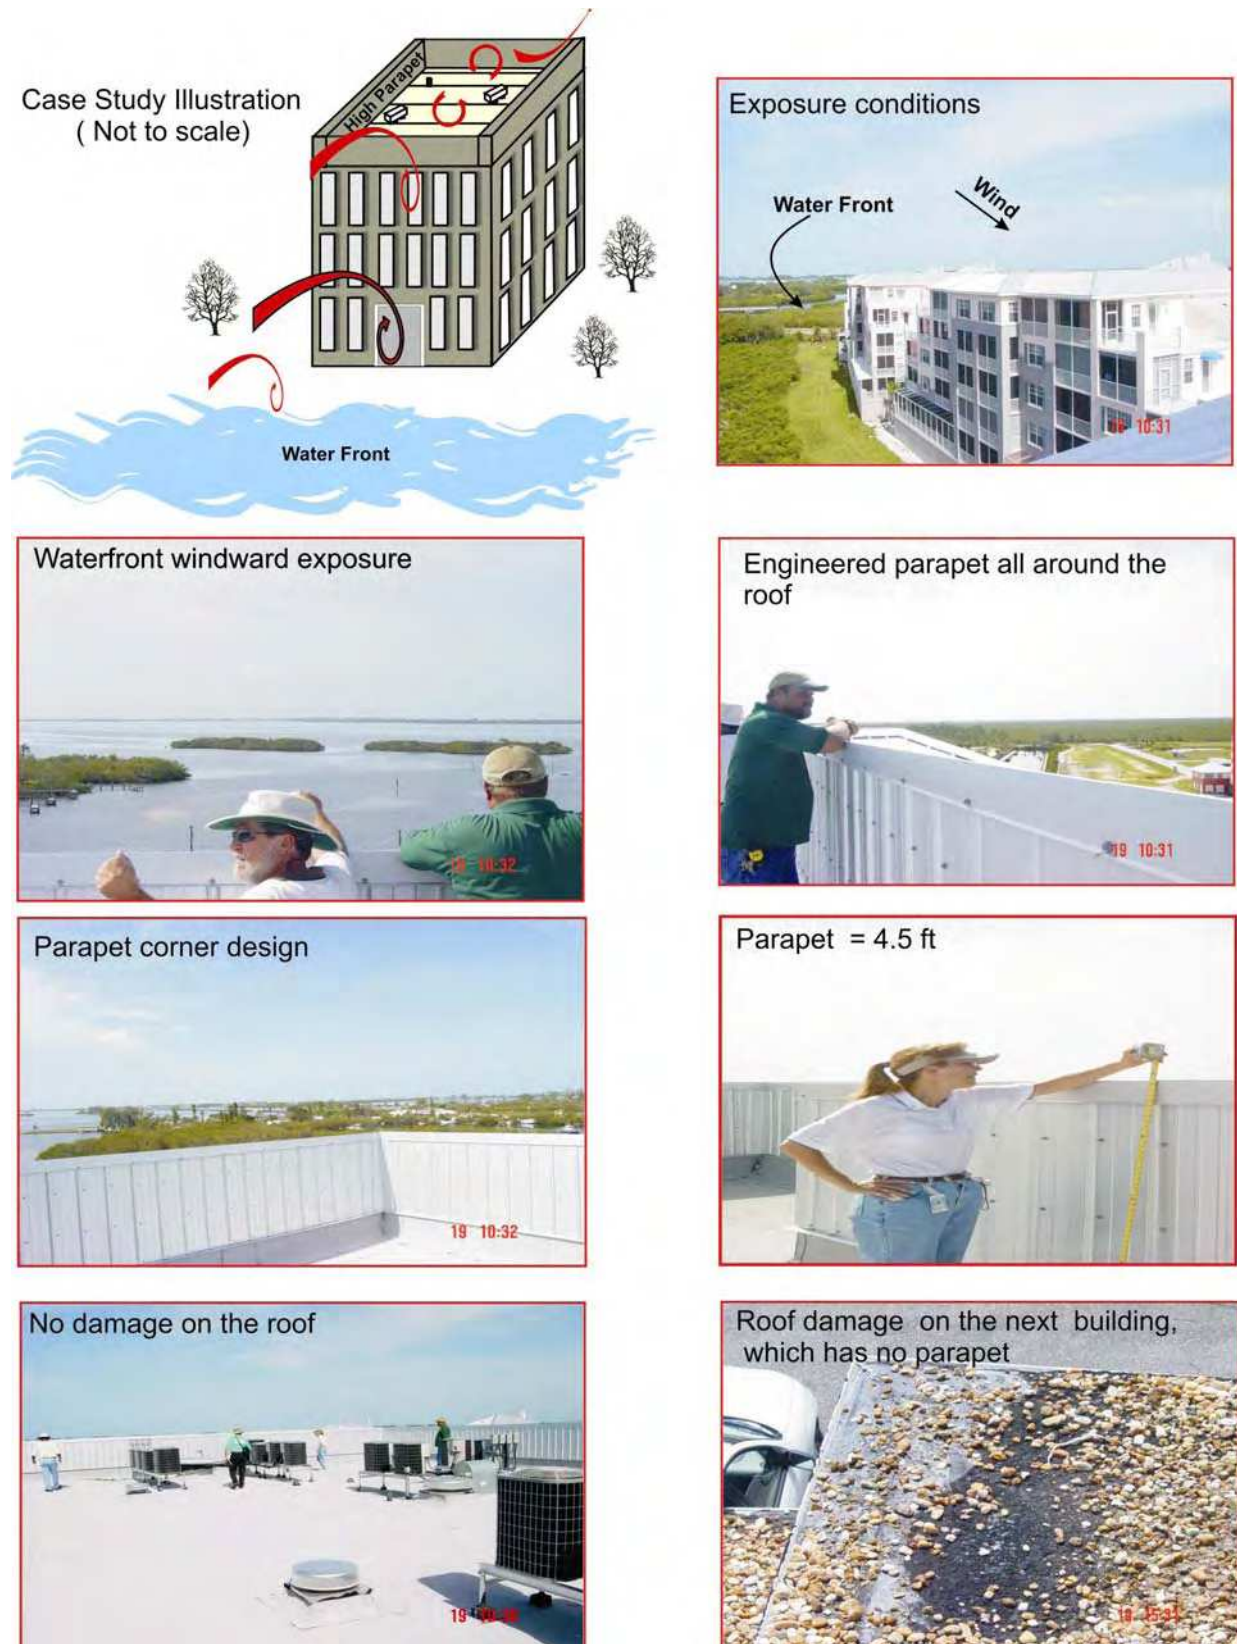
Figure 7 shows the beneficial effect of parapet on the wind uplift resistance of a roof assembly. The investigated building was a six-storey condominium building; stucco wall construction with a poured concrete roof deck. Granule surface BUR system was over mopped-in-place with perlite insulation. Roof was approximately 37,000 sq.ft (3400 sq. m). The perimetric parapets were designed well and the field measurements indicated they are about 5 ft (1.5 m) high. Parapet corners are also well designed and capped with a single piece of metal coping. Wind-related damages were limited to approximately 5% of the wall/parapet cap and underside of soffit. No damages were observed to the roof. As shown in the photograph of Figure 7, the building is relatively new and exposed to water front exposure (“Exposure C” – ASCE 7-05, “Open terrain” –NBCC 2005). This exposure condition is considered to be the most severe exposure condition..

As illustrated in Figure 6, due to high perimetric parapet configuration, the wind suctions on the rooftop of the condominium might have reduced, which possibly could have caused fewer damages to the roof assembly. Also there were many individual HVAC units that were mounted on the condominium rooftop stands and all of these were in excellent condition. No movement was apparent for any of the HVAC units. However, the surrounding buildings in the neighbourhood of this condominium, which had no parapets, experienced severe damages. One such building with gravel blow off from the roof is also shown in Figure 7. This gravel blow-off exposed the membrane to the ultraviolet radiation which may eventually reduce the durability of roof assembly. Note that that the parapet is not the only important factor for the roof assembly to sustain hurricane force uplift. Parapets with sufficient height can influence in reducing the wind-induced loads. It is equally important that other good roofing practices such as attachment of the assembly (i.e., adhesion, cohesion, mechanical attachment, air barrier, etc) should be adequate to sustain whatever uplift forces it experiences. Failure to do so can blows off the roof whether a sufficient height parapet is present or not.

Figure 7: Beneficial effect of parapet on the wind uplift resistance of a roof system

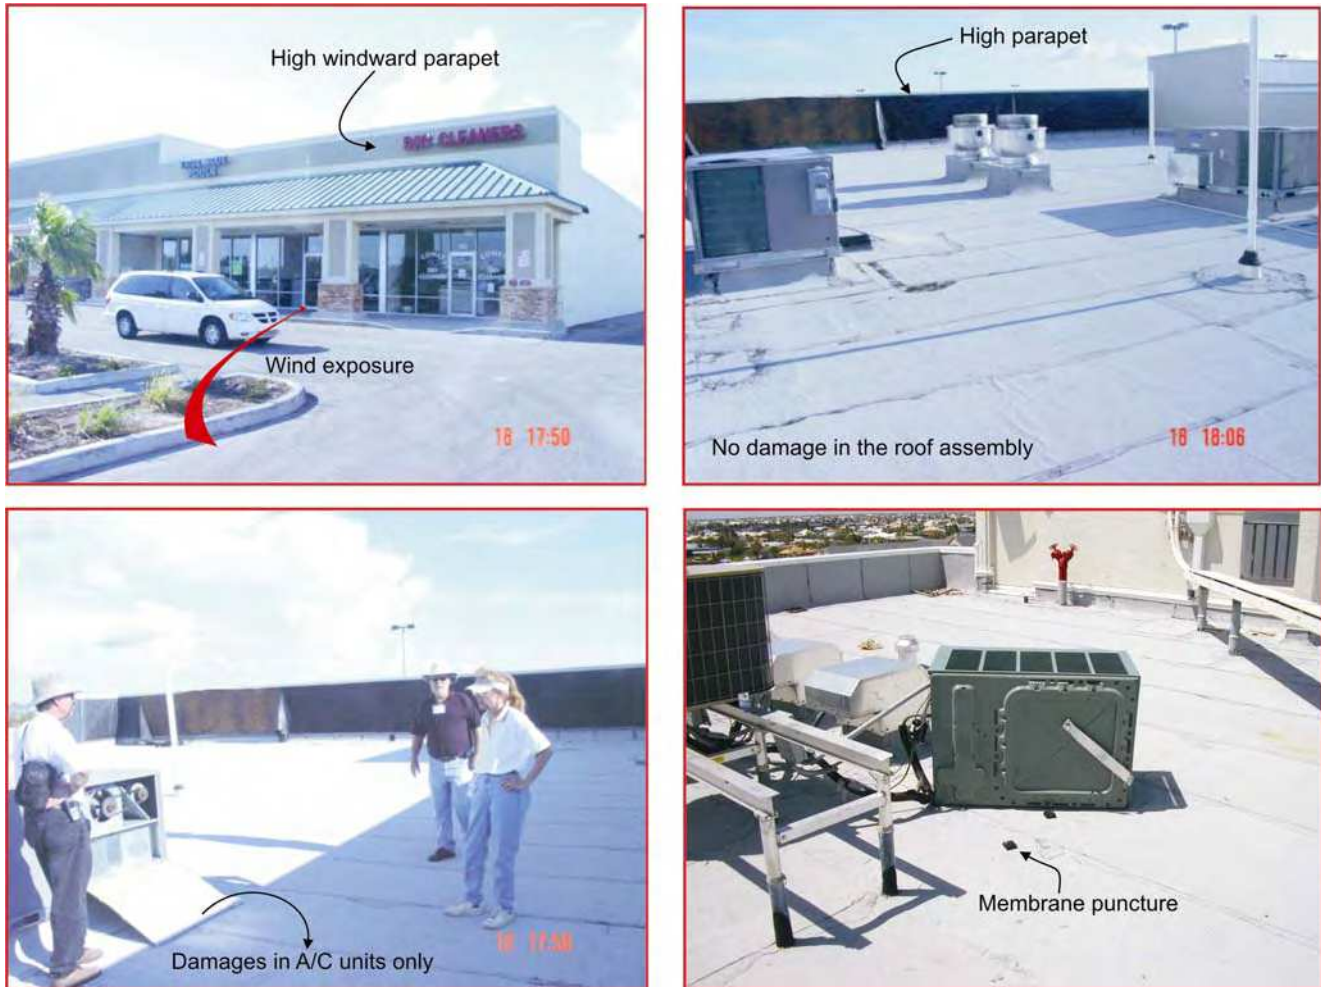
Figure 8 presents a success story of a commercial building roof assembly, which might have survived due to high parapet. Roof area was approximately 5,000 sq.ft (460 sq. m) with a 5.5 ft (1.8 m) parapet on the storefront side, a 4.5 ft (1.5 m) shared wall on one side, a 3 ft (1 m). parapet on the third side, and a gutter edge along the rear side. Granule surface modified bituminous membrane was installed directly over mechanically attached insulation, which had metal deck as the substrate. No damages were noticed on the roof assembly. However, contrary to the case study 2, there were several blow offs of HVAC (Heating Ventilation and Air Conditioning) panels. More severely, some of the air-handling units lifted from their base due to the lack of proper attachment. It has also been observed that these units moved in distance from the base as far as the electric wiring allowed. These blow offs and flip-flop movements caused punctures of the roof membrane and resulted in the failure of the waterproofing capacity of the roof assembly.

Figure 8: Survived roof assembly due to high Parapet and damages caused by the rooftop equipments.

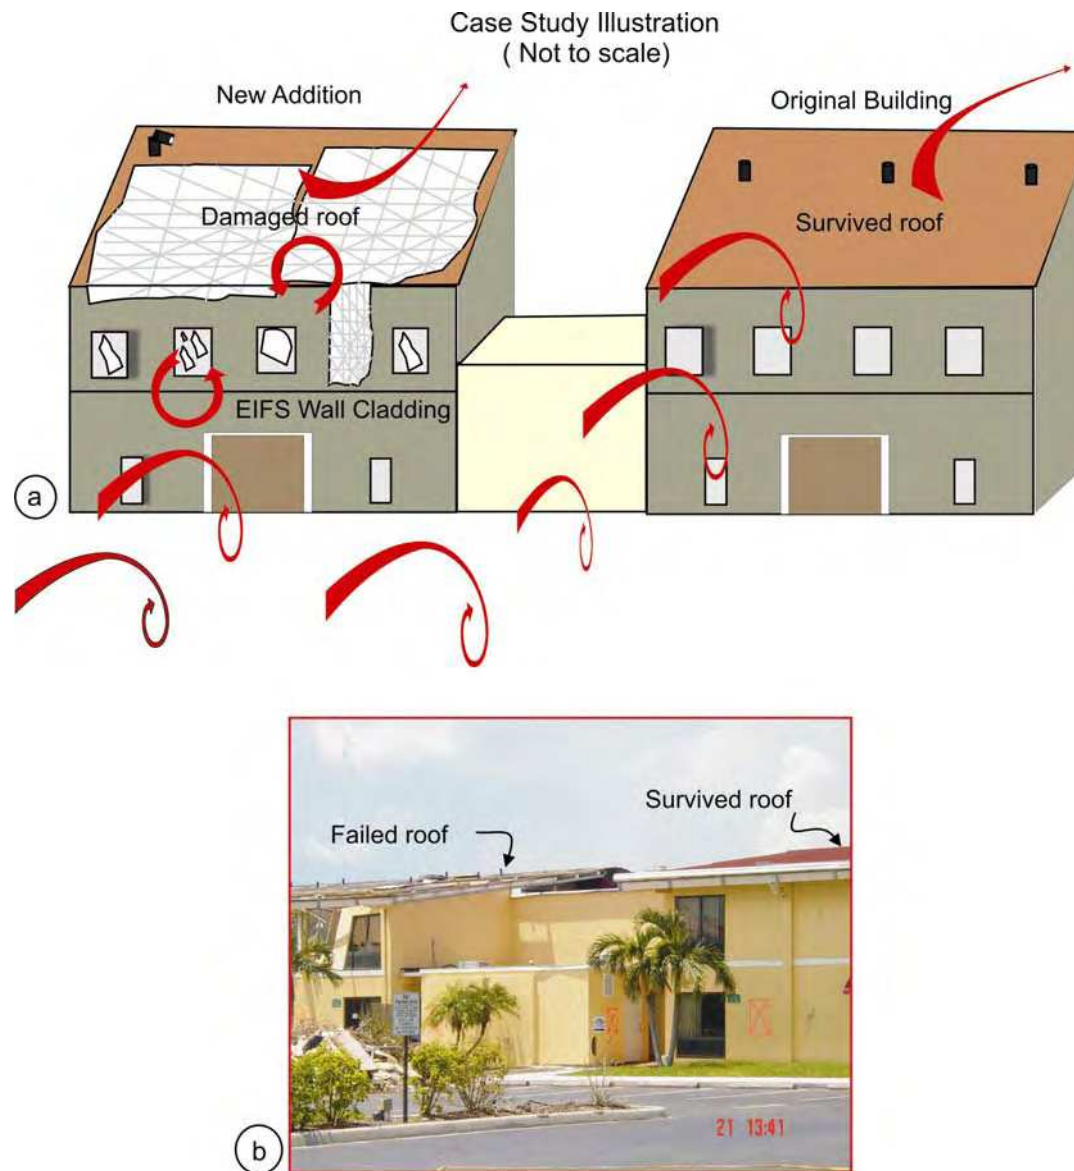
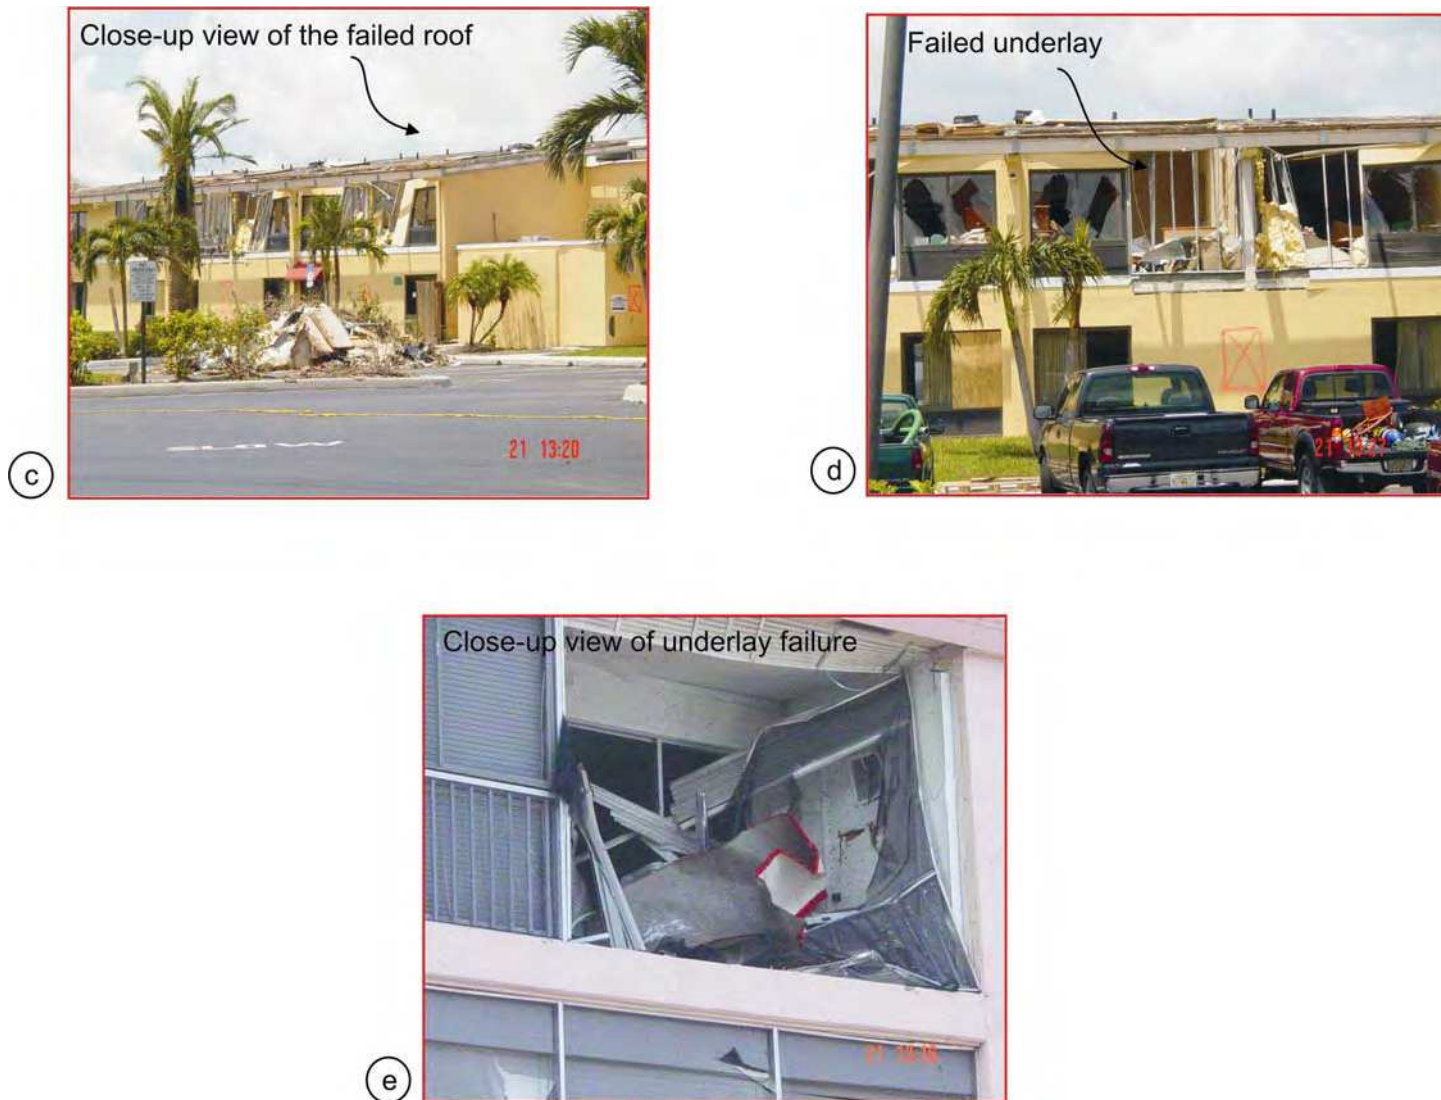
As shown in Figure 9, the failed roof assembly belongs to a multi-occupancy building. The building comprised of two sections, the section on the right was an old construction on which the

roof survived. An addition to this section on the left was a relatively new construction on which the roof assembly completely failed. The walls of this new addition were constructed of EIFS (Exterior Insulation and Finish System). Field failure observation indicated that poor integration of wall/window interface. In other words, windows were just plastered without any anchorage to the structural support to the walls as part of the whole building envelope system. As a result, the blowing wind on the windward side as shown in Figure 9, ripped apart the windows from the EIFS surged inside the building and increased the internal pressure, which ultimately lifted the entire roof assembly. In contrast, the old construction was of brick cladding and the windows were properly integrated with the building envelope, and as shown in Figure 9, it was devoid of any damage. This case study is a good illustration of the scientific phenomenon of internal pressure build-up and the severity of the damage it can cause to the roof assembly.

Figure 9(a),(b): Roofing assembly failure due to sudden build-up in the internal pressure

Figure 9 (c), (d), (e): Roofing assembly failure due to sudden build-up in the internal pressure

Internal pressure build-up can increase the roof failure probability. Probabilities of window cladding failures are high in hurricane prone regions and such failures can significantly increase the internal pressure that can lead to roof uplift failures. It is recommended that designer should allow provisions to account for such failures during the design and the selection of the roofing system. This can be achieved by classifying the building as Category 3 as per NBCC 2005 or Partially enclosed building as per ASCE 7-05.
