**NRCC-53232**

# Development of a remote monitoring strategy for building foundations affected by AAR

G. Nery<sup>1</sup>, D. Cusson<sup>2</sup>, P. Helene<sup>1</sup> & J.C. Margeson<sup>2</sup>

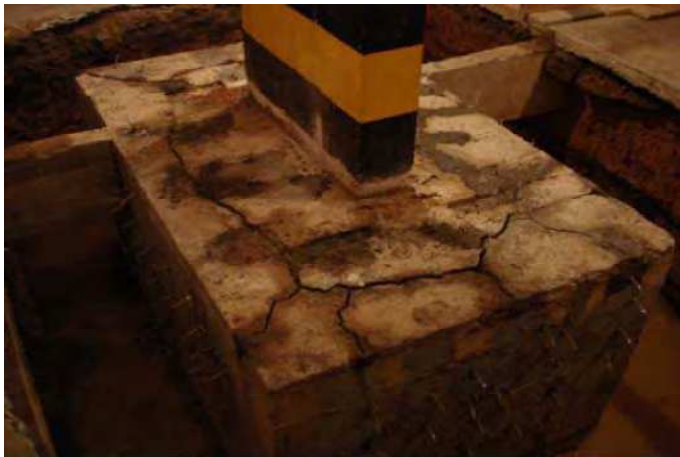
Figure 1. Building foundation with AAR-induced cracks under repair by epoxy injection (Andrade 2006).

The rehabilitation of AAR-affected structures still represents a considerable engineering challenge and the corrective actions are usually very costly, especially for building foundations that are not easily accessible, often requiring the demolition of the concrete slab and excavation to gain access to the buried foundation (Fig. 1). The repair of AAR-affected structures is also problematic since the reactants in the concrete cannot be removed. In order to extend the service life of the affected structures and to keep the life cycle costs down, Newman & Choo (2003) emphasized the necessity of conducting particular corrective actions in cases (i) when the AAR expansion is still progressing; (ii) when the AAR has significantly impaired other concrete structural properties; or (iii) when the AAR damage has rendered the concrete structure potentially vulnerable to other deleterious physico-chemical agents.

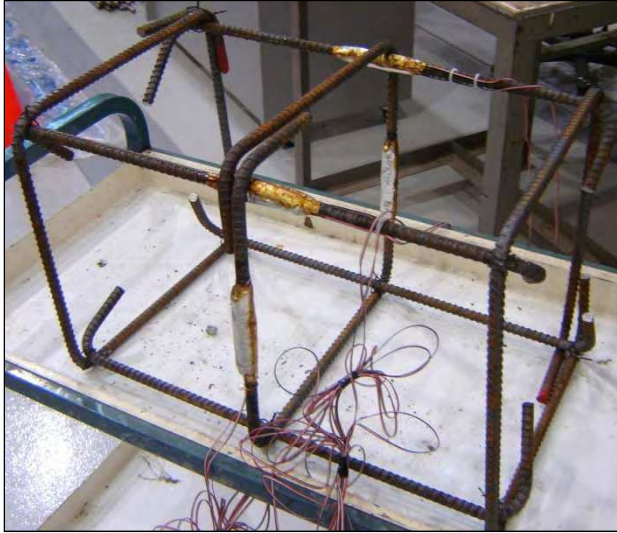
Figure 3. Electrical strain gauges applied on reinforcing bars (with protection).

The strain gauges used in this study had an electrical resistance of 350 ohms. They were bonded to the reinforcement of the concrete prism to monitor the longitudinal strain of 4 reinforcing bars (i.e. 2 horizontal and 2 vertical) as shown in Figure 3. The strain gauges were installed in pairs on opposite sides to compensate the bar bending interference, sealed and protected with rubber coating and aluminum foil (Fig. 3). In order to monitor long lengths of concrete surfaces, long gauges (LG) with gauge lengths of 30 cm and 40 cm were designed and built using thin aluminum plates (thicknesses of 1 mm and 2 mm) with strain gauges bonded to both sides at mid-length (Fig. 4). Each long gauge was anchored to the concrete surface using 2 pairs of short aluminum plates bonded with 24-hour epoxy and 2 concrete screws (Fig. 4). The long gauges were preliminary tested in tension in a hydraulic testing machine, and excellent correlation was found between the strain gauge readings and the imposed displacements (Fig. 5).

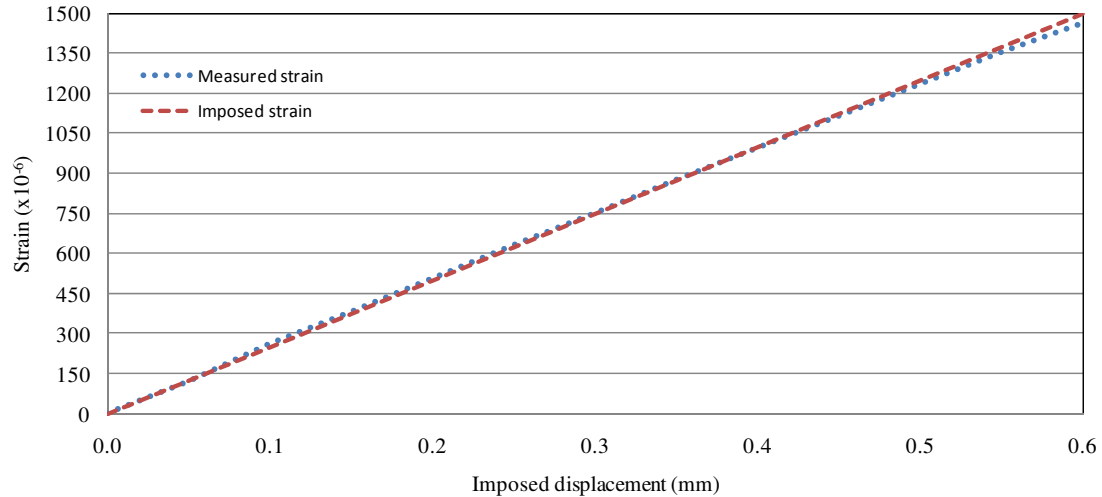
Figure 5. Correlation between imposed displacement and measured strain from long gauge (LG).

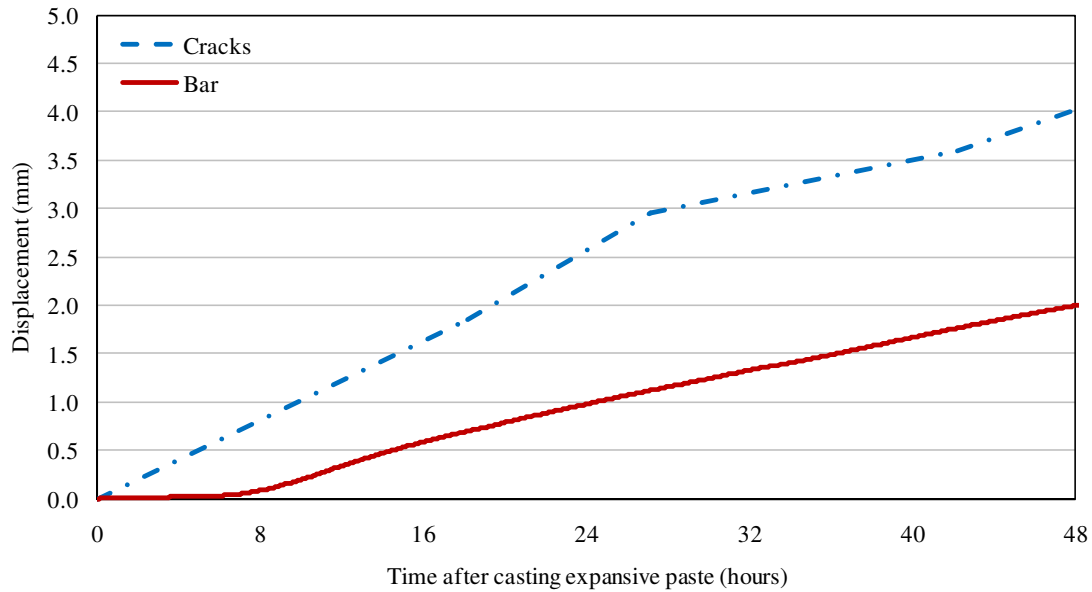
Figure 7. Horizontal expansion measured on Face S.

In order to compare the measured values from the strain gauges to the measured cumulative crack opening or to the measured displacement from the LVDTs, the strain readings were multiplied by the bar length on which the gauges were installed. In general, the strain gauge readings showed good response to the expansion, but were always proportionally smaller than the cumulative opening of the cracks that developed perpendicularly to the sensor measuring path (Fig. 7). This effect could be due to the gradual debonding of the reinforcement from the surrounding concrete when the deterioration level became relatively high in the expanding concrete. The outward bending of the reinforcing bars also caused the failure of some strain gauges, after which time it was difficult to cancel out the bending effect of the bar on the strain measurement. The use of supplementary (redundant) pairs of strain gauges on the reinforcing bars with additional mechanical protection would minimize the impact of gauge failure on the measurements.

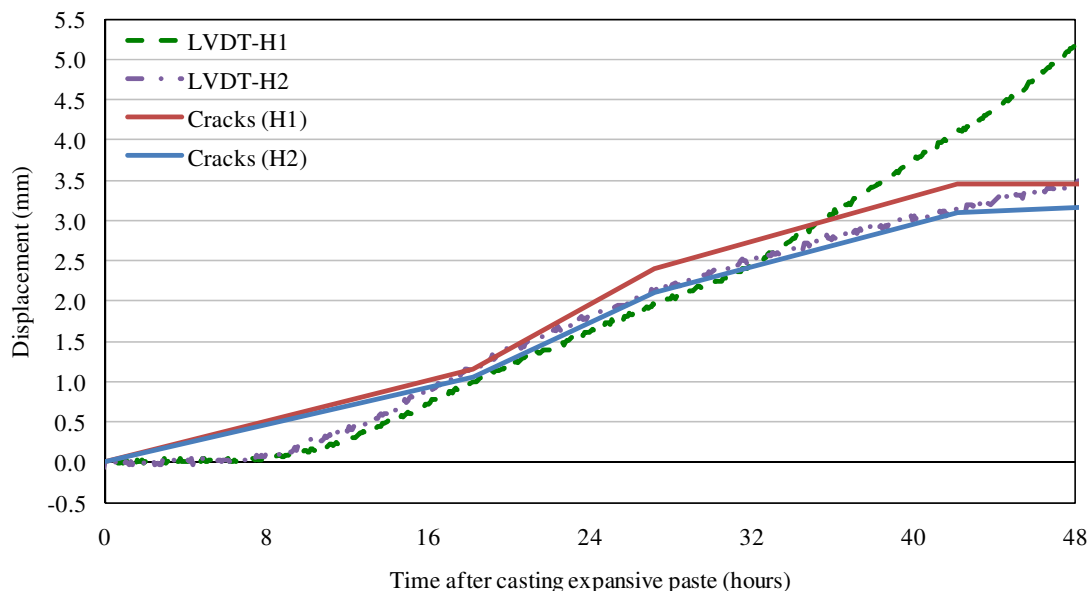
Figure 8. Horizontal expansion measured on Face E.

The LVDTs showed good correlation with the measured cumulative crack opening (Fig. 8). In an advanced stage of accelerated expansion and deterioration, the cracked surfaces of the concrete prism moved in all directions, which affected the alignments of the LDVTs, as expected. The LVDT-H1 on Face E provides an example of the misalignment problem when the cumulative crack opening exceeded 3 mm, as shown in Figure 8.
