DAMAGE TO MASONRY CONSTRUCTIONS BY THE  
ICE-LENSING MECHANISM

by  
G. K. Garden

RILEM/CIB Symposium, Helsinki, 1965

Technical Paper No. 225  
of the  
Division of Building Research

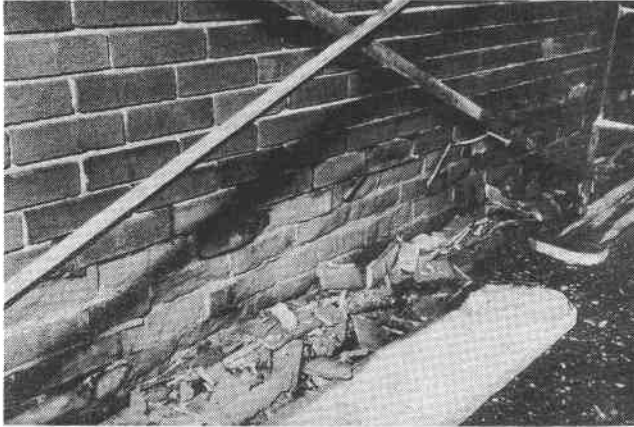
Figure 4. Laminar break-up of masonry units which were covered by a metal flashing.

On a building where roof leaks were permitting water to enter the wall, ice-lensing caused laminar failure of the bricks behind a base flashing. Above the flashing the bricks were not damaged because the partial drying and their tensile strength were sufficient to resist ice-lensing but the mortar joints were damaged. Figure 4 shows the wall with the flashing removed.
