TERRAIN AND VEGETATION OF SNOW AVALANCHE SITES  
AT ROGERS PASS, BRITISH COLUMBIA

P. A. SCHAEERER

REPRINTED, WITH PERMISSION, FROM  
MOUNTAIN GEOMORPHOLOGY : GEOMORPHOLOGICAL PROCESSES  
IN THE CANADIAN CORDILLERA  
B. C. GEOGRAPHICAL SERIES, NUMBER 14, 1972  
P. 215 - 222

RESEARCH PAPER NO. 550  
OF THE  
DIVISION OF BUILDING RESEARCH

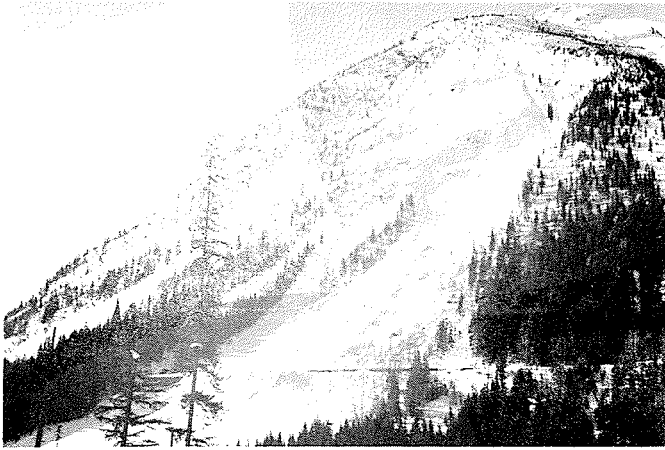
Figure 1 - Cliff type site. Avalanches start to slide at the two sharp drops of slope.

The important characteristic here is one or more steep outcrops of bedrock in a slope covered with loose rock, grass, or shrub (Figure 1). Snow starts to slide on or just below the steep parts of the terrain and then sets more snow into motion on the slope below. The rock outcrops have surface slope angles greater than  $42^{\circ}$  and in order for avalanches to grow to a large size the slope immediately below the starting point must have an incline of  $28^{\circ}$  or more. Cliff-type terrain can usually be recognized by its lack of vegetation and can be identified on black and white air photographs as horizontal bands in a light tone.

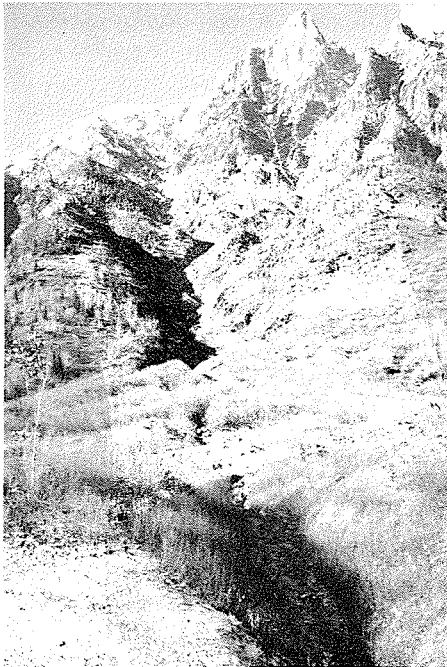
Figure 2 - Gully type avalanche site.

Gully-type sites consist of a V-shaped main gully with numerous branches of steep-sided gullies (Figure 2). There is usually no well defined avalanche starting zone. Avalanches may start in any one of the gullies and, when descending into the main channel, set into motion the unstable snow on the steep gully sides.

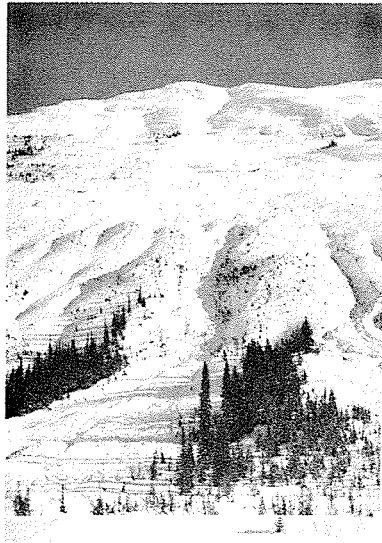
Figure 3 - Lee slope site. The direction of the prevailing wind is from the right-hand side; avalanches start to slide on the slopes in the shade of gully and lee slope sites.

This type of terrain can be found on the leeward side of mountain ridges where large amounts of wind-transported snow are deposited (Figure 3). The slope need not have any steep sections, such as cliffs, but in order to produce large avalanches it would appear that the incline should be more than  $28^{\circ}$ . Avalanches usually fracture close to the ridge in the convex part of the slope just above the deepest accumulation of snow.

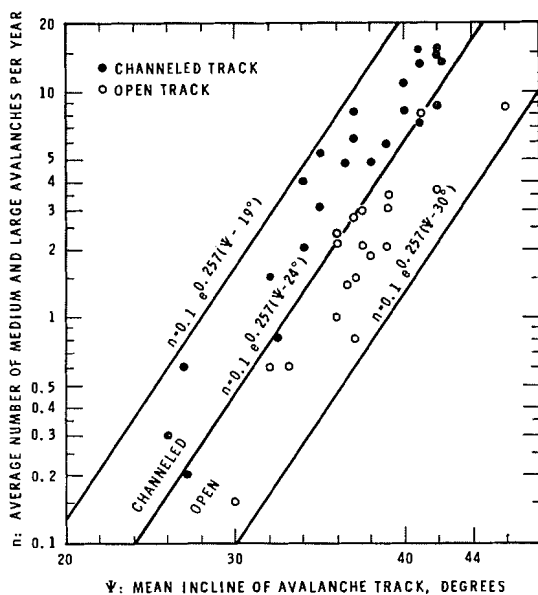
Figure 4 - Relation between frequency of occurrence of avalanches and incline of terrain.

The avalanches close to the highway at Rogers Pass have been recorded since 1953. In Figure 4 the average number of medium and large size avalanches are plotted against the average

slope angle of the avalanche track for the cliff-type and lee slope-type sites. Gully sites could not be included in the analysis because, at most of them, avalanches were controlled by artillery. Use of artillery produces smaller, more frequent avalanches than would occur under natural conditions. The incline was measured over the full length of the track between the usual starting zone and the beginning of the outrun zone, and the analysis included only those avalanches that were large enough to run over the full length of the track.

The graph shows that in order to produce large avalanches a steeper incline is necessary on open slopes than in channels such as valleys, gullies and troughs. One important reason for the difference is that channels tend to have many small avalanches and the snow deposited by them forms a smooth sliding surface. Loup and Lovie (1967) also report a remarkable difference in the frequency of avalanches between gullies and open slopes.

Exposure to wind and sun, variations of the incline, ruggedness of the terrain and ground cover are responsible for the scatter of the points in Figure 4. It is not yet possible to analyze the influence of terrain characteristics. The method of slope angle distribution, recommended by Strahler (1956), appeared to be promising. The surface slope angles were determined with the
