BEST2 Conference (Building Enclosure Science & Technology): 12 April 2010, Portland, (OR), USA [Proceedings], pp. 1-15, 2010-04-12

A Field Monitoring Investigation of the Effect of Adding Different Exterior Thermal Insulation Materials on the Hygrothermal Response of Wood-Frame Walls in a Cold Climate

W. Maref* (wahid.maref@nrc.ca), **M. Armstrong** (marianne.armstrong@nrc.ca),
M. Rousseau (madeleine.rousseau@nrc.ca) and **W. Lei** (William.lei@nrc.ca)
National Research Council Canada

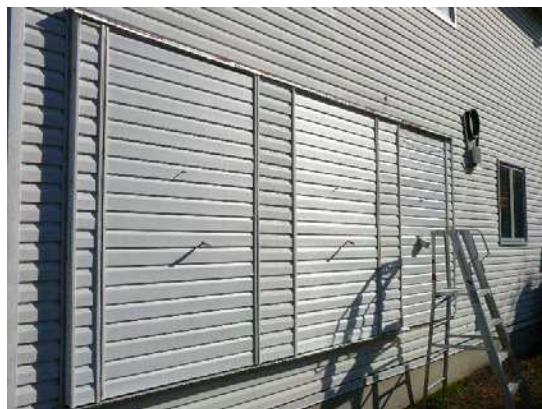
Figure 1: Field Exposure of walls facility and exterior view of the three test specimens

To gather data to verify the research hypotheses, three wall assemblies (W1, W2 & W3) of different composition were placed side-by-side in the test bay of the NRC-IRC Field Exposure of Walls facility (FEWF). W1 specimen was built using a traditional wood-frame method, with glass fiber insulation batts between studs, while W2 included an exterior insulation material with lower air and vapour permeance, and W3 included an exterior insulation with higher air and vapour permeance. See the next section for a full description of the test specimens.

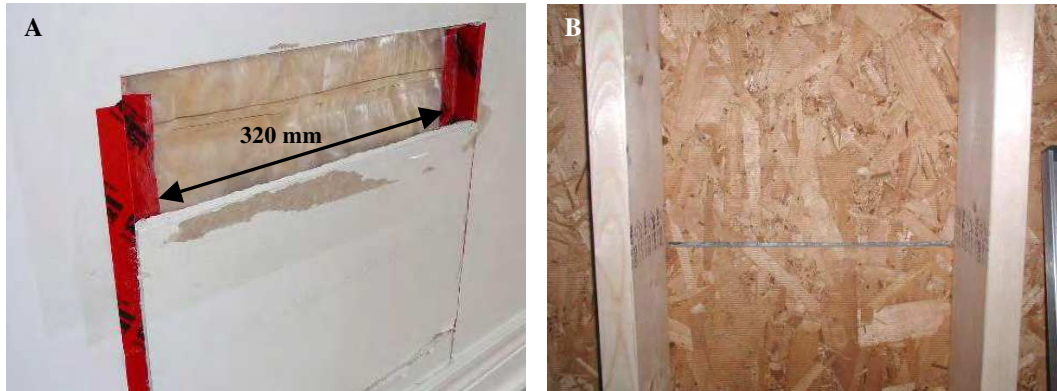
Figure 5: Air leakage openings A - Horizontal opening in the polyethylene membrane of 320 x 3mm. B- A 6 mm horizontal opening in the wood-based sheathing representing an open horizontal joint between panels

W1 test specimen was exposed to naturally occurring weather conditions outdoors and the uncontrolled indoor conditions of the adjacent room (about 20% RH- dry wintertime level). No deficiency in the air/vapour barrier polyethylene membrane was introduced in W1. W2 and W3 test specimens were subjected to naturally occurring weather conditions outside, and to a variety of indoor relative humidity (30-50%) and air pressure (up to 10 Pa above room air pressure) as introduced in the indoor climatic chamber. In wintertime indoor relative humidity levels in the indoor climatic chamber were controlled to represent low, average and high indoor RH conditions. Indoor air pressure levels resulted in a low level of pressurization under calm wind conditions. The two energy retrofitted test specimens were subjected to air leakage (infiltration or exfiltration depending on wind pressure) when a path for airflow was introduced at the poly air/vapour barrier and drywall indoors, and at the wood-based sheathing board (a 6 mm (1/4 in) gap at mid-height of the test specimen, simulating an open joint between two boards installed horizontally).

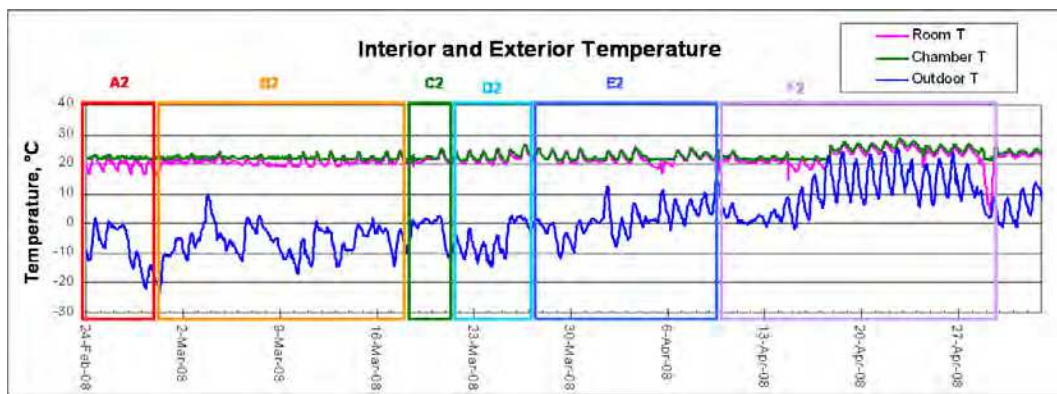
Figure 8-The six steps of the Phase 2 test program with corresponding indoor room, chamber temperature and outdoor temperature.

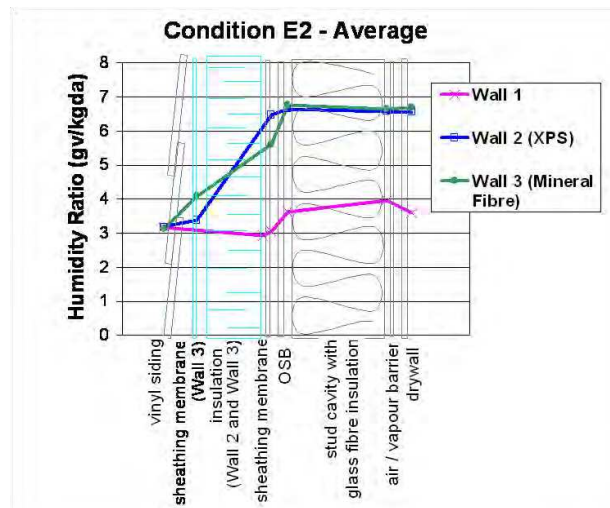
Figure 20 W2 and W3 were predominantly subjected to air exfiltration, and exposed to 50%RH indoors. W1 was not changed from Condition A2 and had no air leakage path in place.

Figure 21 shows the average humidity conditions at each layer of the wall assemblies during Condition E2 (10 Pa chamber pressure, 50% indoor RH). During this period, the 10 Pa pressure forced exfiltration on all but one day. As a result, moist indoor chamber air was driven into the wall. The graph shows the effect of air exfiltration on the increase in moisture content of the air
