Winter concreting: canadian practice

WINTER CONCRETING - CANADIAN PRACTICE

DBR Paper No. 848
Division of Building Research

A General Report
presented at the
Second International RILEM
Symposium on Winter Concreting
October 14-16, 1975
Moscow, U.S.S.R.

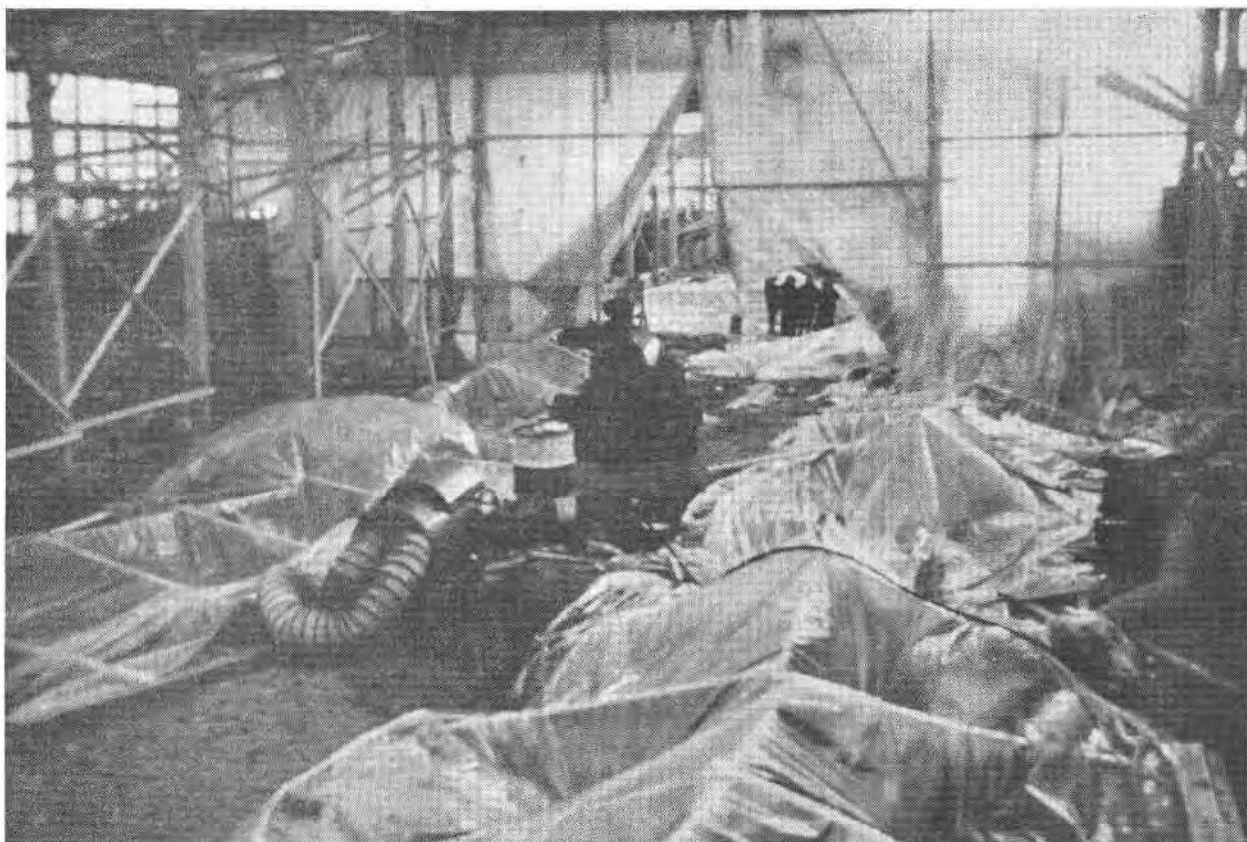
FIG. 5 Temporary enclosure, Fermont project (courtesy Pentagon Construction (1969) Co. Ltd.)

The construction of the foundations for the 3 1/2-storey wood-frame apartments posed a different problem. A complete temporary enclosure was required if proper conditions were to be maintained for all the various operations including footings, basement walls, columns and structural floor slabs and beams. A hoarding was therefore designed to take advantage of the materials on site which would eventually be incorporated in the superstructure of the building (Fig. 4). The wood trusses that supported the roof provided a clear span with lean-to's added on either side to give the required width. Beams and posts were laminated from 4- by 14-cm lumber; floor joists were used for the lean-to roofs. The trusses were assembled into panels and covered with polyethylene prior to being hoisted into place. The enclosure performed satisfactorily; it even withstood, without damage, winds gusting to 100 km/hr (Fig. 5).

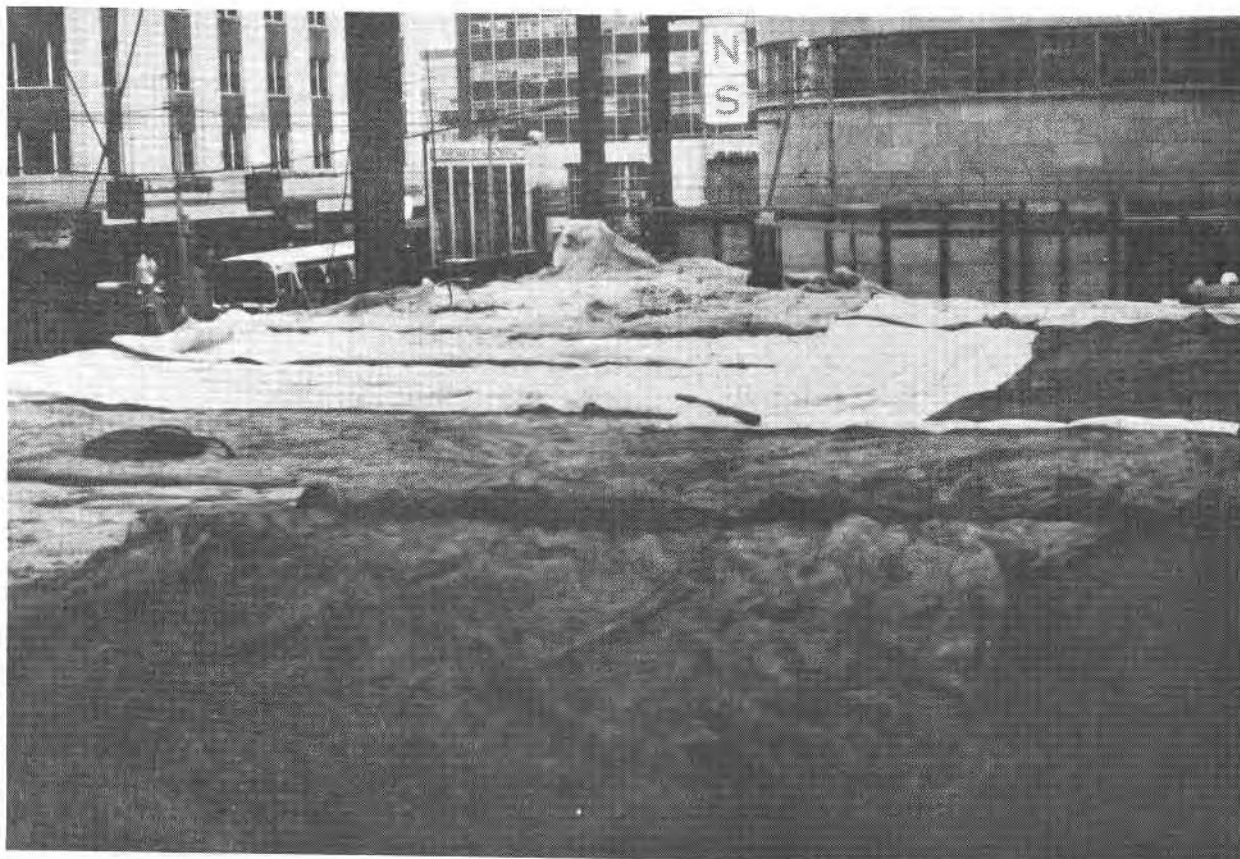
FIG. 8 Insulating blankets protecting newly placed concrete floor,
Edmonton Centre

Floors for the three lower levels, which housed retail stores, were of reinforced concrete. The slab thickness varied between 15 and 20 cm. Plywood was used to form the slab, columns and beams. Heaters were placed below the slab to be cured and the area enclosed with polyethylene and canvas. These heaters, which also burned natural gas, were larger than those used for the core; they were rated at 1950 MJ. The temperature within the enclosure was maintained at about 18°C. The slabs were not required to be trowel finished, they were merely screeded to the correct elevation and given a light wood float finish. As soon as the concrete had hardened sufficiently, the floors were covered with a 5-cm-thick insulating blanket with the polyethylene cover acting as a curing membrane (Fig. 8). Although these structural slabs were heated for seven days, stripping of the formwork generally started on the fourth day. The specified concrete strength for the floors was 20 MPa. Columns were not heated but merely wrapped with insulation.

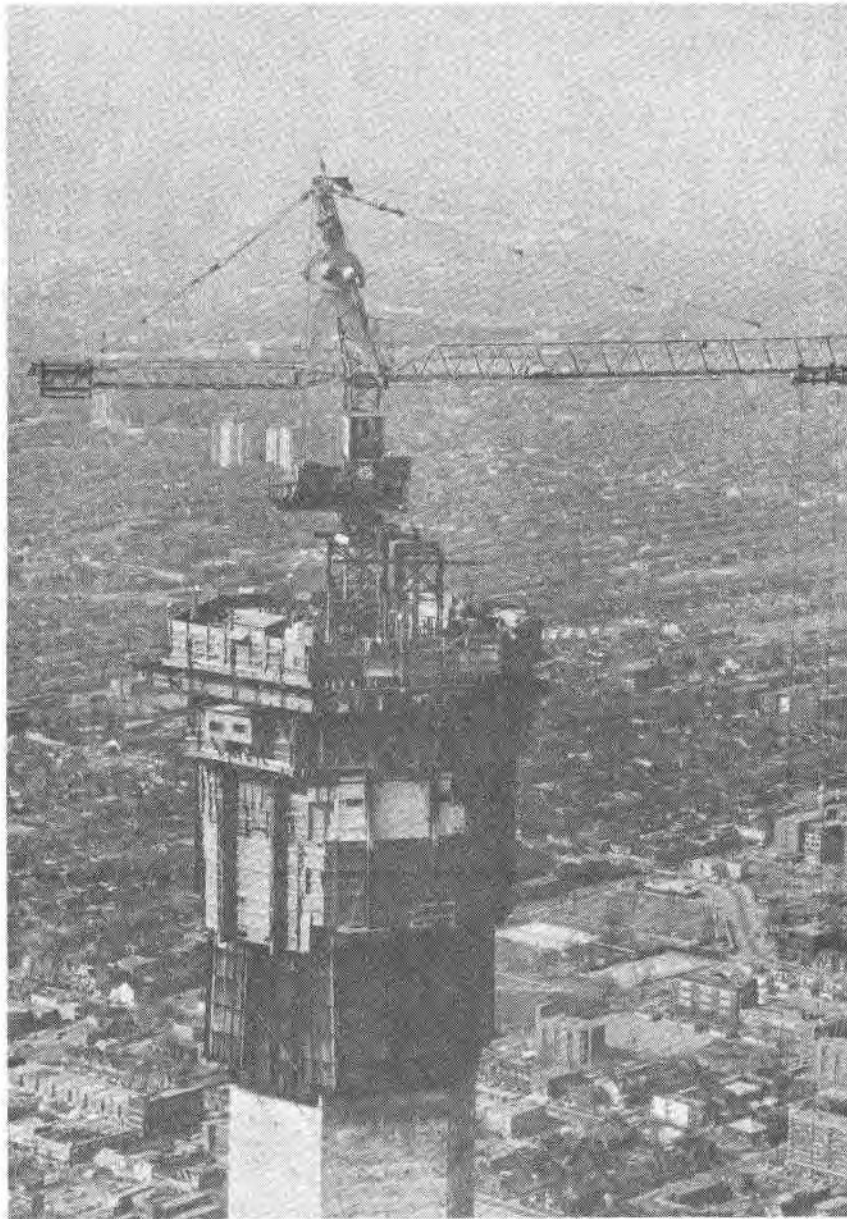
FIG. 9 View of tower showing winter protection and working area at the top of the slipform, CN Communication Tower (Courtesy CN Tower)

The CN Tower in downtown Toronto (Fig. 9) consists of a hexagonal core 11 m in diameter with 61-cm-thick concrete walls rising 446 m above the foundation.

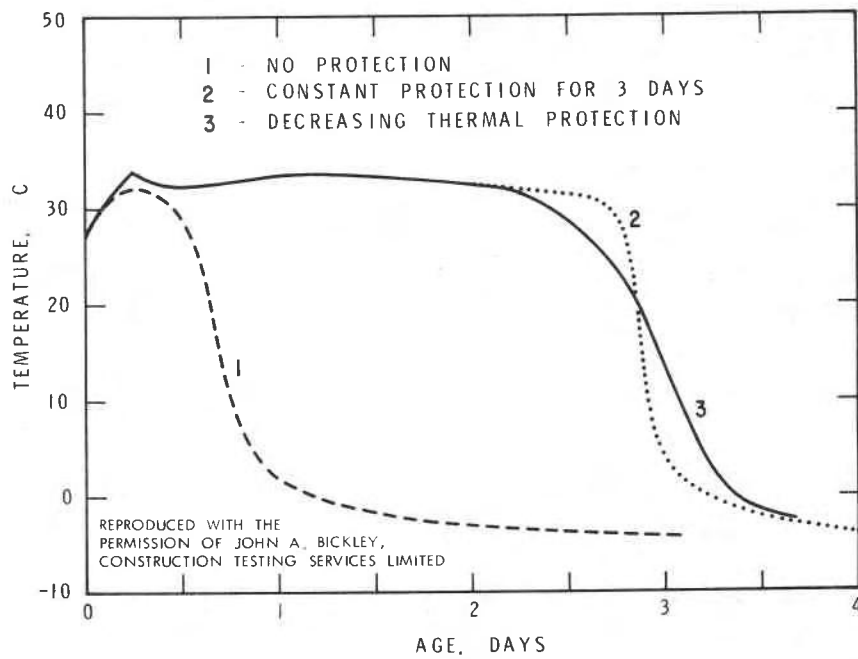
FIGURE 11
GRAPH SHOWING CALCULATED SURFACE TEMPERATURES
OF CONCRETE WALL, CN TOWER

If slipforming were to proceed at the rate of 3.65 m per day, the second requirement would be satisfied by suspending an 11-m-high insulated skirt from the slipform. This skirt, shown in Fig. 10, was constructed as follows: top section, 6 m high, of 2.5-cm-thick rigid polystyrene sandwiched between 2 sheets of plywood; middle section, 2.5 m high, of 1.25-cm-thick sheet of polystyrene between two sheets of plywood; bottom section, 2.5 m high, of plywood. This provided adequate protection for initial strength gain. It

also allowed the concrete to cool sufficiently before being exposed to the atmosphere to avoid temperature gradients severe enough to cause cracking (Fig. 11). Some heat was provided to the interior of the core by a 7,000 MJ heater installed at the base of the tower.

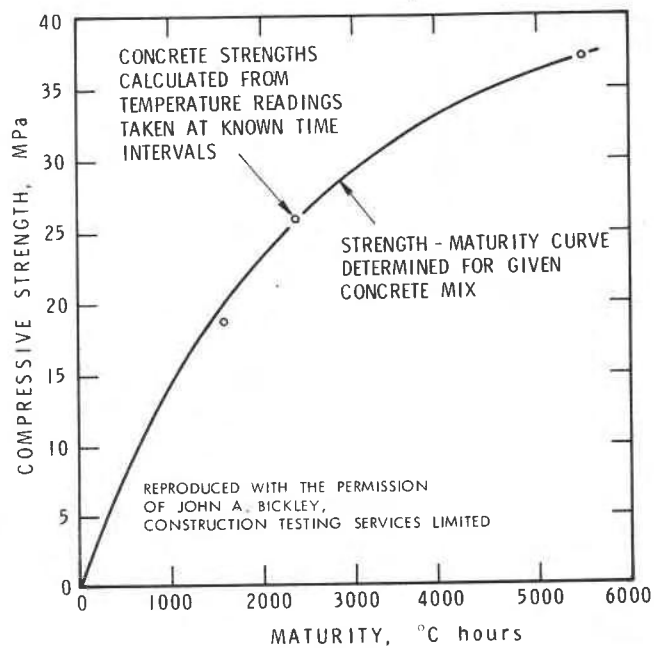
FIGURE 12
GRAPH SHOWING CORRELATION OF STRENGTH -
MATURITY CONCEPT, CN TOWER

With a planned rate of rise of 3.65 m per day, the 2-day accelerated tests did not enable the resident engineer to monitor concrete strengths as they developed. It was therefore decided to adopt the maturity testing concept along with the 2-day accelerated tests. A strength maturity curve for the concrete mix in use was established. Thermocouples were installed in the concrete during each shift (1.2 m vertical spacing). The thermocouple wires were coiled on free-turning reels attached to the slipform framework so that the wires unwound as the form rose and readings could be taken at regular intervals within the enclosure. Individual thermocouple readings were plotted against the previously established strength-maturity curve as a function of time and temperature so that the in-place strength of the concrete could be predicted as it developed (Fig. 12). Verification of the in-place strength and of the maturity concept was obtained from the testing of concrete cylinders cored out of the tower walls.

These two testing methods, accelerated curing and strength maturity measurement, demonstrated the adequacy of the concrete and thus the safety of the structure. The concreting crew, however, could not wait for these results to determine the safe rate of concrete placing at any given time. It was necessary to determine quickly and accurately if the 8-h-old concrete was hard and strong enough to be slipped out of the forms; neither testing method could provide this information. As a result, a very simple test was devised which proved reliable. It consisted in having a man push a smooth steel bar 1 cm in diameter into the fresh concrete and measure the depth of penetration to the hardened concrete. The bar bore a mark 1.37 m up from the bottom end corresponding to the over-all
