Use of fibre reinforced polymer reinforcement integrated with fibre optic sensors for concrete bridge deck slab construction

https://doi.org/10.1139/cjce-27-5-928 Canadian Journal of Civil Engineering, 27, October 5, pp. 928-940, 2000-10-01

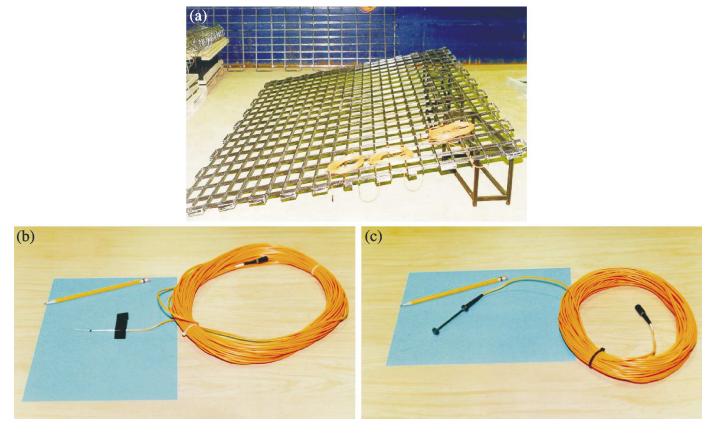
Fig. 1. CFRP NEFMAC C19-R2 grid and integrated FOS: (*a*) CFRP grid with integrated Fabry-Perot fibre optic sensors (FOS), (*b*) typical surface mounted Fabry-Perot FOS, and (*c*) typical embedded Fabry-Perot FOS.

Figure 1 shows a typical CFRP NEFMAC C19-R2 grid. The grids were manufactured with longitudinal spacing of 200 mm and transverse spacing of 100 mm. Experimental tests on the CFRP grid using the water-immersion method yielded a density of 1360 kg/m³ and a cross-sectional area of each bar element of the grid around 200 mm². Extensive tensile tests indicated an average ultimate strength of 1400 MPa, modulus of elasticity of 90 GPa, and 1.5% elastic strain at failure. In addition, conventional deformed steel rebars of 15 mm diameter having a yield strength of 400 MPa and elastic modulus of 200 GPa were used as steel reinforcement for the laboratory investigation, and galvanized deformed steel rebars of similar size and mechanical properties were used for the field application.

A number of CFRP reinforcement grids were integrated with fibre optic sensors during the manufacturing process as shown in Fig. 1. This was the first attempt in the world to use integrated fibre optic sensors to monitor the performance of the FRP reinforcement inside the concrete in a bridge structure. Figure 9 shows the schematic depiction of installed gauges on the steel girders and the nine locations of the embedded strain gauges placed inside the concrete.

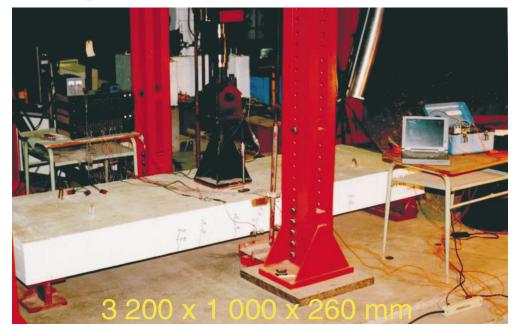
Fig. 2. Set-up for slab test under point load at the centre.

on four one-way concrete slabs of size 3200 \times 1000 \times 260 mm were performed in the laboratory, as shown in Fig. 2. The slabs were reinforced in the tension zone with either NEFMAC C16 type grid, NEFMAC C19-R2 type grid, or conventional 15 mm diameter deformed steel rebars. The slabs were extensively instrumented to record the structural response of slabs during the load testing. The slabs were subjected to static and dynamic loading with four million cycles. The analysis of the results included crack-width, midspan deflection, strain in concrete and reinforcement, ultimate moment capacity, and failure pattern. Figure 3 shows the crack patterns and failure modes of the slabs. The details of this laboratory investigation were provided in another study (Chekired et al. 1999; Benmokrane et al. 1999). The results available from the study clearly indicated the viability and effectiveness of CFRP grid reinforcement to be used in reinforced concrete deck slabs. Hence, CFRP NEFMAC

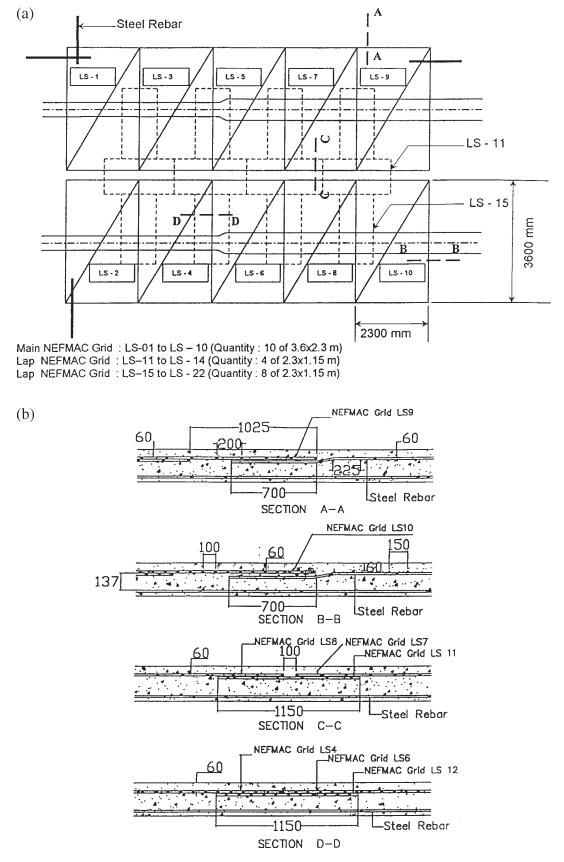
Fig. 4. Layout of the bridge: (a) plan and (b) section.

The Joffre bridge consists of five longitudinal spans of different lengths between 26 and 37 m and has four transverse spans, each of 3.7 m (Fig. 4). The thickness of the concrete deck slab is 260 mm. The shaded areas of concrete bridge deck, sidewalk, and traffic barrier, as shown in Fig. 4, were selected for the application of FRP reinforcement. The structural design was carried out according to appropriate

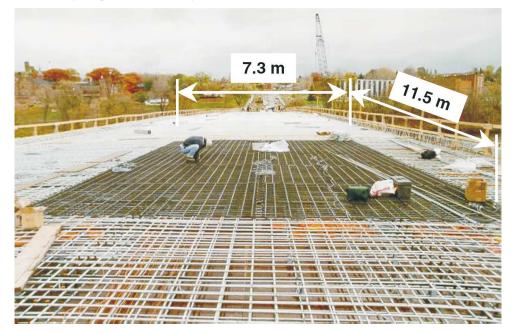
Fig. 5. Structural details of bridge decks: (a) plan view of CFRP grids used in deck slab and (b) cross section of CFRP grid reinforced concrete slab.

The selected part of the deck slab $(7.3 \times 11.5 \text{ m})$ was reinforced with CFRP reinforcement. The reinforcement near the top surface of the slab was made of CFRP grids but steel rebars were placed at the bottom (Fig. 5). This was done because steel reinforcement at the top face of the deck slab, close to the road surface, is prone to corrosion related damage and hence should be replaced with FRP rebars. The main CFRP reinforcement consists of 10 CFRP grids each 3.6 m in length and 2.3 m in width. In addition, a total of 12 CFRP grids of size 2.3×1.15 m were used as laps, in both

longitudinal and transverse directions, on the joints of main CFRP reinforcement grids (Fig. 5*a*). The grids were placed in such a way that the longitudinal spacing was 200 mm and the transverse spacing was 100 mm with reference to the deck slab. The light weight of the FRP reinforcements was very convenient for easy handling and placement during construction. In order to resist the floatation of the lightweight CFRP grid during vibration of fresh concrete, it was tied with plastic chairs, fixed to the bottom steel reinforcement, at 2000 mm intervals. The lap splice length between CFRP grid and steel rebar was 700 mm long and that between CFRP grids was 525 mm long (Fig. 5*b*) to satisfy the basic development length required for the lap joint. Plastic spacer bars were used in the reinforcement splice laps between CFRP and steel rebars to avoid any contact between

them to prevent the occurrence of galvanic current flow (Fig. 5b). A general view of FRP reinforcements installed in the deck slab can be seen in Fig. 6.

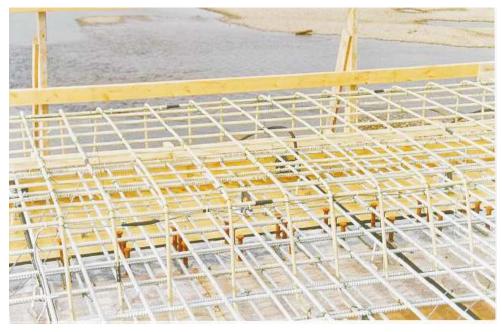
Fig. 7. Close-up view of GFRP reinforcement installed in the sidewalk.

A portion of the traffic barrier and the sidewalk (4.75 m) were reinforced with GFRP reinforcement. This reinforcement consisted of GFRP straight and bent-up rebars, as shown in Figs. 7 and 8.

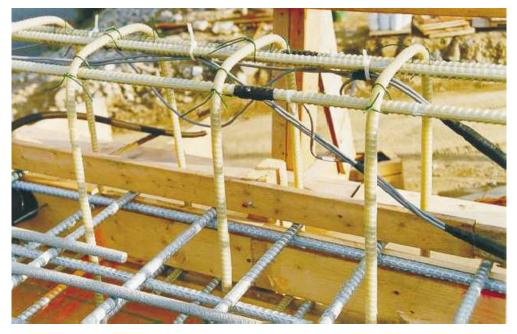
Fig. 8. GFRP reinforcement in the traffic barrier.

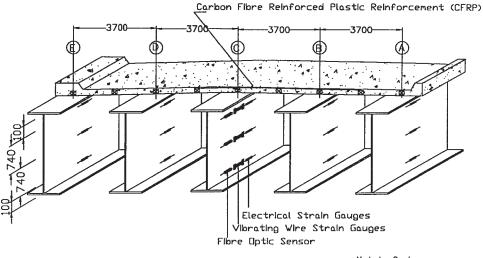
Fig. 9. Layout of fibre optic sensors, vibrating wire strain gauges and electrical strain gauges.

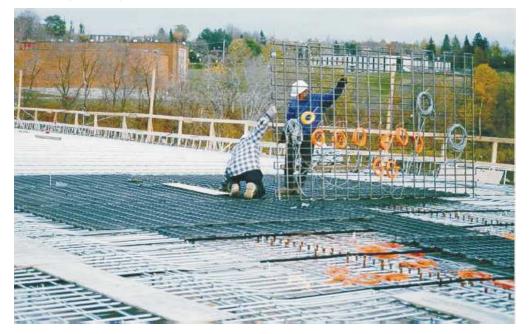
Fig. 10. Instrumented CFRP grid during the installation.

Figure 10 shows a CFRP reinforcement grid, instrumented with fibre optic sensors and electrical strain gauges, on its way for final placement on the bridge deck. Figure 11 shows placement of ready-mix pumped concrete on the bridge deck.

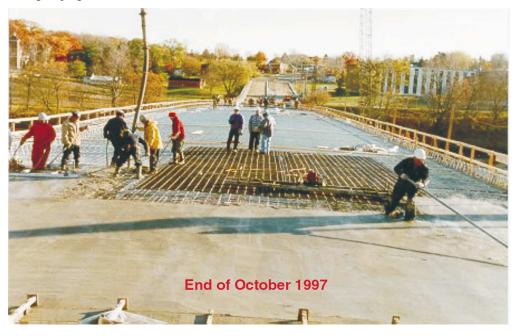
Fig. 11. Concrete casting in progress.

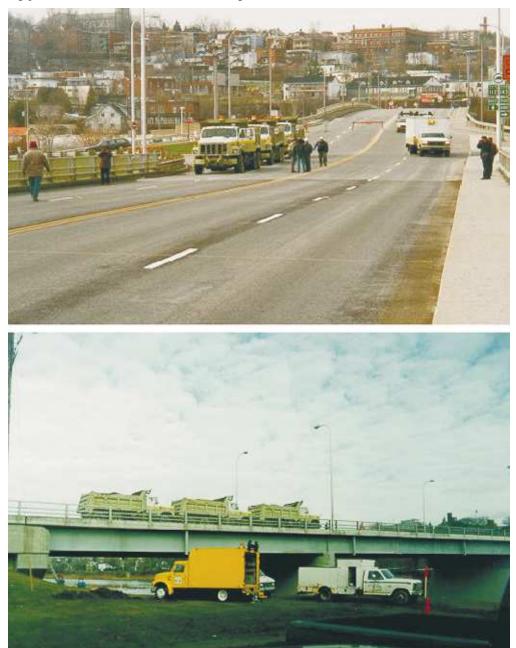
Fig. 13. Trucks being positioned for static calibrated load testing.

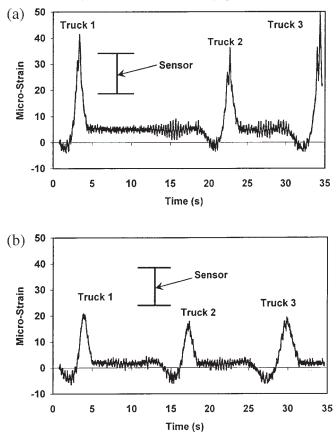
Fig. 14. Strain responses from dynamic load tests of Joffre bridge: (*a*) strains recorded at the middle of the web of the girder due to trucks loading (path B) and (*b*) strains recorded at the middle of the web of the girder due to trucks loading (path C).

Figure 14a and b shows the results of strains recorded using fibre optic sensors at the middle of the web of steel girder due to movement of trucks loading at paths B and C. The data clearly show that during 35 s, a large strain event (e.g., a truck) followed by two similar strain events (e.g., two consecutive trucks) took place on the bridge. As indicated in Fig. 14a and b, the truck produces peak positive strains of about 40 and 20 micro-strain at the middle of the steel girder web, for truck loading on path B and path C, respectively. As shown in Fig. 14b, a closer look at the data reveals that the strain response at the two locations changes sign between the time periods of about 1 to 3, 14 to 16, and 26 to 28 s. For instance, in Fig. 14b (middle web FOS), negative strain of about 6 micro-strain is observed in the FOS followed by a sharp rise in strain towards the positive direction, eventually peaking at about 20 micro-strain. This can be explained as follows. The steel bridge girder is a continuous structure that undergoes compressive strain at the middle and bottom web prior to the truck reaching the sensor location (half-span, girder I). The truck travelling at about 50-60 km/h reaches the location directly above half-span girder-I, thus inducing a bend in the beam due to direct loading, which results in positive strain at the middle of the web of the I-beam. A similar argument explains the sensor responses at the bottom of the web of the steel girder.

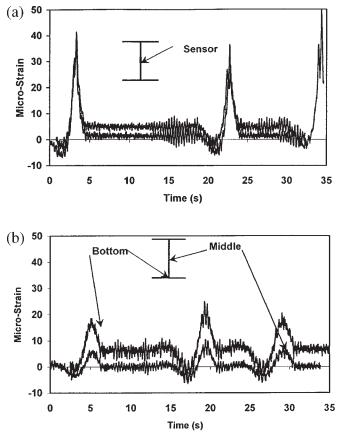
Fig. 15. Strain responses from dynamic-calibrated load tests: (*a*) strains recorded from two similar tests and (*b*) strains recorded at the middle and bottom edge of the steel girder.

Figure 15*a* and *b* presents strains recorded using fibre optic sensors at the middle and bottom of the web of a steel girder due to movement of trucks at several pathways along the bridge deck. The striking similarity in the recorded data at the middle of the beam girder (Fig. 15*a*) obtained from two similar tests and the higher values of strain recorded at the bottom edge of the girder compared to those recorded at the middle (Fig. 15*b*) clearly confirm the reliability of the gauges used. Also, at the middle of the web of the girder, higher values of strain were recorded due to truck loading on path B (Fig. 15*a*), where the truck was moving right above the girder that has the FOS, than that for truck loading on path C (Fig. 15*b*).

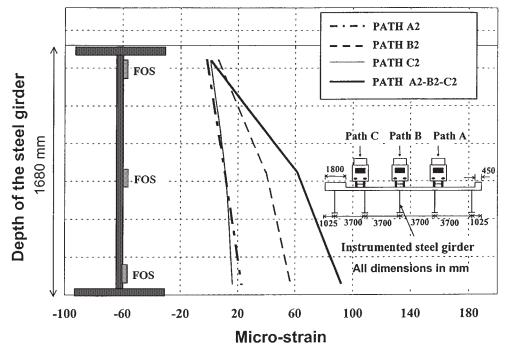
Figure 16 shows typical CFRP reinforcement strain under the static calibrated load test, recorded by the fibre optic sensors. It can be seen that, for given calibrated loads, the CFRP reinforcement strain variation is small for similar tests. Figure 17 depicts the variation of strain along the depth of a steel bridge girder due to a truck at position A2 (on path A), B2 (on path B), C2 (on path C), and the combined effect A2-B2-C2. Figure 17 reflects two interesting facts. First, the presence of tensile strain throughout the section depth and at the top of the girder suggests that the effective composite action between the concrete deck and the steel girder did exist. Second, the strain profiles produced by the truck position A2 and C2 were very similar, which reflected the fact that path A and path C were indeed symmetrical pathways. Another important feature, seen in Fig. 17, is that the combined load of three trucks on positions A2, B2, and C2 produced the strain values, at the top, middle, and bottom of the steel girder that were approximately the summation of the effects of three individual truck loads. The results show that measured girder steel strains resulting from static tests are less than 120 micro-strain and measured strains in concrete and FRP reinforcements resulting from static tests are very low (less than 20 micro-strain). Once again, these rational observations prove the validity of the results obtained from fibre optic sensors. Additional analysis of the calibrated load results is in progress and will be published in due course. Subsequent calibrated load tests on the bridge will also be carried out at regular interval.
