EXPERIMENTAL STUDY ON BEHAVIOUR OF STRUCTURAL ELEMENTS MADE OF HOT-ROLLED AND COLD-FORMED STEELS IN FIRE

Fire Study No. 35
of the
Division of Building Research

November 1974

Two types of open-web steel joists have been designed for the same span and the same loading conditions. The first type of joist was made of hot-rolled steel shapes. Coldformed steel was used for construction of the second type. The effect of this difference on the behaviour of joists exposed to fire, is investigated in this experimental study.

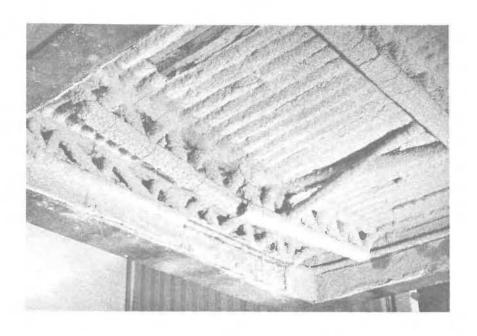
(a) Exposed surface of the assembly after fire test

Fig. 16 Roof assembly after fire test

After 70 minutes several cracks developed to a much larger extent. These disturbances caused the roof assembly using hot-rolled steel to collapse after 98.5 min. The assembly using cold-formed steel withstood 95.5 min of fire test. Details of the collapsed roof assemblies are shown in Figure 16 (a) to (e).

A picture of the surface of the roof assembly exposed to the fire test is shown in Figure 16 (a). Detail of the ruptured lower chord of the open-web steel joist is in Figure 16 (b). Deformed structural steel and resulting rupture of the lower chord of the open-web steel joist is shown in Figure 16 (c), (d), and (e). Figure 16 (a) to (e) shows the ruptured open-web steel joist where hot-rolled steel was used. Figure 17 shows a ruptured lower chord of open-web steel joist made of cold-formed steel.

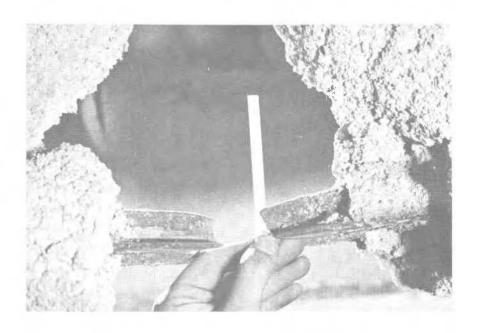
(c) Details of ruptured lower chord of open-web steel joist
