Moisture Management and Energy Rating in Building Envelopes / Part I : A field monitoring study of interstitial condensation in wood-frame walls in cold climate

4th International Building Physics Conference (4th IBPC) [Proceedings], 2009-06-14

MOISTURE MANAGEMENT AND ENERGY ANALYSIS IN BUILDINGS

***Part I- A FIELD MONITORING STUDY OF INTERSTITIAL
CONDENSATION IN WOOD-FRAME WALLS IN COLD CLIMATE***

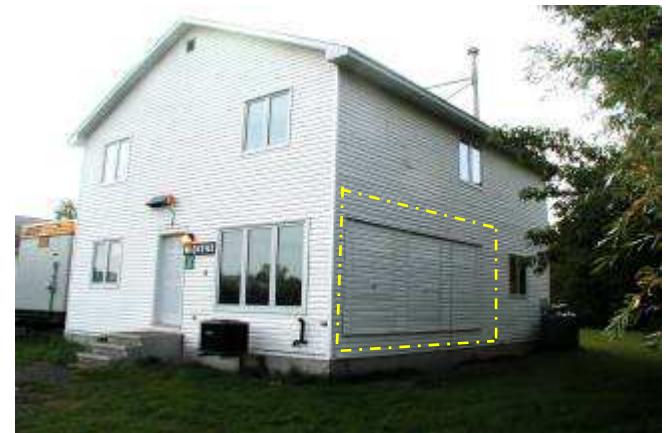
Field Exposure of Wall Facility (FEWF)

- Compare performance of different side-by-side wall assemblies
- improve understanding of HAM response of wall and window assemblies exposed to naturally occurring climate loads of Ottawa as well as to indoor environment loads of T, RH and P defined by occupancy and HVAC systems.
- Research the interaction between the building envelope and the indoor environment
- Complement IRC's controlled laboratory test and modeling simulations

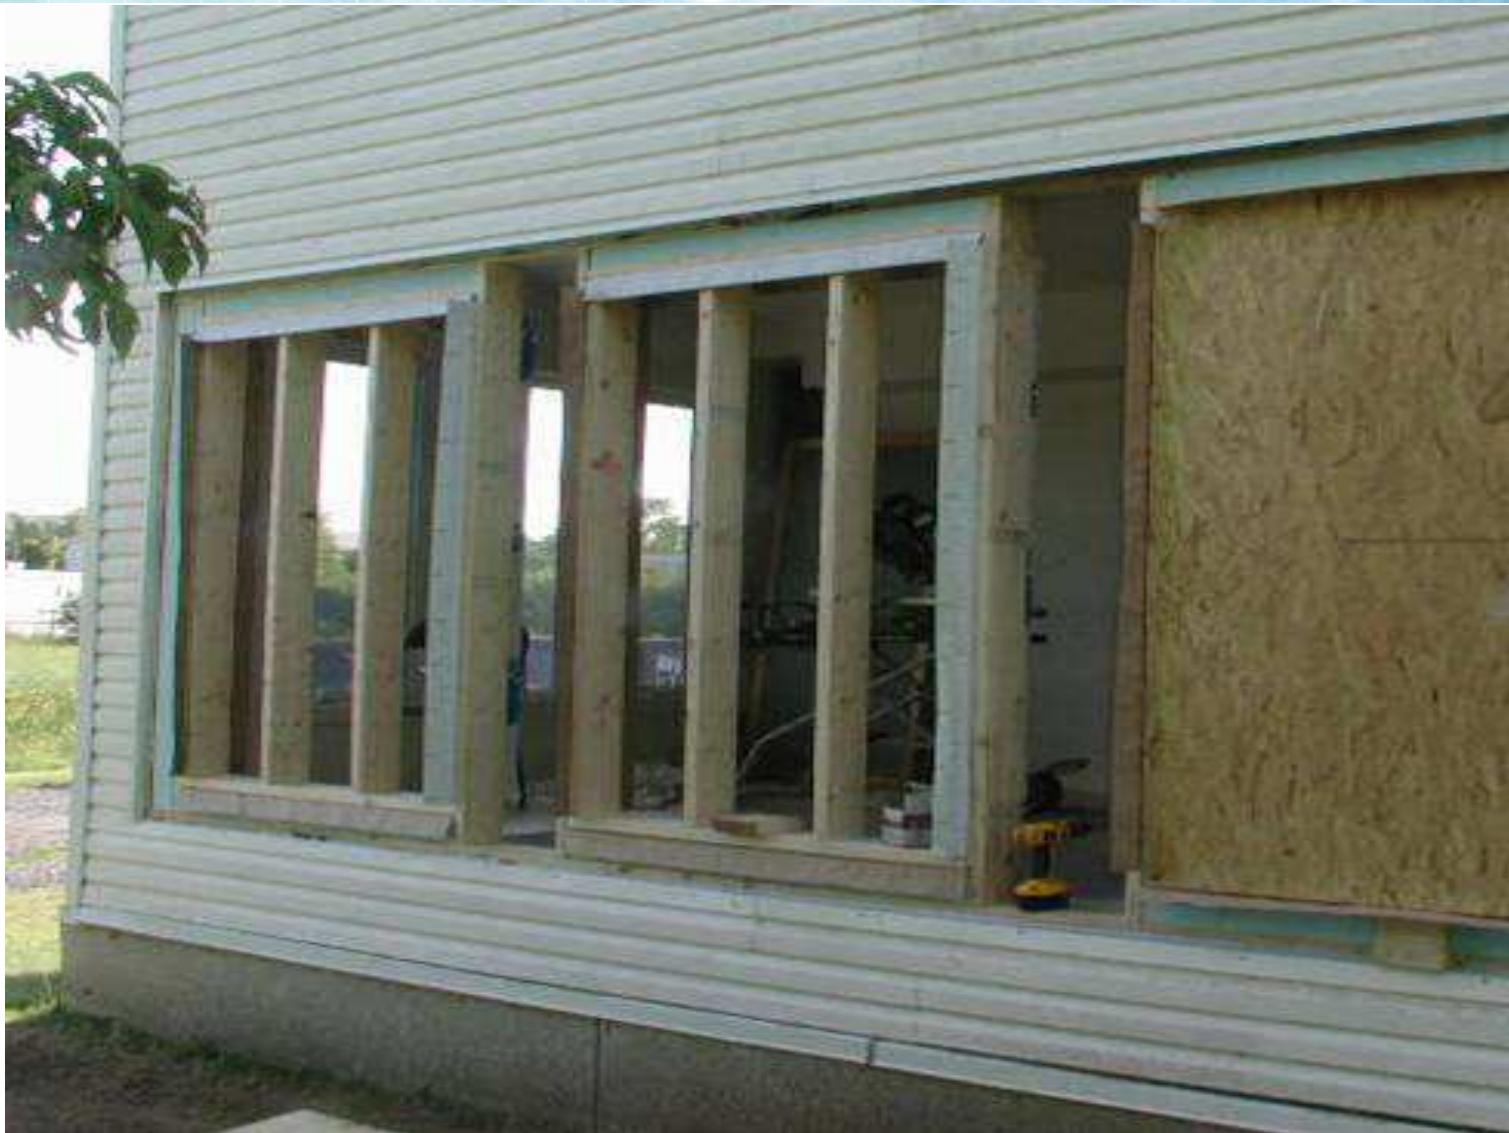
IRC Field Exposure of Wall Facility (FEWF)

- Validate: identical test specimens, protocol and instrumentation
- Characterize heat and moisture response

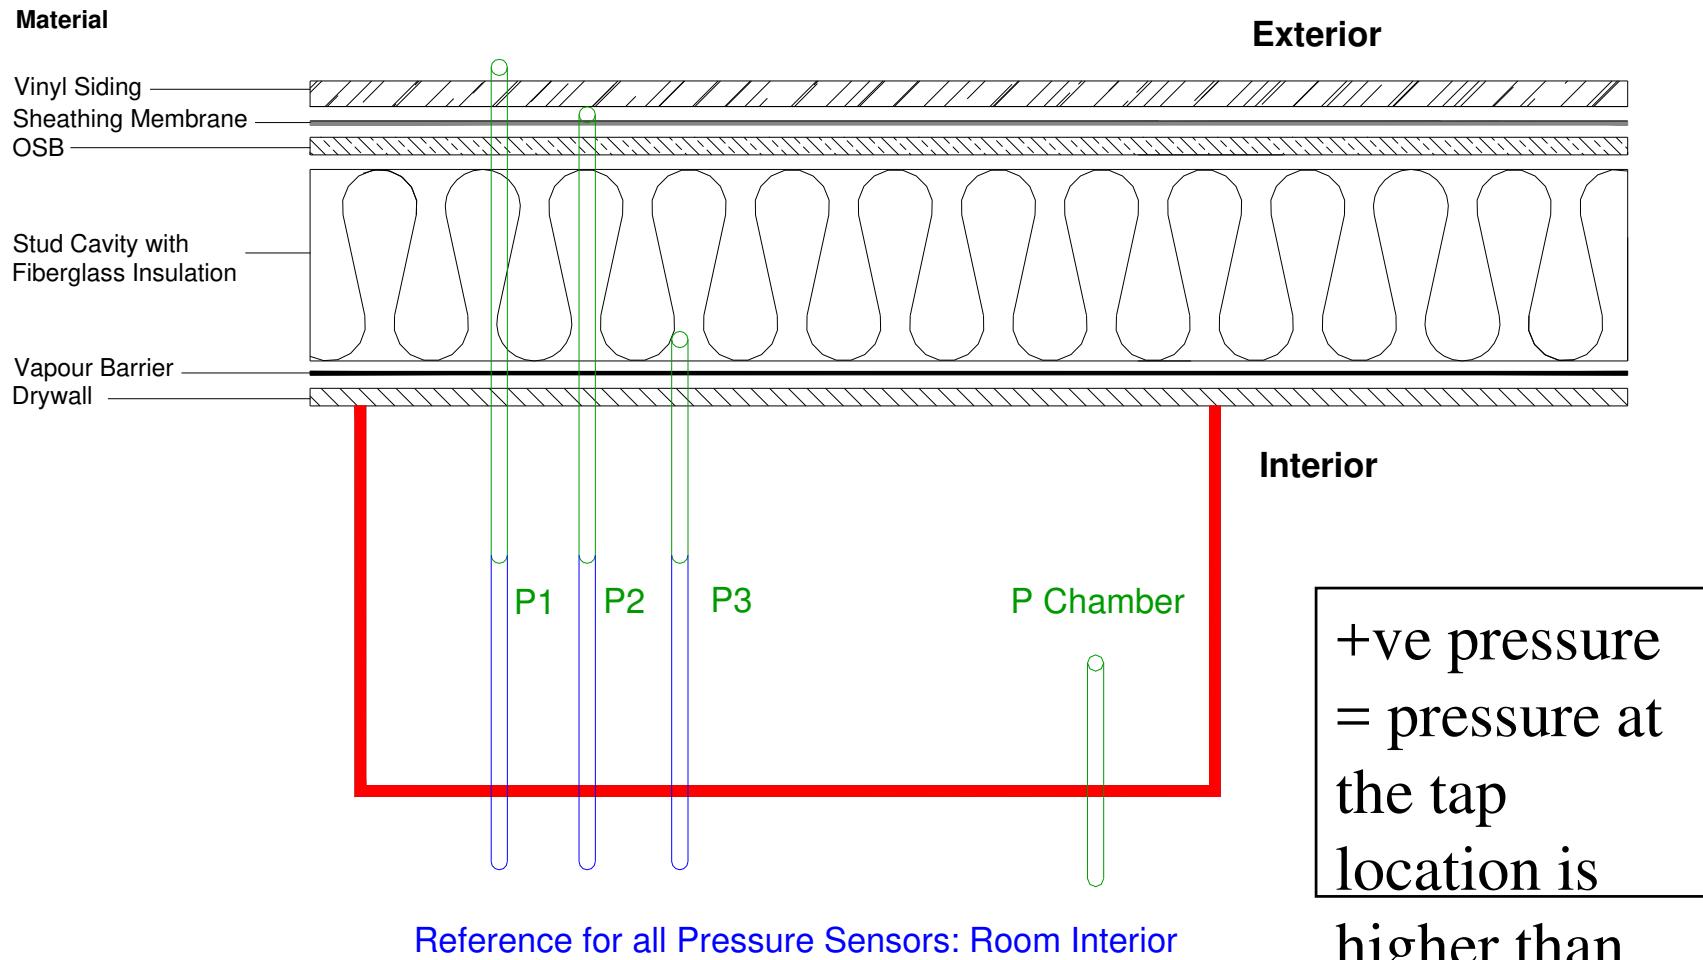
Pressure Tap Locations

+ve pressure
= pressure at
the tap
location is

higher than
the pressure
in the room

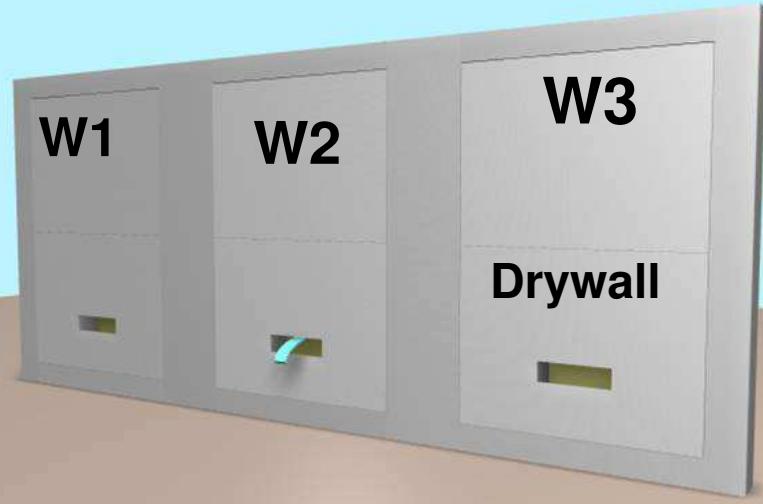
Conditioning Chamber on the Room Side

- Walls 2 and 3 exposed to chamber conditions
- Control T, RH, Pressure
- Deficiency in air barrier (Wall 2 and 3 only)

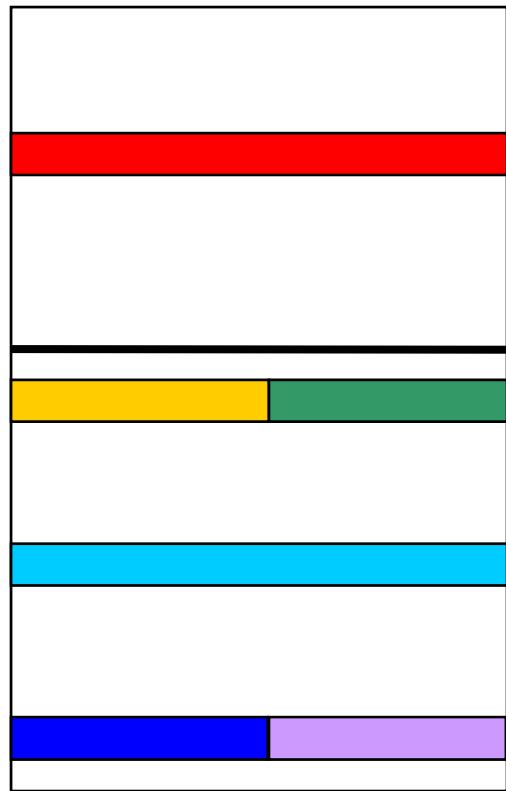
Diagram for Moisture Detection Tape Locations on the interior of the OSB

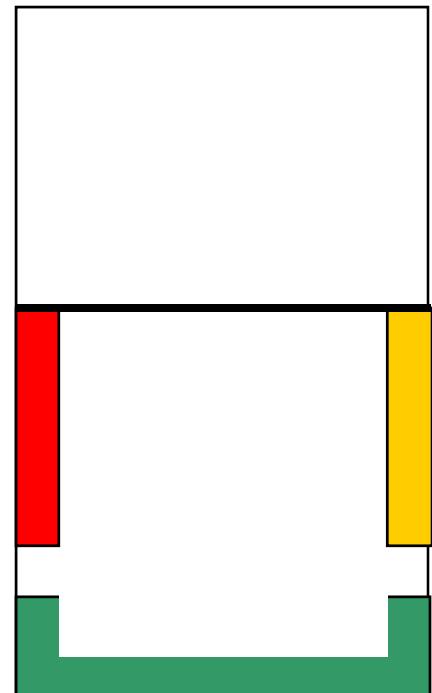
Diagram for Moisture Detection Tape Locations in the Stud Cavity

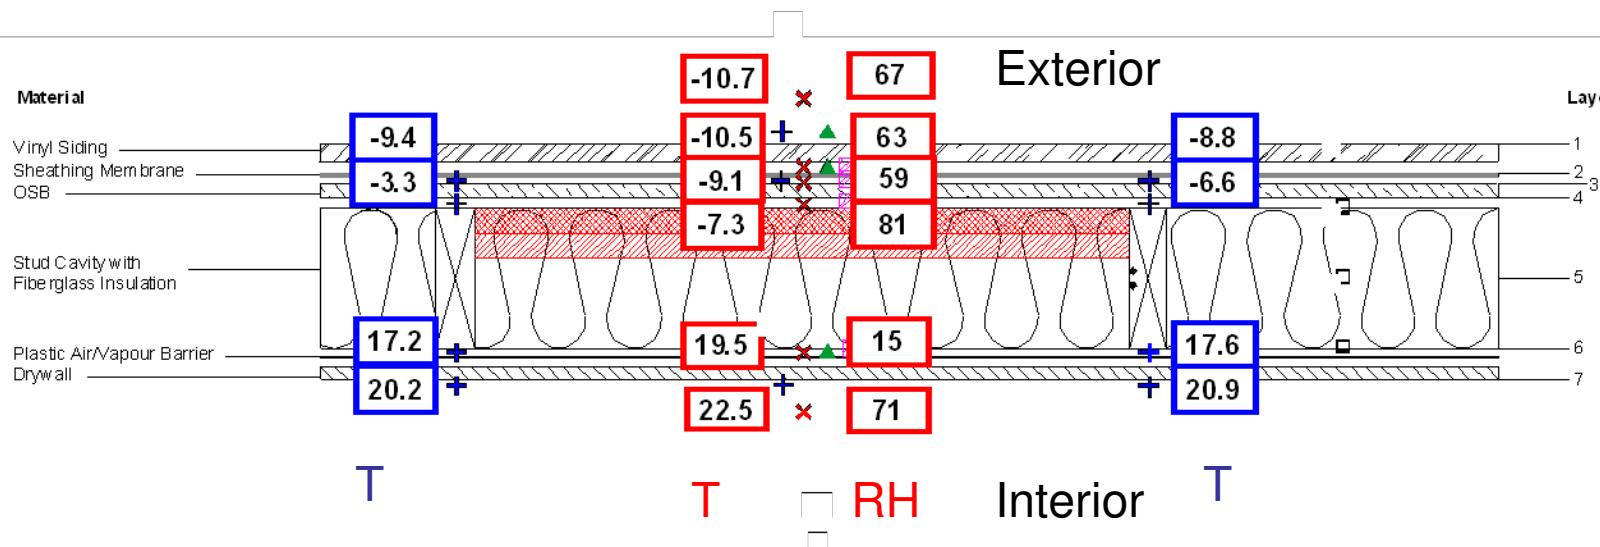
Wall 2 Horizontal Cross Section

Condition A: 0 Pa, 70% RH, no opening

- Despite the high humidity on the interior of the room (71%), the humidity behind the air/vapour barrier is low, 15%
 - The location with the highest RH is the interior of the OSB, at ~81% - still below dewpoint

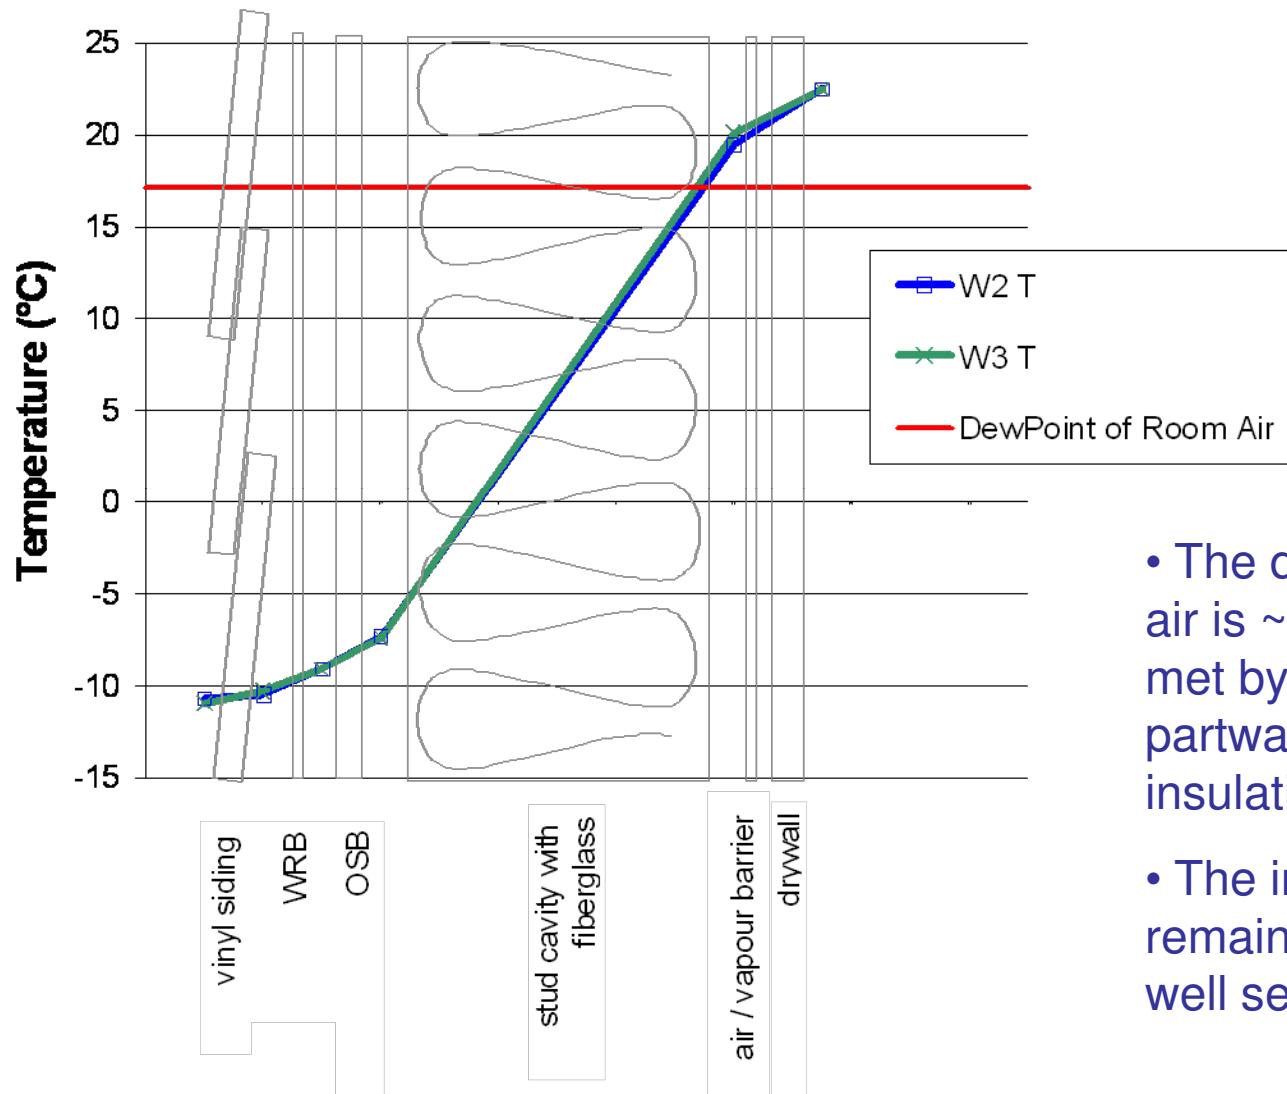
Condition A: 0 Pa, 70% RH, no opening

- The dewpoint of room air is $\sim 17^{\circ}\text{C}$, a condition met by temperatures partway through the insulation
- The interior of the wall remains dry due to being well sealed

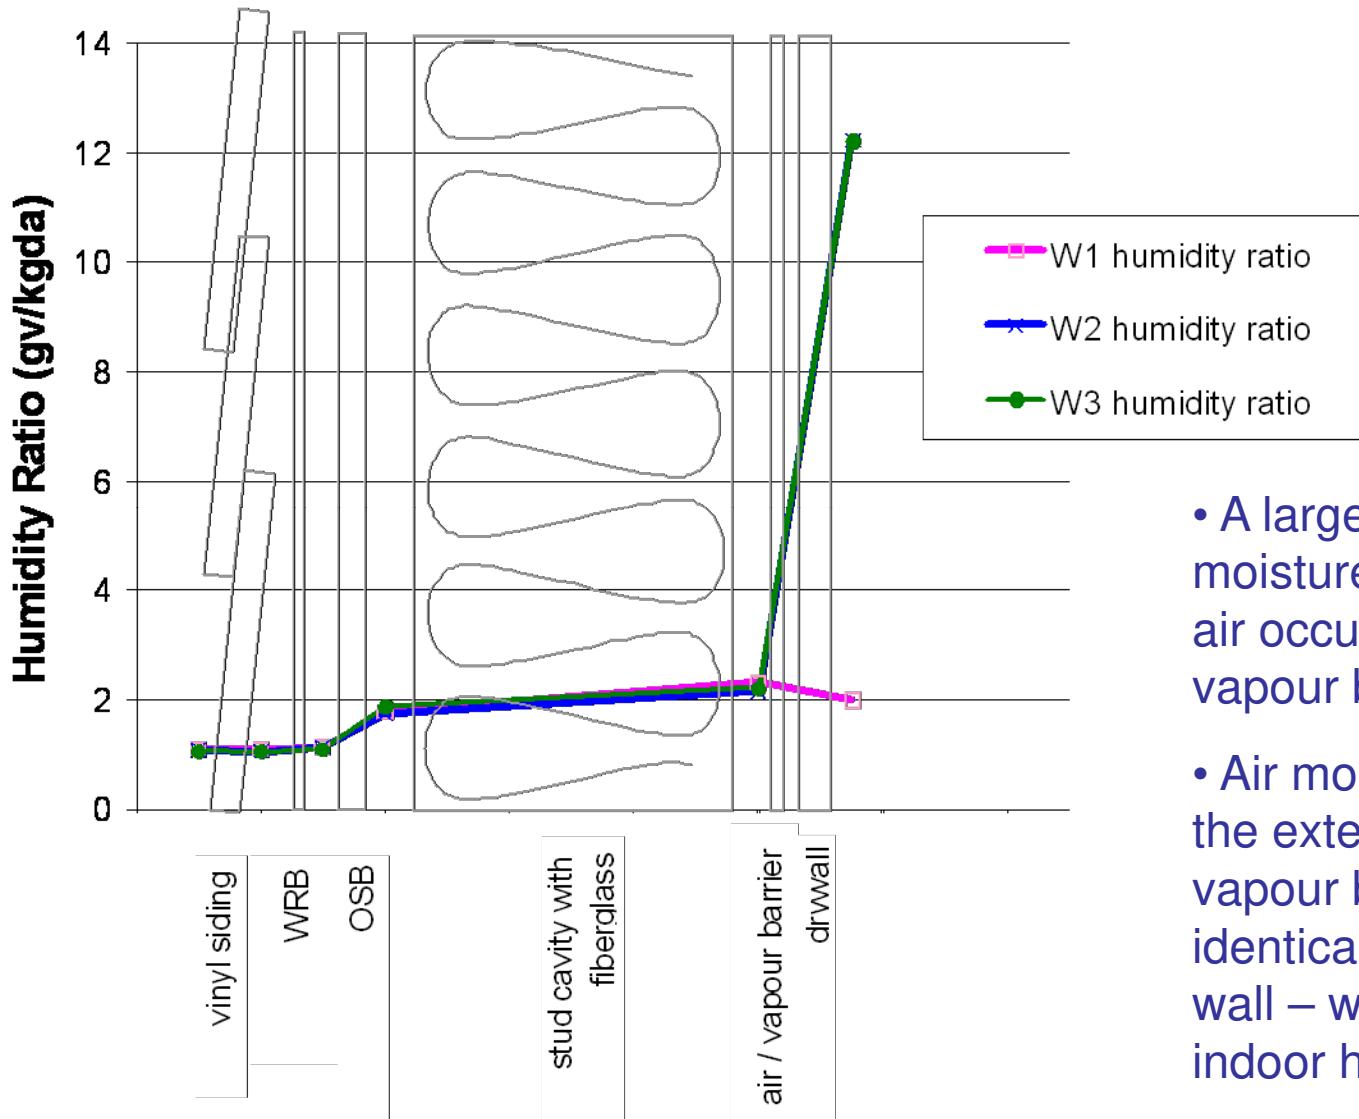
Condition A: 0 Pa, 70% RH, no opening

- A large drop in the moisture content of the air occurs across the vapour barrier
- Air moisture content on the exterior side of the vapour barrier is nearly identical to the reference wall – with no added indoor humidity loads

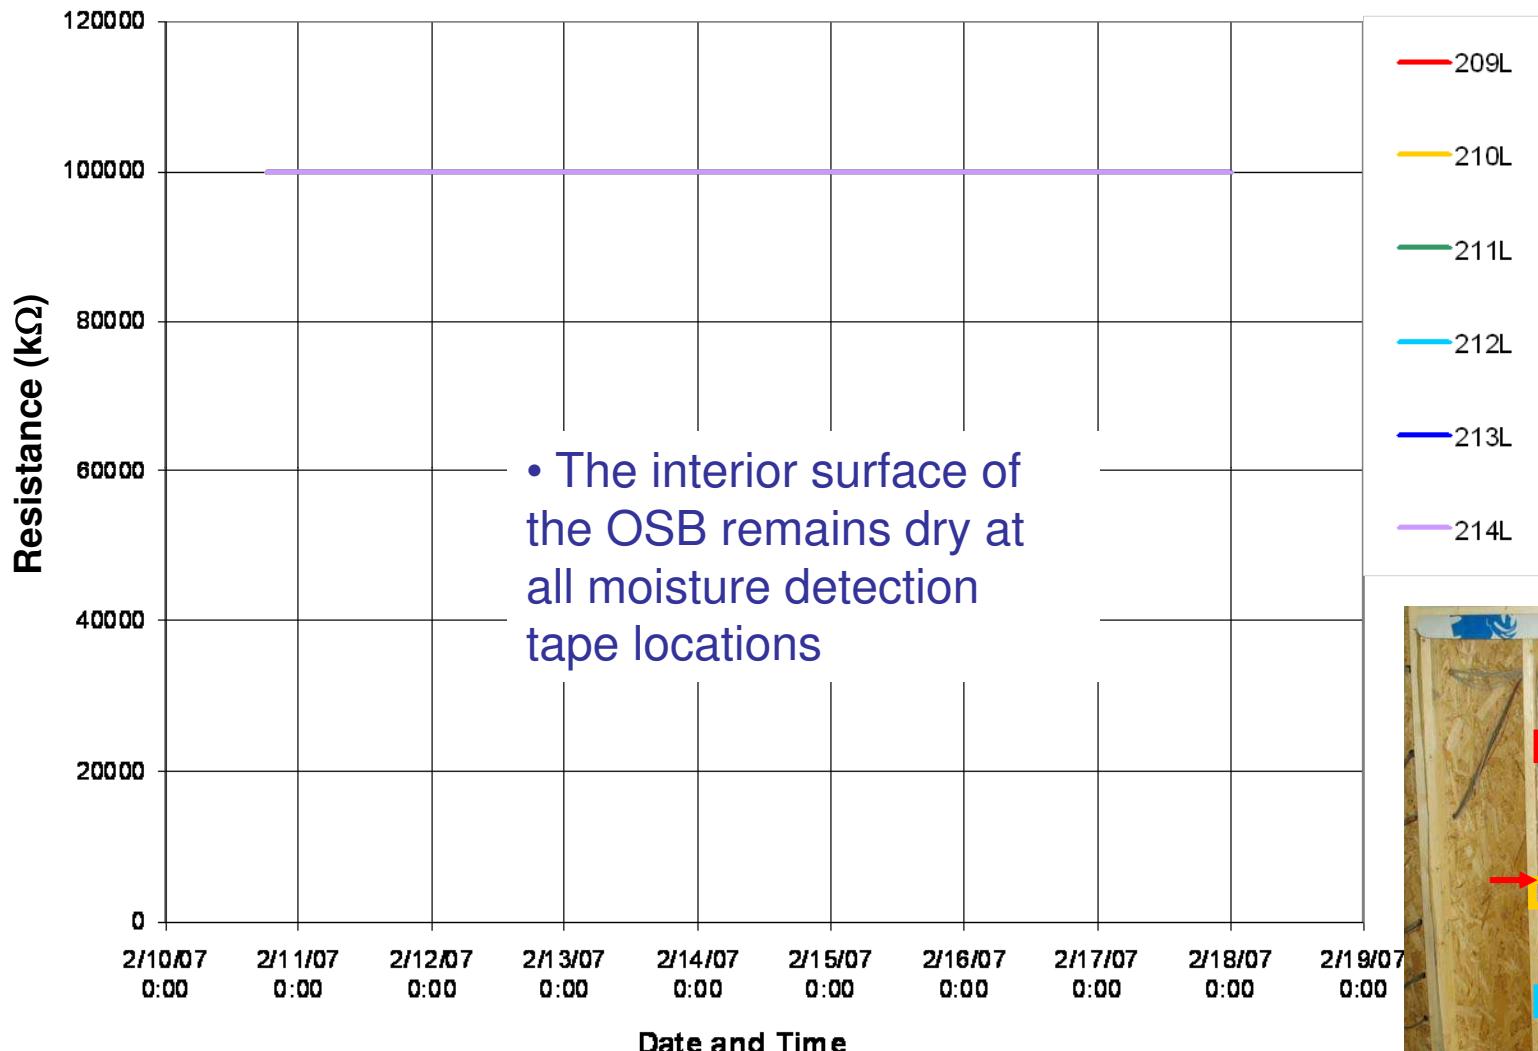
FEWF Wall 2 - Interior of OSB - Layer 4 - Liquid

- The interior surface of the OSB remains dry at all moisture detection tape locations

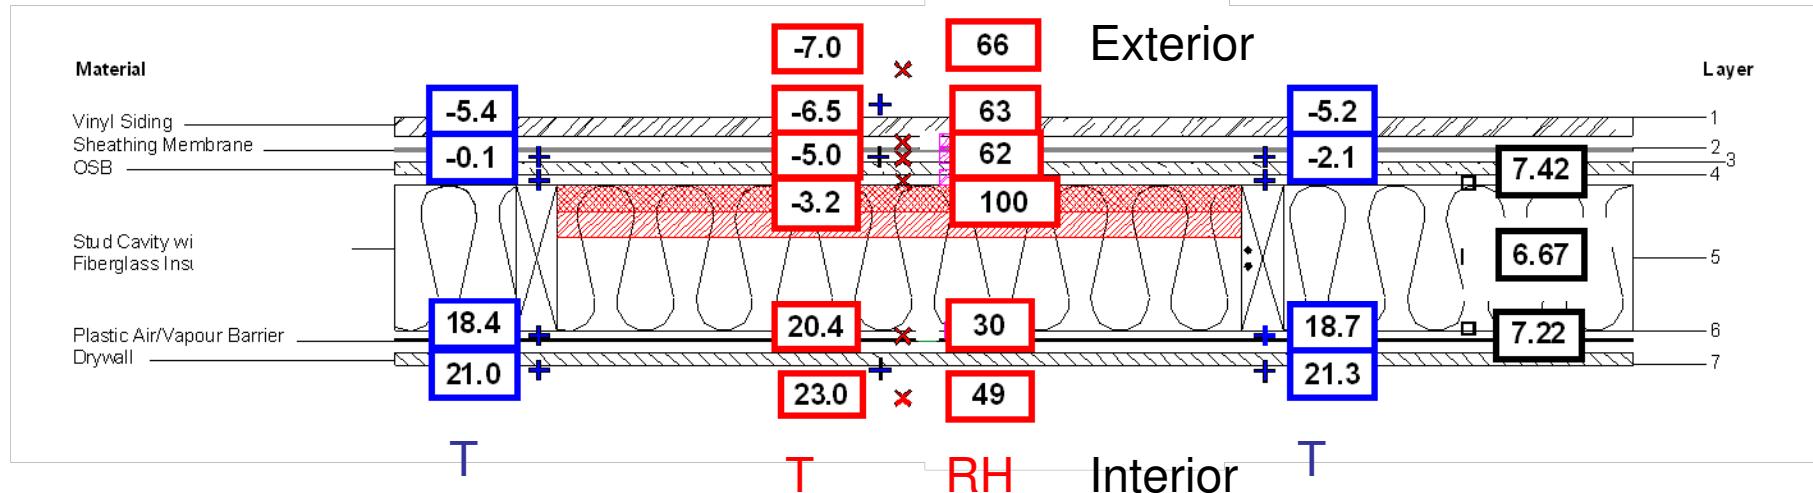
Wall 2 Horizontal Cross Section

Condition B: 5 Pa, 50% RH, 6mm opening

- The interior of the room is at 49% RH, the humidity behind the air/vapour barrier is 30% RH – indicating that moisture is being introduced through the opening
- The location with the highest RH is the interior of the OSB, at 100% - condensation would be expected

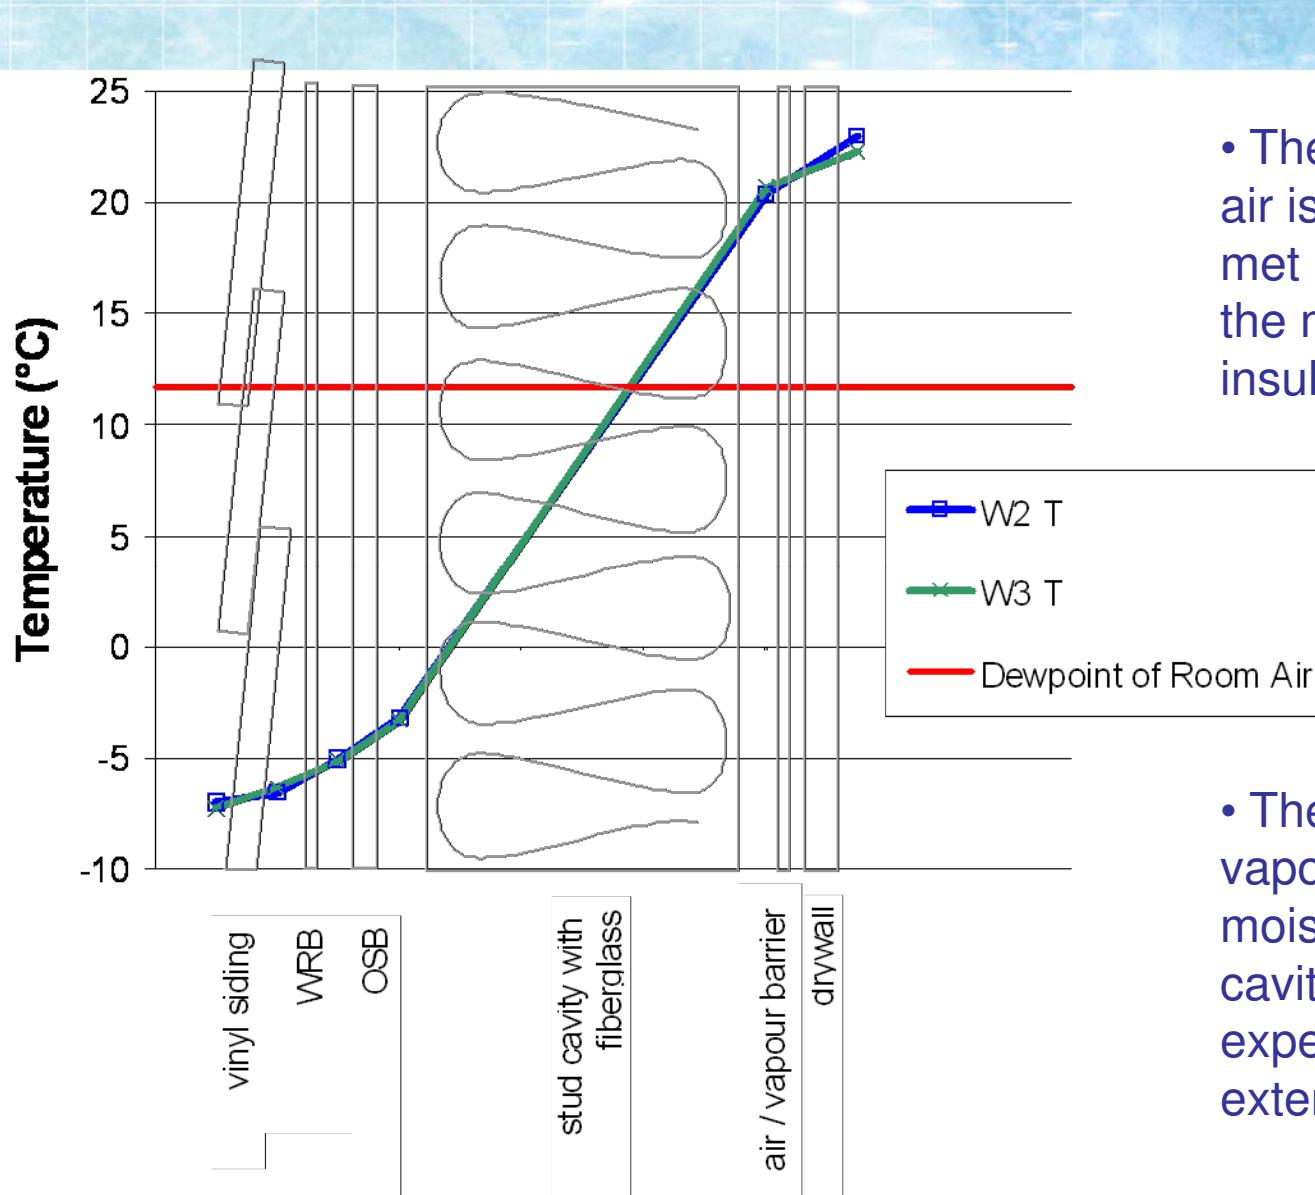
Condition B: 5 Pa, 50% RH, 6mm opening

- The dewpoint of room air is $\sim 12^{\circ}\text{C}$, a condition met by temperatures at the middle of the insulation

- The opening in the vapour barrier allows moisture to enter the cavity, condensation is expected anywhere to the exterior of the insulation

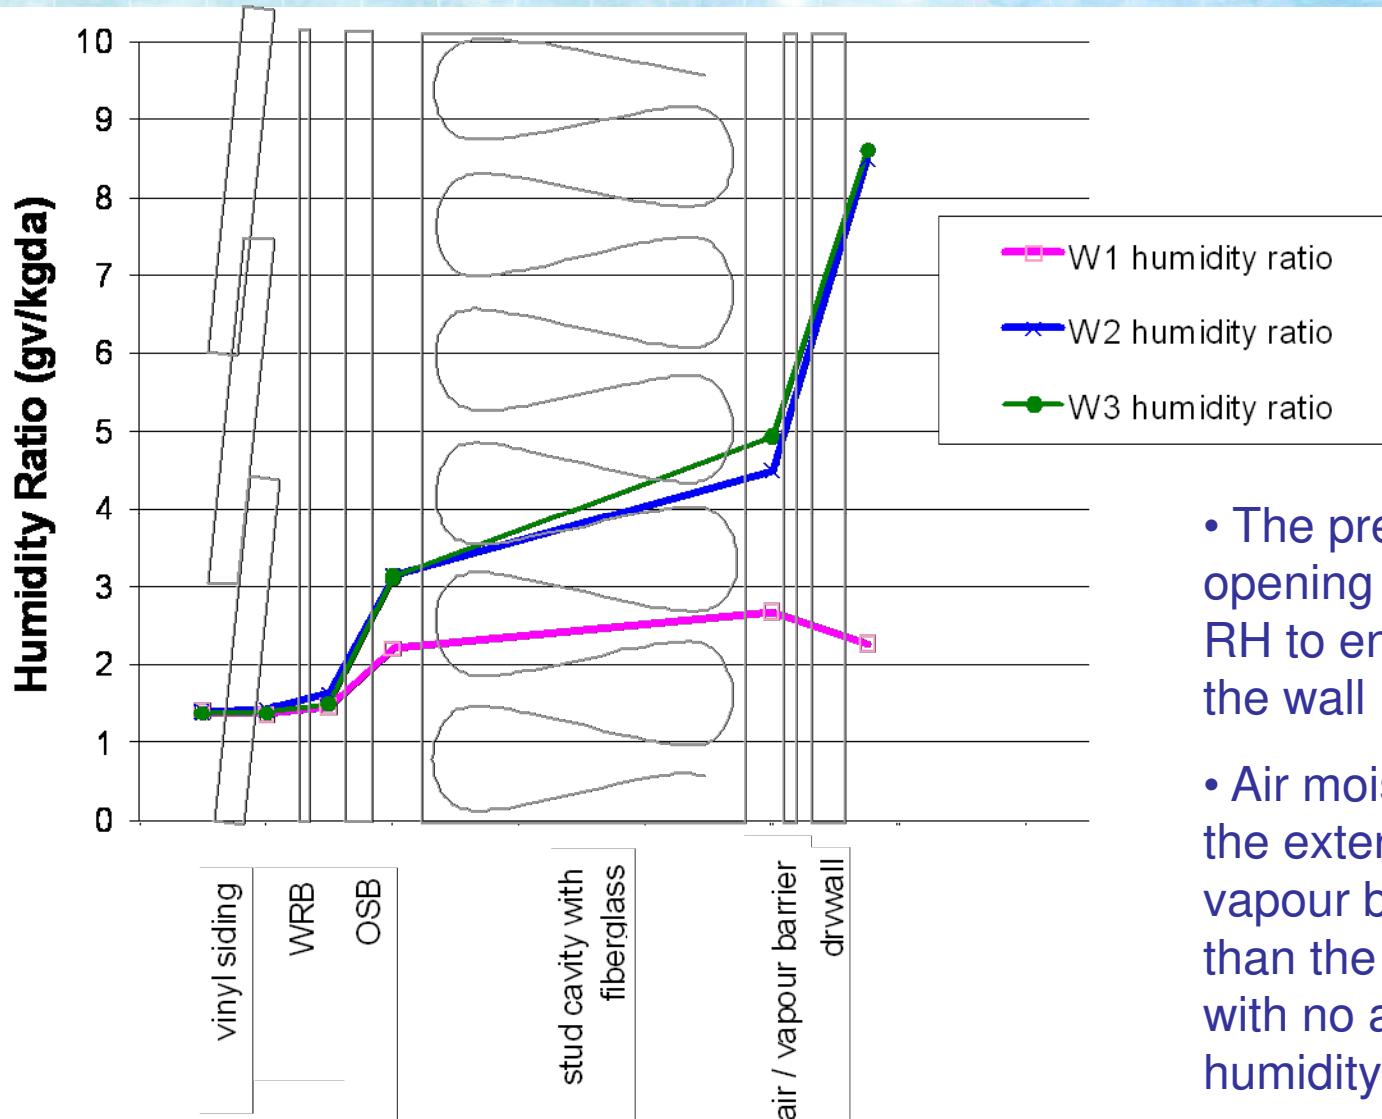
Condition B: 5 Pa, 50% RH, 6mm opening

- The pressure and opening allow the high RH to enter the interior of the wall
- Air moisture content on the exterior side of the vapour barrier is higher than the reference wall – with no added indoor humidity loads

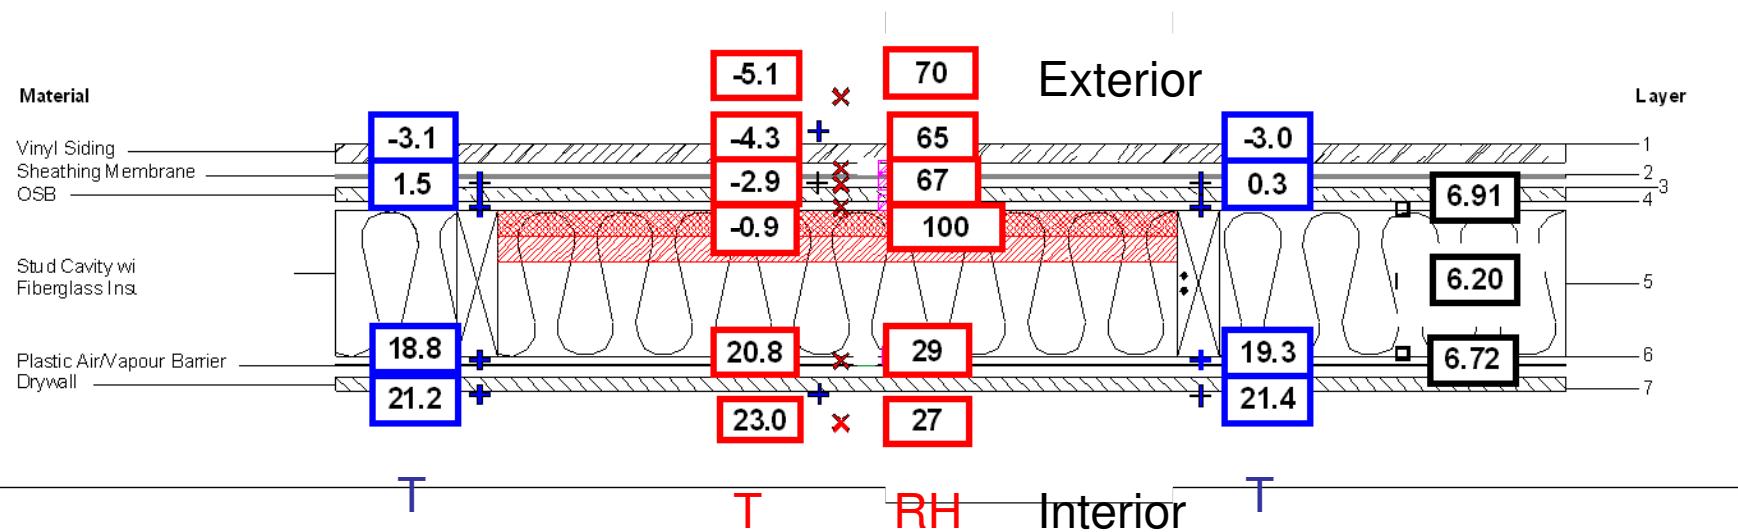
Wall 2 Horizontal Cross Section

Condition C: 5 Pa, 30% RH, 3mm opening

- The interior of the room is at 27% RH, the humidity behind the air/vapour barrier is 29% RH – indicating that moisture is being introduced through the opening
- The location with the highest RH is the interior of the OSB, at 100% - condensation would be expected

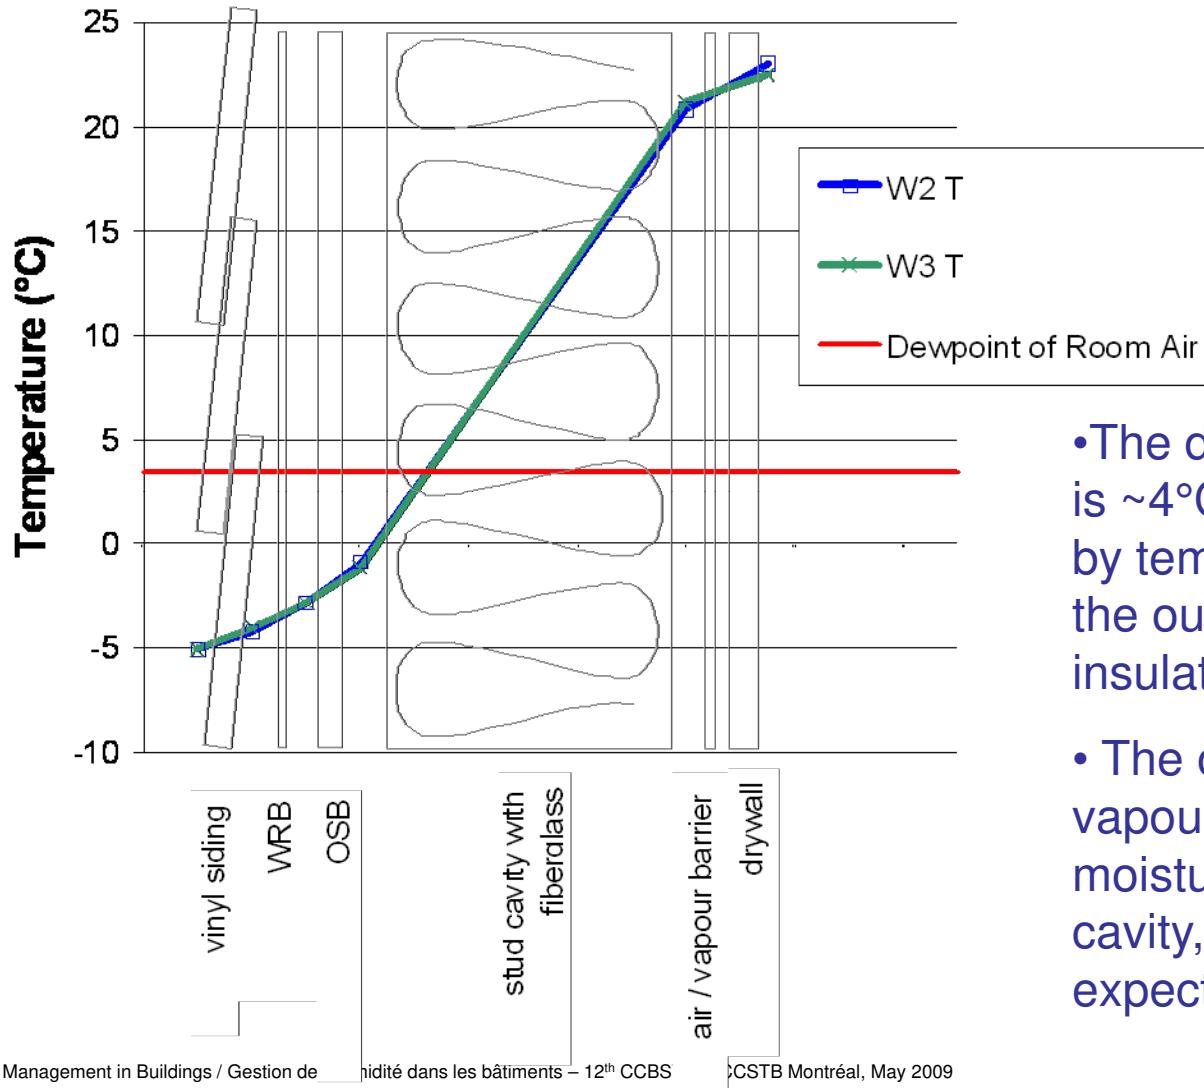
Condition C: 5 Pa, 30% RH, 3mm opening

- The dewpoint of room air is ~4°C, a condition met by temperatures towards the outside of the insulation
- The opening in the vapour barrier allows moisture to enter the cavity, condensation is expected at the OSB

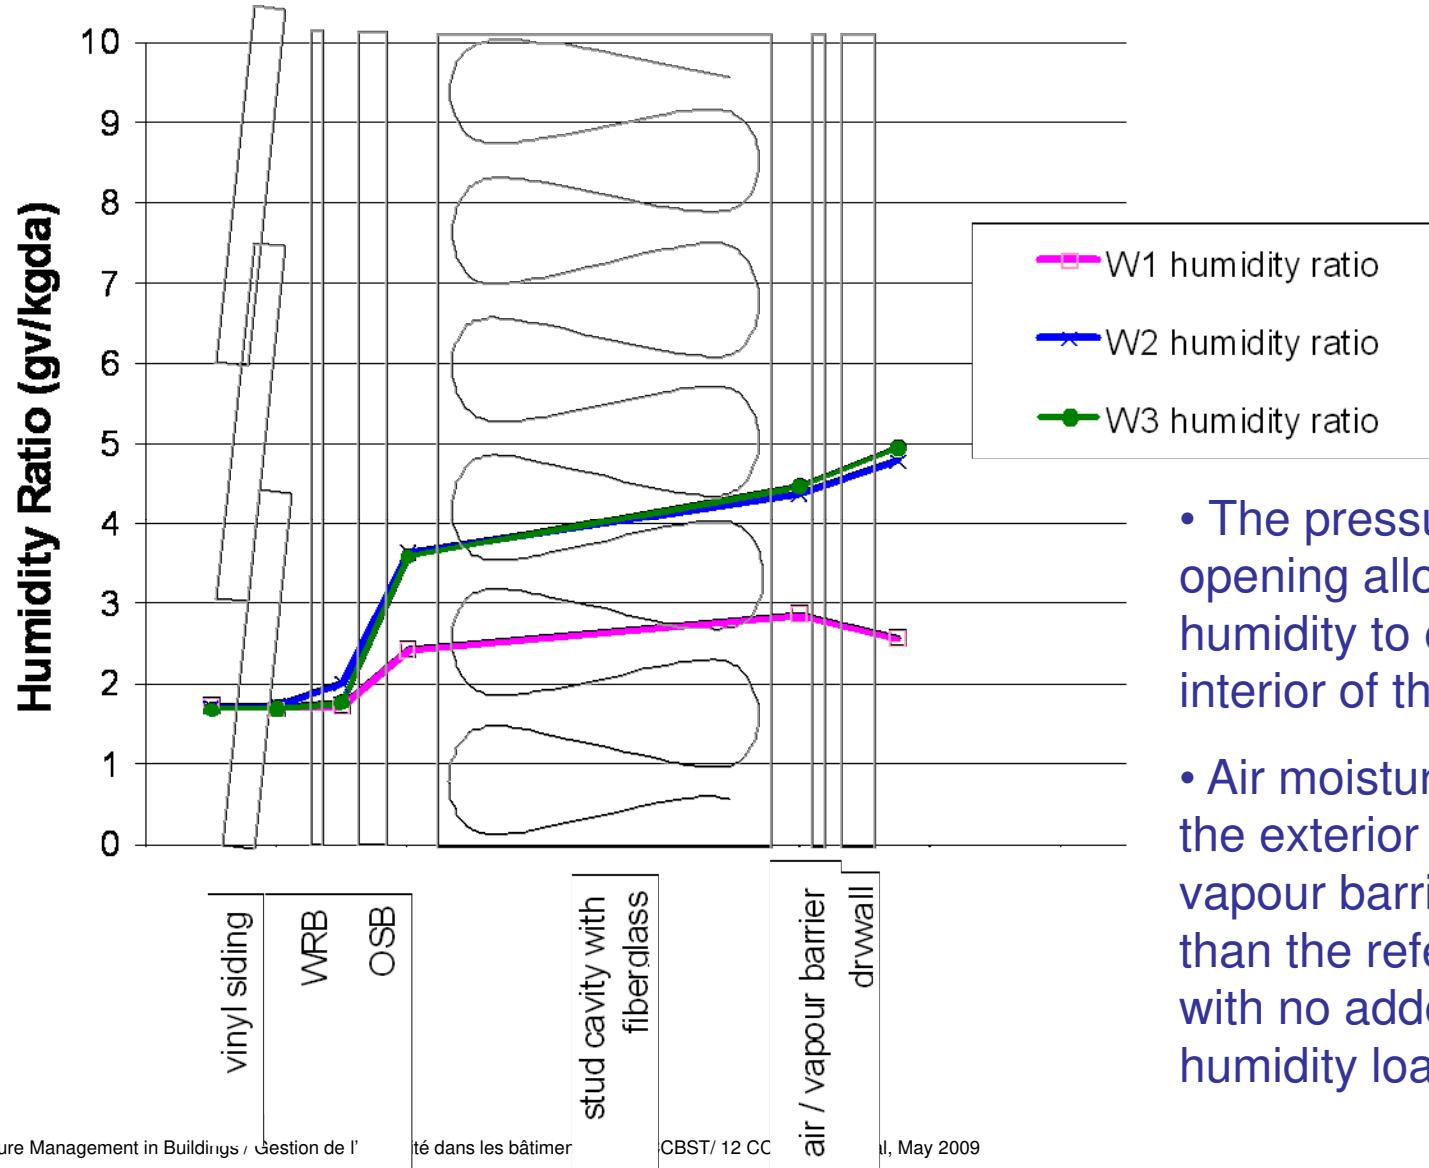
Condition C: 5 Pa, 30% RH, 3mm opening

- The pressure and opening allow the humidity to enter the interior of the wall
- Air moisture content on the exterior side of the vapour barrier is higher than the reference wall – with no added indoor humidity loads

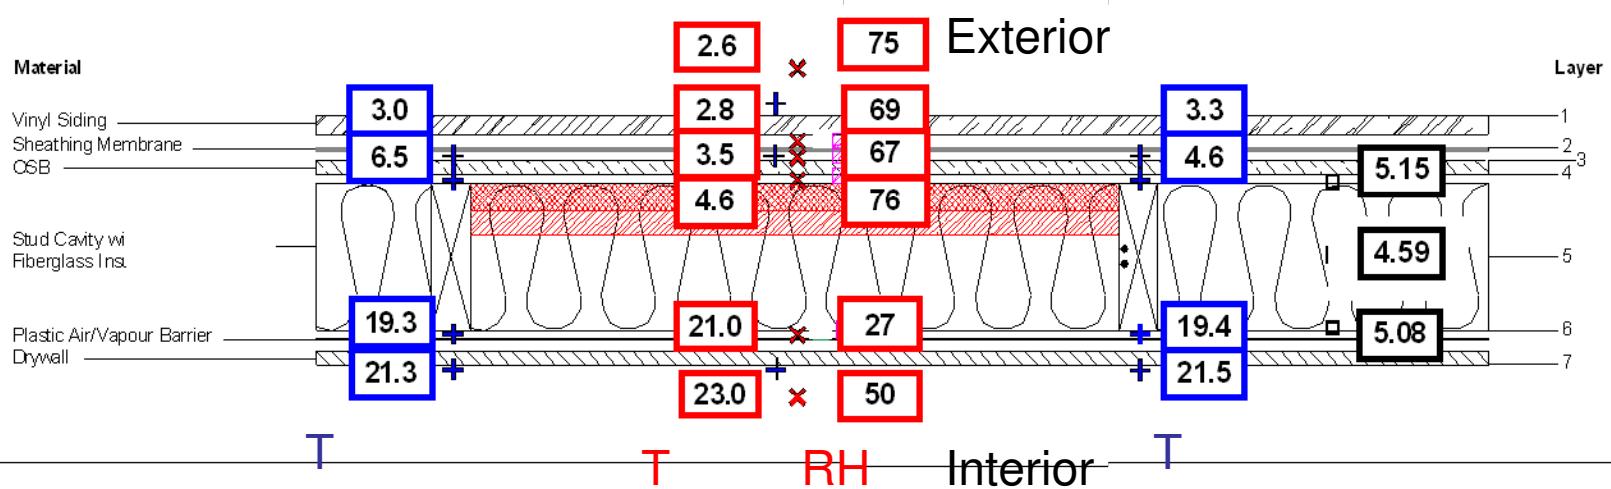
Wall 2 Horizontal Cross Section

Condition D: 0 Pa, 50% RH, 3mm opening

- The interior of the room is at 50% RH, the humidity behind the air/vapour barrier is 27% RH
- The location with the highest RH is the interior of the OSB, at 76% (likely due to the lack of a pressure driving force for exfiltration, and warmer exterior temperatures)

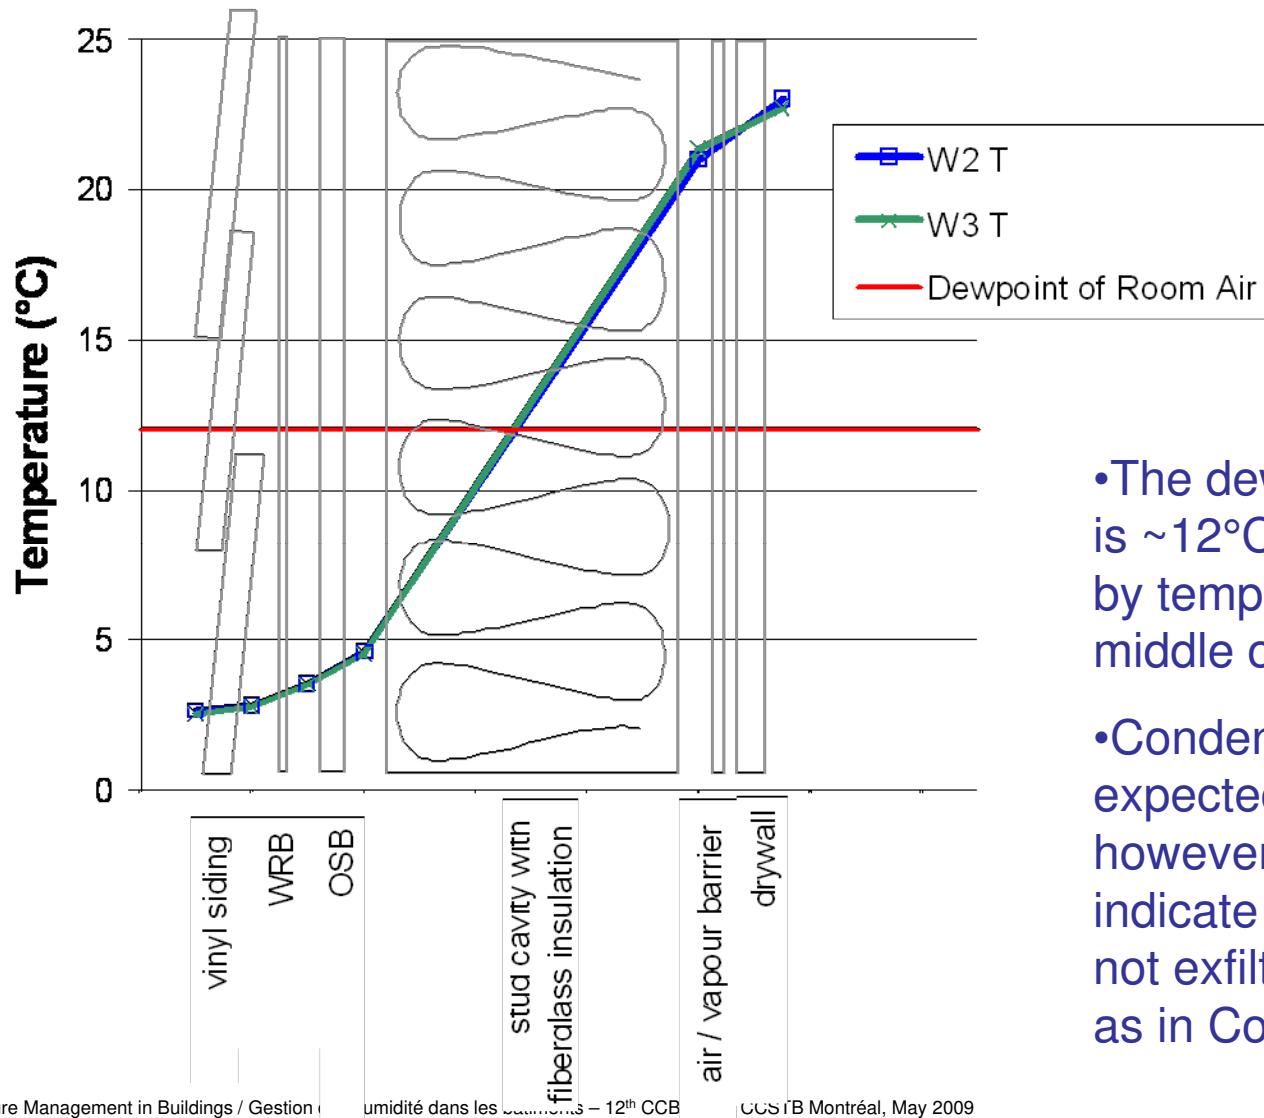
Condition D: 0 Pa, 50% RH, 3mm opening

- The dewpoint of room air is $\sim 12^{\circ}\text{C}$, a condition met by temperatures at the middle of the insulation
- Condensation is expected at the OSB, however, measurements indicate that room air is not exfiltrating as much as in Conditions B and C

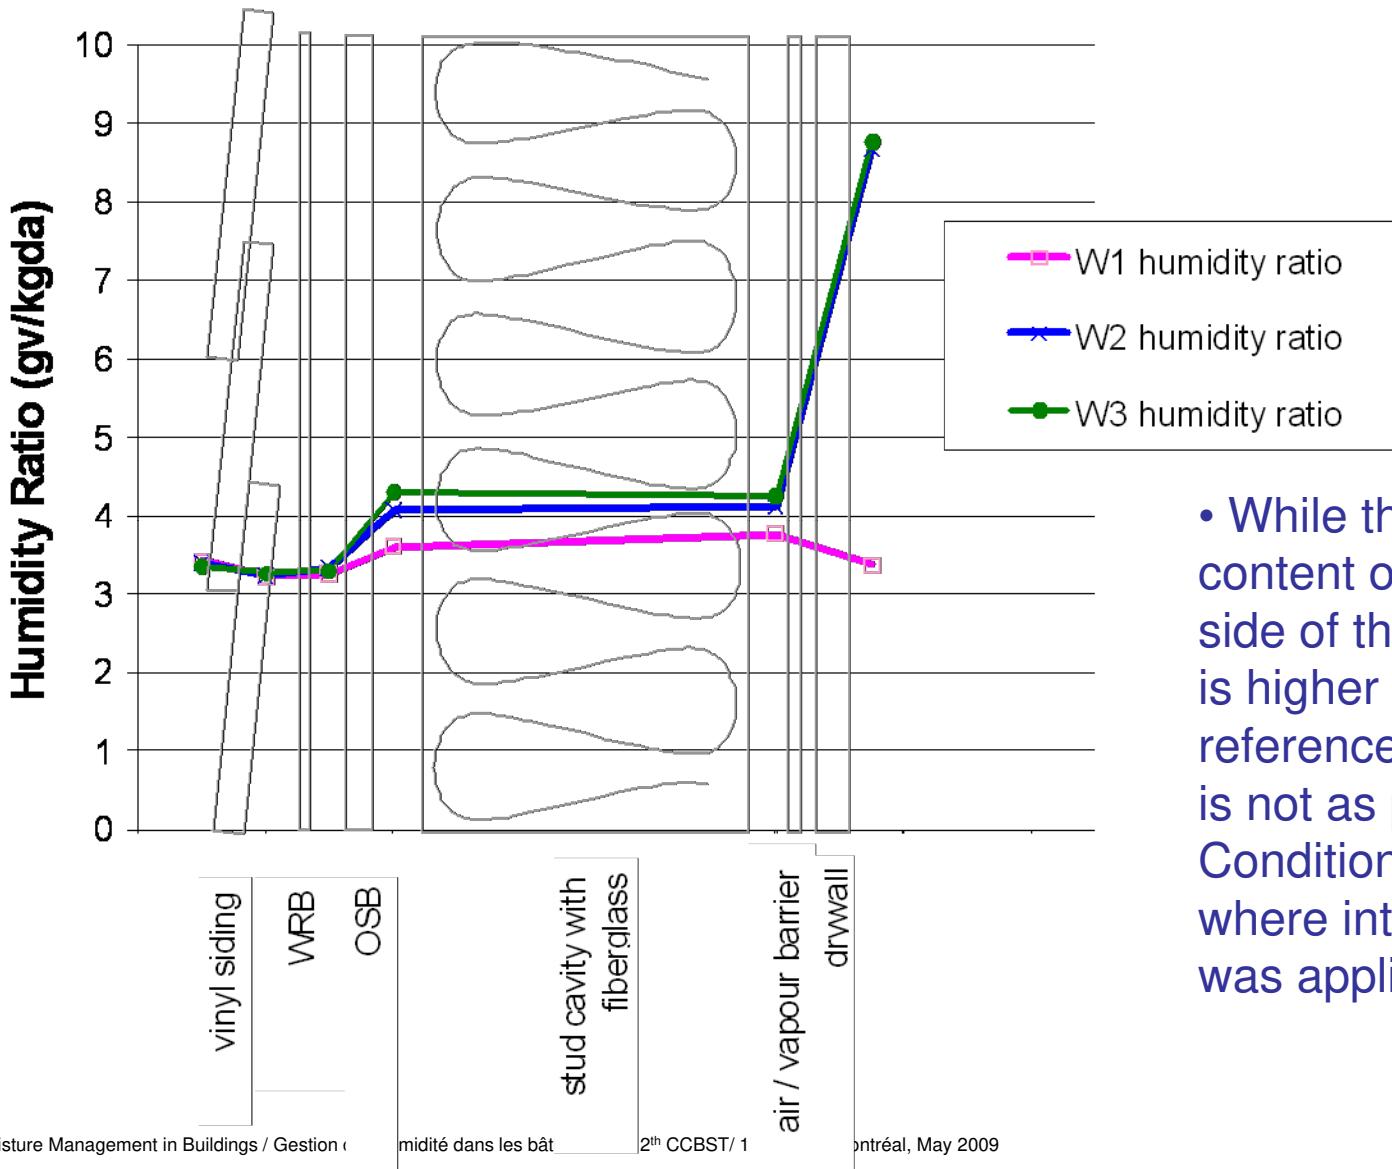
Condition D: 0 Pa, 50% RH, 3mm opening

- While the air moisture content on the exterior side of the vapour barrier is higher than the reference wall, the effect is not as pronounced as Conditions B and C – where interior pressure was applied
