Construction Technology Update; no. 73, 2010-06-01

Inhibiting Chloride-Induced Corrosion in Concrete Bridges

By Daniel Cusson and Shiyuan Qian

The use of de-icing salts can significantly reduce the service life of concrete transportation structures by causing corrosion of the reinforcing steel. This Update provides guidance on controlling corrosion, drawing on a ten-year study to assess the performance of eight commercial corrosion-inhibiting systems on a concrete highway bridge.

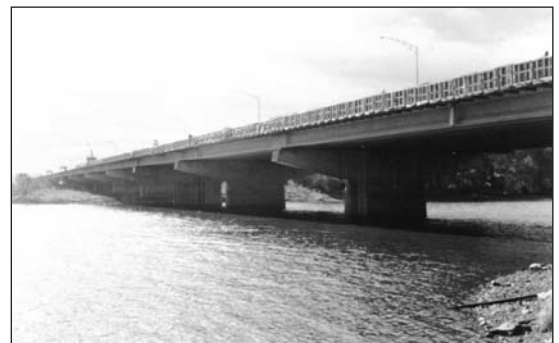
Figure 1. Vachon Bridge during rehabilitation in 1996, Laval, Québec

the Vachon Bridge in Laval, Québec (Figure 1). The bridge is a 6-lane, 714-m long structure with 21 spans of prestressed concrete girders supporting a reinforced concrete slab. In 1996, Transports Québec undertook a major rehabilitation of the bridge including a rebuilding of the barrier walls.

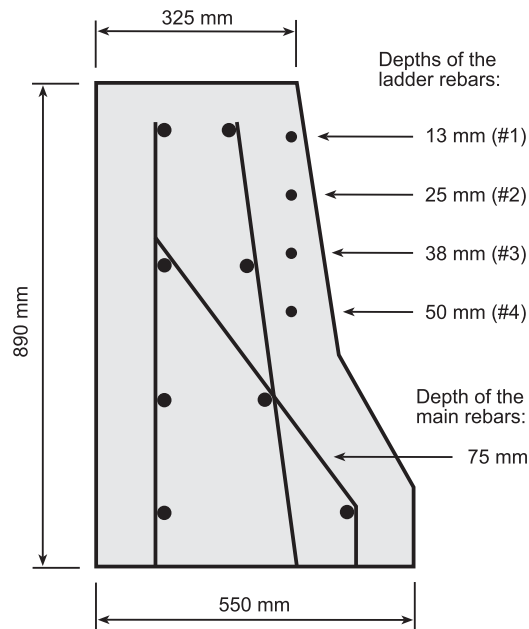
To detect corrosion early, two sets of 10M rebar ladders were embedded in each test section during construction (Figure 2) with concrete covers varying from 13 mm to 50 mm. The main reinforcement in the barrier wall had a concrete cover of 75 mm.

Figure 2. Dimensions and reinforcement details of barrier wall showing main reinforcement with transverse bars spaced at 230 mm, and a test rebar ladder to the right.

The barrier wall surface in each test section was inspected in June 2006 for corrosion-induced damage in the region of Bar #1 of each test ladder (13 mm concrete cover, Figure 2). Corrosion had become evident in this region in all test sections. Sections D and H had the lowest degree of damage with only minor horizontal cracks over the rebars. Sections A, C, E and F had horizontal cracking, small delaminations and spalled areas over these shallow ladder bars.

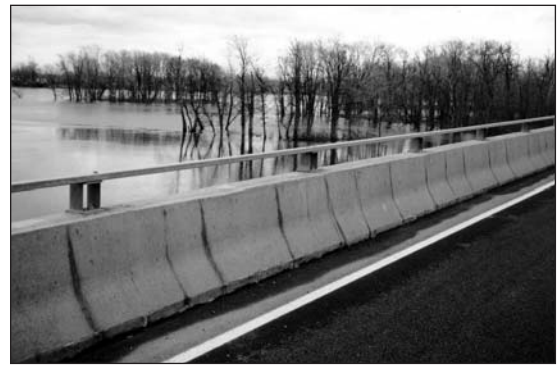
Vertical cracks about 800 mm apart appeared on the barrier walls several days after concrete placement (Figure 3). It was determined that the cracking was mainly due to uncontrolled thermal effects and

restrained autogenous shrinkage, typical of concrete with high cement content and low water-cement ratio. It was decided to proceed with the study and to monitor the effect of early cracking on corrosion.

Figure 3. Typical span of barrier wall after reconstruction.
