Corrosion, 51, 8, pp. 639-644, 1995-08-01

Laboratory Performance of Zinc Anodes for Impressed Current Cathodic Protection of Reinforced Concrete

R. Brousseau, M. Arnott, and B. Baldock*

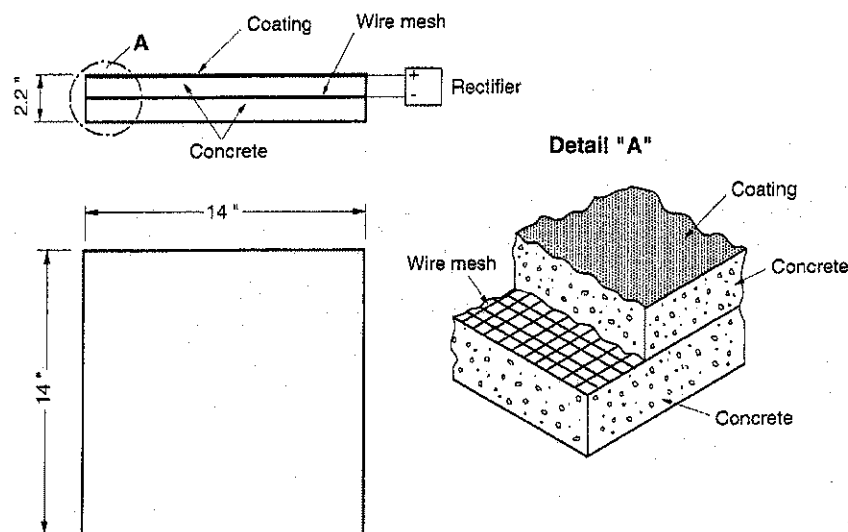
FIGURE 1. Schematic of the polarized samples.

The various anode systems were applied to concrete samples manufactured according to specifications given in Figure 1. A mild steel mesh was placed 2.54 cm (1 in.) from the face on which the anode system was applied. The same concrete mix formulation was used for all samples (i.e., cement/sand/aggregate ratio = 1:2:3). Type 1 portland cement was used, with a water-to-cement ratio of 0.43. Chlorides also were introduced in the concrete mix as sodium chloride (NaCl) to better simulate aggressive environments. The chloride content was 0.6% by weight of cement. After demolding, the samples were cured in a humid room at 23°C and 100% relative humidity (RH) for 28 days. The concrete surface on which the anode was to be applied was grit-blasted using a 16-mesh silica sand at 758 kPa (110 psi). The sample surface was grit-blasted until the smooth cement paste surface created by the mold was removed and a mainly sand-cement surface remained.

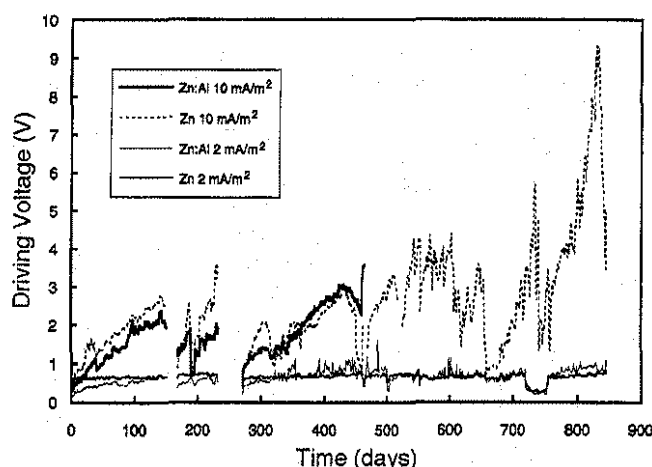
FIGURE 2. Average voltage drop across arc-sprayed anodes.

The driving voltage, which was the potential difference between the anode and the steel mesh, is plotted as a function of time in Figures 2 and 3. These graphs illustrate the increase in effective circuit resistance occurring at the various anode-concrete interfaces. The gaps in the curves represent the time during which the current was shut off due to maintenance of the system or to measure adhesion of the metallized coating. Occasionally, individual samples developed very high driving voltages (> 30 V to 50 V). Typically, these samples had a driving voltage similar to the other samples until it began to steadily increase. The erratic sample was removed from the test circuit at that time. The driving voltage results, beginning from the point where the voltage began to increase, were not included in the calculated average. Only a few samples remained after 230 days for the 85% Zn-15% Al alloy at 10 mA/m^2 (0.929 mA/ft^2). Although discontinued from that point, it was evident that the driving voltages were increasing sharply for the 85% Zn-15% Al.

The change of the driving voltages with time for the metallized coatings were quite different at the two current densities. The driving voltages at 2 mA/m^2 (0.186 mA/ft^2) remained relatively constant at < 1 V. Initially, the driving voltages were slightly lower for the 85% Zn-15% Al alloy than for pure zinc. However, the driving voltages for both metallized coatings were equal after 350 days of polarization, and remained similar thereafter. Interruptions in current, for maintenance or testing, did not affect the driving voltages across these samples.

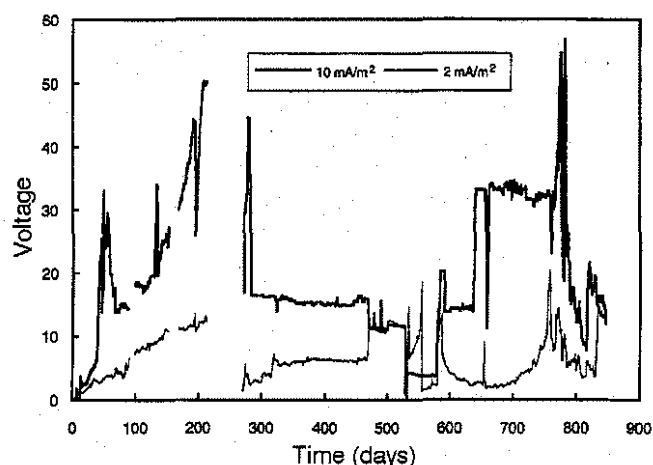
FIGURE 3. Driving voltage, zinc sheet anodes, powered at 2 mA/m^2 (0.186 mA/ft^2) and 10 mA/m^2 (0.929 mA/ft^2).

The driving voltages for the zinc sheets are shown in Figure 3. The driving voltage for this type of

anode system was much higher and exhibited the largest fluctuations. Such high driving voltages are unacceptable for CP of reinforced concrete. The overlay and rolled zinc sheets delaminated. In general, a poor bond was found between the rolled zinc sheets and the encapsulating mortar. Large areas of the zinc appeared to have little or no contact with the underlying mortar. The first delamination of the encapsulating overlay occurred after 55 days of polarization. The delamination likely was caused by the expansion force generated by the zinc oxidation products. The lack of intimate surface contact between the rolled zinc and mortar overlay was believed to have promoted the excessively high driving voltages observed.

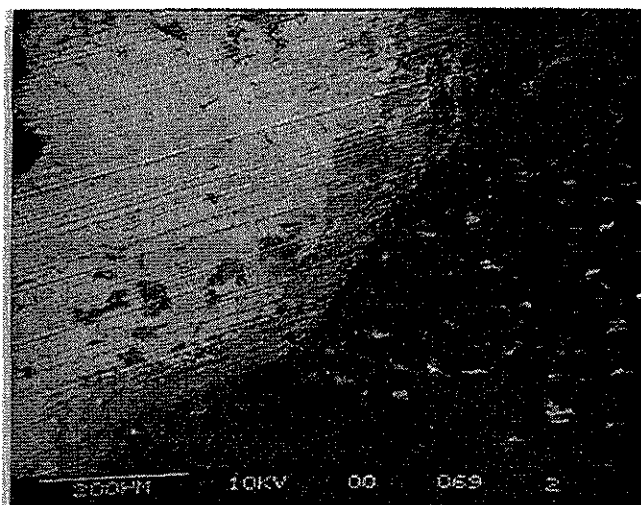
FIGURE 4. Backscattered SEM micrograph of zinc-concrete interface from a sample polarized at a current density of 10 mA/m² (0.929 mA/ft²) for 845 days. (Magnification = 150x).

Zinc oxidation products were found on samples polarized at 10 mA/m² (0.929 mA/ft²) for 845 days. A white powdery material was observed on the surface of the concrete after the zinc was pulled off in adhesion measurements. The formation of zinc oxides, hydroxides, and chlorides also was supported by scanning electron microscopy (SEM) and optical microscopy (OM) examinations of the zinc-concrete interface. A typical SEM photograph in the back scatter mode is presented in Figure 4. The paler areas represent unoxidized zinc, while the pockets of darker gray reveal the oxidized zinc products. The very dark regions correspond to the concrete. There was an absence of oxidation at the interface between the zinc and aggregate. A possible explanation was the absence of anodic current flow through the dense aggregate relative to the cement paste. Transverse cuts through the interface examined by OM revealed white deposits formed at the zinc-concrete interface (Figure 5). There were insufficient amounts of this white powder to conduct an analysis.

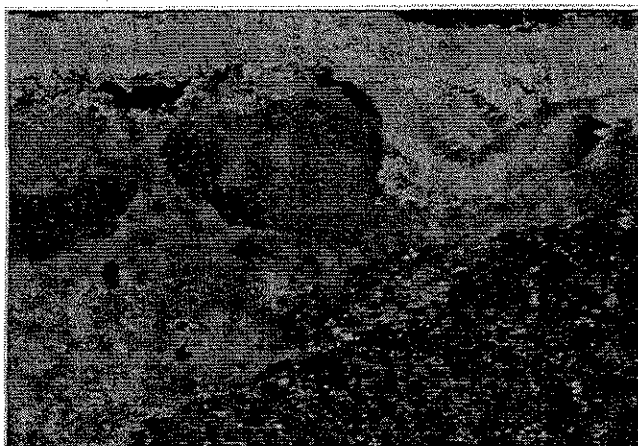
FIGURE 5. OM photograph of the zinc-concrete interface after being polarized for 845 days at 10 mA/m² (0.929 mA/ft²). (Magnification = 45x).

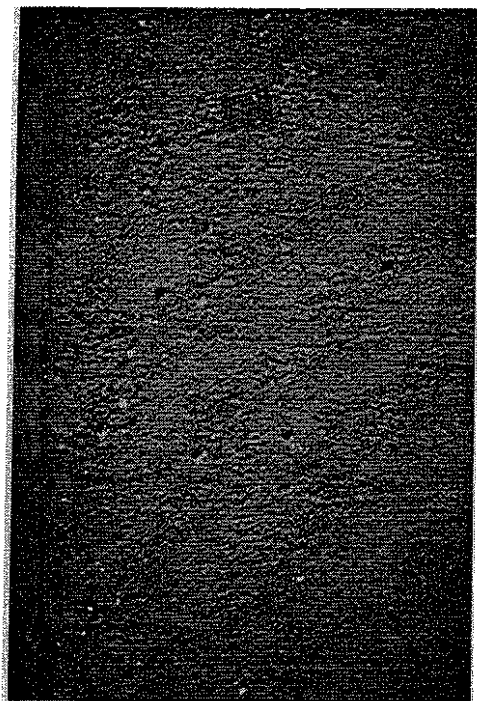
FIGURE 6. Cape Creek bridge in Oregon showing formation of white deposits at surface defects of the metallized zinc coating. (Scale = 1:10).

imperfections in the zinc coating. Evaporation of the moisture originating from underneath the coating resulted in crystallization of the products on the external surface of the coating. This explained the "anthill" of white deposits that was found on the external surfaces of the zinc and 85% Zn-15% Al coatings. Formation of white powdery crystals at surface defects on the zinc coating also was observed in the field. This is shown in Figure 6, which is a photograph taken on the Cape Creek bridge in Oregon, where 10,000 m² (93,000 ft²) of concrete was zinc-metallized. A white powdery material was noticeable at surface holes and voids 2 y after the impressed current CP was applied.
