### **Unprotected floor assemblies and tenability conditions in a test house under two basement fire scenarios**

*Fire Technology*, 47, pp. 631-664, 2011-03-01

### NRCC-52719

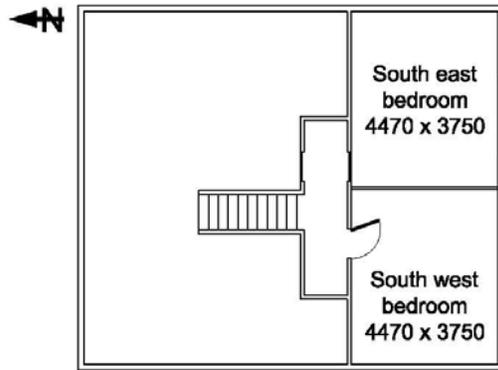
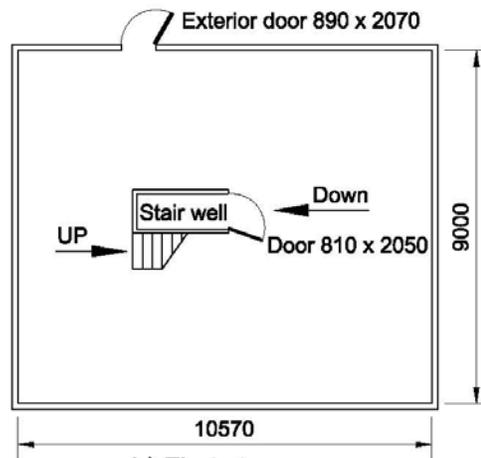
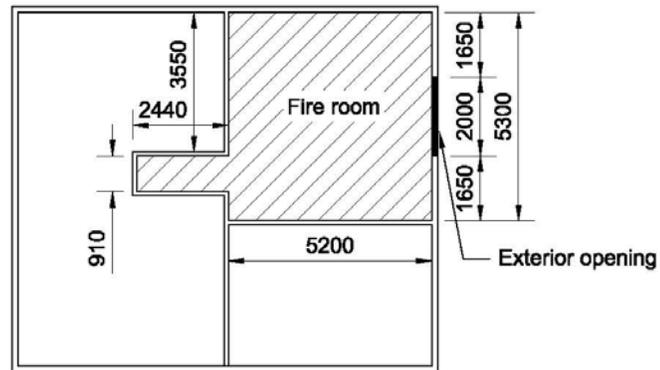
Figure 1. Facility plan view (all dimensions in mm)

A test facility was designed to represent a typical two-storey detached single-family house with a basement. The floor layout of the facility is shown in Figure 1. Each storey has a floor area of 95 m<sup>2</sup> and a ceiling height of 2.4 m. There were no openings that are normally associated with heating, ventilating and air-conditioning or plumbing systems in a house.

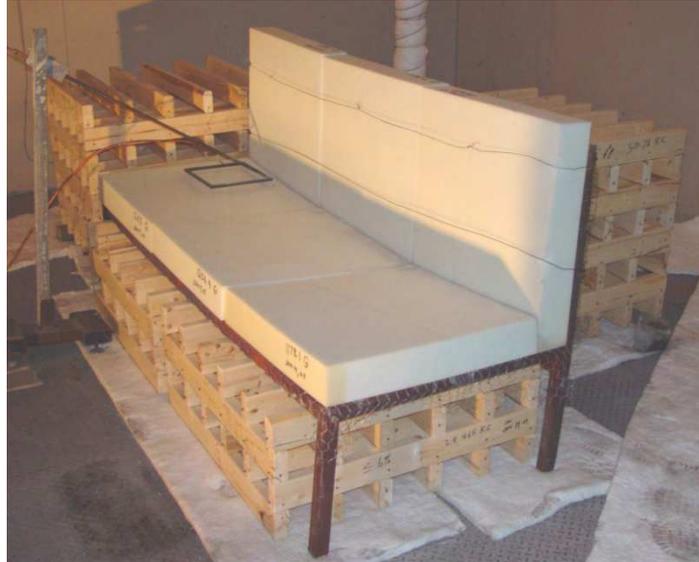
**Figure 2.** Fuel package

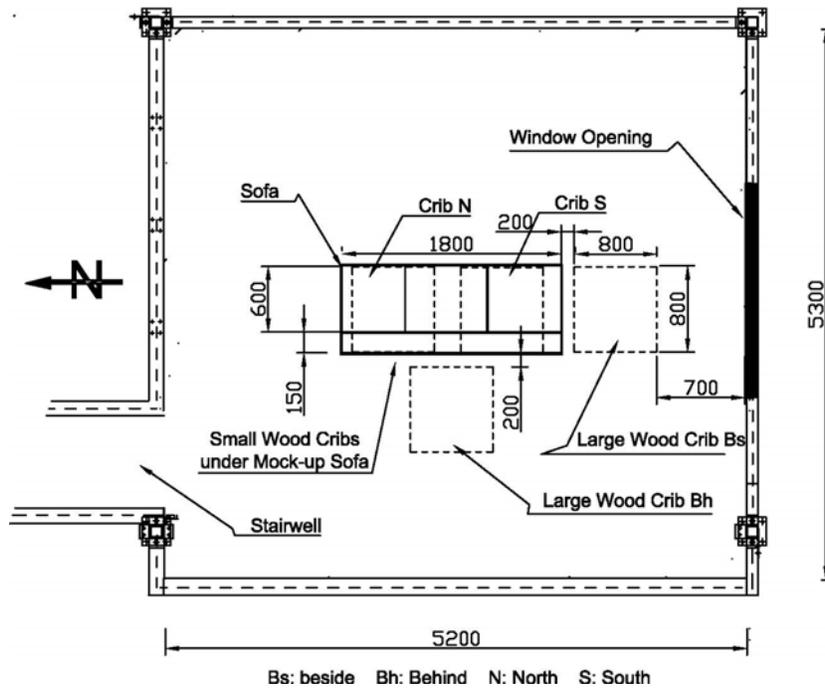
**Figure 3.** Layout of the fuel package (all dimensions in mm)

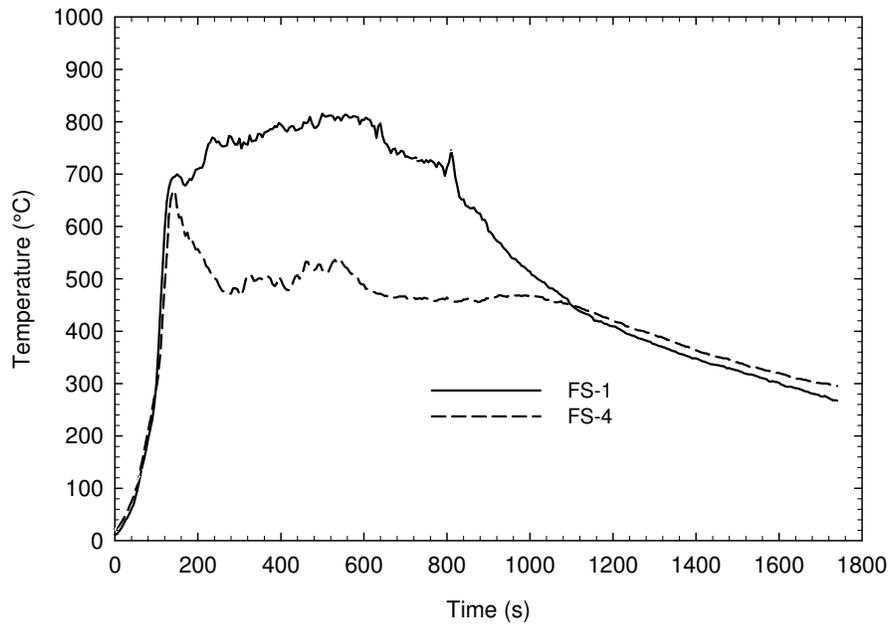
**Figure 4.** Average temperature profiles in basement fire compartment at 2.4 m height for FS-1 and FS-4

The temperatures in the fire room were lower in FS-4 than in FS-1 during the wood-crib-dominated period (Figure 4). Closing the basement door limited the oxygen supply to the fire in the basement and acted as a barrier to smoke movement into the upper storeys before the door burnt through. The effect of the limited ventilation became pronounced after the polyurethane foam was consumed and the fire became wood-crib-dominated due to limited oxygen to support active combustion of the wood cribs. Although FS-4 was less severe than FS-1, it would still provide a reasonably severe challenge to unprotected floor assemblies. This scenario was selected for use in subsequent experiments to understand the impact of a closed basement door on the tenability conditions in the test house and the structural integrity of unprotected floor assemblies.

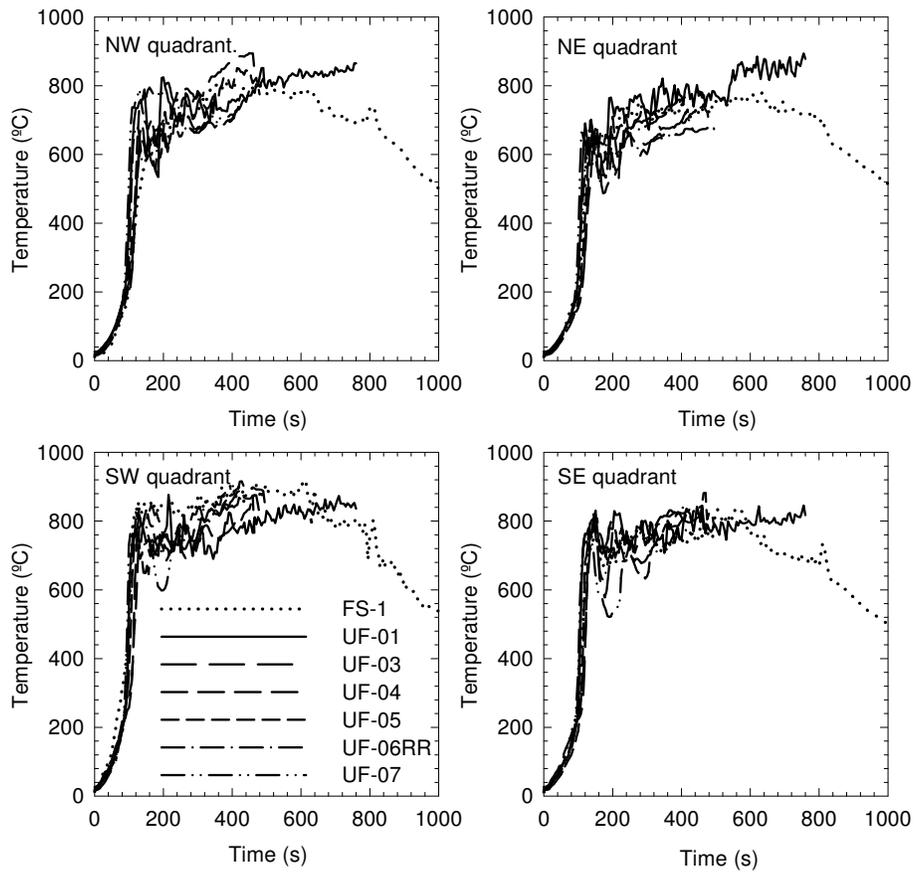
**Figure 5.** Temperatures in basement fire compartment at 2.4 m height (open basement doorway)

Figure 5 and Figure 6 show the temperature profiles measured at the centre of the four quadrants of the basement fire room at a height of 2.4 m above the floor for all of the tests. Data on temperature stratification at different heights in the fire room can be found in a series of reports [17-22]. The polyurethane foam used for the mock-up sofa dominated the initial fire growth. The fast development of the fire from ignition to attainment of the first temperature peak was consistent for all of the tests. Following this initial stage, the effects of ventilation became more pronounced and the fire became wood-crib-dominated and also involved the unprotected floor assemblies.

There was good repeatability of the fire development and severity. The temperatures at the 2.4 m height exceeded 600°C at approximately 120 s in all of the tests, indicating that the basement fire compartment reached flashover conditions. Figure 5 indicates that under the full ventilation conditions (open basement doorway) the fire scenario provided a very reproducible fire exposure to the unprotected floor assemblies in all experiments. As shown in Figure 6, under the limited ventilation conditions (closed basement doorway), the fire scenario also provided a relatively severe and consistent fire exposure to the unprotected floor assemblies (the closed hollow-core interior door at the top of the basement stairwell was breached by the fire later in the experiments). There was a quick transition from a well-ventilated flaming fire to an under-ventilated fire in all experiments. The results from the fire scenario tests (FS-1 and FS-4), with a non-combustible ceiling in the fire room, are also included in Figure 5 and Figure 6 for reference.

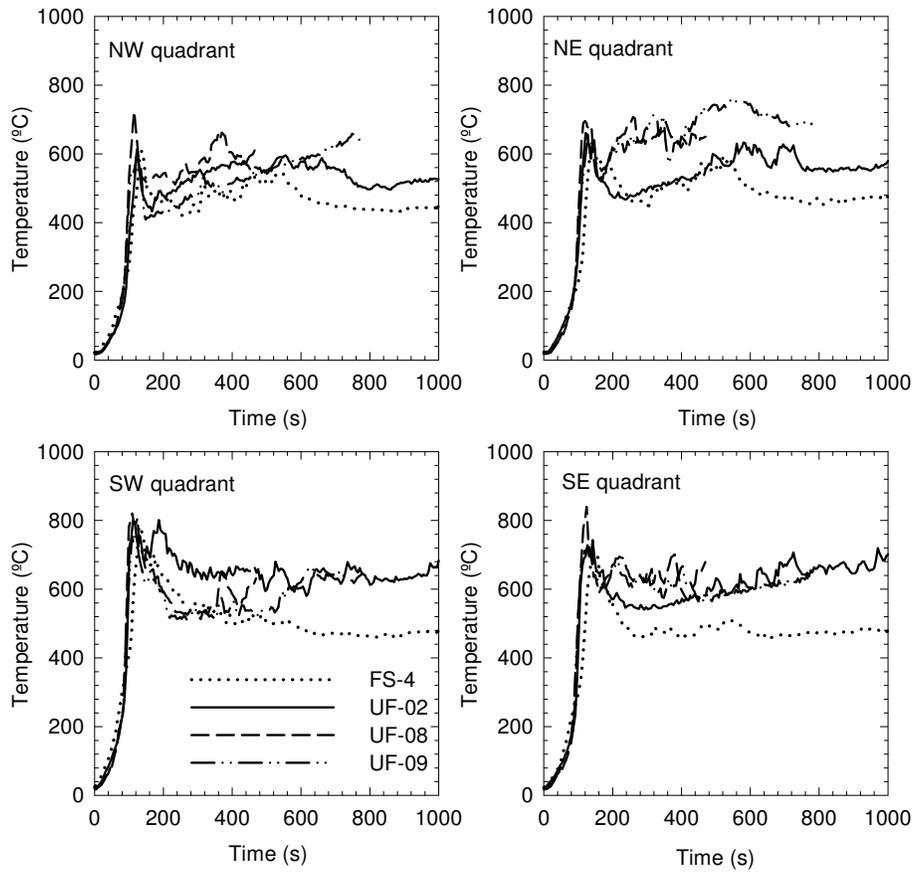
**Figure 6.** Temperatures in basement fire compartment at 2.4 m height (closed basement doorway)

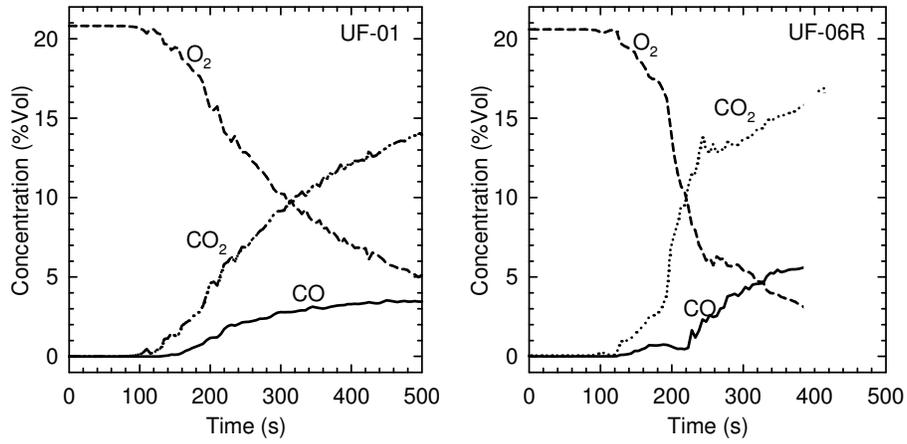
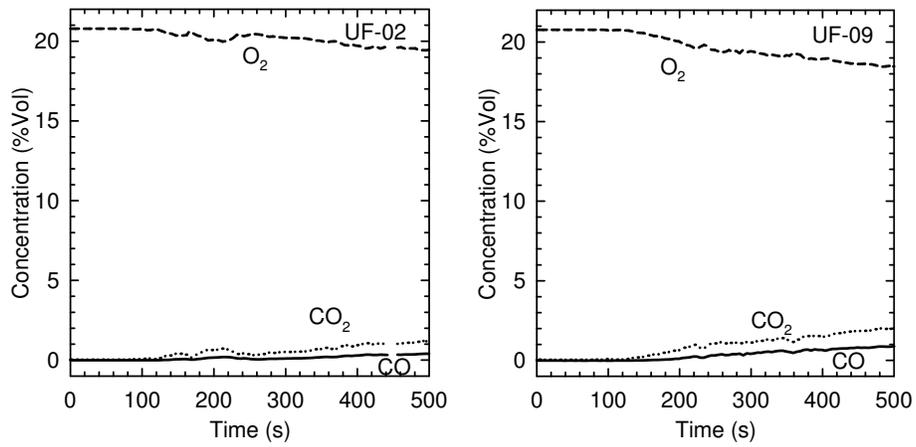
**Figure 7.** Exemplar CO, CO<sub>2</sub> and O<sub>2</sub> concentrations measured at the southwest quarter point on the first storey at 1.5 m height

Figure 7 shows the CO, CO<sub>2</sub> and O<sub>2</sub> concentration-time profiles measured during each experiment. For the experiments with the open basement doorway, within 220-300 s, oxygen was diminished to below 10% and CO<sub>2</sub> increased to above 10%, which could cause incapacitation and lead to loss of consciousness rapidly due to lack of oxygen alone or due to the CO<sub>2</sub> asphyxiant effect alone [24]. The concentrations reached a minimum of 3% O<sub>2</sub> and above 16% CO<sub>2</sub> near the end of the experiments. For the experiments with the closed basement doorway, the migration of smoke and hot fire gases into the upper storey(s) was significantly delayed and the O<sub>2</sub> concentrations on the upper storey(s) were 15% or above before structural failure occurred.

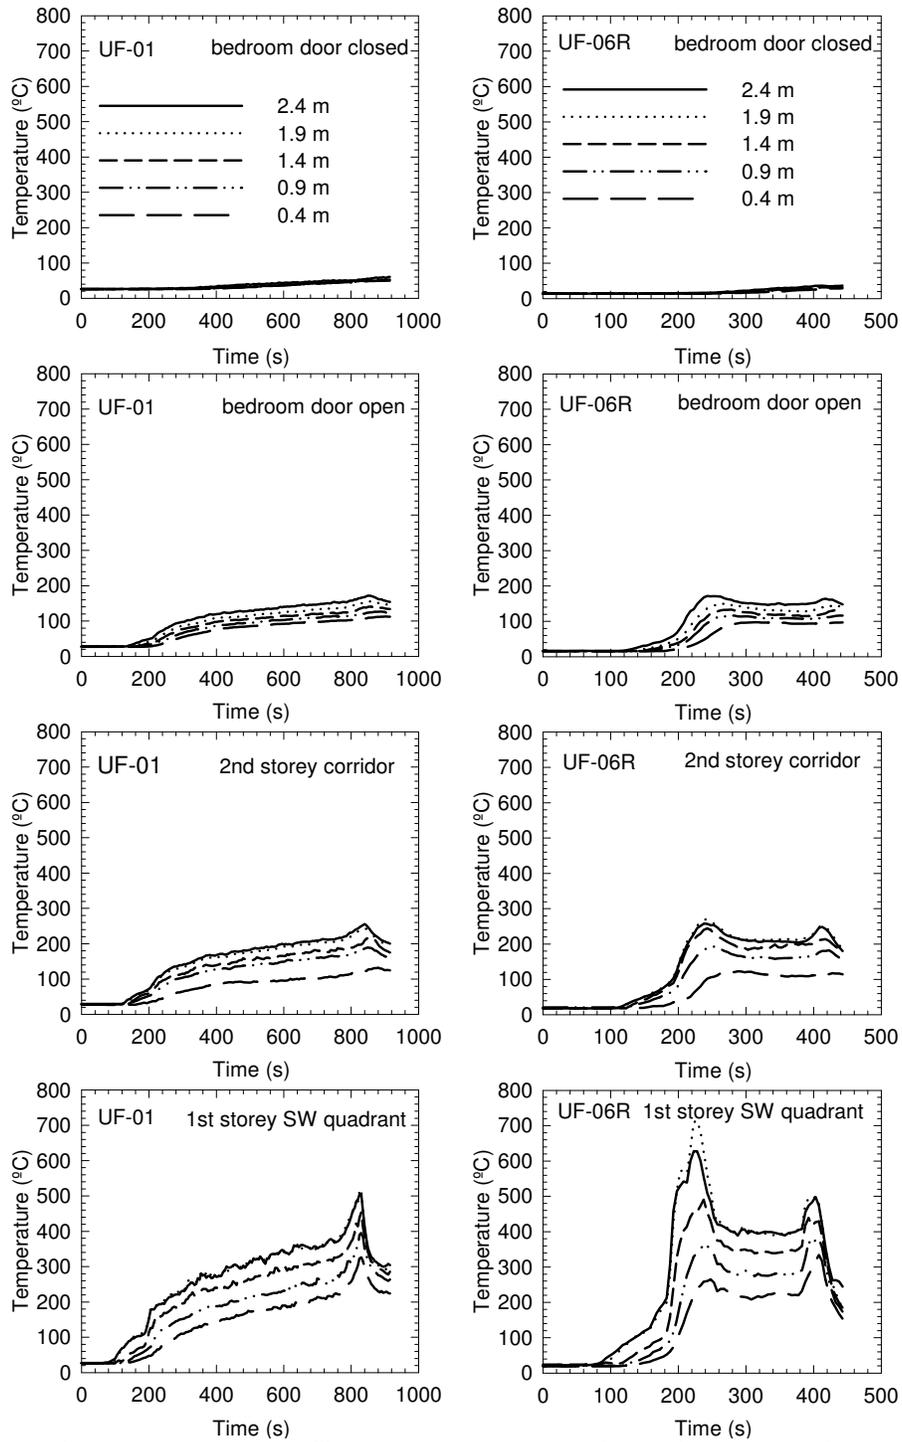
**Figure 8.** Exemplar temperature profiles on upper storeys (open basement doorway)

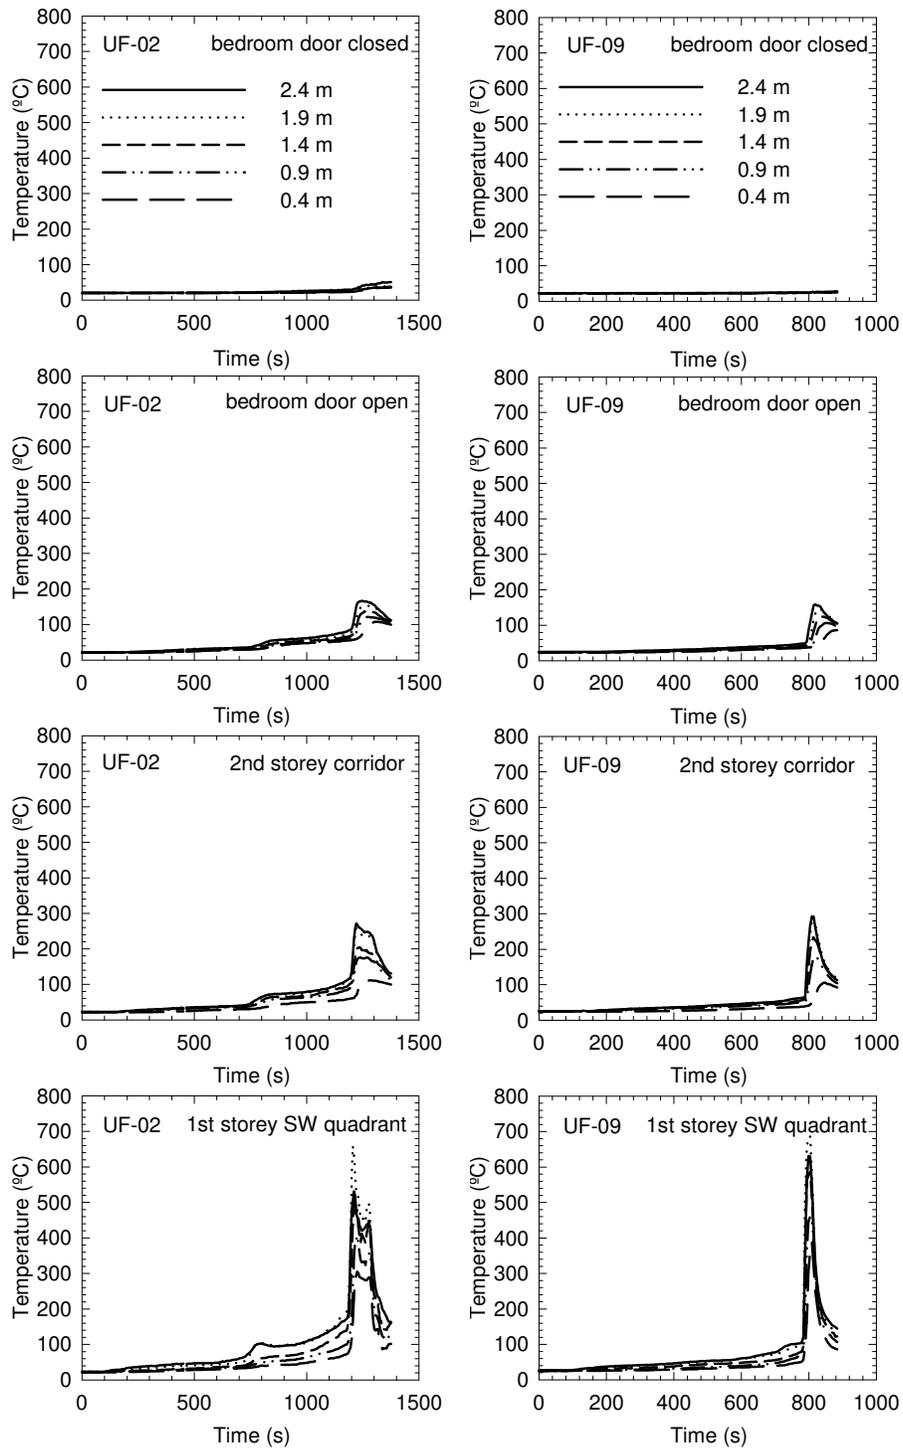
**Figure 9. Exemplar temperature profiles on upper storeys (closed basement doorway)**

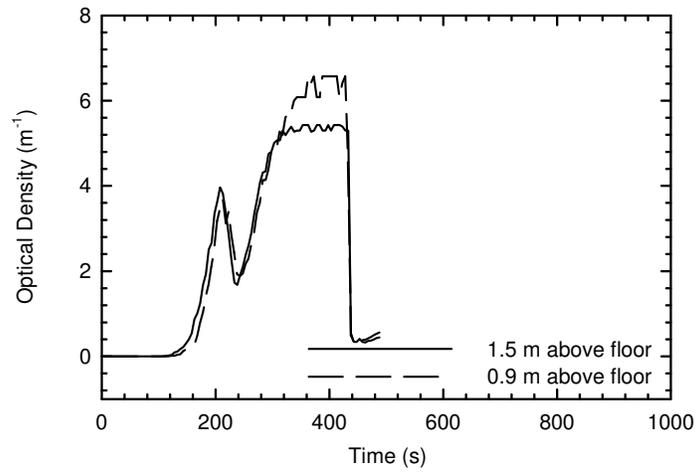
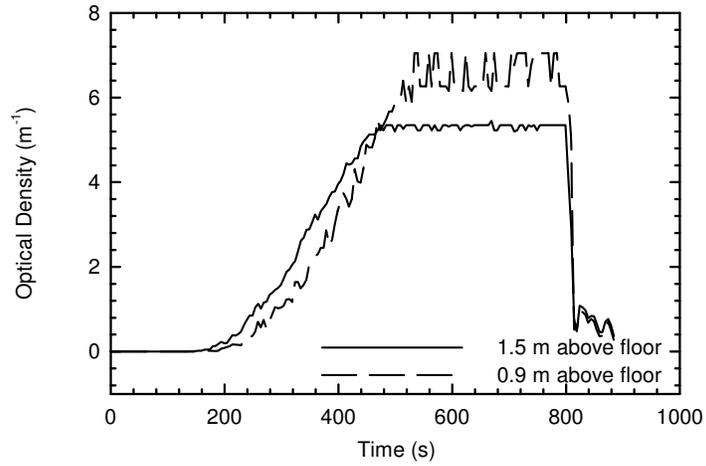
**Figure 10.** Exemplar data of smoke optical density (measured in the corridor on the second storey for Test UF-06RR and Test UF-09)

During the experiments, the optical density was measured at 0.9 and 1.5 m heights above the floor on the first and second storeys (simulating the height of the nose/mouth of an average height individual crawling and standing, respectively). Figure 10 shows exemplar optical density-time profiles. These profiles are also representative for other tests using corresponding scenarios. It was observed that in the experiments with the open basement doorway, the optical

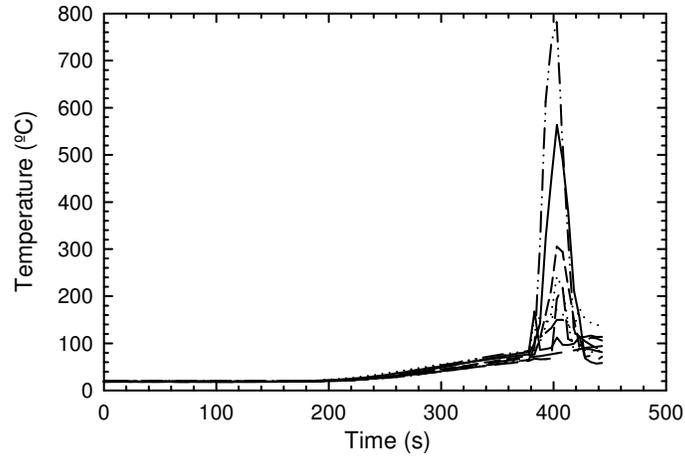
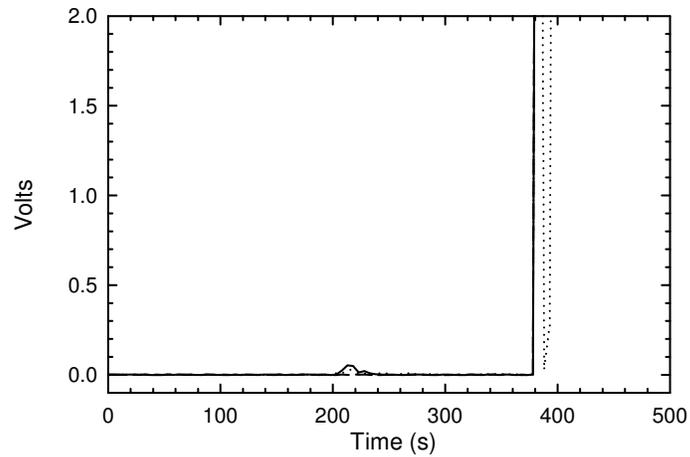
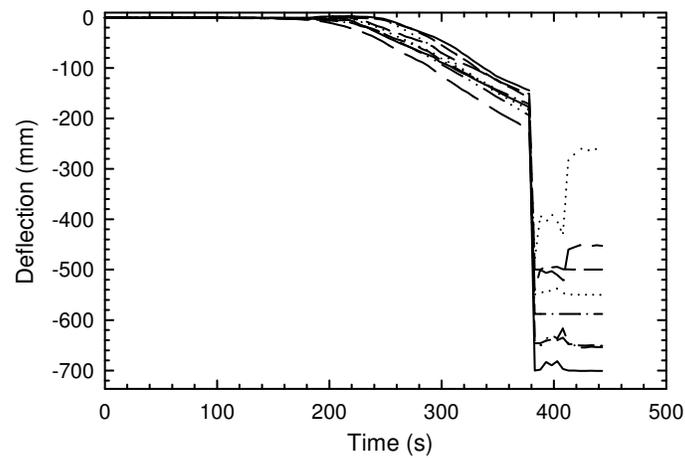
a) Thermocouples under insulated pad on top of the subfloor

b) Flame sensors at 3 tongue and groove joints of the subfloor

c) Floor deflections at 9 points on top of the floor assembly

**Figure 11.** Exemplar plots of measurements for determination of floor structural failure (Test UF-06R)

The temperatures shown in Figure 11(a) are from measurements by nine thermocouples under insulated pads on top of the OSB subfloor of the first storey. A rapid increase in temperature indicates that the floor was being significantly breached. The subsequent rapid decrease in temperature was due to the termination of the experiment by extinguishing the fire with water. Under standard fire resistance test conditions [33, 34], the temperature criterion for floor failure is defined as a temperature rise of 140°C on average of the nine padded thermocouples or a temperature rise of 180°C at any single point.

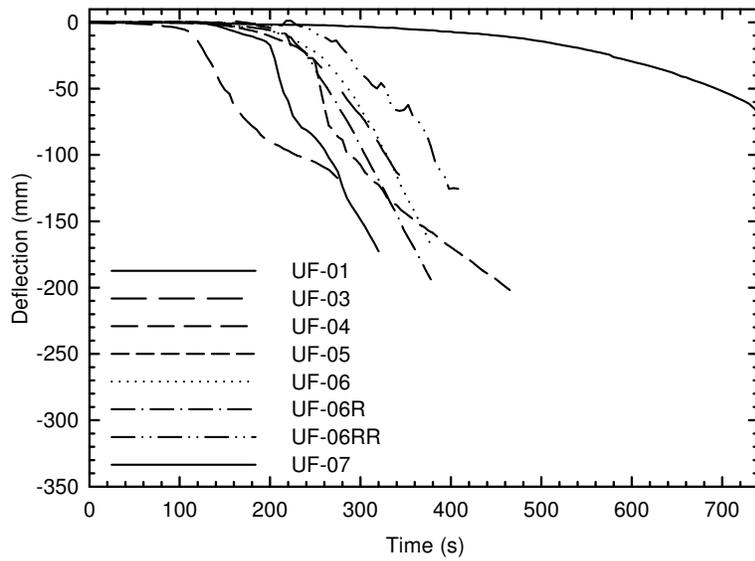
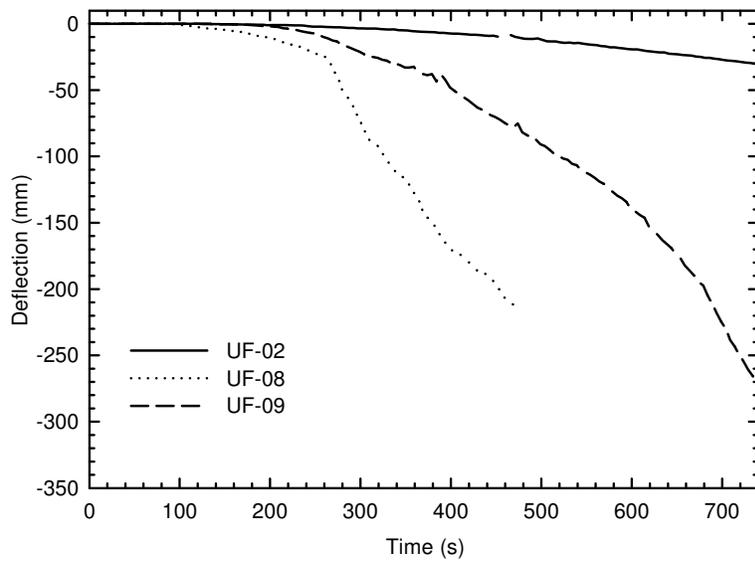
**Figure 12.** Floor deflection near the centre of the test assemblies prior to structural failure

There was structural deflection of all of the floor assemblies prior to their structural failure. Figure 12 shows a comparison of the floor deflection near the centre of all of the test assemblies prior to the structural failure. The steel C-joist floor assembly produced the highest deflection rate, followed by the metal-web and metal-plate wood truss assemblies. The solid wood joist assemblies produced the lowest deflection rate.
