Construction Technology Update; no. 23, 1998-12-01

Water-Shedding Details Improve Masonry Performance

by **A.H.P. Maurenbrecher**

This Update shows how the lack of effective water-shedding details can affect the appearance and performance of the exterior surface of masonry walls. Practical recommendations for avoiding problems are presented.

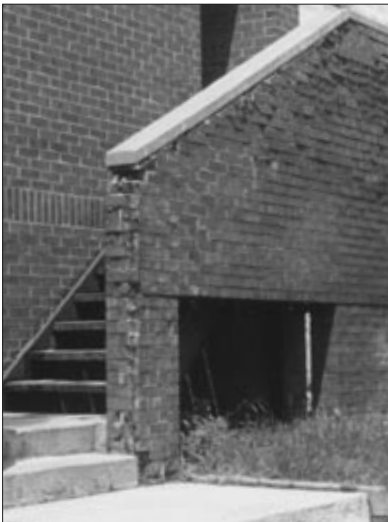
Figure 1. Frost damage (coping allows water to drain onto the wall)

Overhanging copings (caps) at the top of walls, parapets and chimneys can effectively reduce the potential for water damage. In regions with freezing temperatures, damage can be serious: high moisture content together with freeze-thaw cycles can lead to spalling. The staircase wall shown in Figure 1 has a concrete coping but

because it was built flush with the face of the wall, water can still run onto the masonry below. The problem is most severe when snow on the coping melts during the day and the water freezes at night; this cycle may be repeated over several days. Another problem with this wall is that the bricks go all the way down to ground level (not recommended practice). At ground level, rain and melting snow have also caused frost damage (de-icing salts used on the walkway make matters worse). The same brick on the more sheltered wall of the apartment building has suffered no damage.

Damage can be avoided by using copings that extend beyond the face of the wall, by using a projecting metal flashing between the coping and the wall, or by using masonry with a known high frost resistance (but then staining may still occur). Field observations indicate that drips that project at least 25 mm beyond the face of the wall are effective. Concrete or stone copings must have a drip groove to stop water from running back under the overhang, while metal copings must be shaped to form a drip (see diagram). Junctions in copings should be carefully designed to avoid water getting through, or alternatively there should be a projecting flashing underneath to intercept the water. Staining below junctions is a common defect observed in practice.

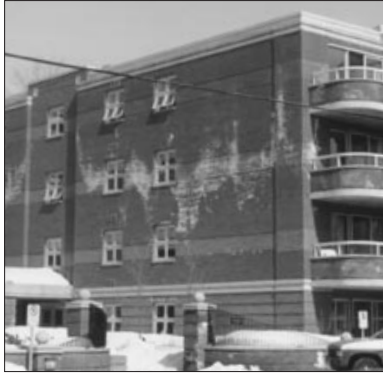
Figure 2. Efflorescence (coping allows water to drain onto the wall)

Figure 2 shows a building with a stepped back parapet. The lower section has a concrete coping with a metal cap which slopes towards the front of the wall and allows water to drain straight onto the wall (insufficient overhang). One small section of parapet without a setback on the left of the photograph does not have this problem; the top of the metal coping slopes towards the roof and at the face of the wall the bottom end projects outward to shed water. At the balconies, a concrete

coping overhangs the brick but water can still run back underneath the coping (no drip groove) and through junctions in the coping. Extensive efflorescence during the colder months of the year is the result.

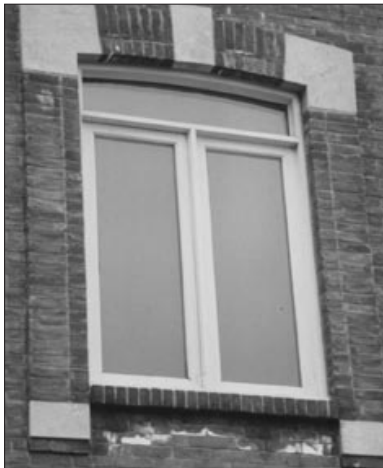
Figure 3. Efflorescence (water migrates through brick sill)

Brick window sills are generally not recommended unless care is taken to choose durable brick and mortar (especially in areas where freezing occurs). They may be acceptable in drier parts of the country and in low-rise housing with a protective roof overhang. If a brick sill is used, a continuous waterproof flashing material must be bedded immediately under it. The flashing should also project beyond the face of the wall; this will intercept water coming through the sill, usually through fine cracks at the brick/mortar interface. Figure 3 shows a brick sill that allows water to drain through, causing efflorescence below. Figure 4 shows ventilation vents in a parking garage with a brick sill flush with the face of the wall, resulting in staining and ice formation. A projecting metal flashing on the sill would have avoided this problem.

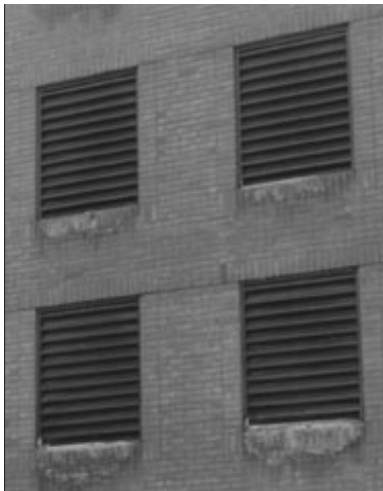
Figure 4. Staining and icing below garage vents (sills flush with the wall)

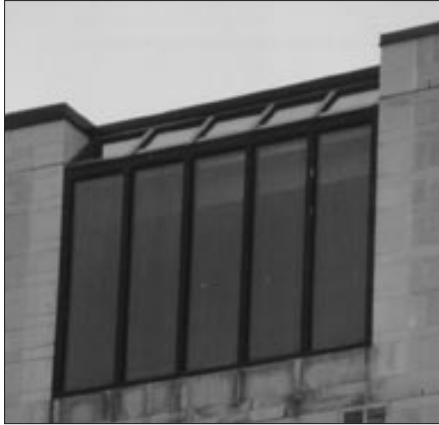
Figure 5. Staining below window (no sill projecting beyond wall)

Large window areas and sloping sections increase the water run-off considerably (Figure 5). The lack of a projecting sill beneath the window has resulted in severe staining, all the more obvious with the light-coloured masonry. With large areas of sloped glazing, the minimum projection for the sill may need to be increased to 50 mm; alternatively a gutter could be installed to collect the water. Each end of a sill should have a barrier to stop water from running off the ends onto the wall (often a raised section to deflect the water forward). Figure 6 shows the typical staining pattern when barriers are not provided. Where possible, sills should be made in one piece to avoid junctions (Figure 7). When

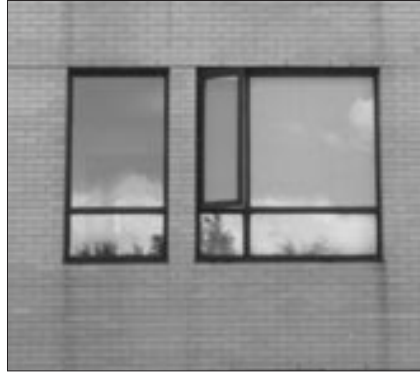
Figure 6. Staining below windows (no end barriers on sills)

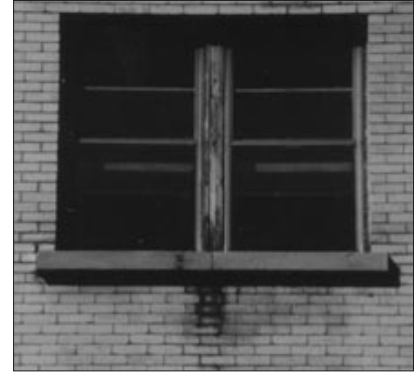
Figure 7. Staining beneath junction in a window sill

junctions are unavoidable, they should be detailed to ensure water will not get through, or a projecting flashing should be bedded underneath to divert any water. Mortar and sealants in junctions may be adequate in the short term but not the long term.

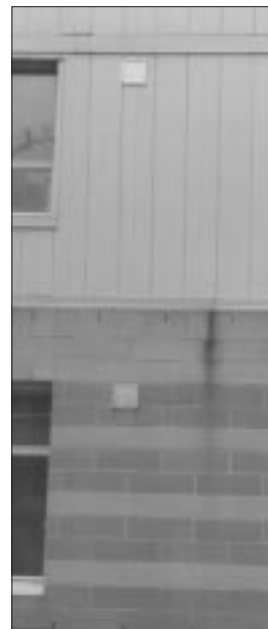
Figure 9. Staining below junction in flashing set back from the wall

Concrete and aluminum or vinyl siding above masonry must have a flashing at the intersection to shed water away from the masonry. Figure 9 shows an apartment building with aluminum siding. The siding has drips at every storey to break the flow of water down the wall. But above the ground storey masonry the flashing does not project beyond the masonry. Here much of the water runs along the flashing until it hits a junction and then drains down, leading to staining.

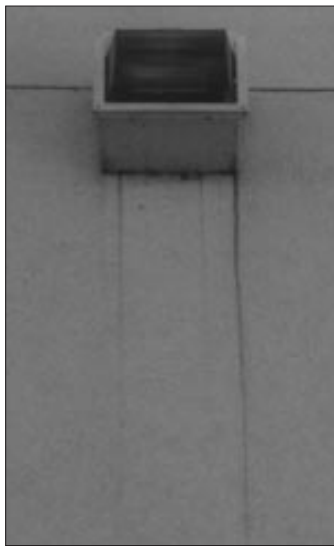
Figure 10. Staining below light fixture (water run-off)

Water running off fittings and decorative items (e.g., lights, signs and flagpole supports) projecting beyond the surface of the wall must also be diverted to avoid staining. Staining may be caused by dirt, lime from concrete or limestone products, or corrosion products from iron or copper. The staining

shown in Figure 10 can be avoided by placing a flashing between the lamp fixture and the wall with a projection beneath, or a gap between the fixture and the wall.

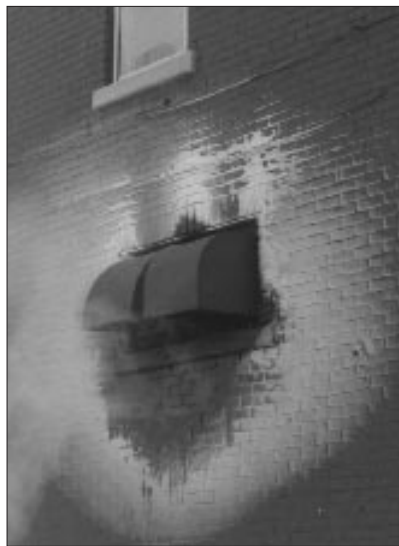
Figure 11. Frost on wall at a laundry exhaust vent

Kitchen and laundry exhaust vents should be designed to direct the air away from the wall, including adjacent walls (Figure 11).

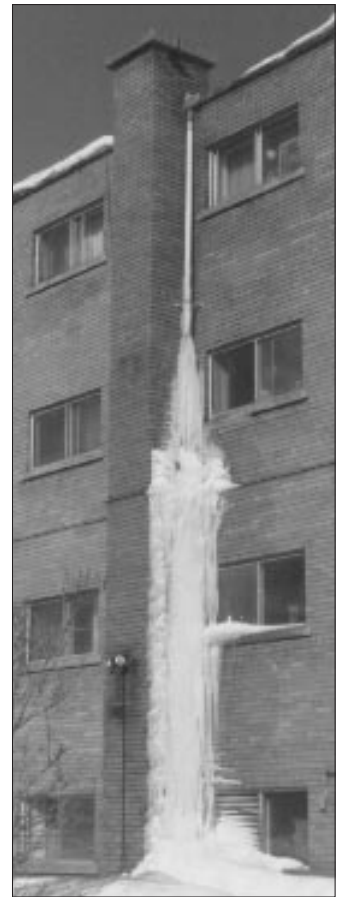
Figure 12. Severe icing below break in downspout

The prompt repair of water-shedding elements is important especially in the case of gutters and downspouts (gutters should be regularly cleared of debris such as leaves from overhanging trees). Figure 12 shows what can happen if repairs are postponed. The brick in this building has good frost resistance and only suffered minor damage. The damage to the concrete window sill is caused by corroding reinforcement (not directly related to the downspout break).
