Experimental studies of the effects of blasting on structures

Edwards, A. T.; Northwood, T. D.

Engineer, 210, pp. 538-546, 1960-10-01

The results are presented of controlled blasting tests on six buildings on two different soils. Damage was correlated with size of charge and distance, and with displacement, velocity, acceleration, settlement, and strain measurements in the buildings. Peak velocity appears to provide the best correlation with damage for all soil conditions.

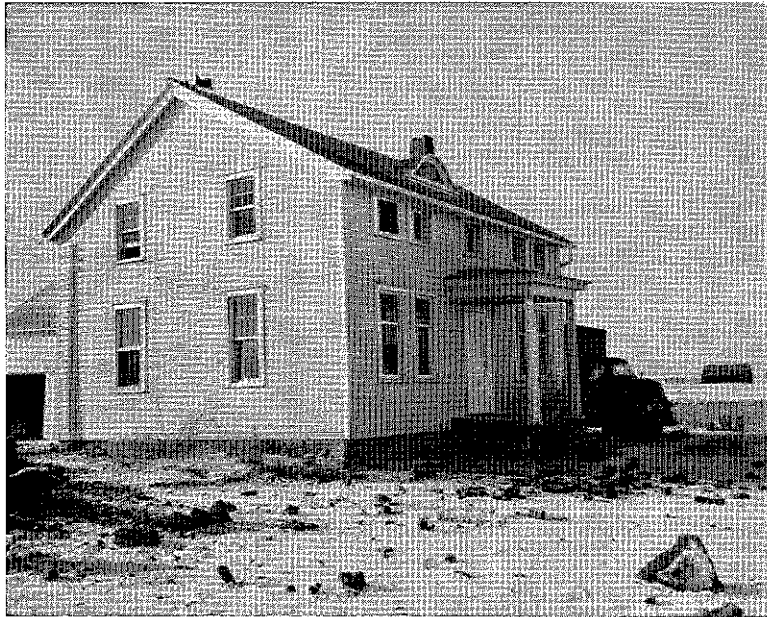
Fig. 1 (above)—Building R (after Test R3)

Six structures on two different types of soil were used in the tests. Three of the structures were on a loose wet sand, about 20ft deep, under which was soft marine clay. The water table at the time of the tests was about 7ft below grade. This soil condition will be referred to as sand-clay for the purpose of this article. The other structures were on glacial till—referred to hereafter as till. This is a high shear strength material consisting of a highly compacted mixture of sand, clay, gravel and boulders. Density of the material was about 145 lb per cubic foot, and the water content about 10 per cent. Both soils were frozen to a depth of about 1ft at the time of the tests. The structures are briefly described and designated in Table 1. Photographs of buildings R, E, C, and F are given in Figs. 1 to 4.

Building R.—No damage occurred until Test R3 (120 lb at 29ft) when some horizontal cracks, up to about $\frac{1}{32}$ in wide, developed in the basement walls. These extended out in the two walls, longitudinal with the blast, about 12ft from the rear wall. Nearly all the tell-tales across original cracks broke, although none were opened up. Somewhat fewer tell-tales broke in the walls normal to

the blast. Most of the windows in the ground floor longitudinal walls broke while those in the walls normal to the blast remained intact. The top section of the chimney was sheared through.

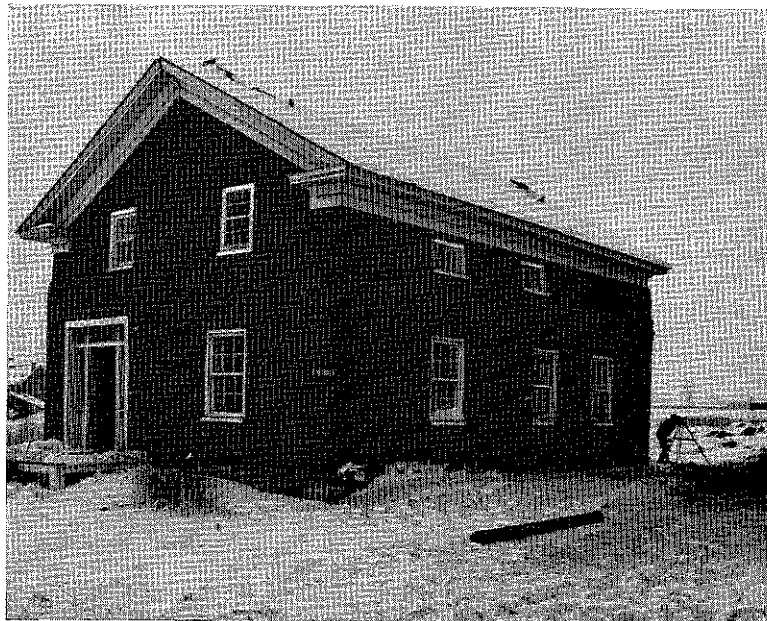
Fig. 2 (below)—Building E (after Test E11)

had a 45 deg. crack across the front wall which had been patched up and which was said to have been caused by the Cornwall earthquake of 1945. The crack may be seen in Fig. 2. Rock was encountered about 15ft down at house F.

Building E.—Damage first occurred with Test E10 (140 lb at 50ft) when some vertical and diagonal cracks developed in the basement and upper walls. An original diagonal crack in the front wall was opened up to $\frac{1}{4}$ in width. Test E11 (140 lb at 25ft) demolished large sections of the two rear walls and caused the rear upper floor to collapse. The diagonal crack in the front wall opened up to about 1 in width.

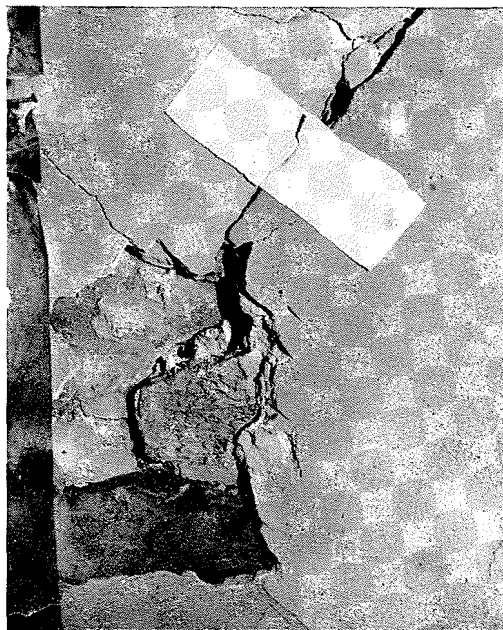
Fig. 5—Showing tell-tale across an original crack

was pasted across each crack (Fig. 5). The adhesive used was a type that is rigid when dry and thus does not yield under load. Consequently, a widening or extension of original cracking produced a tear in the paper.

(a) *Tell-tales*.—In order to obtain a positive indication of movement in existing cracks in plaster or in basement walls, a sheet of paper

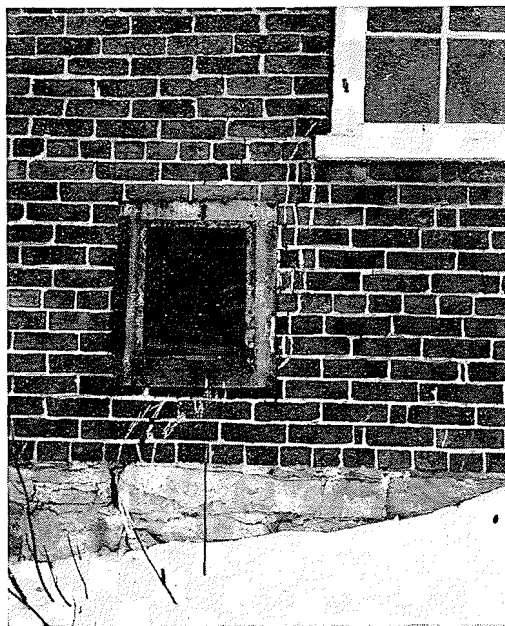
Fig. 6—Vertical crack due to settlement (school)

In general, the type of damage was found to be related to the soil condition. In the sand-clay, vertical cracks occurred which were associated with large settlement. Examples of this type of damage are shown in Figs. 6 and 7. In the till, damage was more often associated with horizontal cracking and shattering of the basement walls as exemplified by Figs. 8 and 9. It is interesting that chimneys are sometimes the first part of a

It may be concluded that the damage in the buildings in sand-clay was caused by failure of the soil, i.e. settlement, under the buildings rather than by wave energy within the building proper.

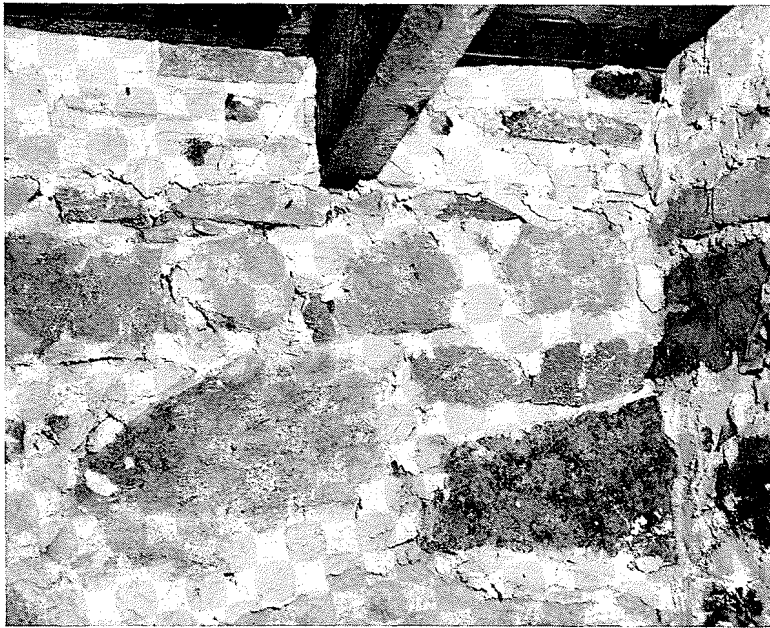
Fig. 8 (above)—Horizontal crack—building T

Building T.—Test T17 (350 lb at 80ft) caused a few of the tell-tales across original cracks to break, although none opened up. No

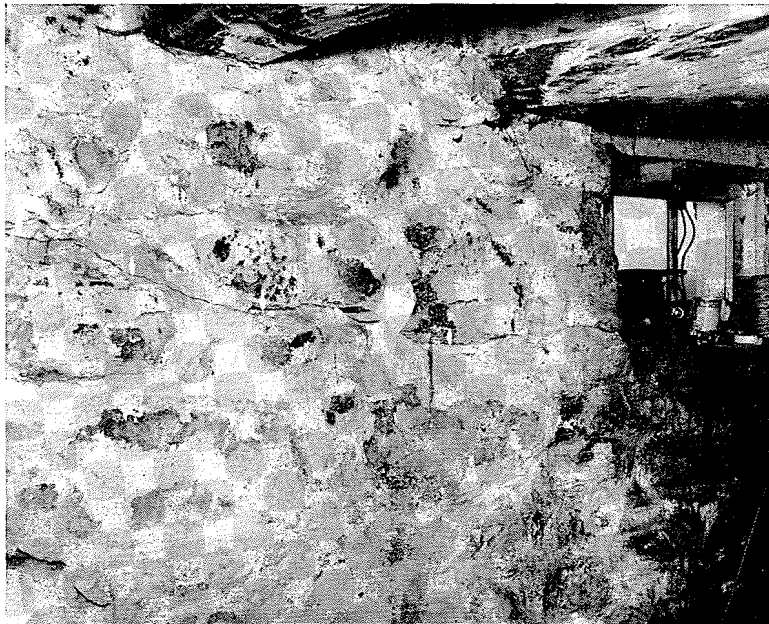
Fig. 9 (below)—Horizontal crack—building F

Building F.—Test F20 (400 lb at 90ft) caused some minor horizontal cracking in the basement wall, generally between courses, and some stone to be dislodged from around one basement window. One partition wall, which was originally in poor shape, was cracked and a few tell-tales were broken. Major damage was inflicted on the building by Test F22 (750 lb at 70ft). Considerable sections of the rear basement wall fell away and the masonry walls above ground level

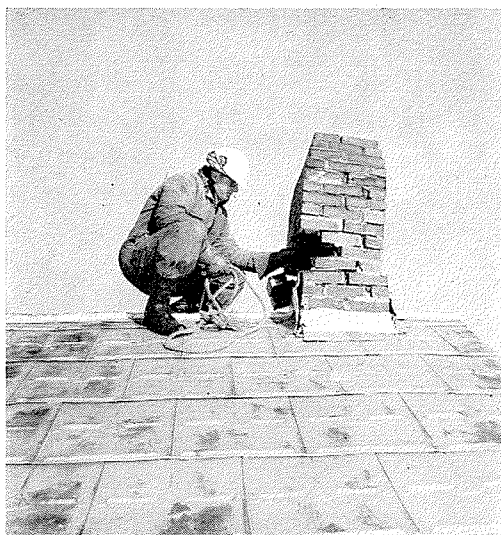
Fig. 10—Chimney damage—building R

building to show signs of weakness. Fig 10 shows an example that occurred at building R.

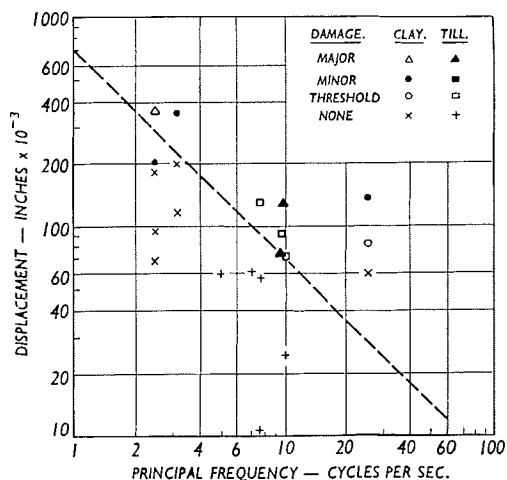
Figs. 13 and 14 are scatter diagrams showing the relations between longitudinal and vertical displacements, frequency and damage. The results show considerable variation in damage threshold depending on the principal frequency. In fact the trend suggests that the threshold corresponds to a constant velocity. (The dashed lines in the figures represent a velocity of 4.5 in per second, a criterion that will be discussed later.) When the results are examined in detail, it is seen that a low-frequency group were all obtained in the sand-clay soils, whereas most of the higher-frequency values were obtained in the till soils. Thus there appears to be some correlation between the nature of the soil and the frequencies predominating on displacement records. It will be seen that it is not possible to assign a damage threshold in terms of displacement without some qualification regarding frequency.

Fig. 13—Longitudinal displacement versus frequency and damage
