A Field Study on Photoluminescent Signage Used to Guide Building Occupants to Exit in Complete Darkness

Report NRCC-43959

Proulx, G.; Creak, J.; Kyle, B.R.

August 2000

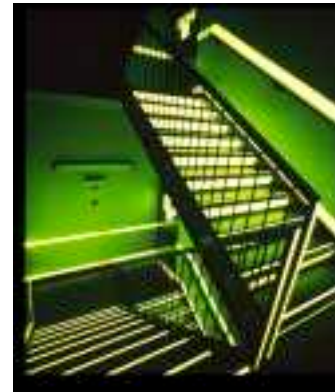
Stairwells C and D were equipped with PLM from the top floor of the building down to the bottom. The installation of the material was according to the Photoluminescent Safety Products Association Standard 002 Part 1 (PSPA, 1997). The stairwell was equipped with two continuous wayguidance lines, 10 cm in width; one line at skirting board and the other 1 m from the floor. Directional signs were enclosed within these continuous lines. A 2 cm strip was fixed on the tread of each step and a 10 cm piece was positioned on the riser of each step. A sign identifying the floor number was installed on each door as well as a sign identifying the "Transfer Floors". Directional signs were positioned on each door and at mid-landing. In accordance with Canadian practice, signs were positioned at the top of each exit door, identifying them as a final exit. The material and installation costs for the stairwells were estimated at \$2,000 CDN/floor.

Figure 1: Stairwell C with PLM and lights off

The building's four identical stairwells were set up with different conditions, as shown in Table 1. It is important to mention that, in this building, the stairwells' emergency lighting was the full lighting with an average output of 245 lux. For the study, the lighting conditions in three of the stairwells were modified while Stairwell B received no treatment; it acted as the control stairwell. Lighting in Stairwells A and D was modified to obtain a reduced output of not less than 3.3 lux, which is a code requirement. To reduce the lighting, 2 out of 3 double-tube luminaires were switched off, providing Stairwell A with an average lighting of 57 lux and Stairwell D with a slightly higher average output of 74 lux. Also, Stairwell D had PLM signs and a wayguidance system installed. Stairwell C also had PLM signs and a wayguidance system and had all lights switched off a few minutes before the evacuation, as presented in Figure 1. During the evacuation drill, the regular lighting was turned off
