NRCC-43938

A version of this paper is published in / Une version de ce document se trouve dans :
InFIRE Conference 2000, Ottawa, Ontario, May 2000, pp.1-8

A FIELD STUDY ON PHOTOLUMINESCENT SIGNAGE USED TO GUIDE BUILDING OCCUPANTS TO EXIT IN COMPLETE DARKNESS

Guylène Proulx, Ph.D., National Research Council of Canada, Ottawa, Canada

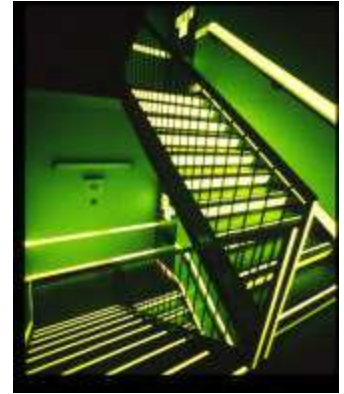
Figure 1: Stairwell C with PLM and lights off

Stairwells C and D were equipped with PLM from the top floor of the building down to the bottom. The installation of the material was according to the Photoluminescent

Safety Products Association Standard 002 Part 1 (PSPA, 1997). The stairwell was equipped with two continuous wayguidance lines, 10 cm in width; one line at skirting board and the other 1 m from the floor. Directional signs were enclosed within these continuous lines. A 2 cm strip was fixed on the tread of each step and a 10 cm piece was positioned on the riser of each step. A sign identifying the floor number was installed on each door as well as a sign identifying the "Transfer Floors". Directional signs were positioned on each door and at mid-landing. In accordance with Canadian practice, signs were positioned at the top of each exit door, identifying them as a final exit. The material and installation costs for the stairwells were estimated at \$2,000 CDN/floor.
