COBOURG BEAM TEST

Report No. 79
of the
Division of Building Research

Ottawa
March 1956

This report describes the testing of a 100-foot continuous (two 50-foot spans) I-shaped prestressed concrete beam, prestressed with 56 high tensile steel wires anchored by the Magnel Blaton system. One hundred such prestressed beams constituted the main roof beams for four large Army ordnance warehouses at Cobourg, Ontario.

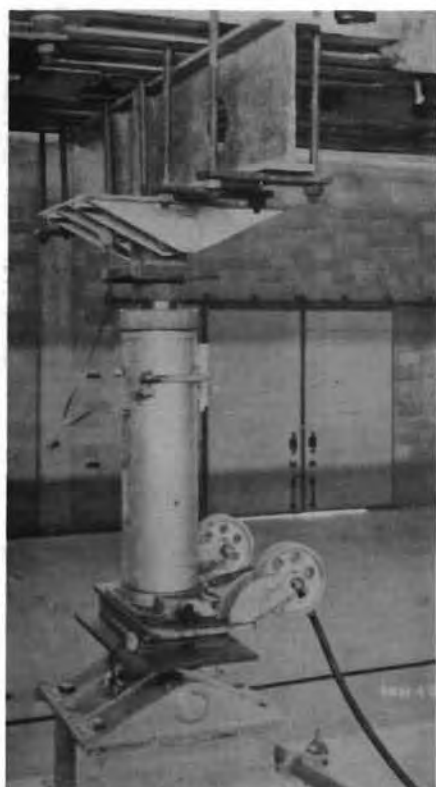
Fig. 3 Typical Hydraulic Ram Used for Applying Load.

The test loads were applied by means of eleven 50-ton hydraulic jacks, their capacity being approximately 75 per cent greater than the estimated required capacity at failure. The chosen type of jack is also characterized by a lock nut arrangement which is very helpful for applying sustained loads (Fig. 3). All pump units were equipped with pressure gauges which had been calibrated against jack load in a testing machine (Fig. 4). Load cells using electrical resistance strain gauges were placed under the ends and the centre of the beam to measure the reactions and also to serve as a check of the overall applied load. The load cells were also calibrated before the test (Fig. 5).

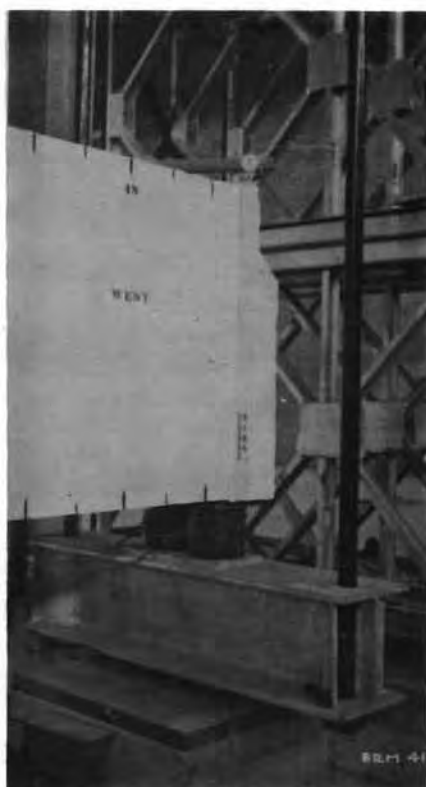
Fig. 5 End Reaction of Beam. Note Load Cells and Deflection Apparatus.

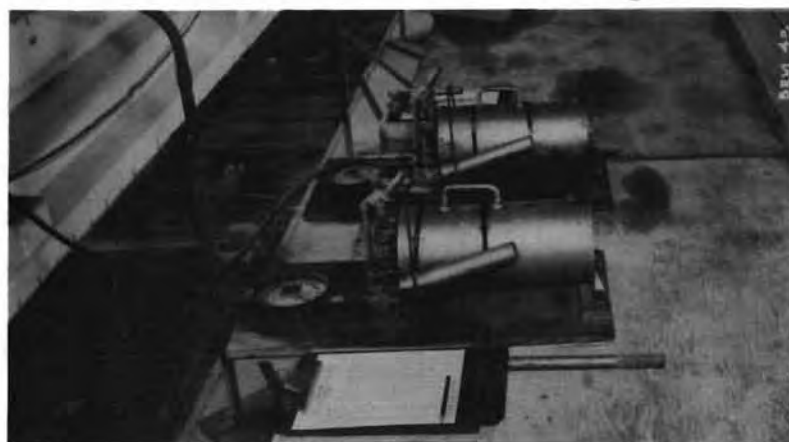
Fig. 4 Hydraulic Pumps and Gauges Used for Loading.

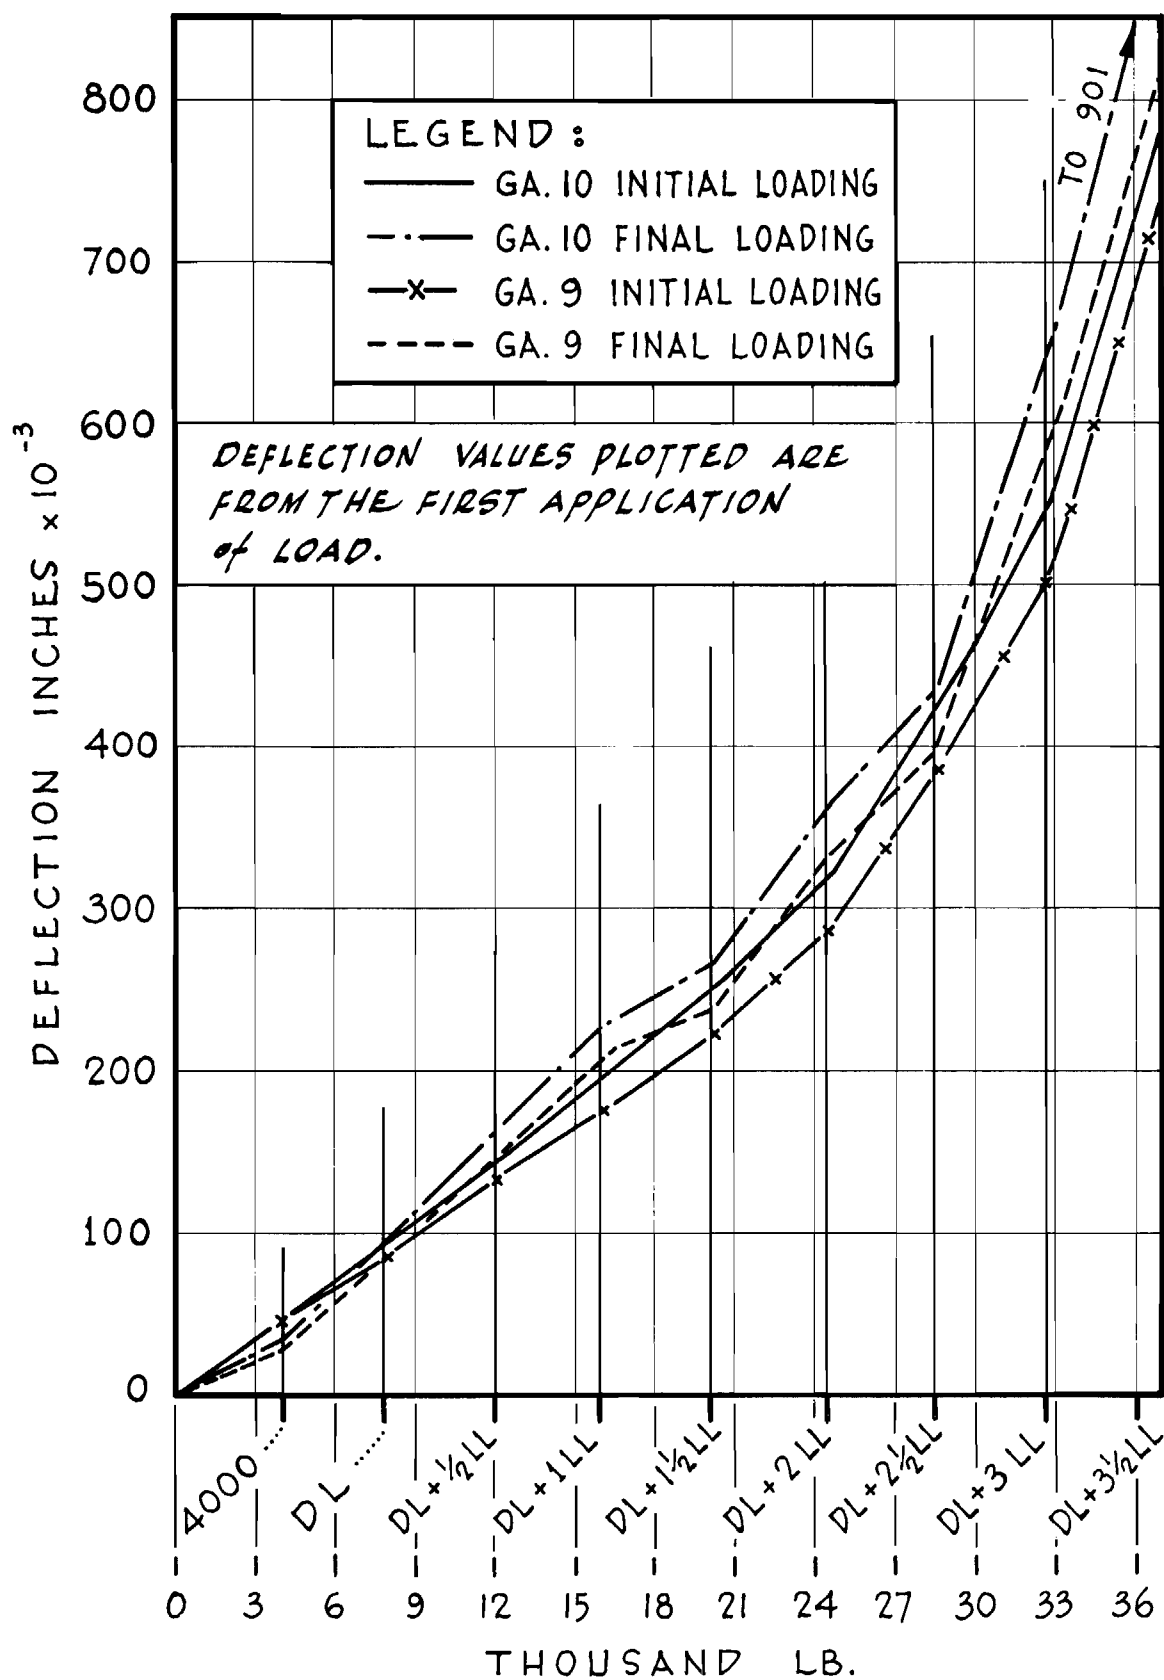
FIGURE 16

INITIAL & FINAL DEFLECTIONS
MEASURED AT VARIOUS APPLIED LOADS

The deflections of the beam for the same load increased after the beam had been cracked. This is clearly

shown in Fig. 16. For loads less than DL the curves are actually reversed but this is probably due to inaccuracies in applying the low loads resulting from temperature and humidity effects. The increase in deflection with the number of load applications becomes obvious for loads greater than DL + 1 LL. For the two gauge positions shown on the graph, the increase in deflection is approximately 0.03 inch for loads up to DL + $2\frac{1}{2}$ LL and increases to 0.10 inch at DL + $3\frac{1}{2}$ LL.

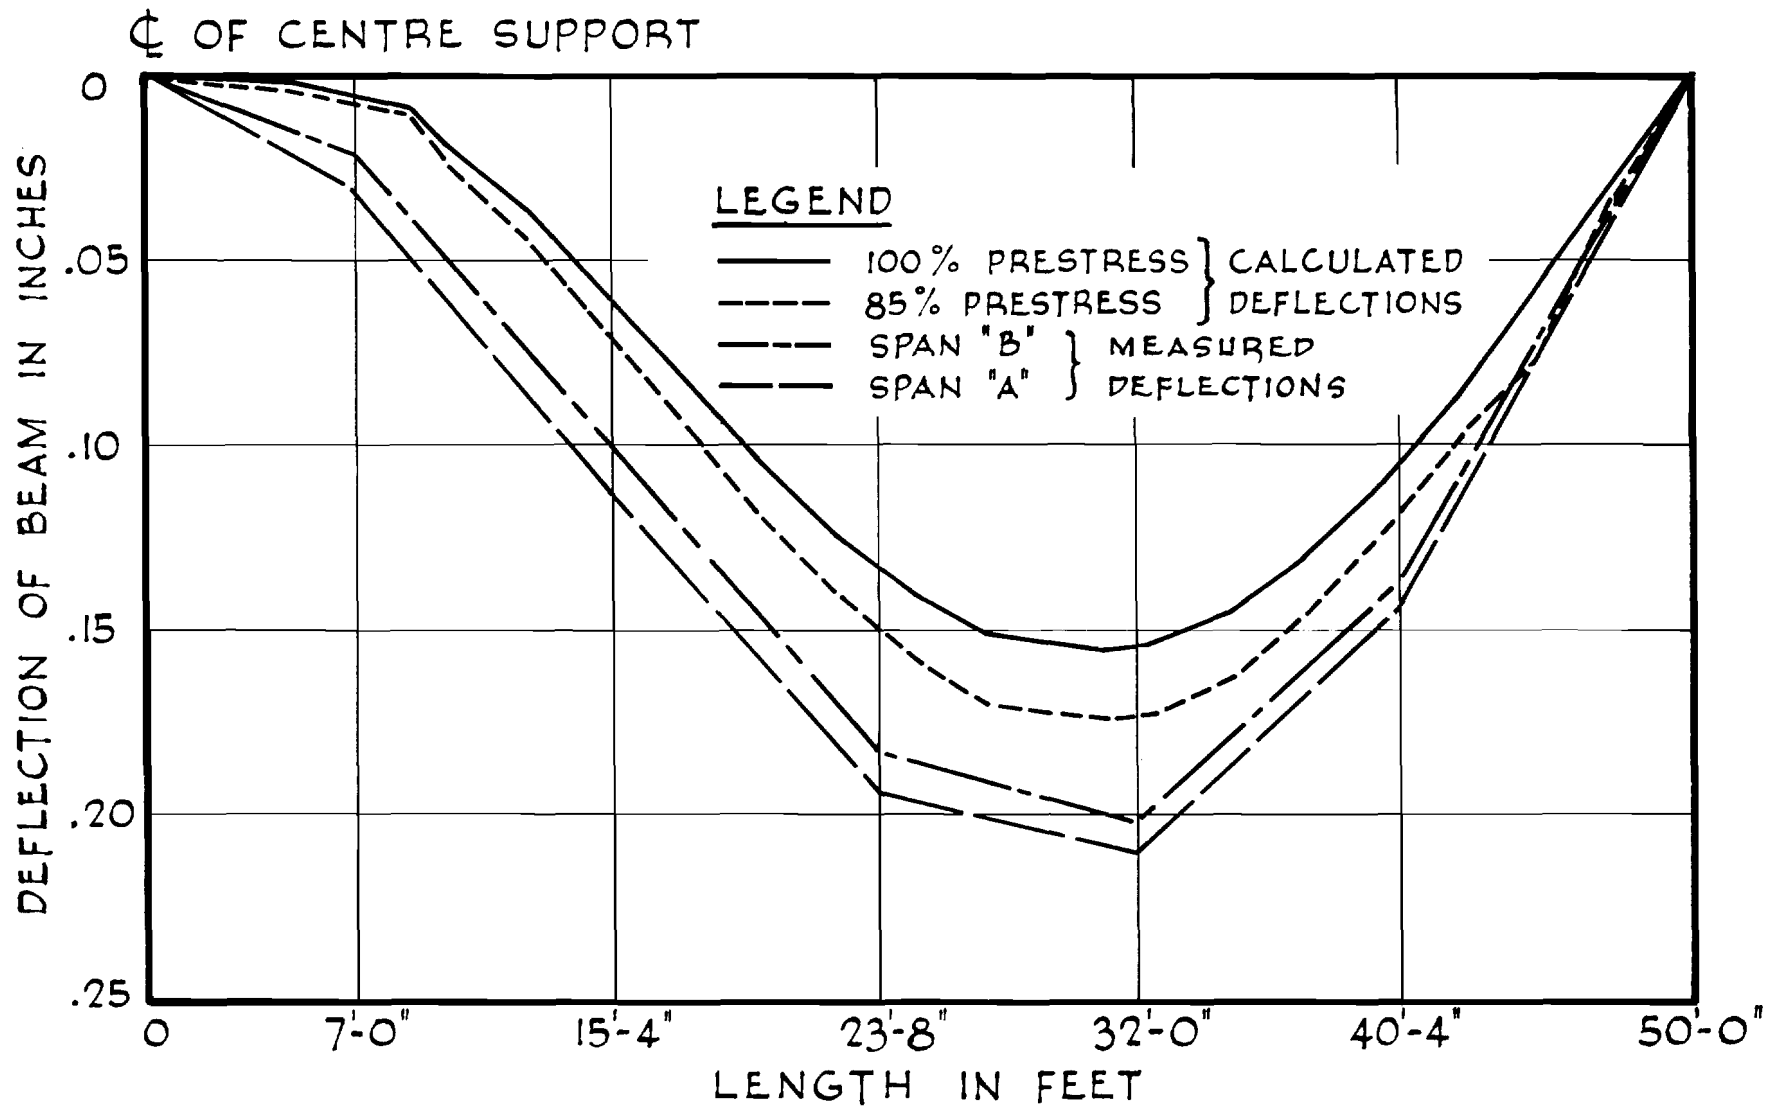
FIGURE 17

CALCULATED AND MEASURED DEFLECTIONS FOR DEAD
LOAD PLUS 1 LIVE LOAD

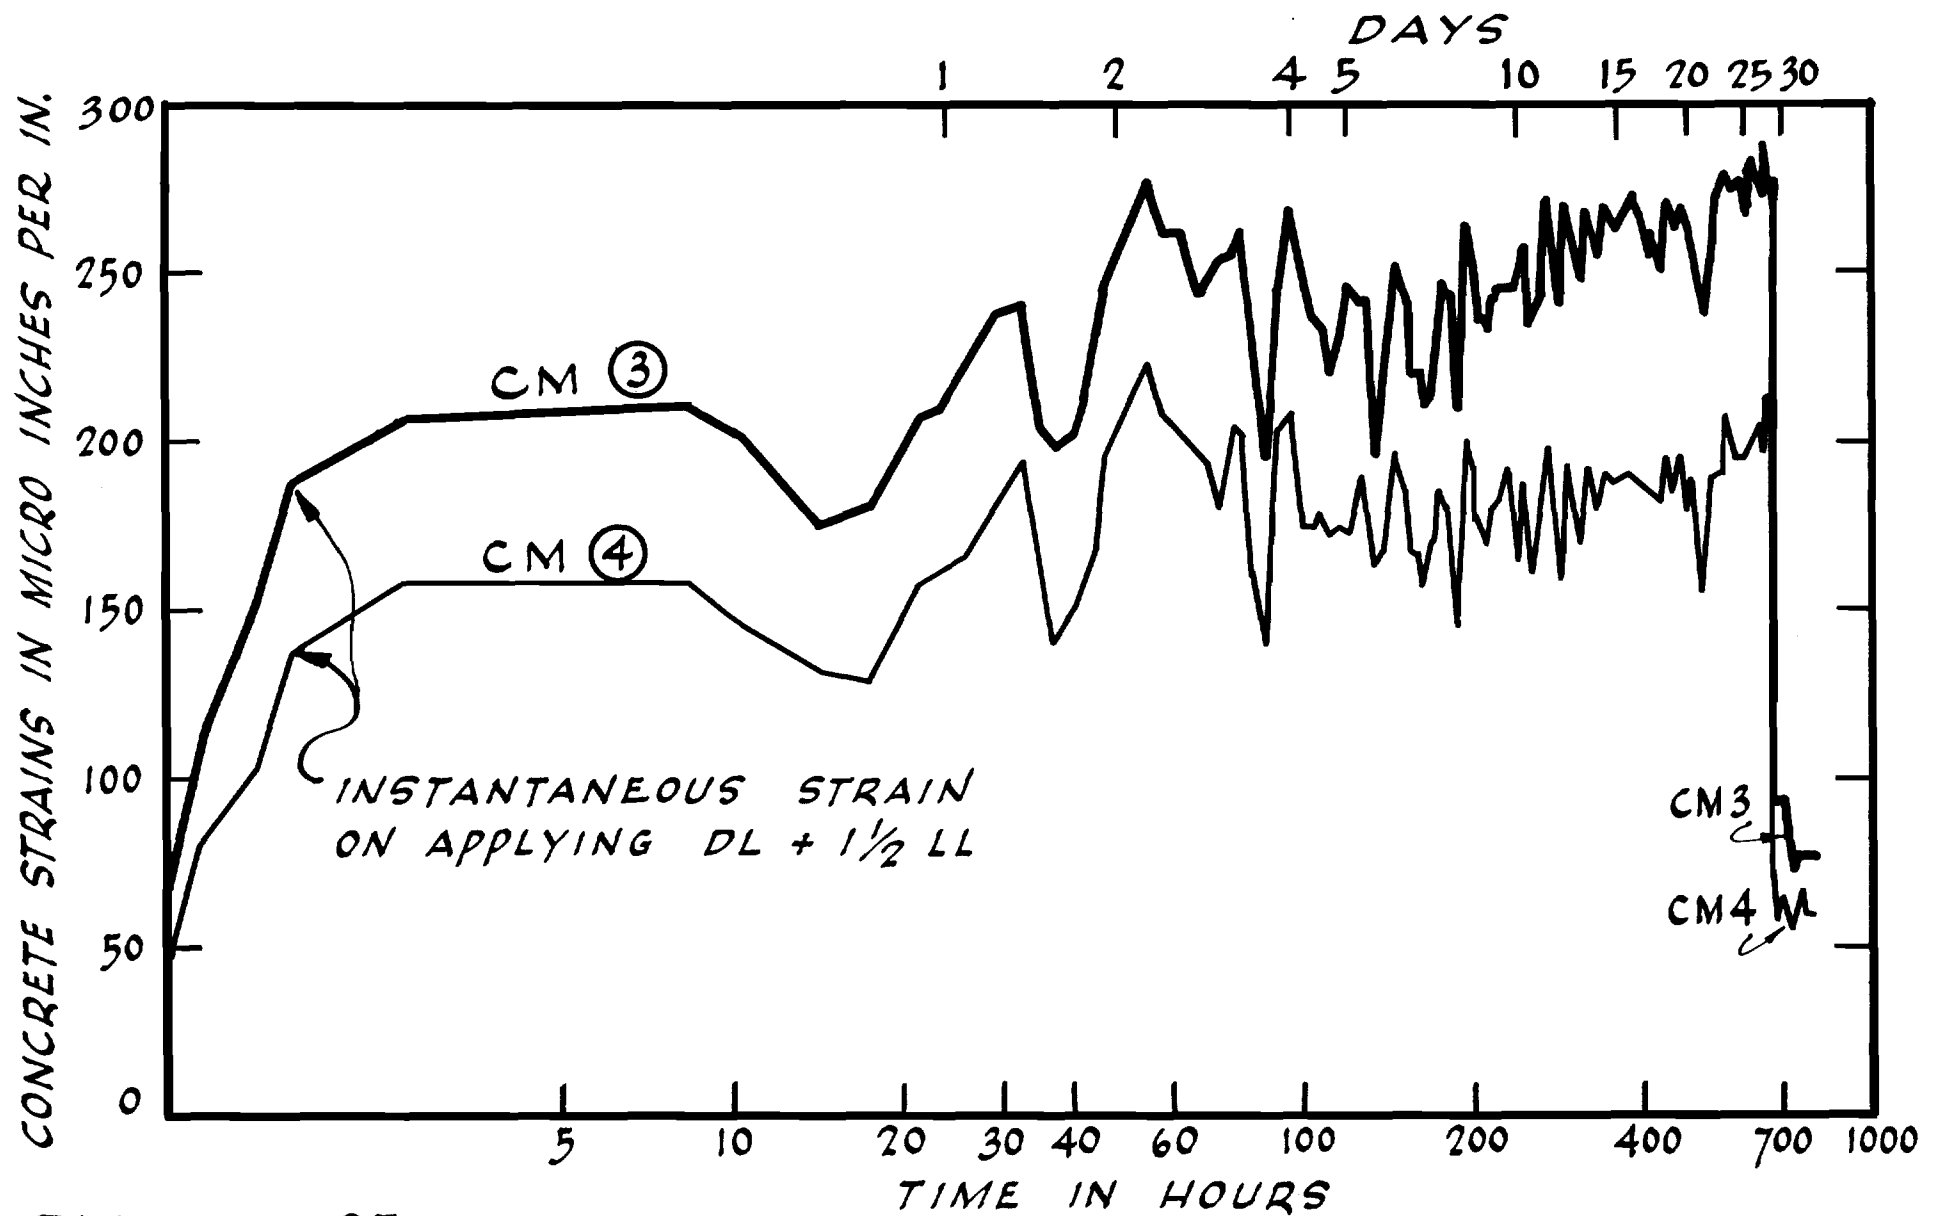
FIGURE 27

HISTORY OF CONCRETE COMPRESSIVE STRAINS AT POSITIONS CM3 & CM4
DURING 28 DAY TEST

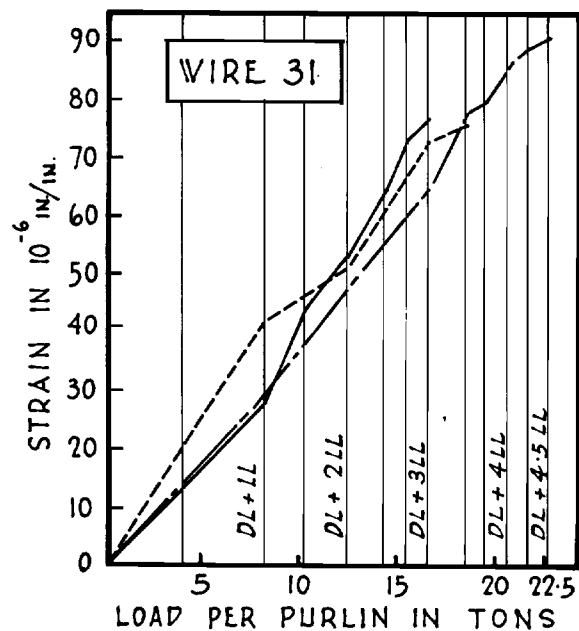
FIGURE 31

**HISTORY of CHANGES IN STRAIN of 6 WIRES DURING LAST THREE
LOAD SERIES**

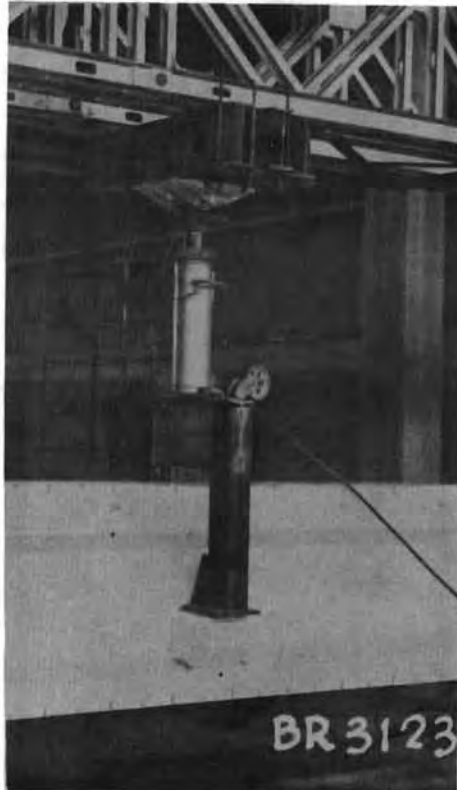
Fig. 37 Test Set Up
Used for Testing Purlin
Seats.

The purlins were loaded with the yoke arrangement shown in Fig. 37. Two pairs of purlins in span A were tested. The first pair, 16 feet, 8 inches from the centre support carried a load equivalent to DL + 4.0 LL before any cracking occurred. The concrete in this area had been cracked due to previous test loads.

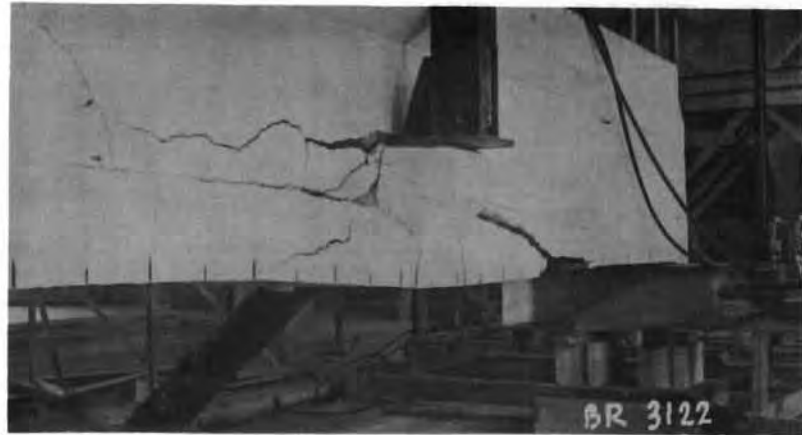
Fig. 38 Cracking at Purlin
Seat at DL + 13 LL.

The purlin brackets at the 32-foot-8-inch section were in a region of uncracked concrete and showed no signs of weakness due to previous test loads. The first crack occurred at DL + 9.8 LL, which resulted in a drop in the jack hydraulic pressure. The purlin brackets were loaded to the capacity of the jack, 58 tons or DL + 13 LL producing the cracking shown in Fig. 38. Further purlin bracket testing was considered unnecessary.

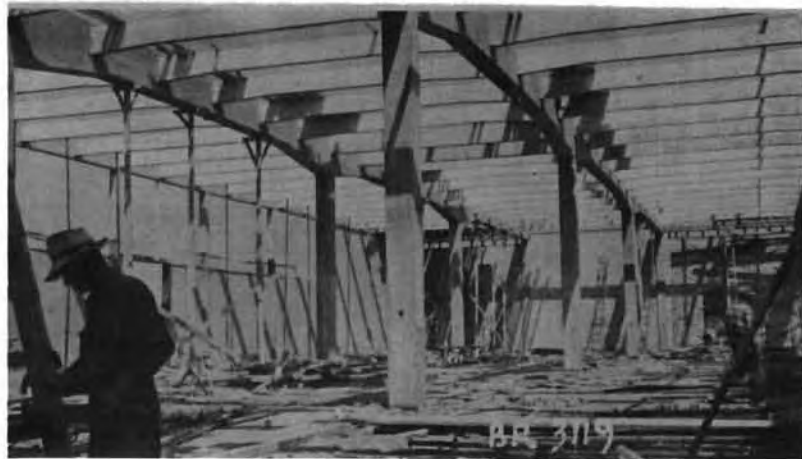
Fig. 39 Reinforced Concrete
Beams Used in Similar Warehouse.
