AIR LEAKAGE DATA FOR THE DESIGN OF ELEVATOR AND
STAIR SHAFT PRESSURIZATION SYSTEMS

by G.T. Tamura and C.Y. Shaw

Reprinted from
ASHRAE TRANSACTIONS 1976
Vol. 82, Part 2,
p. 179 - 190

DBR Paper No. 717
Division of Building Research

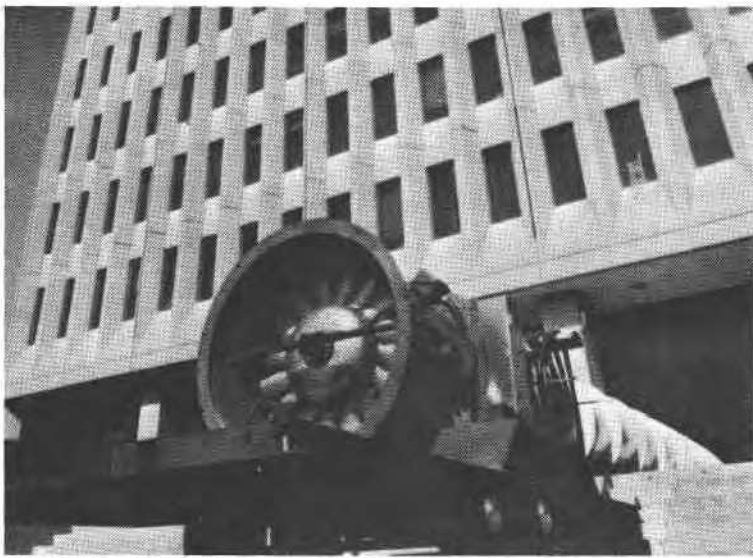
Fig. 1 Air supply fan and ductwork outside test building

A 50,000-cfm ($23.5\text{-m}^3/\text{s}$) vane axial fan was used to conduct the shaft air leakage tests (Fig. 1). The fan was mounted on a trailer so that it could be transported easily to the buildings under test. The fan is equipped with variable pitched blades that permit manual control of the supply air rate. The source of power supply was either a 550-volt circuit of the building, if one was readily accessible, or a mobile generator.
