Corrosion Inhibiting Systems for Durable Concrete Bridges –

Part 1: Five-year Field Performance Evaluation

Daniel Cusson¹, Shiyuan Qian², Nathalie Chagnon³, and Bruce Baldock⁴

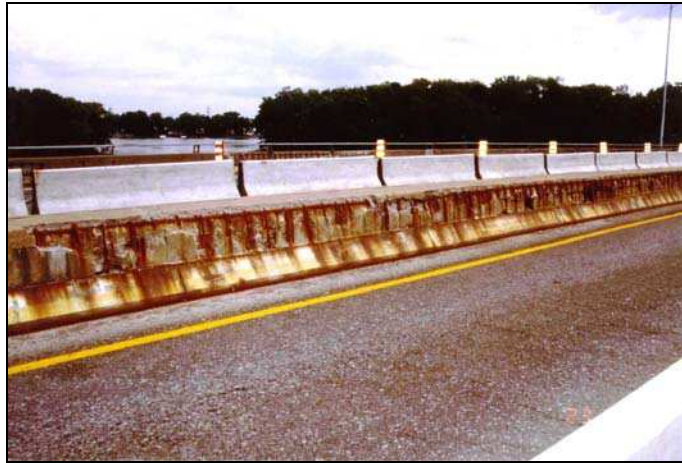
Fig. 1. Central barrier wall of Vachon bridge after 20 years of service (Montreal, Canada)

Many of North America's bridges are in urgent need of substantial rehabilitation, nearly one of every three bridges is rated structurally deficient or functionally obsolete (Smith and Virmani 2000). They estimated the cost of repairing and replacing deteriorated concrete bridges to be over \$20 billion in USA, and increasing at \$500 million per year. The main cause of deterioration of concrete bridge structures (e.g. cracking, delamination and spalling of concrete) is the chloride-induced corrosion of steel reinforcing bars, as illustrated in Figure 1.

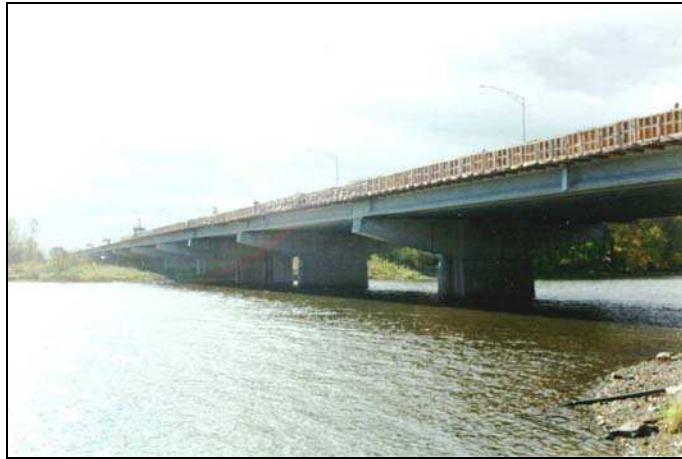
Fig. 2. Vachon bridge during rehabilitation in 1996

In 1996, the Ministry of Transportation of Quebec undertook the rehabilitation of the Vachon bridge located north of Montreal on Highway 13 across Mille-Îles River (Figure 2). The overall rehabilitation included the replacement of the barrier walls and patching of the concrete slab (later paved with asphalt). This 6-lane wide, 714-m long bridge has twenty-one 34-m long single spans consisting of prestressed concrete girders supporting a reinforced concrete slab. Ten consecutive spans of the east-side barrier wall were selected as the test site for the application of proprietary corrosion inhibiting systems. The rebuilt

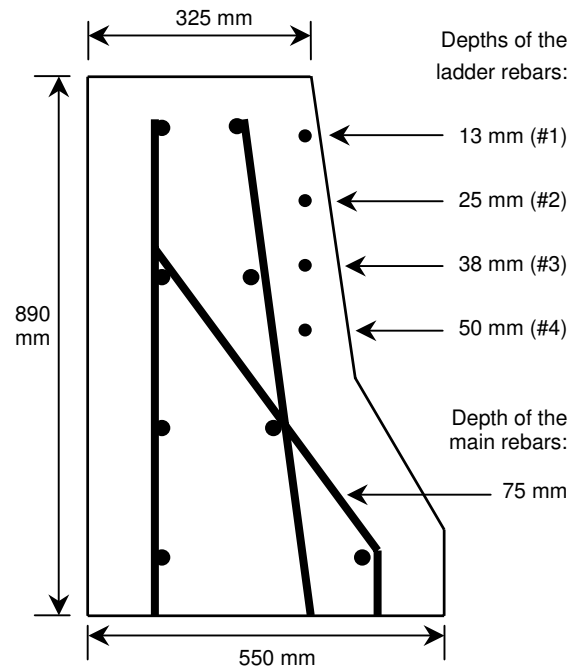
Fig. 3. Cross-section of typical test span of barrier wall

For early detection of corrosion and early performance evaluation of the corrosion inhibiting systems, two sets of rebar ladders were embedded in each test span during rehabilitation (Figures 3 and 4); except in the control concrete, in which four sets of ladders were embedded. Half-cell potentials and corrosion rates were taken over these ladders using the instruments and methods described above. Each ladder was made of four 470-mm long horizontal bars (10-mm diameter) spaced at 125 mm center to center. The ladder bars had varying concrete cover thicknesses ranging from 13 mm for the upper bar, and 25 mm, 38 mm and 50 mm for the 3 other horizontal bars, respectively.

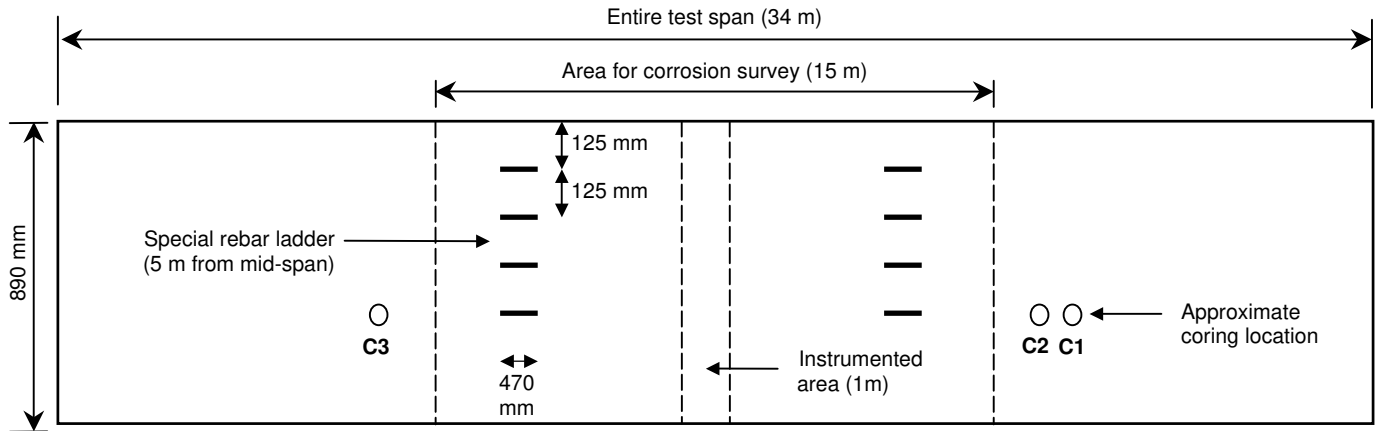
Fig. 4. Elevation of typical test span of barrier wall (not to scale)

As shown in Figure 4, each corrosion-inhibiting system was applied over the 34-m length of its assigned test span of barrier wall. Non-destructive corrosion testing was limited to the 15-m central portion of the span to avoid measuring possible secondary effects from adjacent test spans, since the reinforcement was continuous in the existing slab. Concrete cores for laboratory testing of strength, permeability and chloride content were taken just outside this 15-m central portion; and embedded instrumentation for remote monitoring was installed at mid-span.

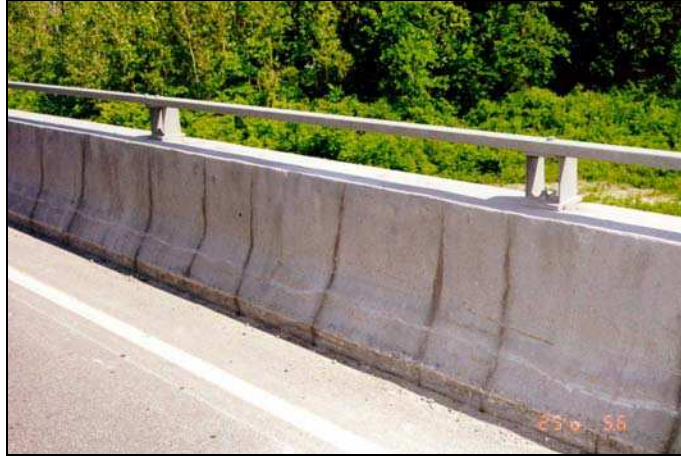
Fig. 5. Transverse cracking observed after reconstruction

A visual inspection of the barrier wall, carried out 1.5 days after casting, revealed closely spaced cracks running completely through the walls, raising a concern for premature rebar corrosion due to accelerated moisture and salt ingress and eventual spalling of the concrete cover. These vertical cracks had an average spacing of 800 mm. No joints other than the control joints between each 34-m long span of barrier wall were present to control crack spacing. Most cracks had a width of 0.2 mm or less, with a few having openings of 0.3 mm. Figure 5 presents a photograph, taken 7 months after reconstruction, illustrating the severe transverse cracking in the barrier wall. This type of cracking is common on such structures according to a survey (TRB 1996) of 52 Departments of Transportation across North America, which revealed that more than 100,000 bridges in the United States – about half of the bridges monitored by the respondents – had developed transverse cracking of the deck shortly after reconstruction.

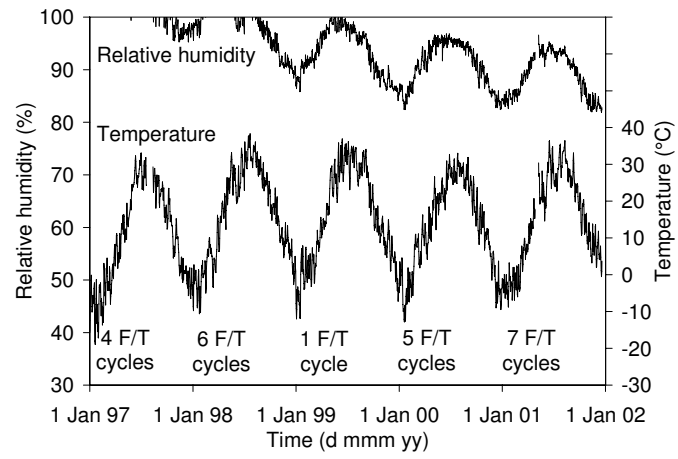
Fig. 6. Relative humidity and temperature measured in concrete of Control Span

Figure 6 shows the typical concrete temperature data measured in the Control Span of the barrier wall. Similar results from other test spans confirmed that the concrete temperature was similar from span to span, indicating that the presence or type of corrosion inhibitors had no effect on the thermal properties of the concrete. The concrete temperature typically varied from approximately -15°C in January to $+35^{\circ}\text{C}$ in August. The temperature in the centre of the barrier was at least 5°C warmer than the ambient temperature at any given time of the year. This was due to solar radiation and the heat capacity of the concrete.

In Fig. 6, the temperature-compensated RH in the Control Span of the barrier is shown to follow a seasonal pattern with high RH measured in May-June and lower RH in December-January. This is typical of this region with the months of May and June having frequent rainy periods and the months of December and January being cold and dry. As expected, the concrete RH decreased over the years as a result of continual cement hydration and drying. Although some differences in RH were observed between the test spans (not shown here); the values at any given time were always above 70 % during the 5-year monitoring period. According to ACI Committee 222, the risk of corrosion can be considered low in dry concrete when RH is lower than 50% due to an impeded electrolytic process, or in fully saturated concrete due to low oxygen concentration at the steel-concrete interface. In partially saturated concrete, however, the risk of corrosion becomes higher since oxygen can easily diffuse through concrete to the reinforcement, which will accelerate the corrosion process. As seen above, the measured RH values were between 70% and 95% for the majority of the time. With the regular use of de-icing salts in winter, it is

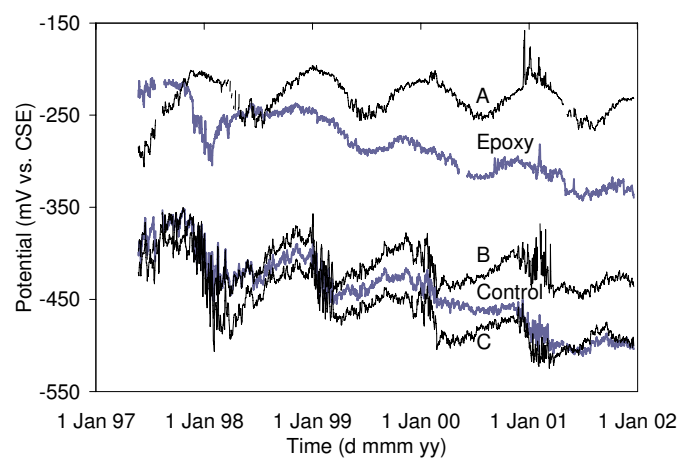
Fig. 7. Half-cell potential measured with embedded reference electrodes

Figure 7 presents five of the ten curves of half-cell potential of the reinforcement monitored continuously by MnO_2 reference electrodes embedded at specific locations in the concrete barrier wall. The five other curves (Spans D to H, not shown for brevity) are similar to the curve presented for the Control Span. In general, all curves show a seasonal variation of the potential with the least negative values occurring during the cold winter months (November–February) and the most negative values occurring in warmer weather, as expected. The half-cell potential curves for the Epoxy Span and Span A stand above all other curves. The apparent difference in potential of these two spans from the other test spans is due to the high electrical resistance induced by the presence of the coating on the reinforcement. In this case, the current flow had to go through the highly resistive path between the reinforcement and the MnO_2 reference electrode, resulting in a shift of the half-cell potential towards less negative values. It is therefore important in the analysis to consider the relative changes in half-cell potential over time rather than the numerical values at a given time, as it is well known, very negative half-cell potential readings can arise from factors other than corrosion (Elsener et al. 2003; Hansson et al. 2004). In this regard, the curves of Spans A and B show the smallest overall decrease in potential over the years, which is a possible indication of the beneficial effect of these corrosion-inhibiting systems in reducing the risk of corrosion.

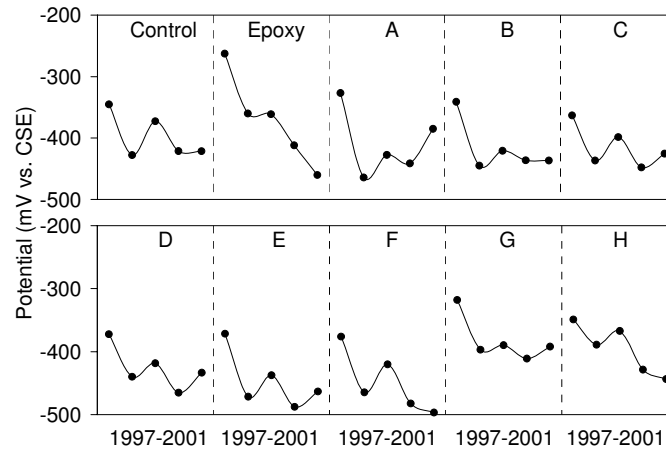
Fig. 8. Average half-cell potential measured over main reinforcement

Figure 8 shows the half-cell potentials measured over the main reinforcement, where each data point is an average of over a hundred readings taken during a single annual survey. The half-cell potentials were between -300 mV and -400 mV in 1997 (except in Epoxy Span) and shifted gradually over time towards more negative values, in general. The Epoxy Span, which had an initial potential of -250 mV in 1997, showed the sharpest change towards negative potential values over the years. The observed negative shifts in half-cell potential may be due to a combination of the following factors: (i) the use of low-permeability

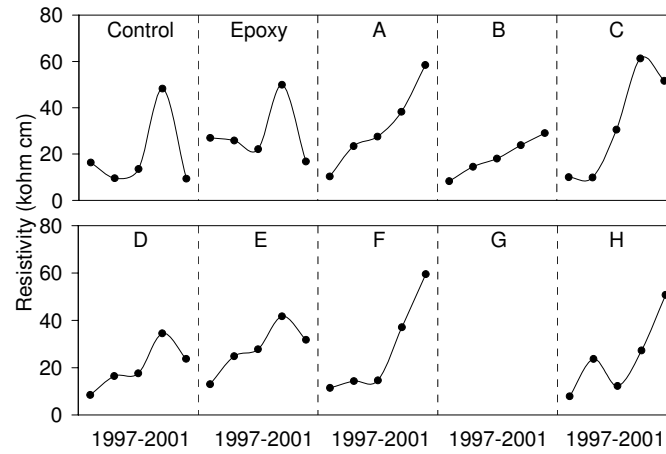
Fig. 11. Concrete electrical resistivity measured over main reinforcement

Figure 11 presents the values of concrete electrical resistivity measured in the barrier wall from 1997 to 2001. In 1997, the measured values were relatively low (8-16 k Ω cm) in most spans, probably due to the high moisture content in the new concrete and the initially-moderate concrete permeability. The resistivity values increased with time, in general, except in the Epoxy Span and the Control Span. In the Epoxy Span, the decrease was probably due to the deterioration of the epoxy coating on the rebar leading to development of corrosion where the epoxy coating was very thin or had been scratched during installation.

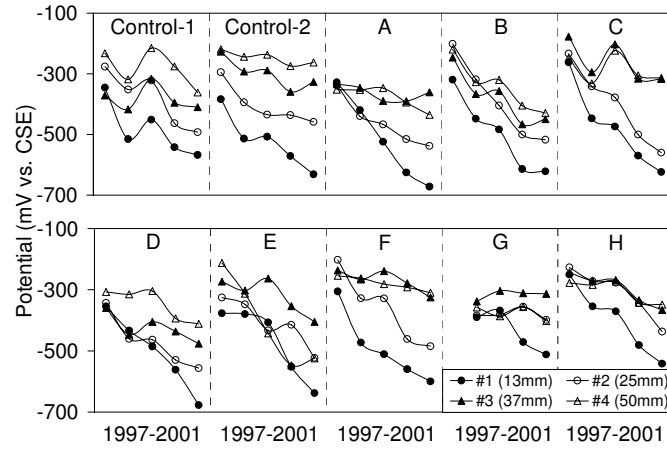
Fig. 12. Half-cell potential measured over embedded rebar ladders

Figure 12 shows the half-cell potential measured on the special rebar ladders for each span. In all spans, it can be seen that the half-cell potentials became more negative with time. In general, half-cell potentials had the most significant change on the top bar (bar 1 with 13 mm cover, highest chloride content) and the least change on the lower bars (bars 2, 3 and 4 with thicker covers), as expected. Of the ten test spans, Spans G and H had the least negative half-cell potentials, especially on the top bars.

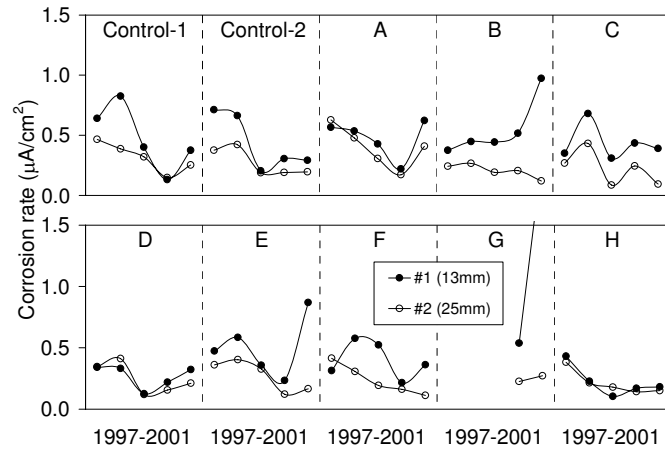
Fig. 13. Corrosion rate measured over embedded rebar ladders

As shown in Figure 13, the corrosion rates were much higher on the top ladder bar (thinnest cover) than on the second ladder bar in most spans, as expected. The corrosion rate on Span G was not measured in the first three years due to the very low concrete conductivity. On Spans E and G, high corrosion rates were measured at the ladders in 2001, coinciding with observations of horizontal cracks and rust stains along the top ladder rebars. It should be noted that corrosion at these locations was probably initiated by the premature shrinkage cracks found over the rebar ladders. A high corrosion rate was also measured on Span B in 2001, however, no shrinkage cracks were observed at the ladder. In Spans D and H, the corrosion rates were quite low on both the first and second bars of the ladders, showing the beneficial effects of these specific corrosion-inhibiting systems.
