Effective Sealing of Pavement Cracks in Cold Urban Environments

J-F. Masson, Ph.D.

Published by
Institute for Research in Construction
National Research Council of Canada
Ottawa, Canada, K1A 0R6

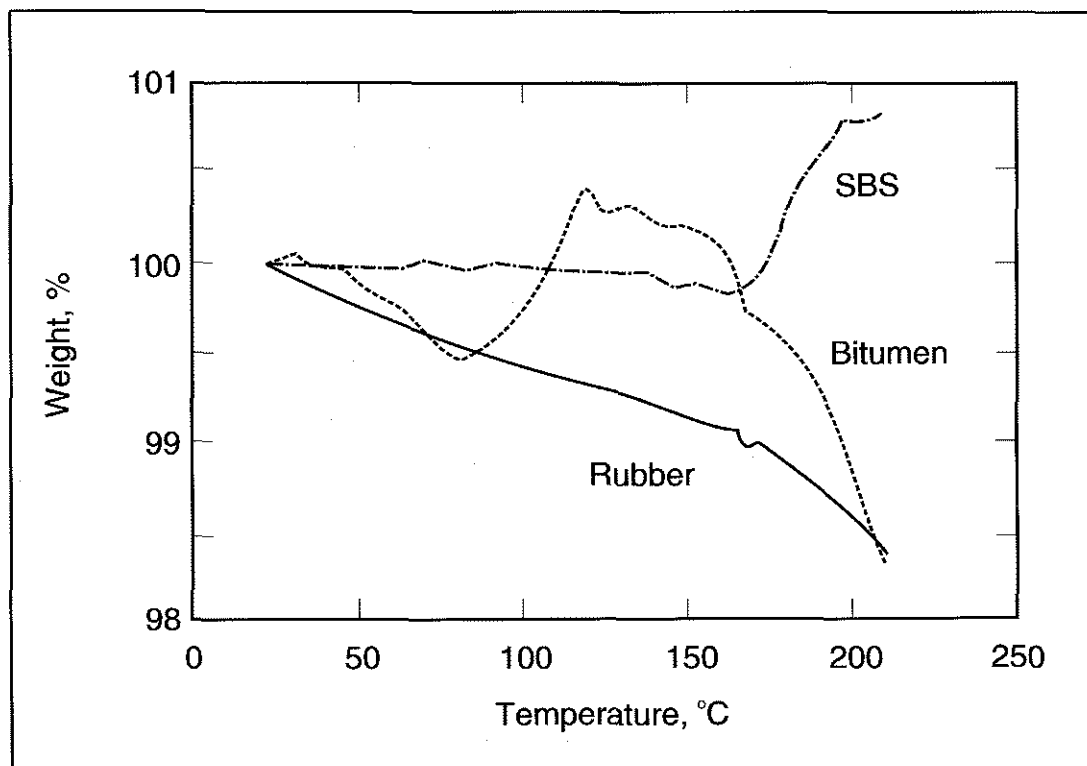
Figure 6. Typical weight change of representative sealant raw materials during heating in air at 5°C/min as measured by thermogravimetry. The weight of the SBS copolymer remains constant until about 170°C and then increases because of its gain in oxygen, i.e., oxidation. In contrast, the recycled powder loses weight as process oils gradually volatilize. Bitumen shows a combined weight loss due to the volatilization of light oils and a weight gain due to oxidation.

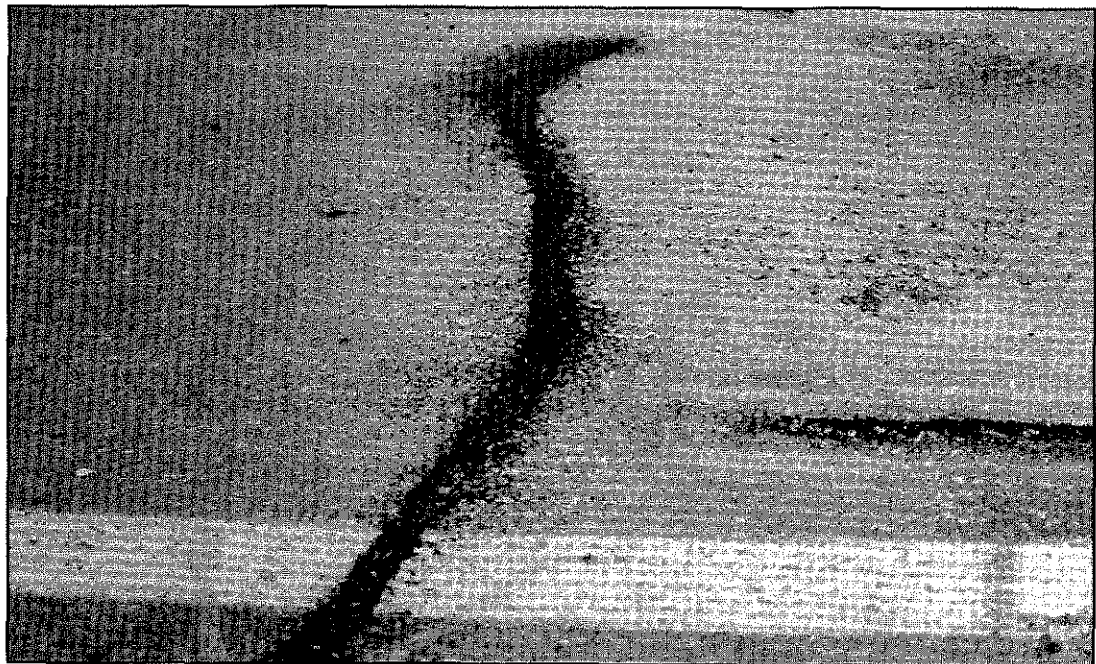
Figure 18. Typical blackening of an overheated rout

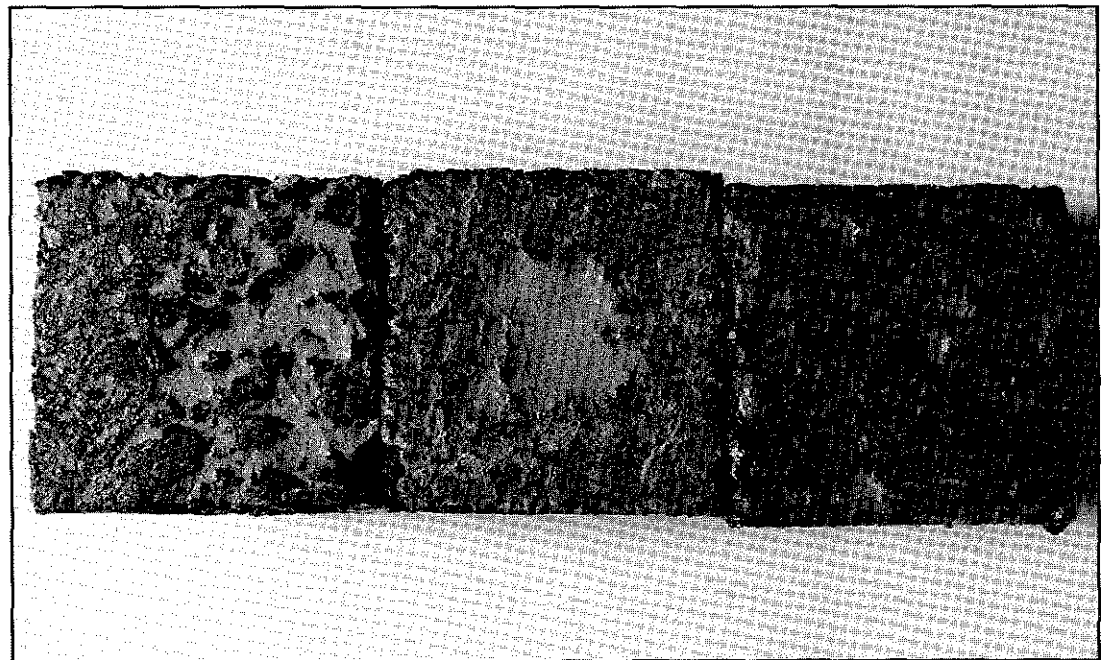
Figure 19. Surface of AC briquettes after tensile tests on sealant-briquette assemblies when the briquette is untreated (middle) and overheated (left). On the right, is the briquette surface without sealant. The briquettes were covered with dyed paste to increase the contrast between the holes in the briquette and the unaltered surface. On the untreated briquette, the sealant pulls out aggregates from the surface, leaving a hole in the middle of the briquette. On the overheated surface, there is no hole where the sealant was adhering. Instead, small holes are scattered across the surface where the hot-air lance caused damage.
