Laboratory evaluation of alkali-silica reaction in concrete from Saunders Generating Station

Laboratory Evaluation of Alkali-Silica Reaction in Concrete from Saunders Generating Station

by P. E. Grattan-Bellew

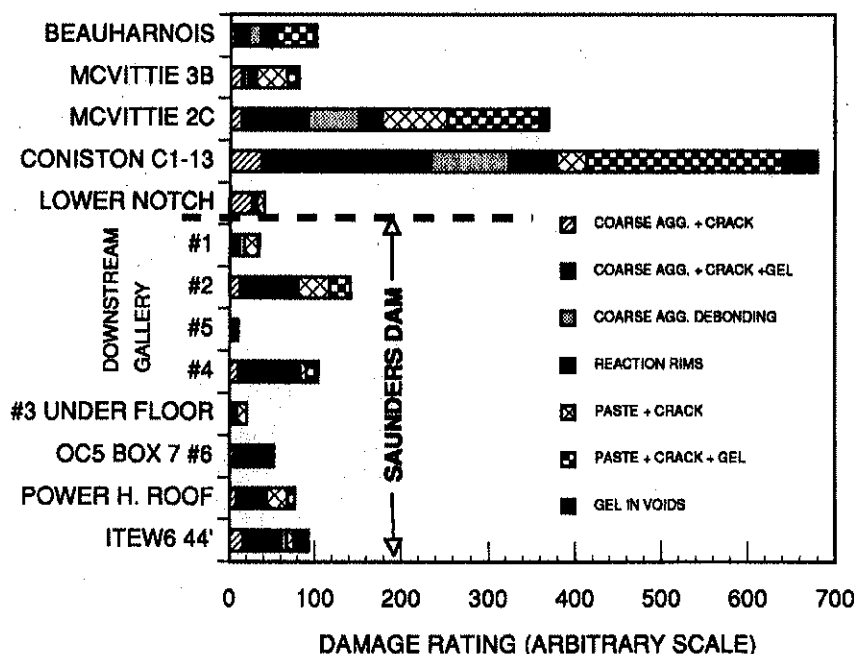
Fig. 2—Comparison of damage ratings of cores from various parts of Saunders G.S., other Ontario Hydro Dams, and Beauharnois Dam. Concrete in Lower Notch Dam was made with reactive aggregate (high-alkali cement with 30 percent replacement of cement by fly ash)

The damage ratings of cores from Saunders G.S. are summarized in Fig. 2; for comparison purposes, four reference samples from other Ontario Hydro dams, and one from Beauharnois Dam, are also included.⁹ The nonreactive reference with a DI of 51 is from Lower Notch Dam, which was built with reactive aggregate and a high-alkali cement with a 30 percent replacement by fly ash. No deterioration was observed after 30 years. Cores from the two other dams, Coniston and McVittie, both show considerable evidence of deterioration. A wall at the National Research Council in Ottawa, built with a nonreactive granitic gravel that showed no sign of cracking after 40 years, had a damage rating of 35. Cracking of aggregate particles and a trace of gel are usually observed in most concrete, and are not necessarily evidence of significant deterioration. Damage ratings in the range of 20 to 50 are therefore not necessarily indicative of significant deterioration of the concrete.

The DI for cores from Saunders G.S. varies considerably (Fig. 2). This is not too surprising in a large structure built over a period of 4 years, as the aggregate and cement would have varied during the course of construction. Similar variation was also observed in the cores from the McVittie Dam (Fig. 2). Moisture content of the concrete in the structure may also vary; for example, it is probably drier under the floor (Core #3 from under floor) of the generating station than deeper in the structure (Core ITEW6 44').

The four cores No. #1 through 4, from the S3 gallery, located on the downstream side of the generating station, show widely varying damage ratings (Fig. 2). All the cores were taken from the wall separating the gallery from the scroll case. Core #1 was taken from a dry area of the wall showing only a few fine cracks. The other cores were taken from wet areas showing cracking. It is uncertain whether the differ-

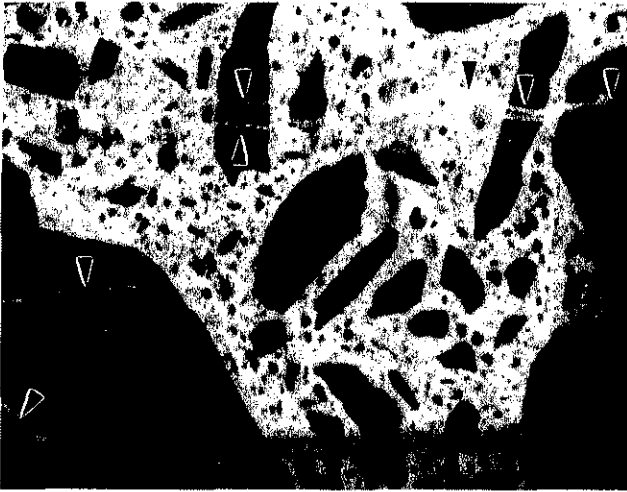
Fig. 3(a)—Optical micrograph of gel filling cracks (indicated by arrows) in limestone aggregate particles and paste; scale divisions in 0.5 mm. (0.02 in.)

The presence of gel lining cracks, in the aggregate, in the paste, and in air voids [Fig. 3(a) and 3(b)] indicates that an alkali-silica reaction has occurred. The very low DI of 10 for Core #5 from ITWW2 at 64 ft (19.5 m) taken from the lower part of the structure may be due to the use of aggregate from the upper, and less reactive, lift of the quarry. Aggregate from near the bottom of the quarry would have been used in the upper parts of the structure, such as the concrete slab for the rails on the roof of the power house, with a DI of 80.

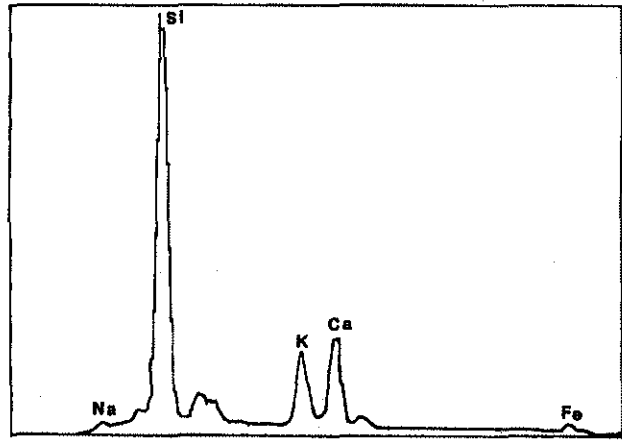
Fig. 3(b)—Electron probe spectrum from silica gel showing the presence of calcium, potassium, sodium, and silica

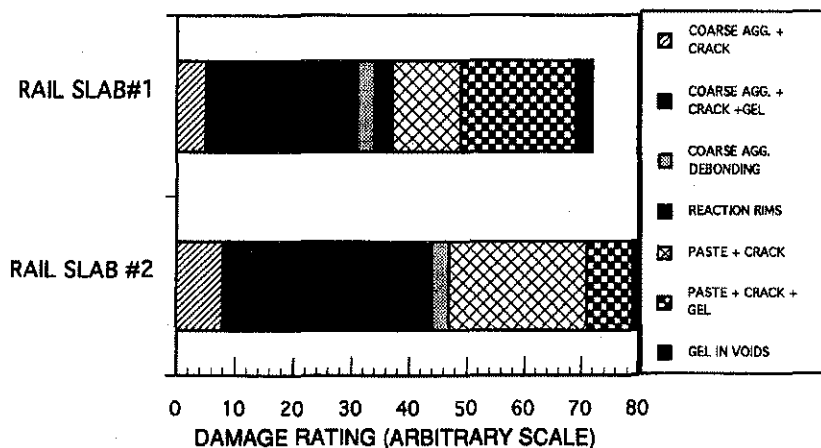
Fig. 4—Damage ratings of two cores taken from slab supporting rails on deck roof [Fig. 3(c)]

The reproducibility of the method for determining the damage rating was investigated by taking two cores from a section of a slab, under the rails on the roof of the power station that showed extensive map-pattern cracking [Fig. 3(c)]. The damage indexes of Cores #1 and 2 are 80 and 72, respectively (Fig. 4). The difference in the indexes of the two cores is 5 percent, which is not significant, as it was shown in previous unpublished experiments that at the 95 percent confidence level, the coefficient of variation between five individual measurements, by one operator, averaged 20 percent. It was concluded that the differences in DI between the cores from the structure are real, and reflect differing degrees of reaction in different parts of the structure.

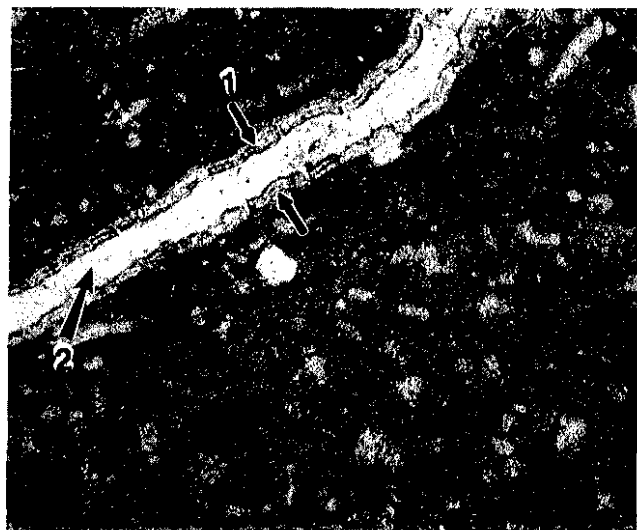
Fig. 5—Optical micrograph of thin section of concrete of two generations of gel, 1 and 2 (indicated by arrows), filling crack in cement paste. Original gel, which appears to have desiccated and broken up, lines crack walls. Subsequently, additional gel filled central part of crack. Field of view is 0.75 mm (0.03 in.) wide

Examination of thin sections from cores taken from various parts of Saunders G.S. showed that there was abundant evidence of alkali-silica reaction in the form of gel filling air voids and cracks. These observations confirm that ASR had occurred in the concrete. In one crack in the aggregate, two generations of gel were found, indicating that ASR had continued for some time (Fig. 5).

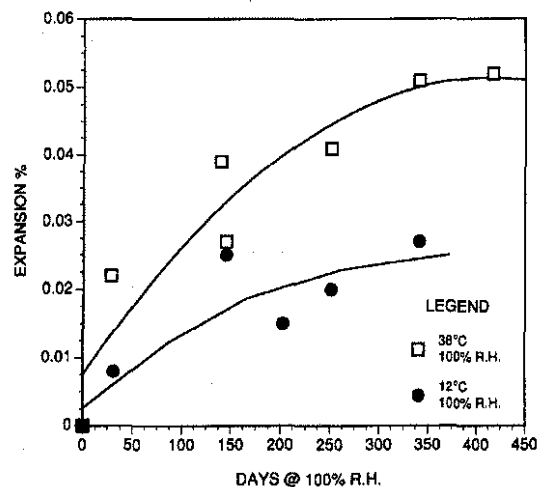
Fig. 6—Expansions of 7-cm-diameter concrete cores stored at 100 percent humidity at 12 and 38 C (53.6 and 100 F)

The mean expansions of pairs of cores stored at 100 percent humidity at 12 and 38 C (53.6 and 100 F) are shown in Fig. 6. If the current rates of expansion, determined according to the method of Grattan-Bellew, are projected for 10 years, expansions of about 0.2 and 0.37 percent would be expected for the cores stored at 12 and 38 C (53.6 and 100 F),

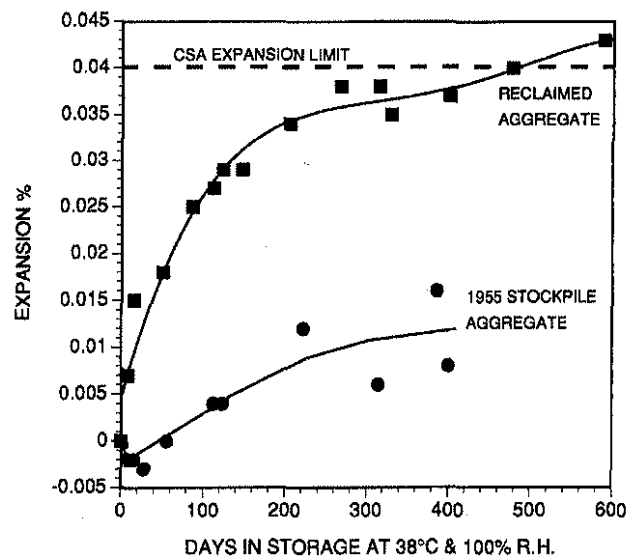
Fig. 7(a)—Expansions of concrete prisms made with aggregate reclaimed from cores from the structure and 1955 stockpile. Both concretes contain 420 kg/m^3 (708 lb/yd^3) of cement

Expansions of concrete prisms made with reclaimed aggregates and aggregates from the 1955 stockpile are shown in Fig. 7(a). At 600 days, the prisms containing aggregate from the cores expanded by 0.043 percent. The expansion appears to have leveled off by 200 days, possibly due to leaching of alkalis.¹¹ The reclaimed aggregate is classed as potentially reactive, as the expansion exceeds the 0.04 percent limit. Prisms containing aggregates from the 1955 stockpile show just under 0.02 percent expansion after 600 days. These prisms showed no expansion for the first 50 days, but thereafter, the trend of the expansion curve is similar to that of the prisms containing aggregate extracted from the cores. This suggests that, although this aggregate is less reactive than that recovered from the cores, it shows some sensitivity toward the alkali content of the pore solution of the concrete.

The projected expansions of the prisms containing aggregate from the cores at 10 and 30 years, calculated from the current rates of expansion, are 0.125 and 0.214 percent, respectively.¹⁰ However, in practice, these rates might not be maintained in a structure.

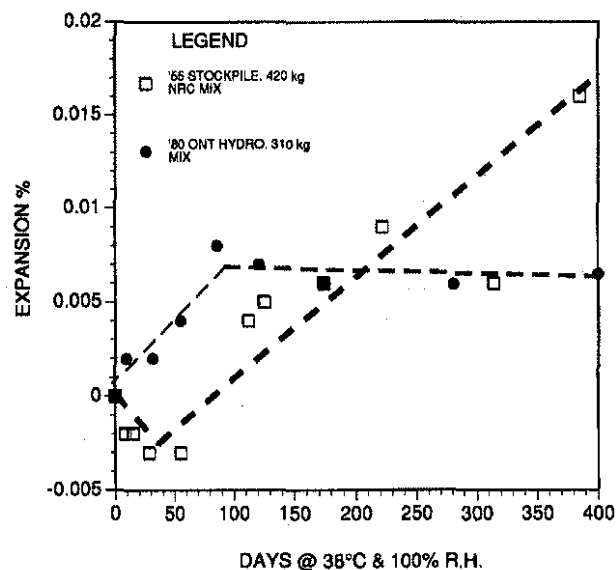
Fig. 7(b)—Comparison of expansions of concrete prisms made with 1955 stockpile aggregate containing 310 kg/m^3 (523 lb/yd^3) of cement (Ontario Hydro 1980 test) and current test using 420 kg/m^3 (708 lb/yd^3) of cement

The expansions of concrete prisms, made with aggregates from the 1955 stockpile, containing 310 kg and 420 kg/m³ (523 lb and 707 lb/yd³) of cement are shown in Fig. 7(b). For the first 90 days, expansions of the prisms containing 420 kg (707 lb/yd³) were lower than those containing 310 kg (523 lb/yd³) of cement, but by 200 days they exhibited double the expansion found with the 310 kg (523 lb/yd³) mix. This confirms that, although the aggregate would normally be classi-

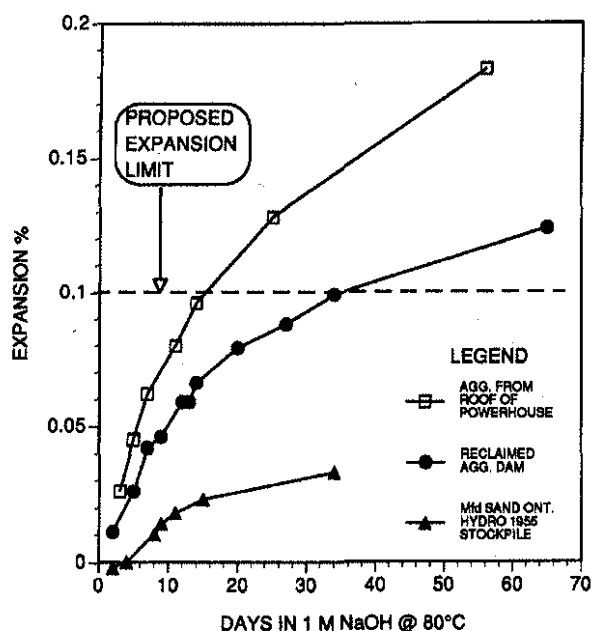
Fig. 8—Expansions of mortar bars in accelerated test at 80°C (176 F) containing fine aggregates extracted from concrete cores taken from structure and from manufactured sand from 1955 stockpile

Results of the accelerated mortar bar test on the three aggregates are shown in Fig. 8. The mortar bars containing reclaimed aggregate expanded by only 0.06 percent at 14 days, while those containing aggregate extracted from cores from the slab supporting the rails expanded by 0.096 percent. The mortar bars made with manufactured sand from the 1955 stockpile expanded by only 0.023 percent. Guidelines given in ASTM P 214 suggest that expansions greater than 0.1 percent at 14 days may be indicative of potentially deleterious expansion in concrete. These tests indicate that the aggregate from within the structure and manufactured sand are innoc-

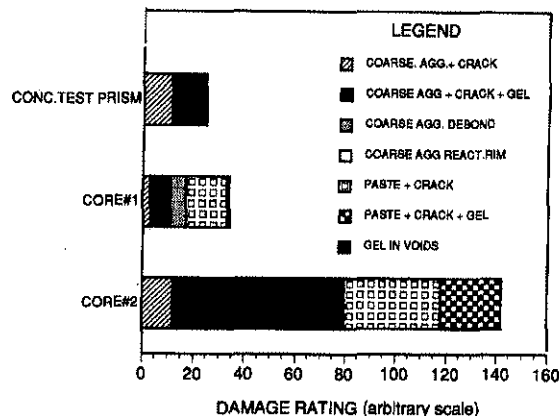
Fig. 9—Comparison of damage ratings of two cores taken from Saunders G.S. with damage rating of 2-year-old concrete prism made with aggregate reclaimed from cores taken from structure

Results of the accelerated mortar bar test ASTM P 214 indicate that, at most, the fine aggregates are only marginally expansive. However, the fine aggregate may, nonetheless, have contributed to overall expansion of the concrete. There is, however, considerable evidence that expansion and damage to concrete due to ASR under laboratory conditions underestimate the amount of expansion and damage observed in the field.¹⁵ The damage rating of 2-year-old concrete prisms made with reclaimed aggregate from Saunders G.S., in which expansion had essentially stopped, was compared to that of cores from the structure showing high and low damage ratings in Fig. 9. Expansion, and hence the damage index of concrete prisms, generally tapers off after about 1.5 years, whereas in structures, deterioration often continues more or less indefinitely. This probably accounts for the lower damage rating of the concrete prisms shown in Fig. 9.
