Ten-year field evaluation of corrosion-inhibiting systems in concrete bridges barrier walls

Cusson, D.; Qian, S. Y.

ACI Materials Journal, 106, 3, pp. 291-300, 2009-05-01

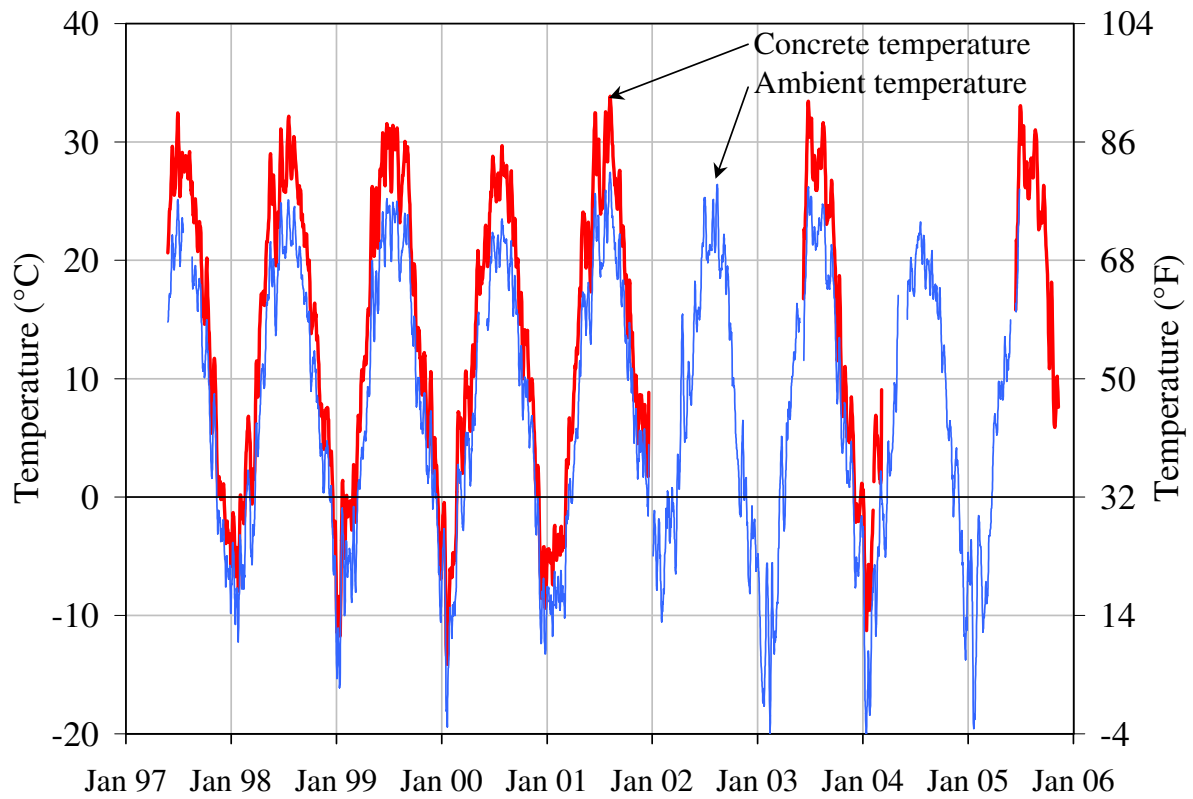
Fig. 2—Typical temperatures monitored at the bridge

Warm temperatures usually accelerate degradation processes, including rate of corrosion; and the moisture level in concrete also has a strong influence on reinforcement corrosion, as it affects carbonation, chloride penetration, chloride threshold, concrete electrical resistivity, and oxygen level (Vennesland *et al.* 2007). Such environmental data are therefore useful for the adequate analysis of the parameters that govern the field performance of concrete systems in corrosive environments. Fig. 2 shows typical temperatures measured at the bridge from 1997 to 2006, which varied from -10°C [14°F] or -15°C [5°F] in January to $+30^{\circ}\text{C}$ [85°F] or $+35^{\circ}\text{C}$ [95°F] in August. It can also be observed that the core concrete temperature remained at least 5°C [9°F] warmer than the ambient air temperature at any given time of the day due to the combined effect of solar exposure and the high heat capacity of concrete. Also from these data, an average number of freeze-thaw cycles was approximated to 5 cycles per year.

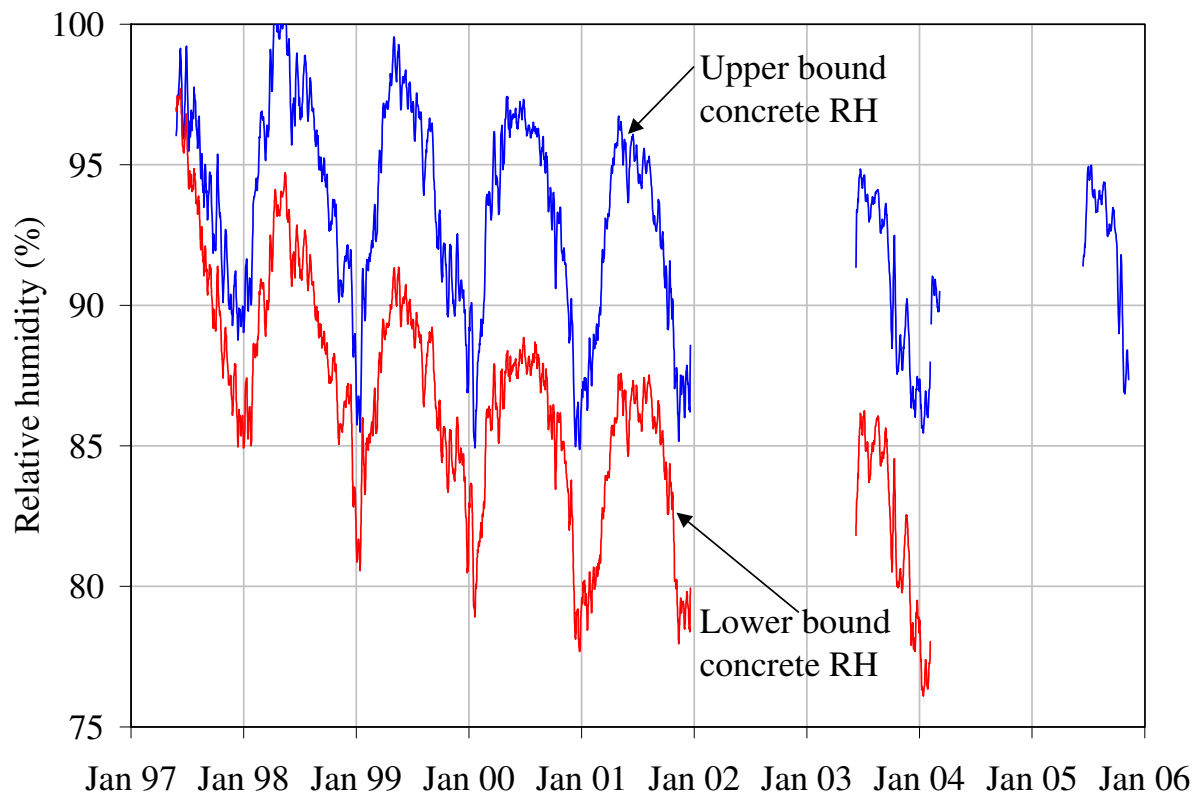
Fig. 3—Range of relative humidity monitored in concrete barrier walls

Fig. 3 shows the range of relative humidity monitored in the concrete barrier walls over the years (all test spans considered). It is noted that some data are missing after 2002 due to multiple power interruptions. Nevertheless, the trends in the data can still be observed. The difference between the upper and lower bounds is most likely due to the different distances between the RH/T sensors and the nearest cracks (i.e. source of moisture) and, to a lesser extent, the slightly different permeability values of the concrete systems. The RH in the barrier walls is shown to follow a seasonal pattern with high RH measured in May-June (frequent rainy periods) and low RH in December-January (cold and dry periods). Overall, the concrete RH decreased with time as a result of continual drying towards values close to $80\% \pm 5\%$ after ten years. In such partially saturated concrete, oxygen can diffuse through concrete and reach the steel reinforcement. The data in Fig. 3 imply that moisture was present in sufficient quantities to provide some of the conditions leading to steel corrosion in the presence of chlorides. The risk of corrosion is usually considered low in dry concrete when RH is lower than 50% due to an impeded electrolytic process, or in saturated concrete (near 100% RH) due to low oxygen content (Tuutti 1982; ACI Committee 222, 2001).

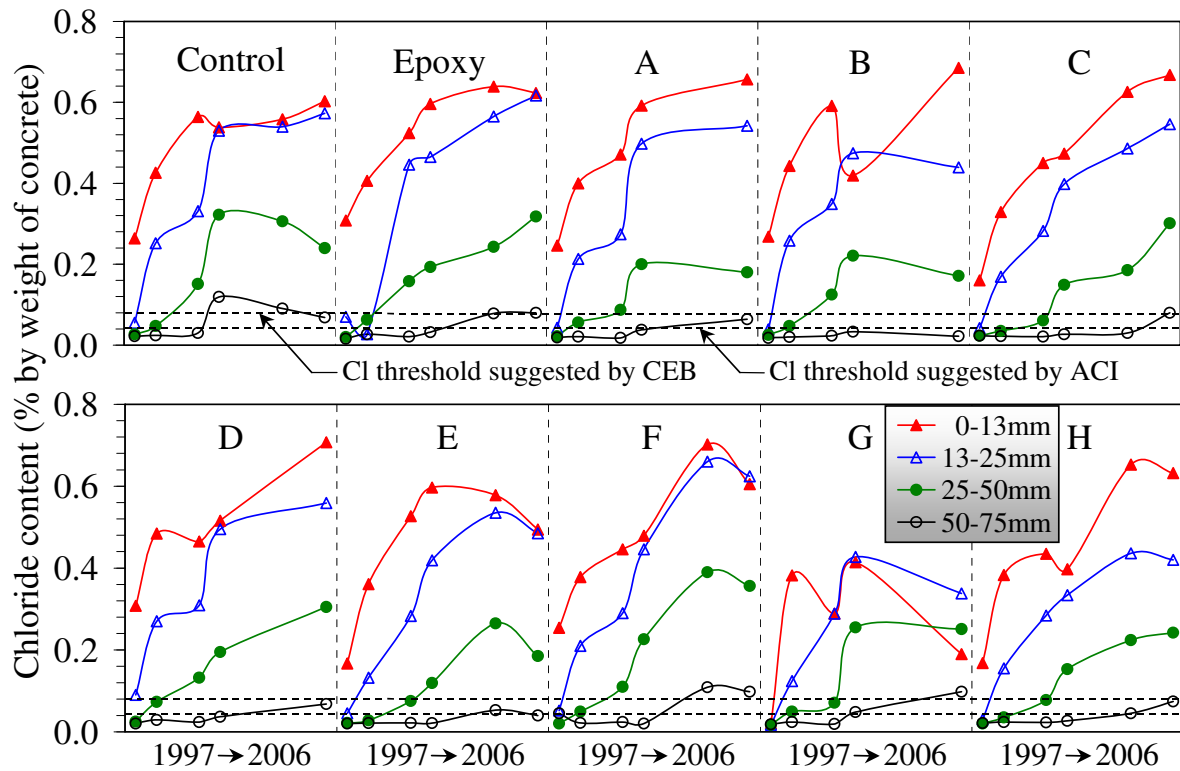
Fig. 4—Total chloride content measured in concrete cores from barrier walls (ASTM C114)

The total chloride content by weight of concrete was determined on concrete cores taken from the barrier walls from 1997 to 2006, as presented in Fig. 4. The range of suggested chloride threshold values required to initiate reinforcement corrosion is also indicated in Fig. 4. This range of values is included within the chloride threshold of 0.7 kg/m^3 [1.2 lb/yd^3] by weight of concrete suggested by ACI Committee 222 (2001) and the chloride threshold of 1.4 kg/m^3 [2.4 lb/yd^3] suggested by CEB (1992) for concrete with a cement content of 350 kg/m^3 [590 lb/yd^3] and

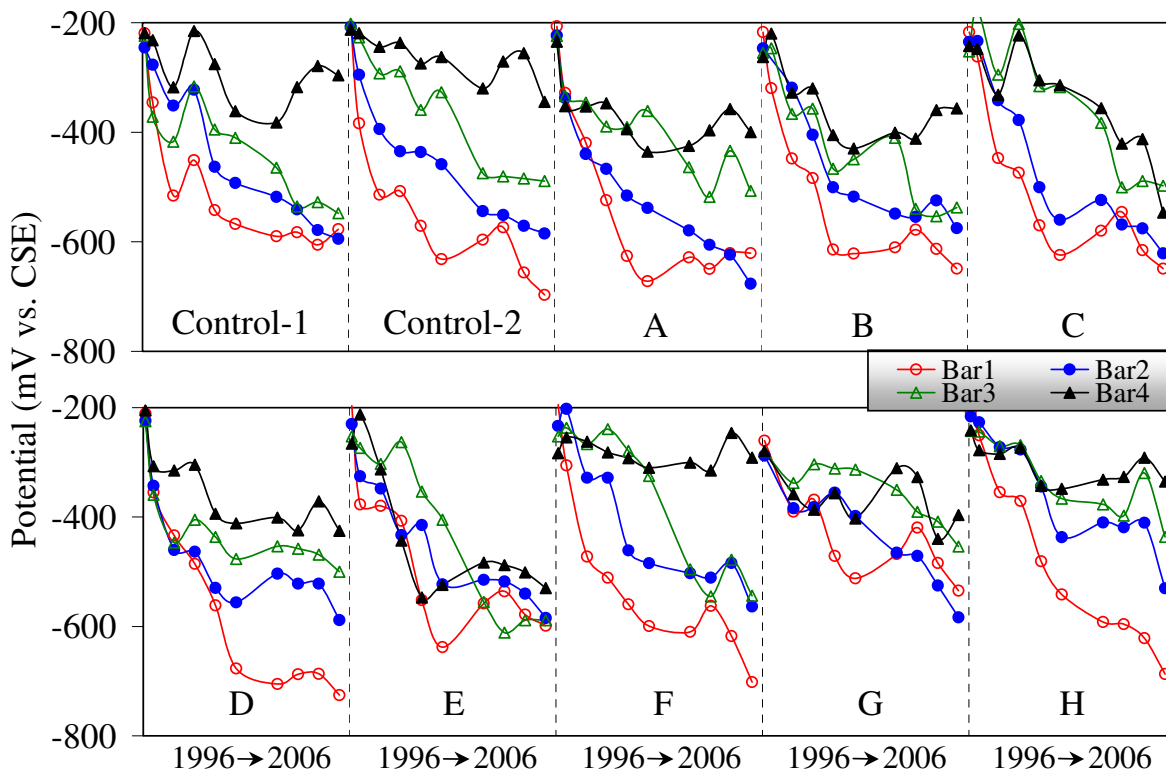
Fig. 8–Half-cell potential measured over embedded rebar ladders

Spans H and F had the least negative potentials in 2006 (≥ -550 mV), indicating the lowest risks of corrosion at a depth of 25 mm [1 in.], compared to the Control Span and the other test systems.
