The Performance of corrosion inhibiting systems in concrete bridge barrier walls - 5 years of field data

Qian, S. Y.; Cusson, D.; Glazer, R.; Hoogeveen, T. J.

**A version of this document is published in / Une version de ce document se trouve dans :
Infra 2002 International Conference on Urban Infrastructure, Montreal, Quebec, Nov. 25-27, 2002, pp. 1-20**

Institute for Research in Construction, National Research Council, Canada

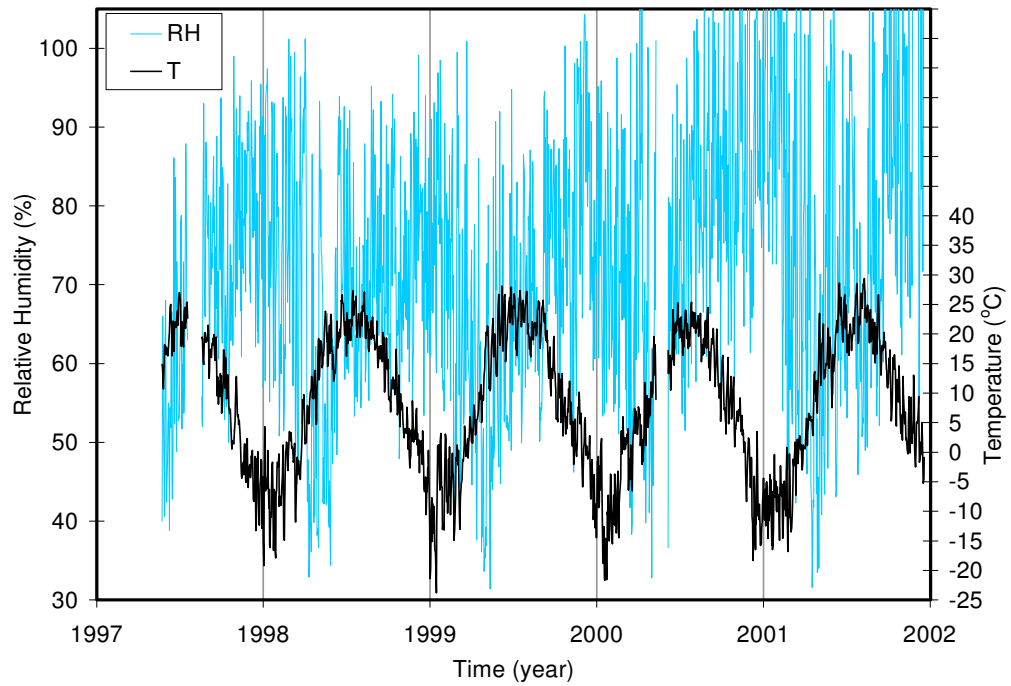
Figure 1. Ambient relative humidity and ambient temperature measured at the Vachon bridge.

Figure 1 illustrates the ambient RH and ambient temperature measured at the bridge from May 1997 to December 2001. The ambient RH varied from 30 % to 100 % with the lower RH values occurring typically at the end of winter in April-May. It should be noted that some values of RH exceeded 100 % by about 5 %, which is within the precision of the sensor for such high levels of RH. Typically, the ambient temperature measured at the bridge varied from about -25°C in January to approximately $+30^{\circ}\text{C}$ in August.

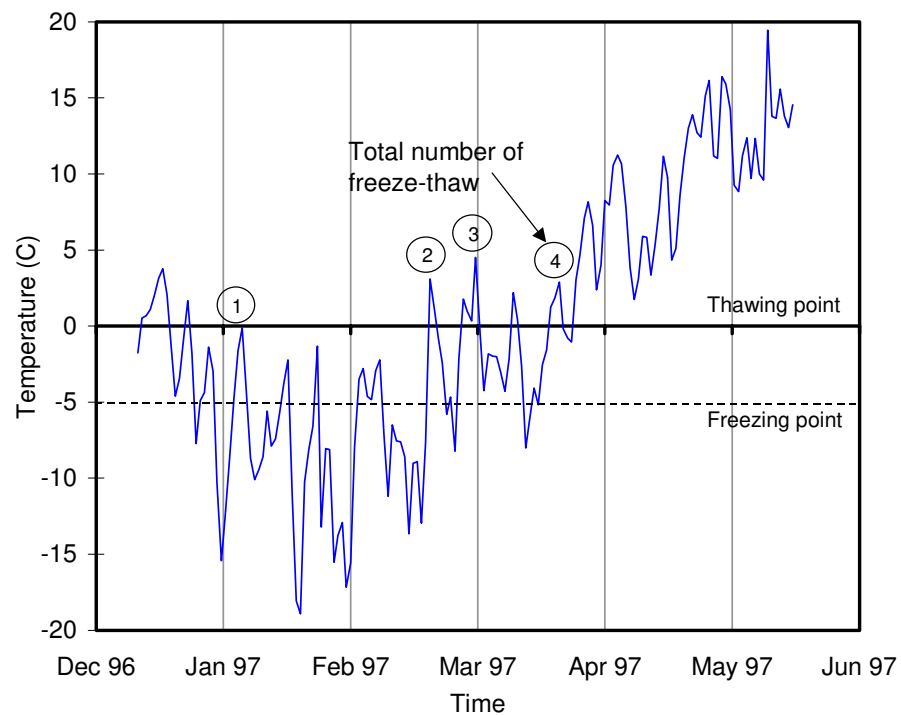
Figure 3. Temperature and freeze-thaw cycles measured during the first winter in control span.

long enough (few hours). Figure 3 illustrates the procedure used to calculate the number of freeze-thaw cycles. During the winter of 1997, 4 cycles were found to occur in Span 21. Figure 2 gives the number of freeze-thaw cycles that occurred during all subsequent winters in the control Span 21. Over the 5-year duration of the study, a total of 23 freeze-thaw cycles was estimated. Since the temperature is the same in all test spans at any given time, it is assumed that these statistics apply to each test section in this study.

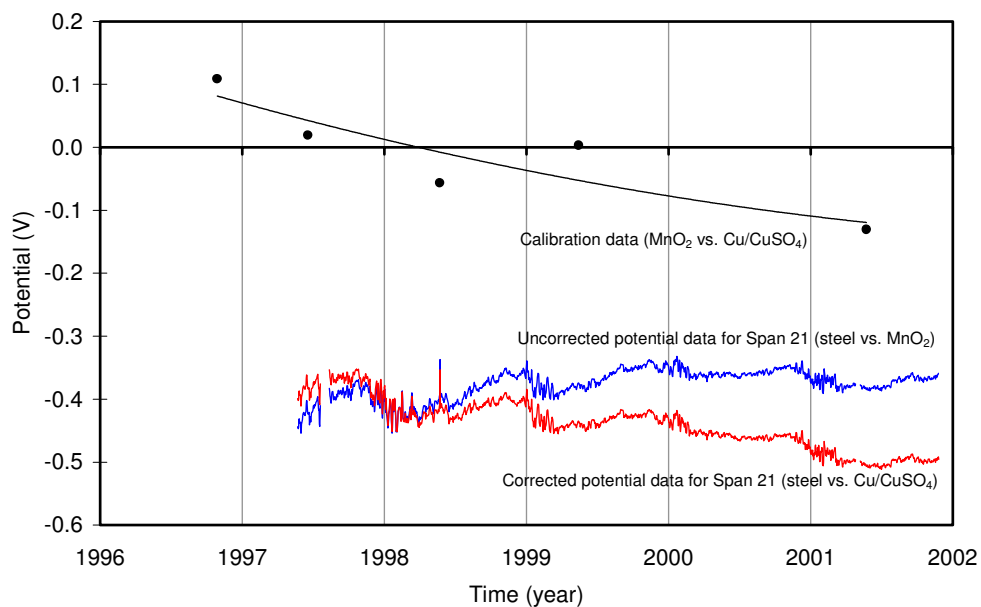
Figure 4. Procedure for the calibration of the embedded MnO_2 reference electrodes.

The stability of the MnO_2 reference electrodes was verified on a yearly basis by taking several half-cell potential measurements with a calibrated reference electrode placed on the surface of the barrier wall near the location of each embedded MnO_2 electrode. It was found that their potential shifted gradually over the years. The potential of MnO_2 electrodes is known to be stable in a constant environment. When the electrodes were embedded in concrete, however, the change in the environmental conditions caused their electrochemical potential to reach a new equilibrium with the surrounding concrete. As a result, the potential of MnO_2 electrodes has been gradually shifting to a new stable value.

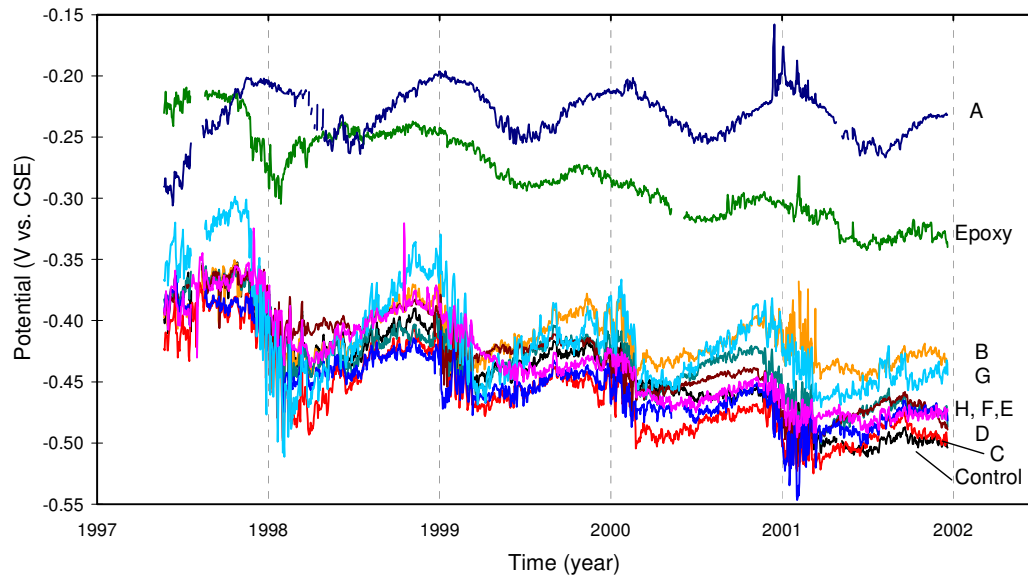
Figure 5. Electrochemical potential measured at the Vachon bridge.

The half-cell potential curves for Spans 12 and A stand above all other curves. This is probably due to the high electrical resistance induced by the presence of the coating on the reinforcement of Spans 12 and A. In this case, the input impedance of the data acquisition system of 10^7 Ohms was not high enough. The current flow, which had to go through the highly resistive path between the reinforcement and the MnO_2 electrode, caused a potential

drop resulting in a shift of the half-cell potential towards less negative values. The above observations were validated by the potential readings taken during the annual corrosion surveys.

It is therefore important in the analysis to consider the relative changes in half-cell potential over time. In this regard, the curves of Spans A and B show the smallest overall decrease in potential over the years. This may be an indication of the effect of these corrosion-inhibiting systems in preventing corrosion initiation.

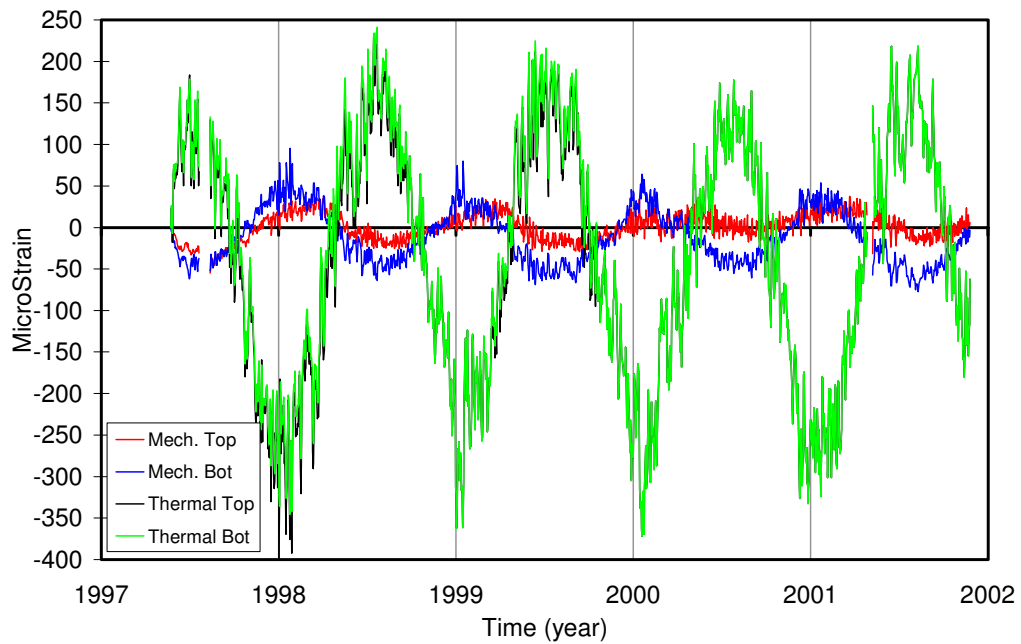
Figure 6. Strains measured in control span.

Figure 6 shows the measured mechanical strain along with the calculated thermal strain in the longitudinal direction of the barrier wall of the control Span 21. Strain measurements in the other test sections were found to follow similar patterns and have similar range of values. The mechanical strain was measured directly by the embedded strain gauges, which were fully compensated against temperature and bending effects. The thermal strain was calculated based on the history of temperatures measured in the concrete.

The mechanical strain varied from approximately $-50\ \mu\epsilon$ to $+50\ \mu\epsilon$ over time, showing a pattern that appears to be 180° out-of-phase with the variation in concrete RH. A crack survey conducted on Span 21 revealed the presence of a crack in the concrete barrier wall at the location of the strain gauge. The strain gauge was in effect monitoring the opening and closing of the crack as a function of the change in concrete RH. For instance, when concrete dried, the resulting shrinkage increased the crack opening, and when concrete swelled the opposite effect took place.

The thermal strain varied from approximately $-350\ \mu\epsilon$ to $+250\ \mu\epsilon$. It was observed that the mechanical strain was relatively small compared to the thermal strain. This is especially true when initial strains are not measured. This was the case in this study because the remote monitoring system became fully operative only in May 1997, which was about half a year after construction (the cold weather in the fall of 1996 prevented the full installation of the data loggers). However, a detailed analysis [13] was conducted using a 2D numerical model along with some available field data to estimate the extent of deformations shortly after construction of the barrier wall. It was found that strains due mainly to thermal contraction and autogenous shrinkage developed rapidly within 36 hours of construction, and resulted in high tensile stresses in the barrier wall causing it to crack.

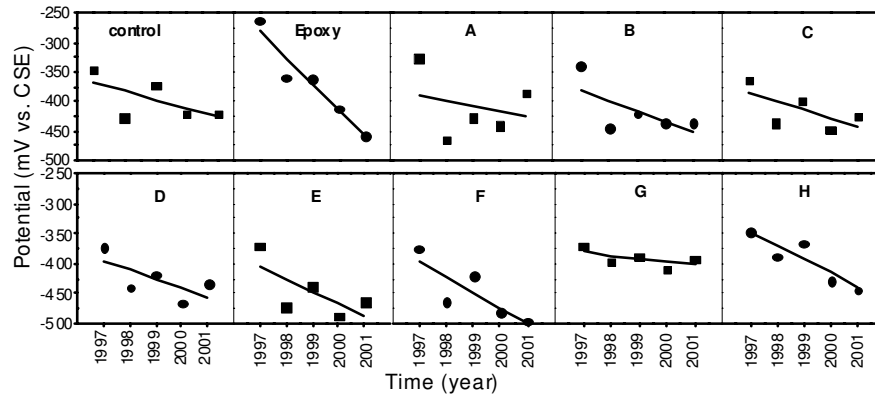
Figure 7. Half-cell potential obtained during the field surveys in 1997 to 2001 at the Vachon bridge.

For all spans, the half-cell potential values were about -350 mV starting in 1997 (except in Span 12 (epoxy) and G). Results were much more negative than -350 mV in 1998. According to the ASTM standard, all spans should be rated as having a high probability of corrosion. Obviously, it is not suitable to rate all these spans as having a high probability of corrosion within one or two years reconstruction of the barrier wall. Since high-density concrete was used, the oxygen depletion in the concrete could result in the negative potential shift. It was noticed that earlier age cracks had appeared in many spans. These cracks could cause early corrosion of reinforcing steel near these areas due to moisture, oxygen and salt ingress, leading to the localized negative potential shift.

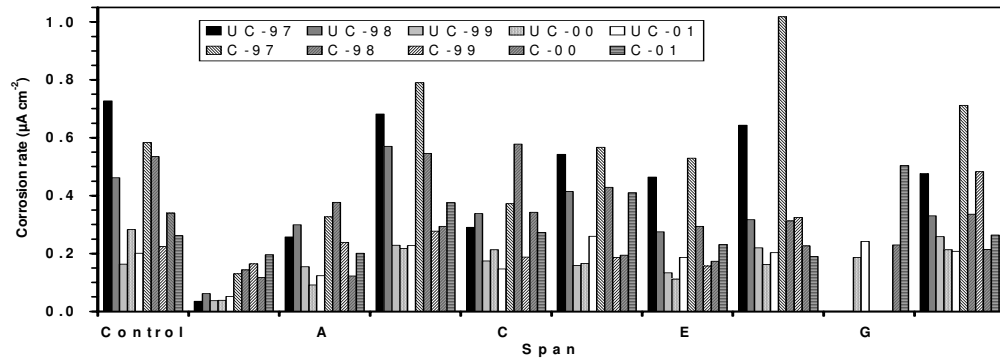
Figure 9. Corrosion rate at cracked (C) and uncracked (UC) locations on the barrier wall.

The average corrosion rates obtained on 10 spans are shown in Fig. 9. They were calculated based on the results from field measurements at cracked locations (C) and uncracked locations (UC) on each span. The corrosion rates were low in all spans in 2001 although some spans showed relatively high rates in 1997 and 1998 probably due to process of the formation of the oxide film. The rates decreased with time in almost all spans probably related to the presence of the corrosion inhibiting systems or to oxygen depletion at the metal surface. Comparing the corrosion rate obtained at different locations, higher rates are observed at cracked locations than at uncracked locations in most spans, as expected. On the span with epoxy-coated rebar, the corrosion rate was small, especially at uncracked locations, but increased continuously over time, probably due to the metal oxidation at the damaged or scratched areas of the epoxy coating near the cracked areas. In Span G, equipment limitations made it impossible to measure the corrosion rates in the first three years, due to the poor conductivity of concrete as a result of the application of this corrosion-inhibiting system on the concrete. Considering the overall corrosion rates measured in 2001, they were in the low rate category ($\leq 0.5 \mu\text{A cm}^2$) [17] in all spans and locations, indicating the effects of inhibiting systems. More time is needed to evaluate the effectiveness of the corrosion-inhibiting systems.

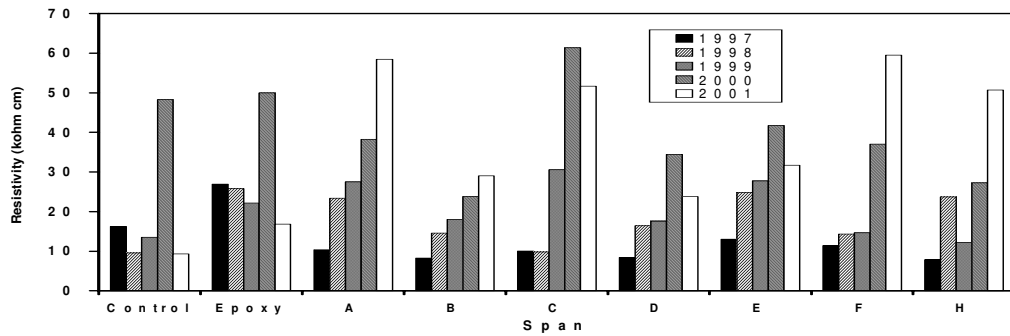
Figure 10. Concrete electrical resistivity measured at the Vachon bridge.

The results of on-site concrete resistivity are shown in Fig. 10. Concrete resistivity was relatively small in 1997 in most spans, probably due to the high moisture content in the new concrete. It increased with time in most spans except in Spans 12 (epoxy) and 21 (control). In Span 12, the resistivity decreased with time, probably due to the deterioration of the epoxy coating on the rebar. GECOR6 was used to measure the resistivity between the rebar surface and a counter electrode, which was placed on the top of the concrete cover. Although a pulse signal was used to perform the measurement, the resistivity of epoxy on the rebar surface was still included in the overall resistivity readings. Therefore, the coatings on the rebar can lead to a higher reading. The development of corrosion at the areas where the epoxy coating was very thin or had been scratched can lead to reduce overall resistivity. Due to some measurement difficulties, the resistivity results on Span G were not shown in Fig. 10.

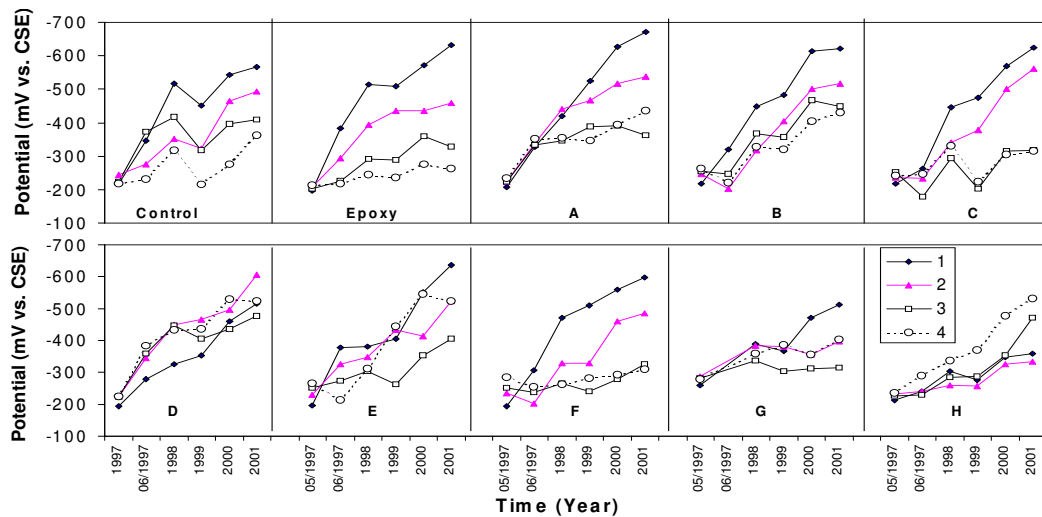
Figure 11. Half-cell potential measured on the rebar ladders (concrete cover thickness: 13mm at bar 1, 25mm at bar 2, 38mm at bar 3 and 50mm at bar 4).

the lower bars (Bars 2, 3 and 4) in most spans (except in Spans D and H). This is because corrosion occurred sooner at the locations with a thinner concrete cover due to the salt ingress to the reinforcement. The half-cell potentials had reached -500 mV to -600 mV vs. Cu/CuSO₄ on the top bars with thinner concrete cover (oxygen depletion was not likely) in many spans indicating a high corrosion probability. On Span D, the half-cell potential difference between the bars is the smallest, although they also shifted to more negative values. On Span H, half-cell potentials on lower bars changed more significantly than on the top ones. This was not expected. The reason behind this unusual result is still not clear.

In Spans D and H, the corrosion rate was quite low on both the top and second bars of ladders. Recall the half-cell potential behaviour (Fig. 11), which was also different from other spans. It is clear that both potential and current behaviours are related to the specific corrosion-inhibiting systems applied on the spans.

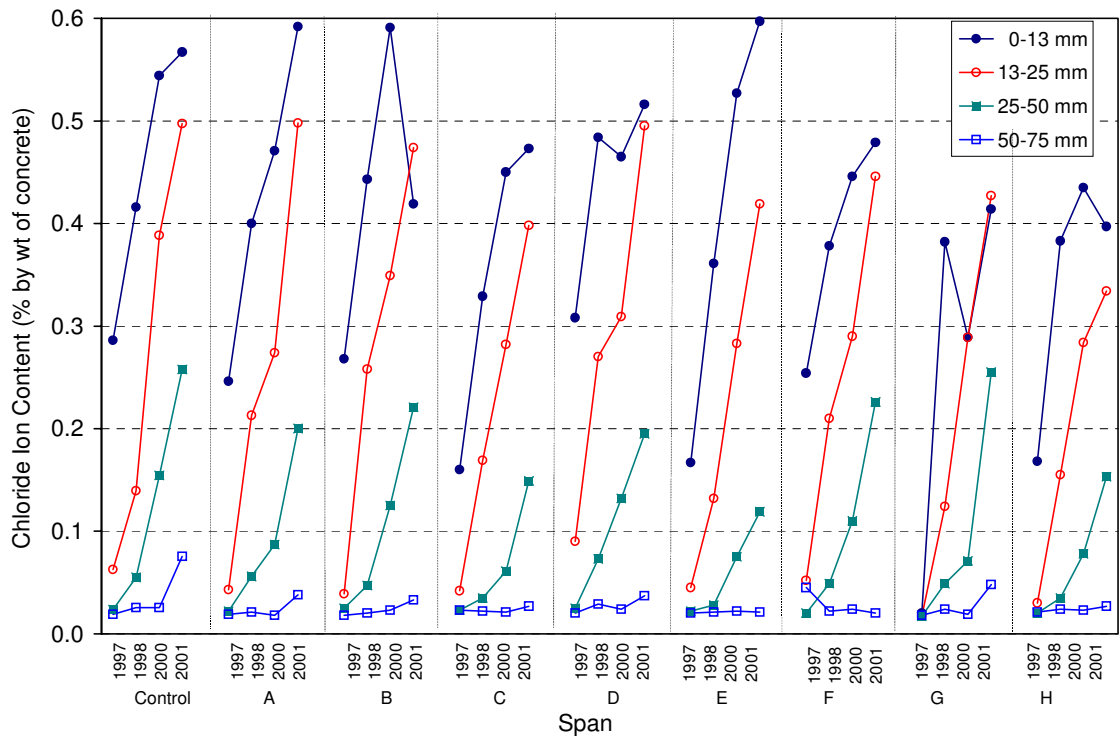
Figure 13. Total Chloride Ion Content Measured on Concrete Cores at various depths.

The chloride content also decreased significantly with the concrete depth. The range of 25 mm to 50 mm corresponds to a depth where the reinforcement would normally be located in older bridges, since most of the corrosion-inhibiting systems tested in this study can be used in rehabilitation applications as well. The chloride concentration in all spans was well below the 0.1% threshold value after the first two winters (1997-1998). Concrete in Spans A, C, E, G and H was still below the chloride threshold limit in 2000. By 2001, all concretes had exceeded the critical threshold value. Concrete E has the best performance by exceeding the corrosion threshold value by only 20% after 4.5 years at the depth of 25 mm to 50 mm.

Corrosion of reinforcing steel should not begin if the concrete cover is between 50 mm and 75 mm, since the chloride concentration is below the threshold. However, corrosion is very likely to develop with cracked concrete when the chloride concentration is high. This is probably the reason for localized corrosion causing the half-cell potential to shift to more negative values.
