STRUCTURAL TESTING OF TWO W-TRUSSES

Report No. 77  
of the  
Division of Building Research

Ottawa  
December 1955

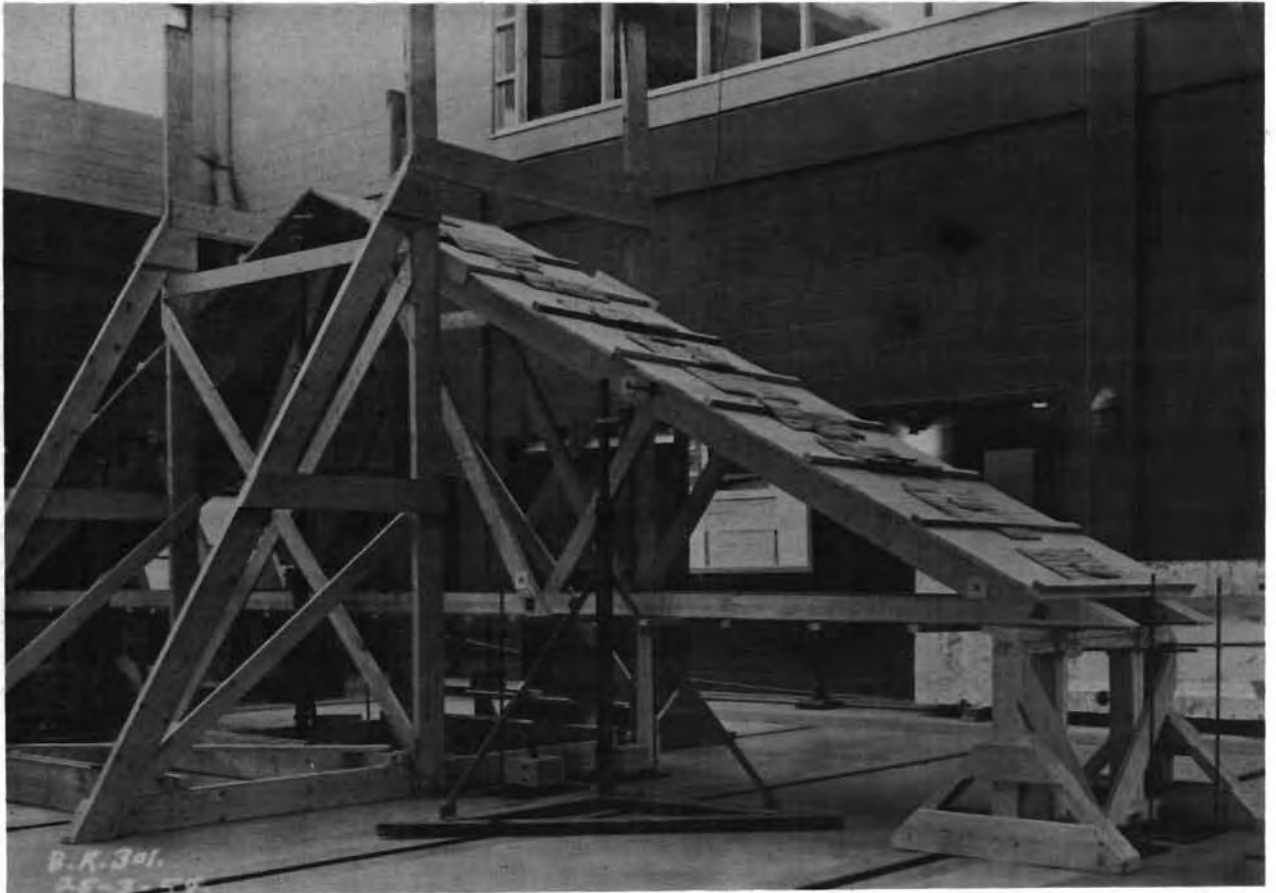
Fig. 2. Test assembly with ceiling load and dead load applied. Trusses free to deflect independently of stabilizing framework.

As opposed to testing each truss separately, the two trusses were mounted side by side on supports having the approximate lateral stability of one-storey house walls. The spacing on the supports was set at the design spacing of 24 inches on centres. The upper chords were joined together with 4-foot lengths of sheathing boards to provide the required tributary roof area for loading and also to simulate the working conditions of trusses in a house roof as nearly as possible. Furring strips were nailed to the lower chords in a manner duplicating the furring arrangement in the ceiling of a house. To prevent sidesway and possible overturning of the test assembly when loaded, a stabilizing framework was anchored to the floor beams of the project laboratory.

Each panel point of both trusses was assigned a reference letter and a system of wires and pulleys was installed to record vertical and horizontal movements at the panel points on W-truss No. II. A deflection board was securely anchored to the floor of the project laboratory and each deflection wire was appropriately referenced and tensioned by a standard reference weight. Figure 2 shows the test assembly with the ceiling load and the equivalent dead load of the shingles in place on the trusses.

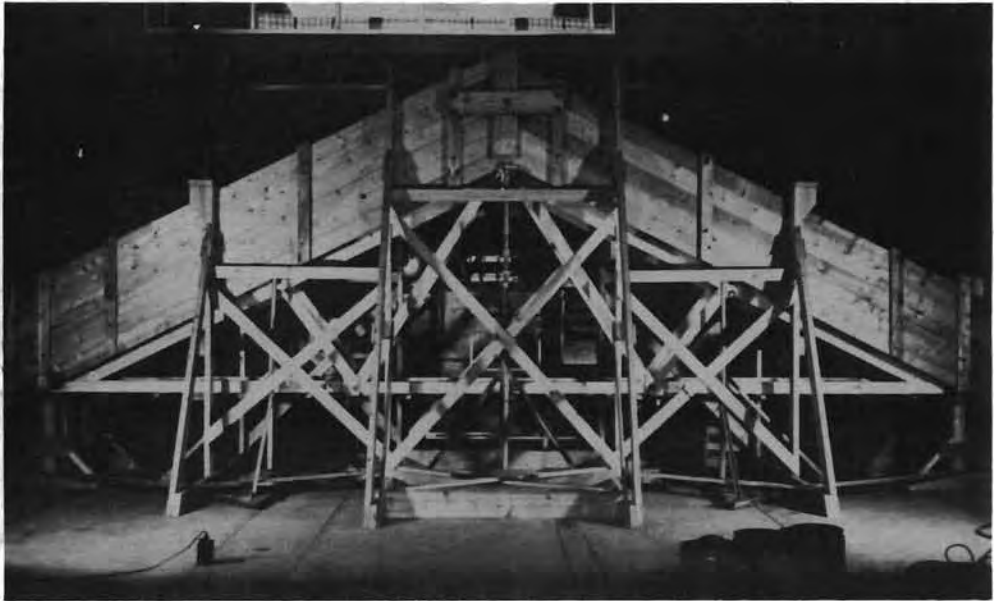
**Fig. 2a. Test assembly with bulkheads  
in position.**

Standard 1-, 10-, and 20-lb. lead-filled bags were uniformly distributed on the tributary roof area and on the furring strips of the lower chords to simulate one times the design load plus dead load. Since the number of lead-filled bags was limited, loads in excess of one times the design live load for symmetrical loading were superimposed by applying pea-sized crushed stone. The crushed stone was confined to the tributary roof area by specially constructed bulkheads. Figure 2a shows the test assembly with the bulkheads in position.

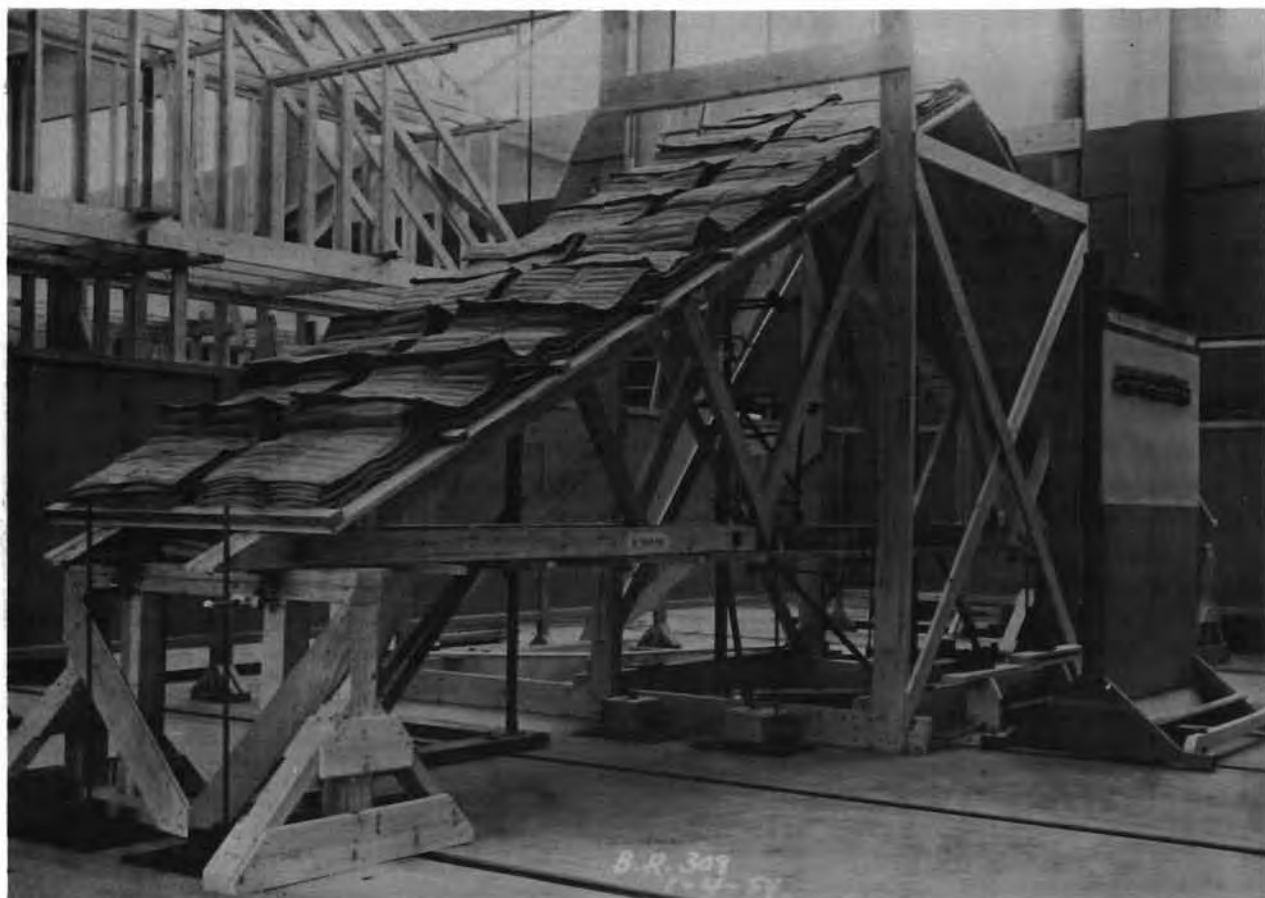
Fig. 3. Trusses loaded with ceiling load (10# per square foot) plus dead load (shingles = 2.1# per square foot) and design live load (snow load = 50.8# per square foot of horizontally projected roof area). Note deflection board and wire and pulley arrangement for recording deflections.

Deflections, both horizontal and vertical, were measured at each panel point on W-truss No. II by a system of wires running over small pulleys. Dial gauges were also used to read deflections on the lower chords of each truss but were removed when twice the design live load was reached. The system of wires and pulleys provided a continuous record of the deformed shape of W-truss No. II; the dial gauges provided a record of the initial deflections in the lower chords and served as a check on the wire and pulley system. In addition to the mechanical methods used for measuring deflections, the Photogrammetry Section of the Division of Physics measured

At the end of the 20-day period of the first loading phase, the N.B.C. design snow loading of 50.8 lb. per square foot of the horizontally projected roof area was applied in increments of one-half the design live load and was allowed to remain on the trusses for a period of seven days. The lead-filled bags were applied manually and simultaneously to both roof slopes from a platform erected beside the test assembly. Deflection records were made from both the dial gauge readings and the deflection board. The dial gauge readings have been reduced in Table III to show the net deflections at the lower chord panel points with respect to the end panel points. Figure 3 shows the trusses loaded with the design live load plus dead loading and ceiling load.

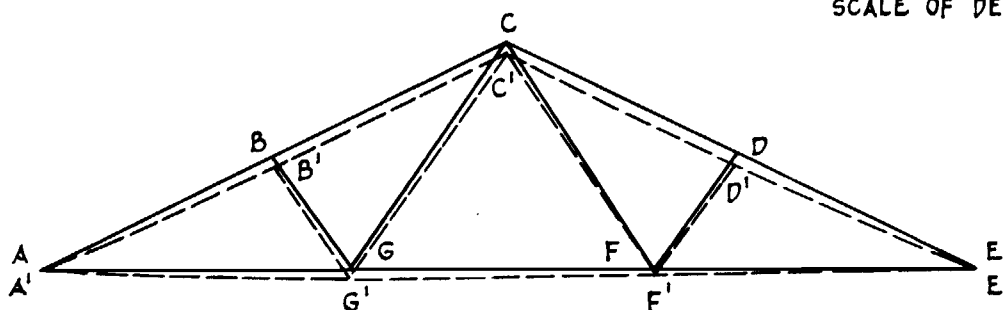
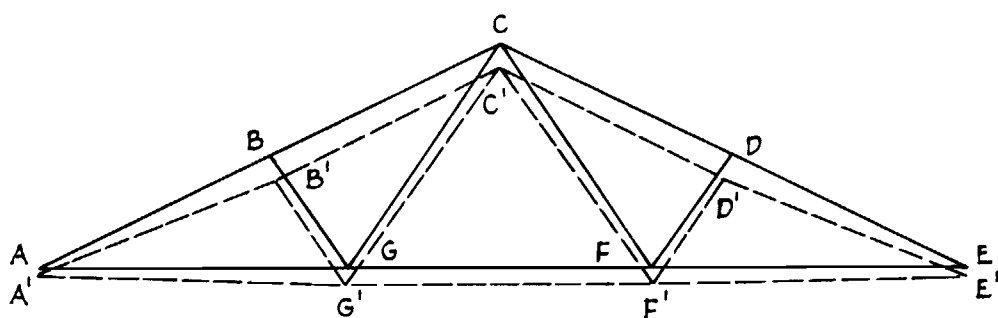
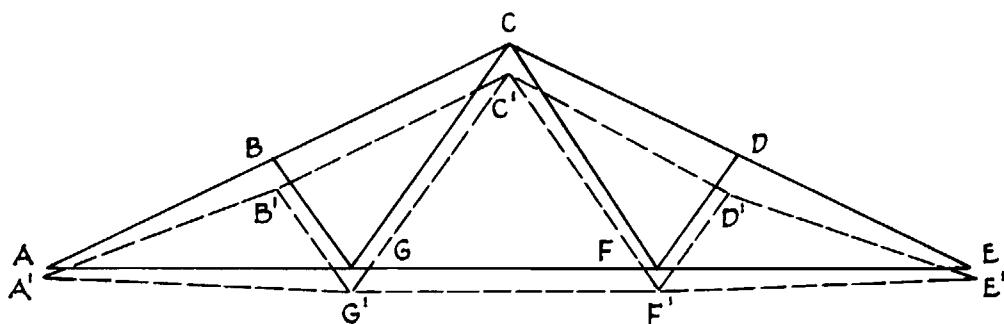
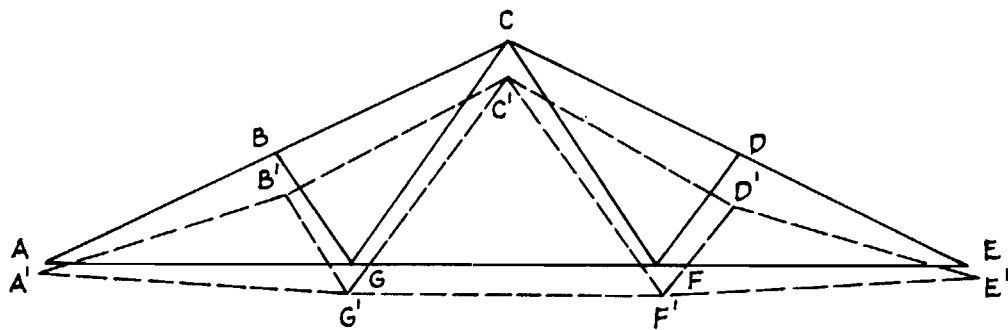
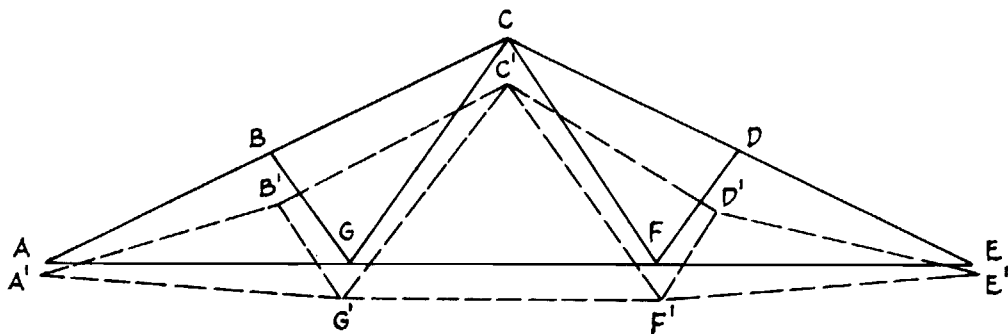
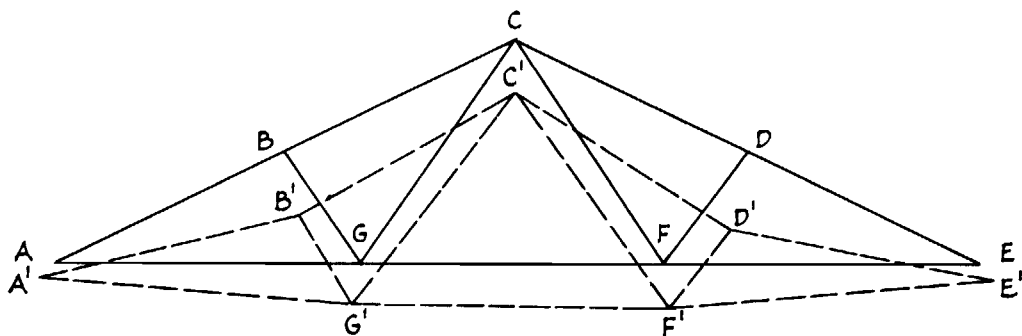
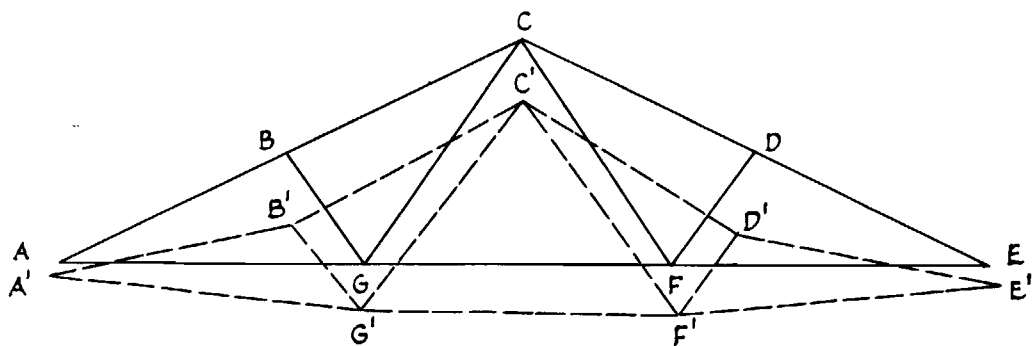
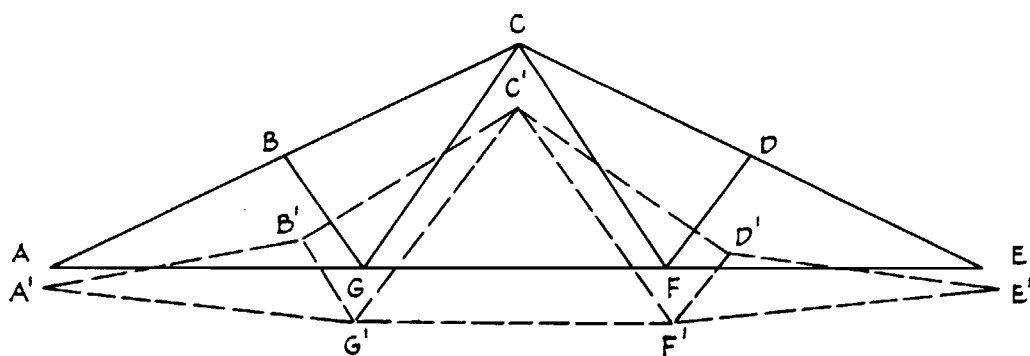
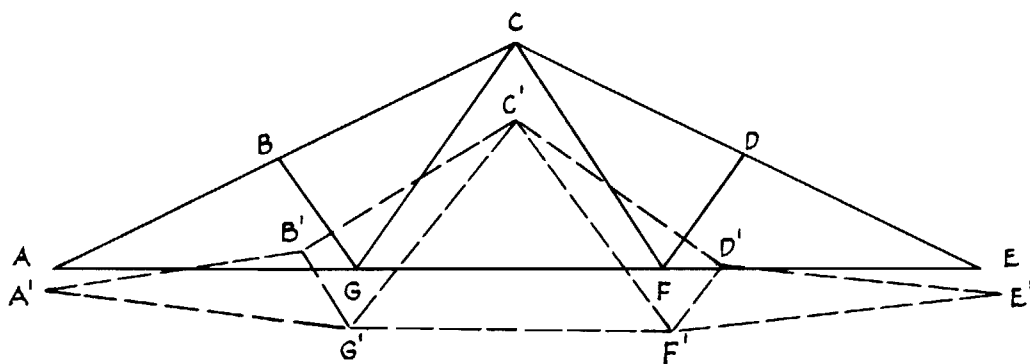
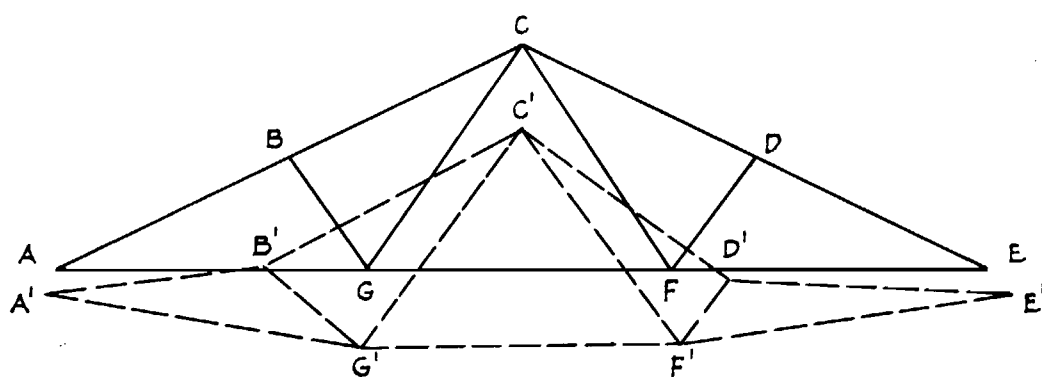
# DEFORMED SHAPE OF W-TRUSS NO. 11 TEST TO FAILURE

FIGURE 4    DEAD LOAD + CEILING LOAD  
+ 1/2 LIVE LOAD

FIGURE 5    D.L. + C.L. + 1 SNOW LOAD

FIGURE 6    D.L. + C.L. + 1 1/2 SNOW LOAD

FIGURE 7 D.L. + C.L. + 2 SNOW LOAD

FIGURE 8 D.L. + C.L. + 2 1/2 SNOW LOAD

FIGURE 9 D.L. + C.L. + 3 SNOW LOAD

FIGURE 10 D.L. + C.L. + 3 1/2 SNOW LOAD

FIGURE 11 D.L. + C.L. + 4 SNOW LOAD

FIGURE 12 D.L. + C.L. + 4 1/2 SNOW LOAD

FIGURE 13 D.L. + C.L. + 5 SNOW LOAD  
INCIPIENT FAILURE

When the superimposed load reached a value equivalent to five times the design live load or a total of 254 lb. per square foot of horizontally projected roof area, failure occurred very suddenly in the lower chords of both trusses simultaneously near the panel point "G" (Figs. 1 and 14-17). Complete collapse was prevented by the upper chords of the trusses coming to rest on the crossbeams. Additional supports were installed as a precautionary measure against local failures in weakened joints and end supports. By preventing complete collapse of the test assembly at failure of 24,443 lb., it was possible to obtain detailed photographic records of the points of most interest, namely, the joints near panel point "G" and the supports where spreading in the direction of the span occurred. The deformed shapes of W-truss No. II for each increment of live load as plotted from the deflection board records are shown in Figs. 4 to 13.

During the test to failure, i.e. sixth loading phase, the wire and pulley deflection apparatus was used to obtain the deformed shape of W-truss No. II as the increments of one-half design live load were applied. The maximum vertical deflection reached before failure occurred took place at point "G" (Fig. 13) and reached a value of 0.56 inch. The corresponding value for point "F" was 0.50 inch. Both values were below the allowable deflection for a plaster ceiling of  $1/360$  of the span, or 0.80 inch. The fact that greater deflections did not occur can be explained by the resistance offered to vertical deflections by the tension developed in the lower chords under superimposed loads.

It will be noted when reviewing Figs. 4 to 13 that there was a trend toward progressive spreading at the supports as successive increments of loading were applied. The total outward movement in the direction of the span at point "A" prior to failure was  $1/10$  of an inch and the corresponding movement at point "E" was approximately  $2/10$  of an inch, thus giving a total elongation of the lower chord of  $3/10$  of an inch. The total deflections of the upper chords measured at right angles to the slope at point "B" and point "D" were 0.50 inch and 0.75 inch respectively.

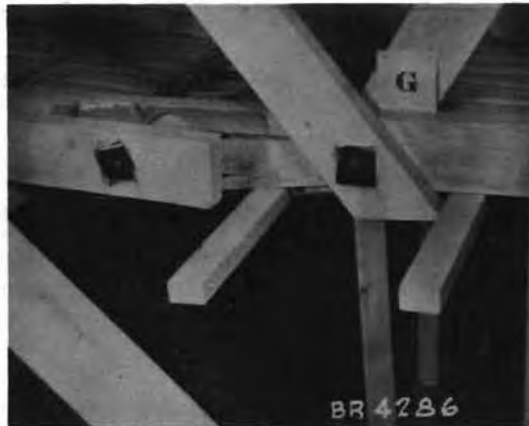
Fig. 14. Failure at joint in lower chord of W-truss No. I under dead load plus ceiling load plus five times live load (snow load)

When the lower chords failed under dead load plus ceiling load plus five times design live load, the test assembly and loading were supported so that photographs could be taken of the points of interest. Both lower chords of the two trusses failed at almost the same instant and at the same location. Figures 14 and 15 show the failures in W-truss No. I and No. II

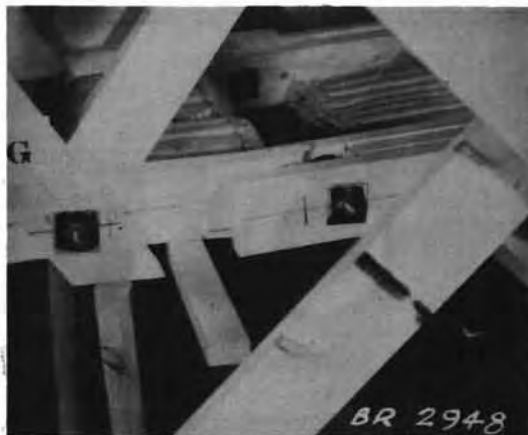
Fig. 15. Failure at joint in lower chord of W-truss No. II under dead load plus ceiling load plus five times live load (snow load)

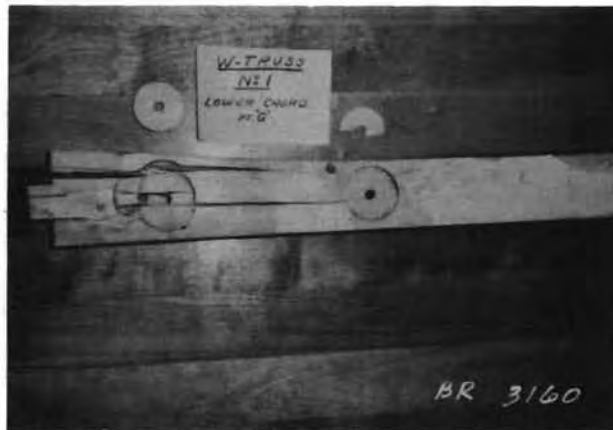
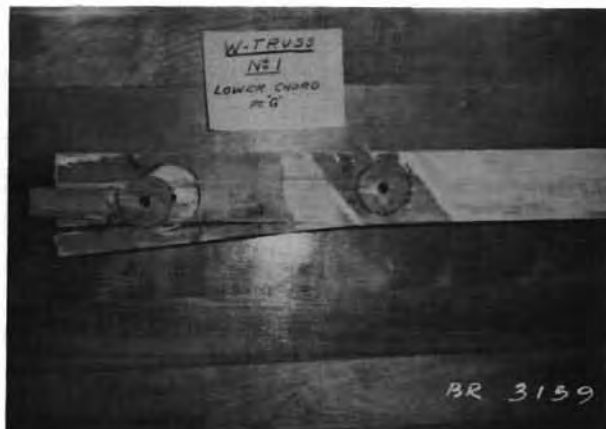
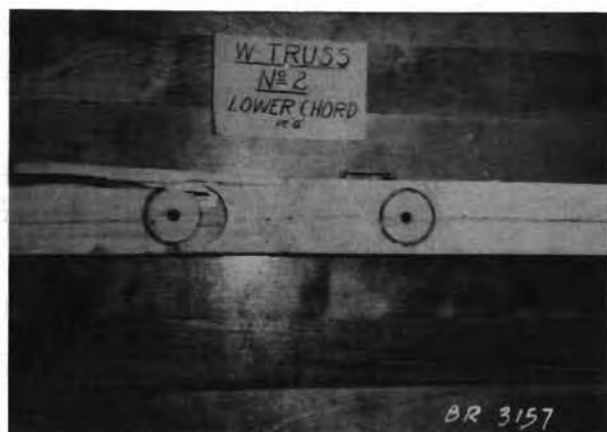
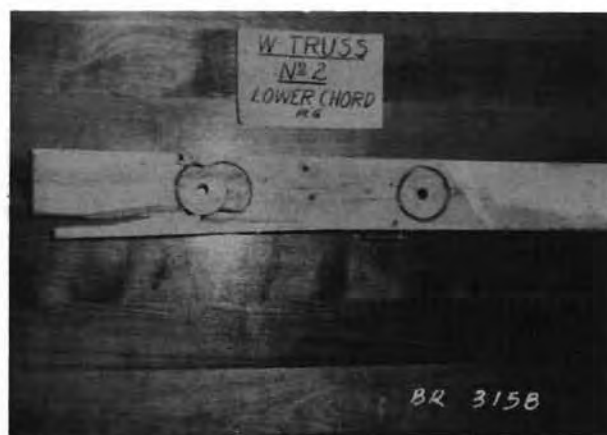
Fig. 16. Failure in lower chord member of W-truss No. I, top view of member

Fig. 17. Failure in lower chord member of W-truss No. I, bottom view of member

Fig. 18. Failure in lower chord member of W-truss No.II, top view of member

Fig. 19. Failure in lower chord member of W-truss No.II, bottom view of member

respectively. Additional features of the joint failures are shown in Figs. 16 to 19, which show the individual members that failed, after the trusses had been disassembled. Failure in each member was by shear and tension; the exact sequence of failure by these forces is difficult to determine.
