WEATHERING OF SILICONE SEALANT ON
STRAIN-CYCLING EXPOSURE RACK
by K. K. Karpati

Reprinted from
Adhesives Age
Vol. 23, No. 11, November 1980
p. 41-47

DBR Paper No. 957
Division of Building Research

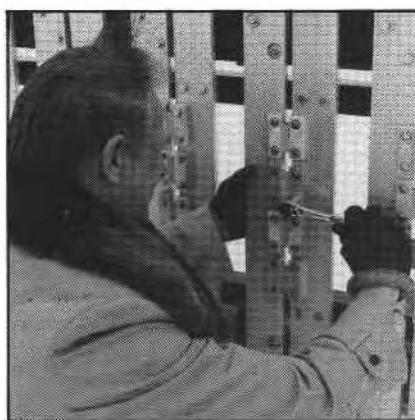
Figure 2. Specimens are bolted to rack.

The specimens were bolted on a strain-cycling rack (Figures 1 and 2) (3), and differential movement between the aluminum and the steel parts of the rack (induced by outdoor temperature changes) was transmitted to the sealant beads. The amount of movement the specimens underwent varied with their position on the rack and was measured weekly by maximum-minimum gauges (5). Simultaneously, the surface temperature of the rack was recorded and related by statistical analysis to the

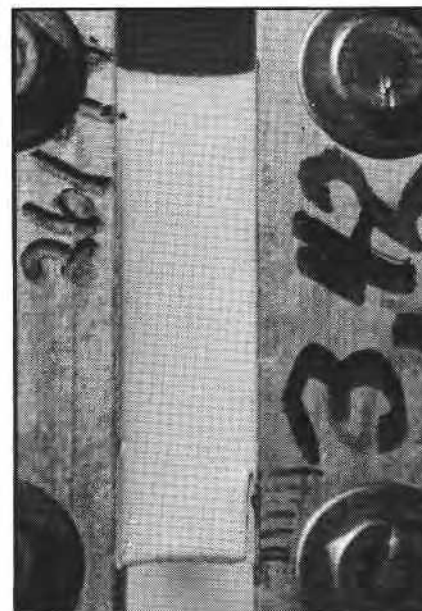
Figure 11. After two months' exposure.

Figure 11 shows the start of failure

within the first two months of exposure for a specimen exposed where the average maximum yearly movement was ± 26.0 percent. Figure 12 indicates the progress of failure on the same specimen. It may be seen that the second half of the failure occurred during the third winter. Figures 13a and 13b show the sides of the same specimen exposed to the south and the north when compressed on the rack in the last summer at air temperatures of about 38°C (100°F). The adhesive failure is barely visible under compression on this specimen (mostly undetectable in others). The front and back views of the specimen following removal from the rack after three years of exposure show that there was no further change after the third winter (Figures 14a and 14b).
