### **Corrosion-inhibiting systems for concrete bridges**

## Evaluation of Corrosion-Inhibiting Systems on a Concrete Bridge Deck

By Dr. Daniel Cusson and Dr. Shiyuan Qian

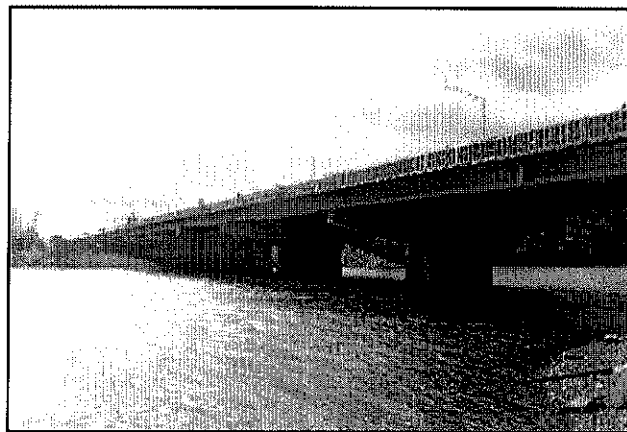
Figure 1. Vachon Bridge, Laval, Québec

The Vachon Bridge is a six-lane structure with a 714-m total length. It has 21 spans of prestressed concrete girders supporting a reinforced concrete deck. The opportunity for the research arose in 1996 when *Transports Québec* was undertaking a major rehabilitation of the bridge, including the rebuilding of the barrier walls. The Ministry and NRC-IRC worked out a collaborative project in which ten consecutive 34-m spans of the east-side barrier wall were selected for the testing of nine corrosion-inhibiting systems (Table 1). The same basic concrete mix was used for the ten test sections of barrier walls.

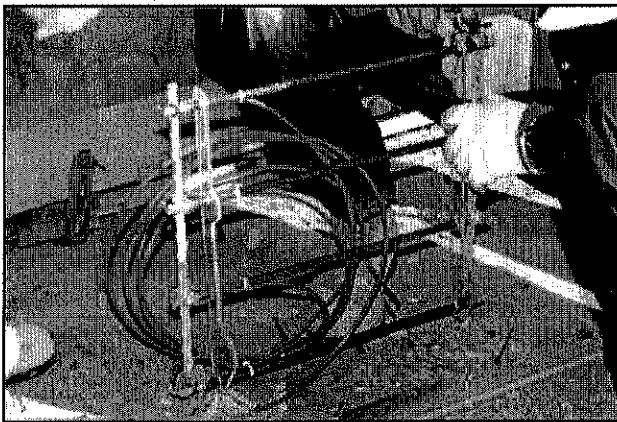
To enable an early evaluation of the performance of the test systems, two sets of rebar ladders were embedded in each test span (Figure 2a). Each ladder was made up of four 10M horizontal bars, installed in the barrier wall to provide concrete cover thicknesses of 13 mm for the upper bar (Bar #1), and 25 mm, 38 mm and 50 mm for the other three bars (Figure 2b).

Figure 2a. Rebar ladder being prepared before installation in formwork.

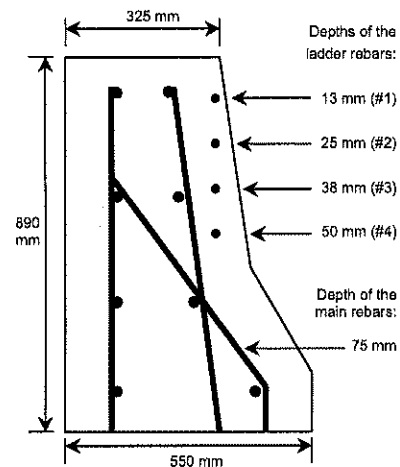
Figure 2b. Cross-section of barrier wall showing the main reinforcement with transverse bars spaced at 230 mm, and a test rebar ladder to the right.

The barrier wall surface was visually inspected in June 2006 for corrosion-induced damage over Bar #1 (concrete cover 13 mm, Figure 2b) of each test ladder. After ten years, corrosion had become evident in the region of Bar #1 in each test span. Test sections D and H had the lowest degree of damage with only minor horizontal cracks over these rebars. Sections A, C, E and F had horizontal cracking, small delaminations and spalled areas near these rebars.

Concrete cores over Bar #2 (25 mm concrete cover, Figure 2b) were taken in June 2006 from the test ladders. The rust observed at the steel surface had not progressed significantly on these bars by this time. Another set of cores was taken in June 2006 over the main reinforcement (75 mm cover) of the barrier wall. Their locations were chosen to correspond to places where readings indicated the most negative half-cell potentials and the highest corrosion rates. The results from the core sampling indicated that the main reinforcement showed no significant active corrosion, which can be attributed to the substantial depth of the concrete cover (75 mm) and the very low permeability of the concrete.

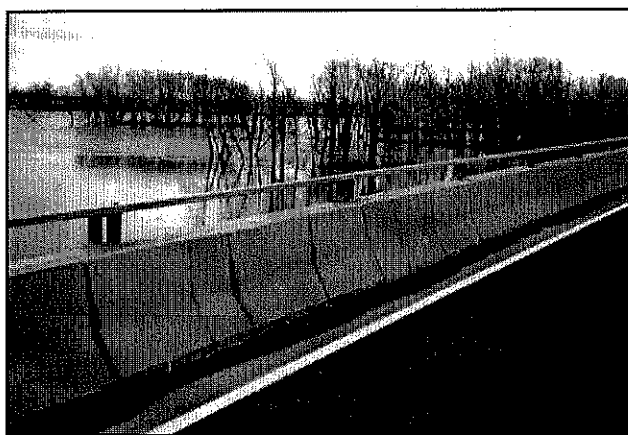
A visual inspection of the barrier wall a few days after casting revealed closely spaced vertical cracks running through the walls (Figure 3). The cracks were 800 mm apart on average and less than 0.3 mm in width. It was determined that this cracking was mainly due to uncontrolled thermal effects and autogenous shrinkage, typical of concrete with high cement content and low water-cement ratio.

Figure 3. Typical span of the barrier wall showing early-age shrinkage cracks

- Corrosion rates on the main reinforcement measured over the vertical shrinkage cracks (which appeared shortly after construction) were consistently higher than those measured over uncracked locations, regardless of the corrosion-inhibiting system used, including the system with epoxy-coated reinforcement.

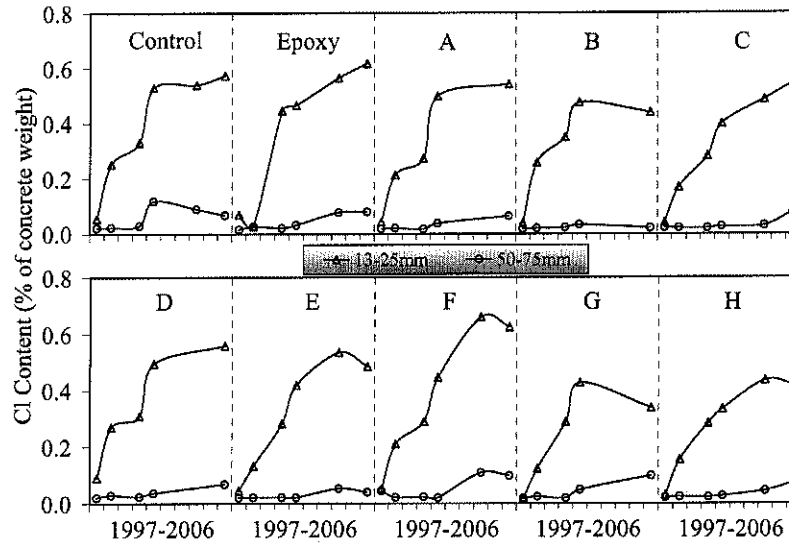
The chloride contents periodically measured in the barrier wall are shown in Figure 4. In general, chloride contents increased over time and decreased with cover depth, as expected. By 2001, the chloride contents at a depth of 13-25 mm in all test spans exceeded the critical value of 0.1%, above which chlorides may initiate corrosion of the reinforcement. (This critical chloride value is approximate only and is likely higher for concretes containing corrosion inhibitors.)

Figure 4. Total chloride content (from core samples)

By 2006, the chloride contents at depths of 50-75 mm in all test sections were still below the critical value of 0.1%. This suggests that the risk of corrosion of the main reinforcement was low in areas where the initial cracking was not present. The system in Span G performed very well in 1997, at which time no chlorides had penetrated into the concrete. This was due to the protective sealer applied to the concrete surface. In the following years, chlorides penetrated into the concrete of Span G but at a lower rate than in the other systems tested.

- Total chloride contents measured after 10 years at depths of 50-75 mm remained below or near the critical chloride value of 0.1% in all test spans. This suggests that the risk of corrosion of the 75-mm deep reinforcement remained low at uncracked locations.

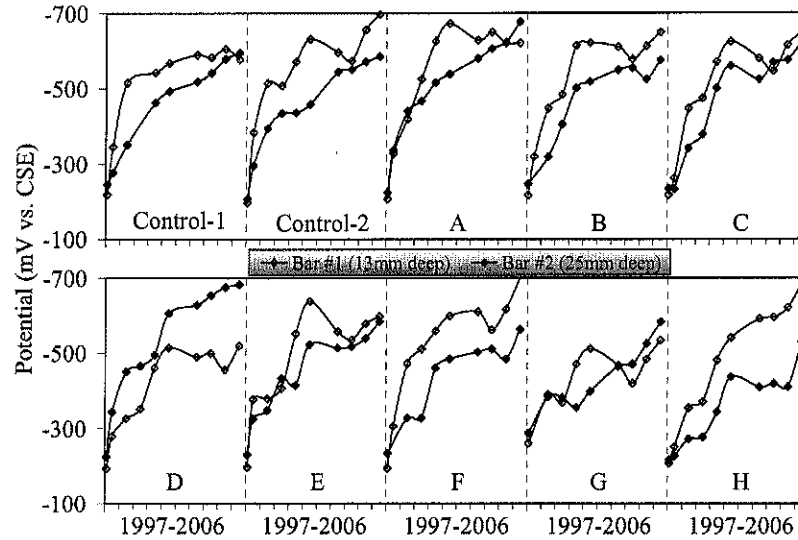
Figure 5 shows the half-cell potential measured non-destructively on Bars #1 and #2 in the test rebar ladders. For all the test spans, the half-cell potential started at a value near -200 mV and decreased with time. There was a higher risk of corrosion at Bar #1 (13 mm cover) because of a higher chloride content at that bar. The curves in Figure 5 also show that Spans F and H had the least negative potentials (i.e. lowest risks of corrosion) at a depth of 25 mm (Bar #2) compared to the other test sections.

Figure 5. Half-cell potential measured over test rebar ladders (more negative values indicate higher risks of corrosion)

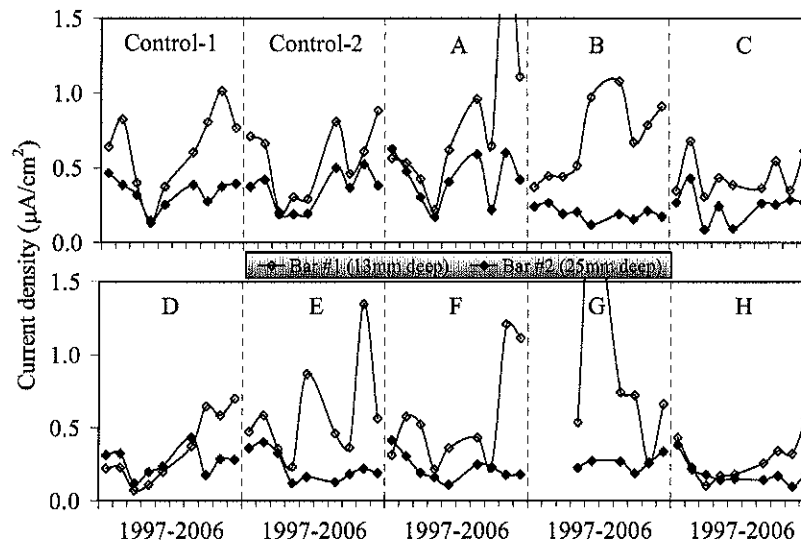
Figure 6 shows the current density (indicator of the rate of corrosion) measured on the test rebar ladders for each span. In general, the corrosion rates were much higher for Bar #1 (13 mm cover) than for Bar #2 (25 mm cover). In 2006, all corrosion rates on Bar #1 exceeded the critical value of  $0.5 \mu\text{A}/\text{cm}^2$ , indicating active corrosion. This is consistent with the actual damage to the concrete observed over Bar #1 of the rebar ladders. The curves of the corrosion rate at Bar #2 show that test spans H and B had the lowest rates in 2006 compared to the control span and the other systems. Spans E and F also had low corrosion rates.

Figure 6. Corrosion rate measured over test rebar ladders.
