NATIONAL RESEARCH COUNCIL OF CANADA  
DIVISION OF BUILDING RESEARCH

THE SAINT JOHN FIRE OF 20 JUNE 1877

G. W. Shorter

Fire Study No. 18

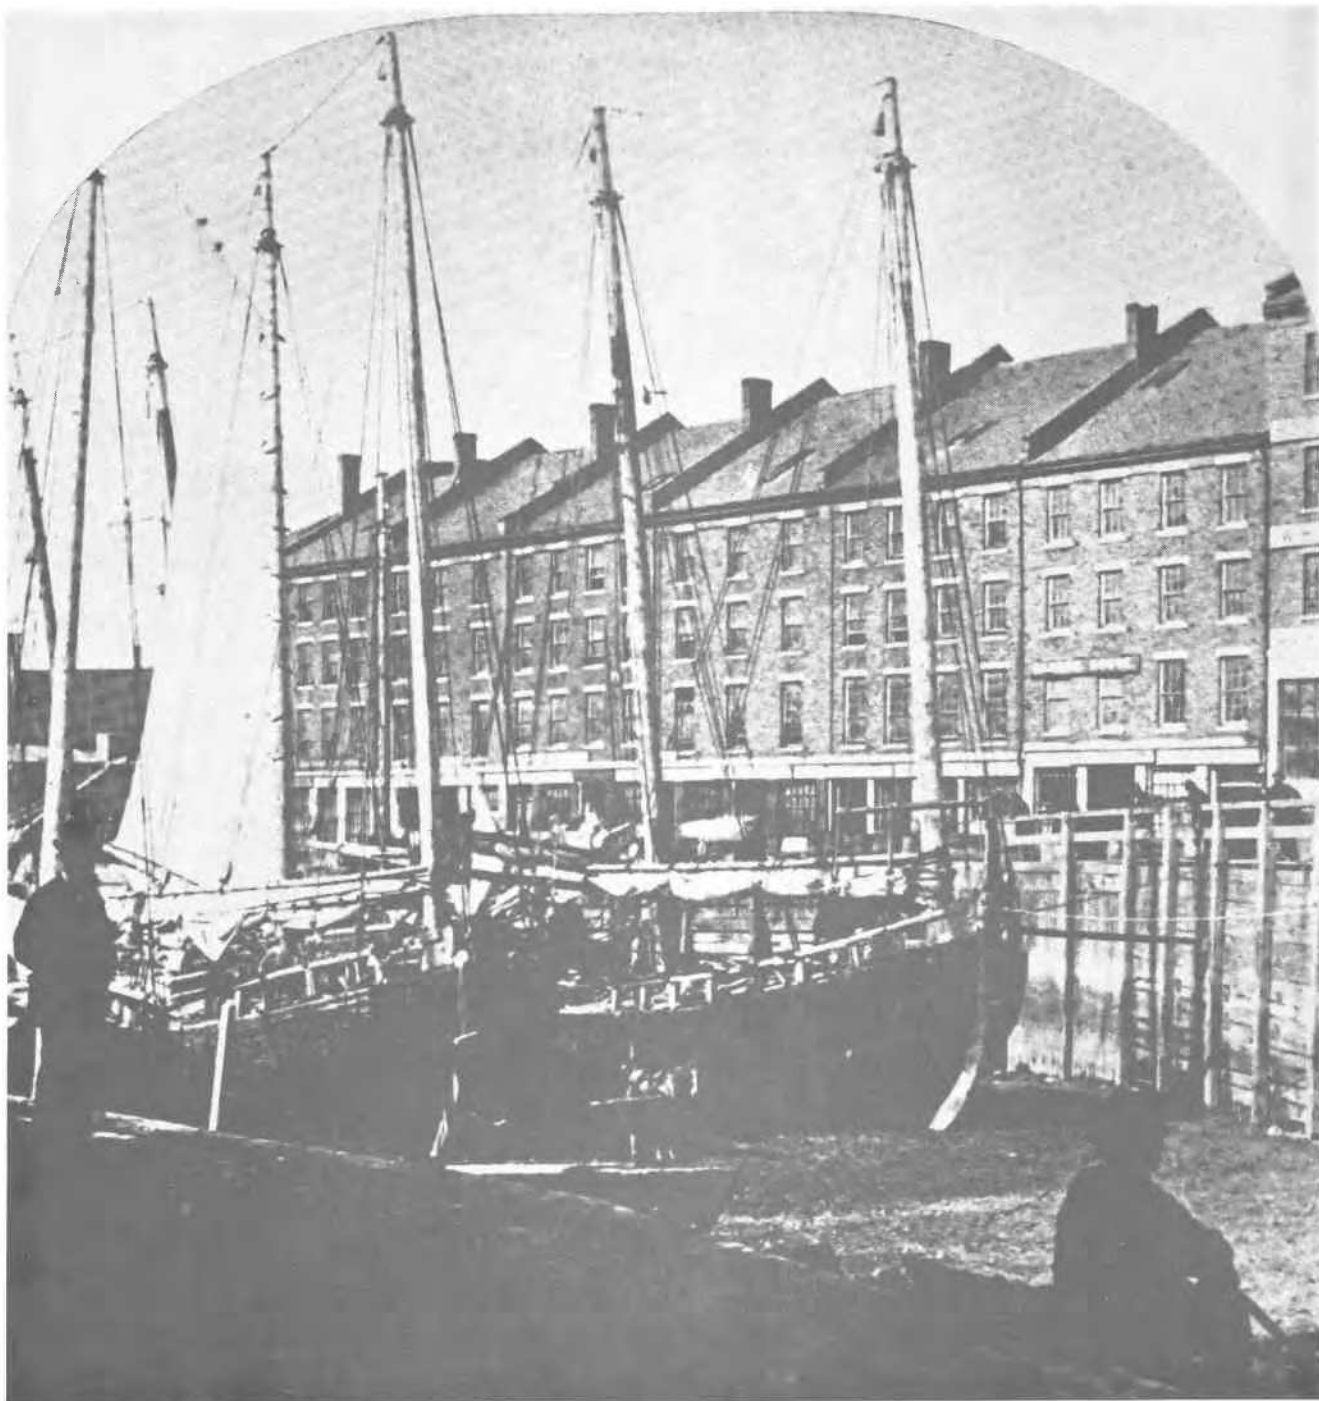
Figure 2 Market Slip, St. John, N. B. Early 1870's, South Market wharf in background  
(Photograph courtesy Early Photographs in Canada - Ralph Greenhill)

The fire quickly involved Smyth Street and spread south to South Wharf (Figure 2) involving Nelson Street and Robertson Place. At the same time, it spread into Drury Lane, Mill Street and Dock Street. The Saint John firemen assisted by Carleton and Portland firemen, who came with their engines, attempted to hold the fire at Union Street near Drury Lane. Unfortunately, houses past this point on Union Street caught fire and forced the firemen to retreat. In spite of great personal discomfort the firemen eventually held the fire in Union Street at the next block, east of Dock Street. This was the key to saving the part of the city lying north of King Street.

A row of typical buildings in the wharf area may be seen in Figure 2, which shows South Market Wharf. These were masonry buildings with parapeted party walls and slate roofs with access

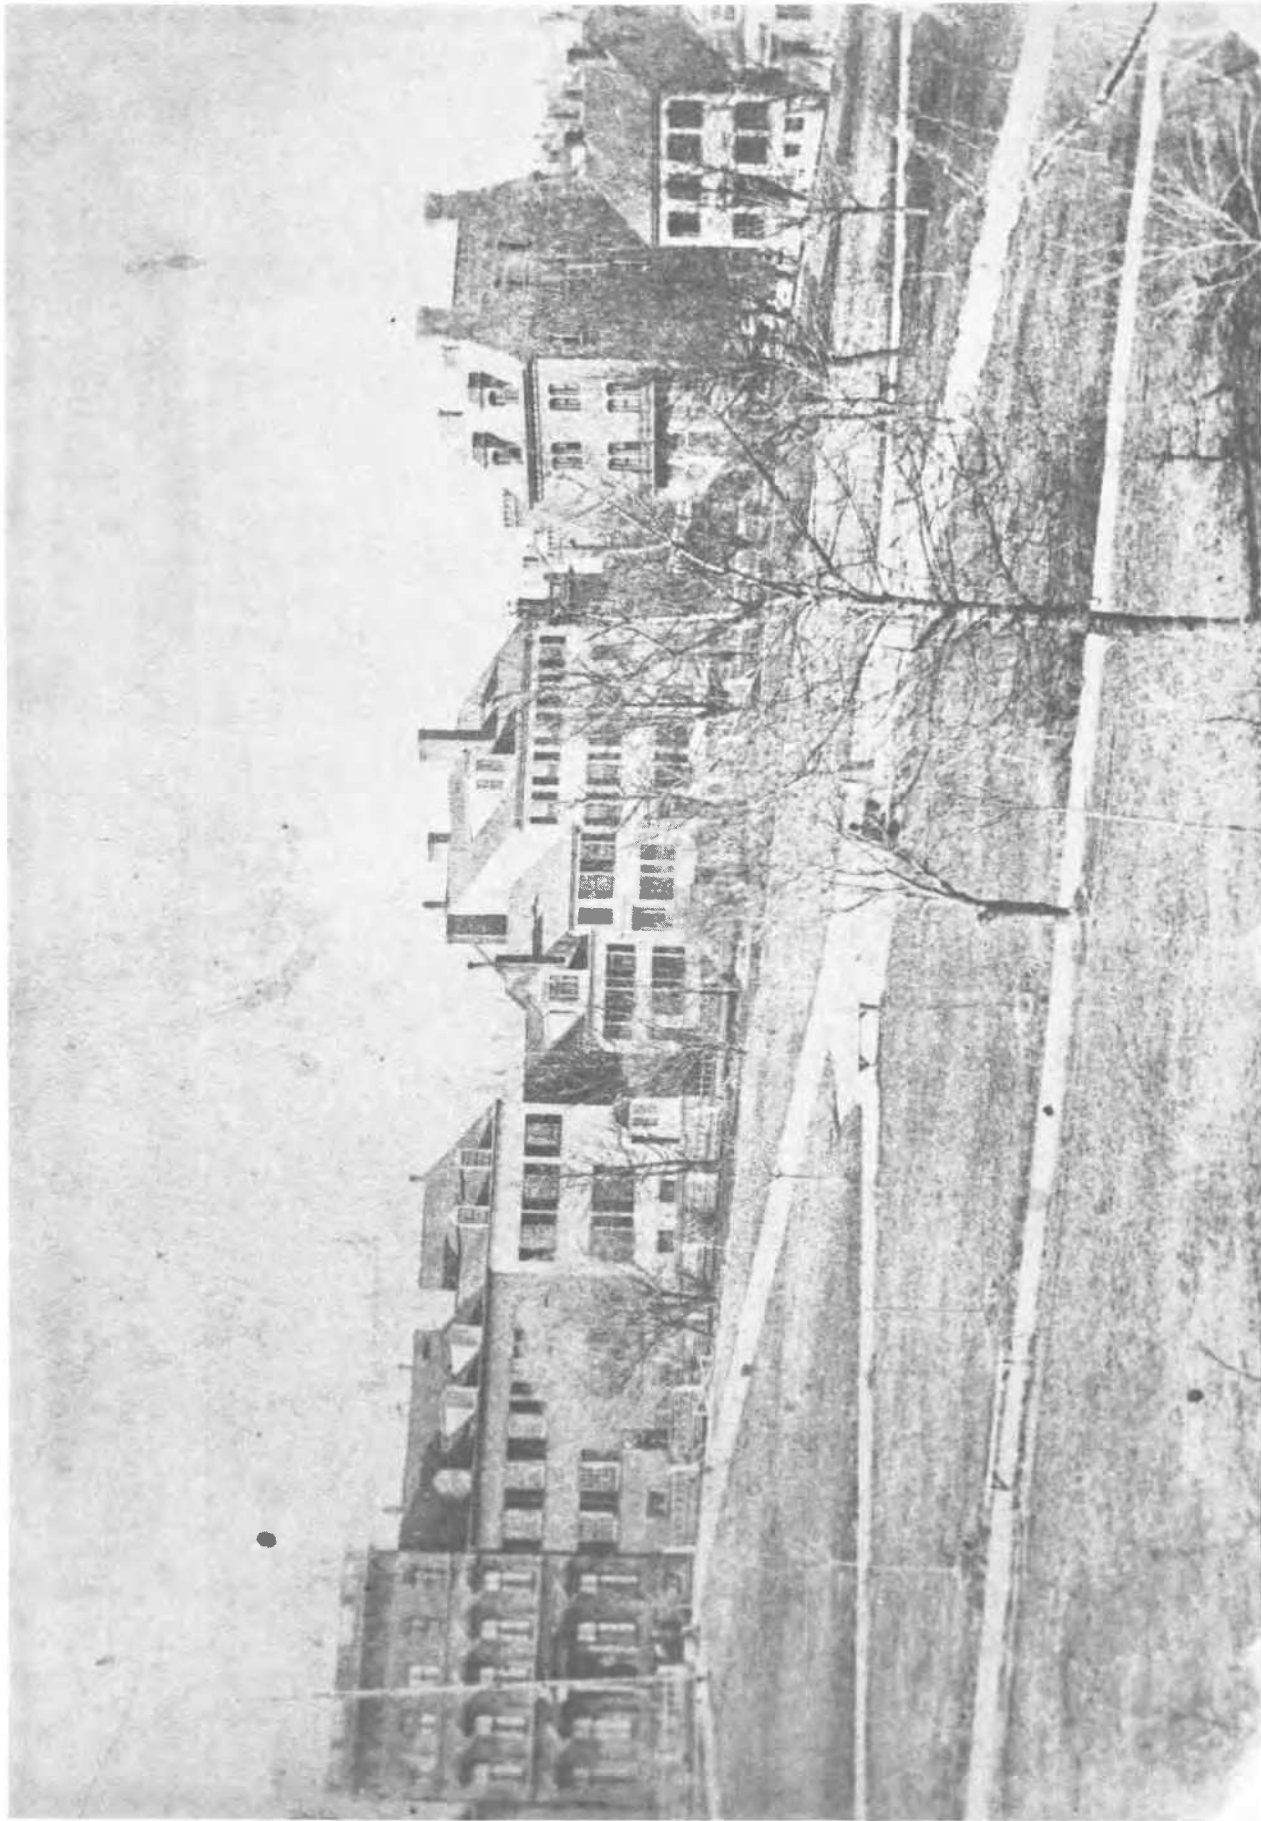
Figure 12 Residences facing Queen Square  
(Photograph courtesy New Brunswick Museum)

During the fire, people sought refuge both for themselves and their goods on Queen and King Squares. On Queen Square, 1,000 people watched the burning of the handsome residences on all sides of the Square (Figure 12). Two buildings stood on St. James Street - the Marine Hospital, an old barn-like structure, and a splendid new orphanage of masonry construction. An irony of the fire was the saving of the hospital and the loss of the orphanage. All the fine residences on Mecklenburg Street were destroyed. The fire in Canterbury Street levelled a number of masonry buildings housing many of the city's leading merchants. The stone Savings Bank on the corner of Princess and Canterbury Streets was destroyed.
