LODD - Full-scale Experiments to Investigate a Smoldering Sofa Fire Incident

G.D. Lougheed
National Research Council

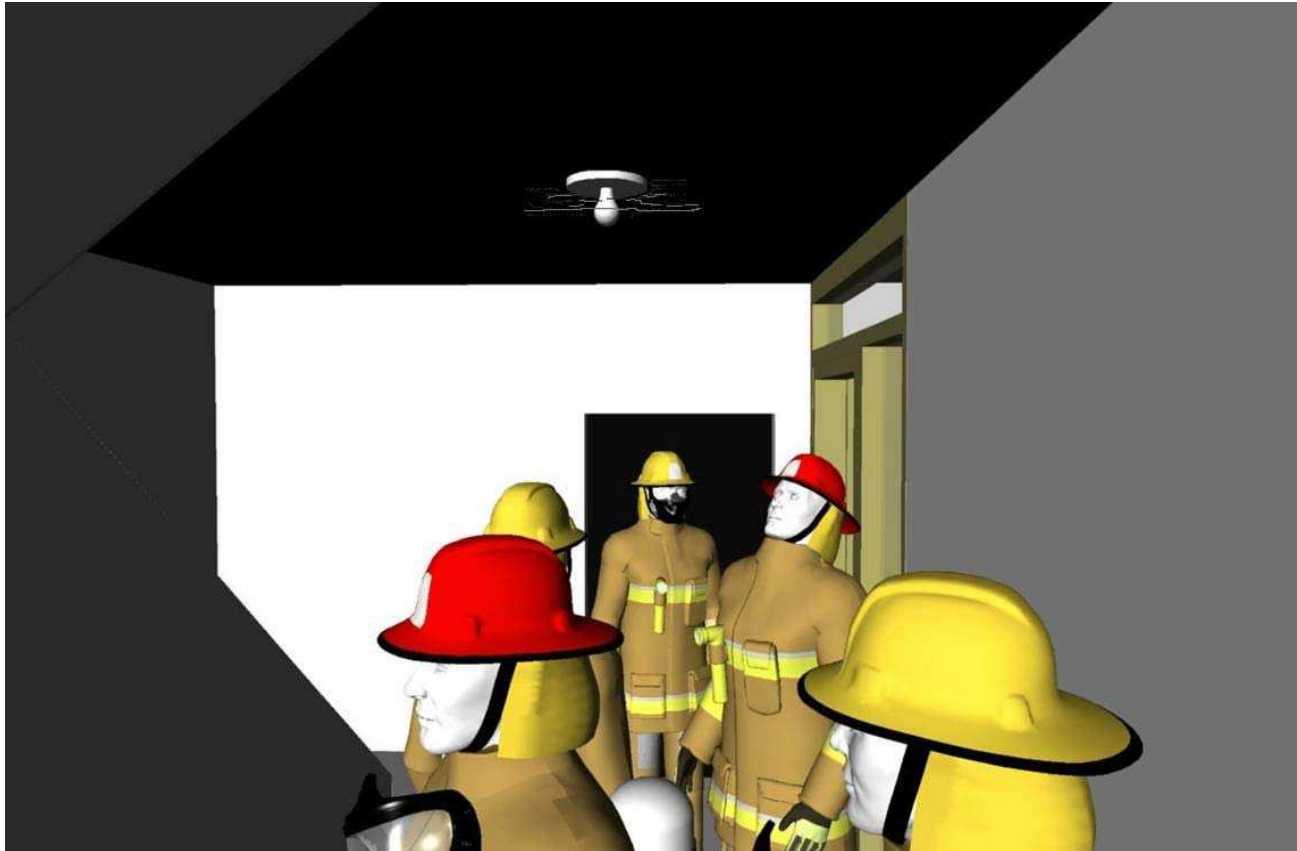
Fire Incident

After the second crew arrived, the building was searched. Nothing was found until the two crews met back on the landing on the first floor. A firefighter noticed white puffs of smoke coming from the light fixture in the landing.

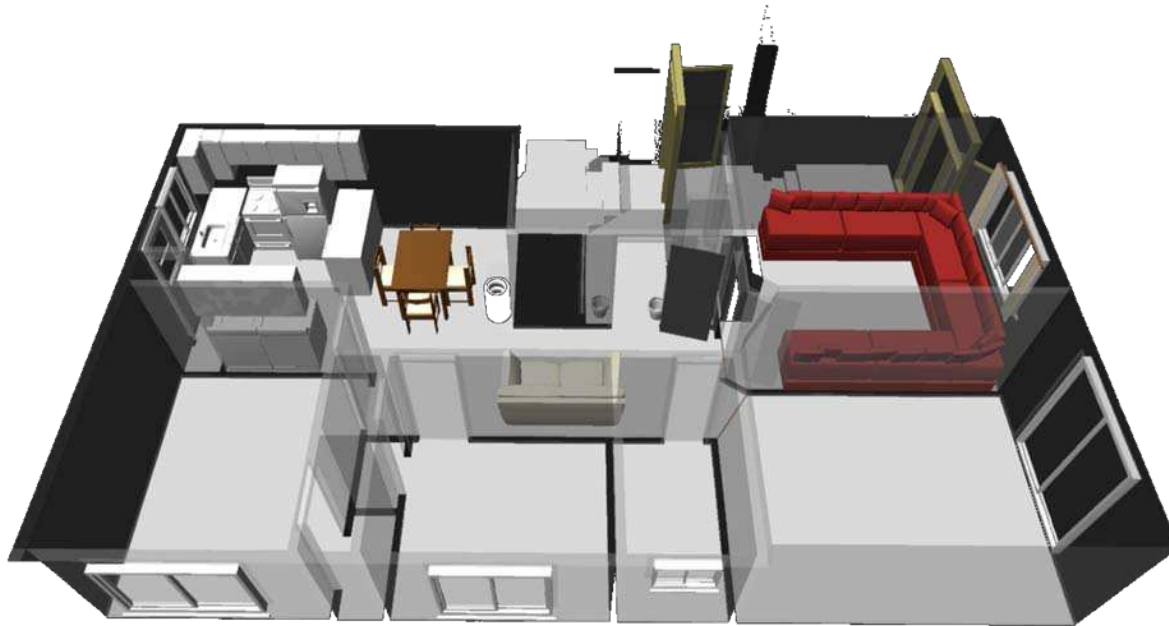
Fire Incident

The apartment door was forced open releasing a large cloud of smoke into the stairwell. This smoke engulfed a firefighter on the second floor landing forcing him to enter an apartment to get fresh air on a balcony.

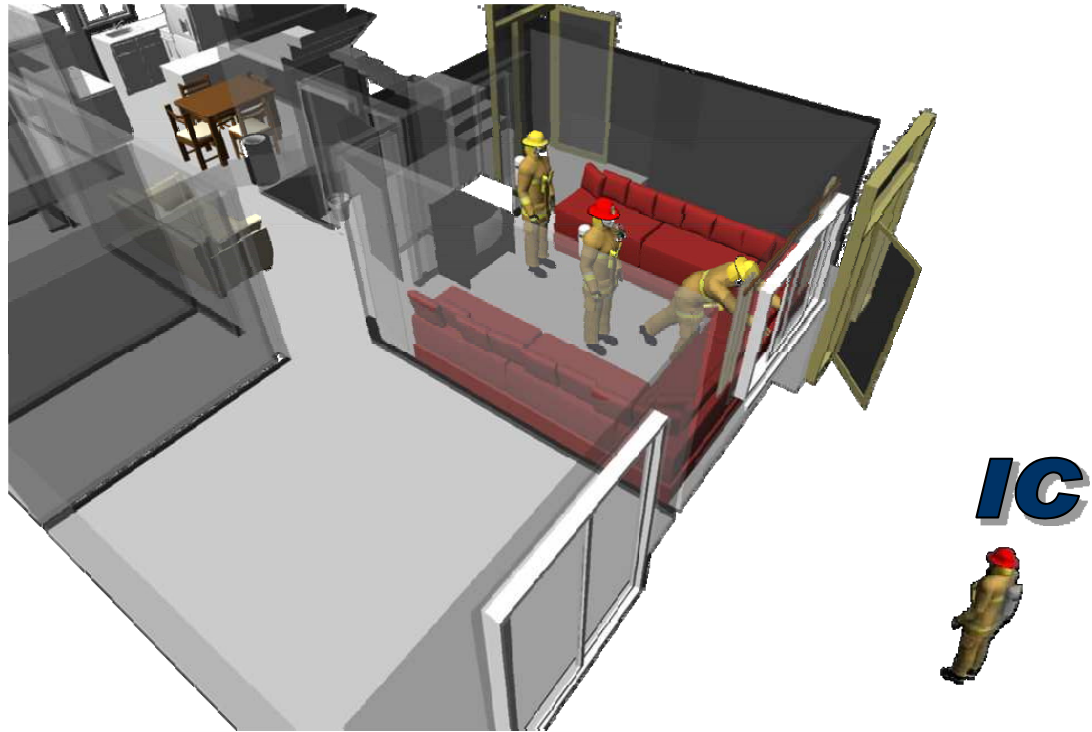
During ventilation, a smoldering sofa was found.

The firefighters decided to open the window in the room and toss the cushions and sofa out the window.

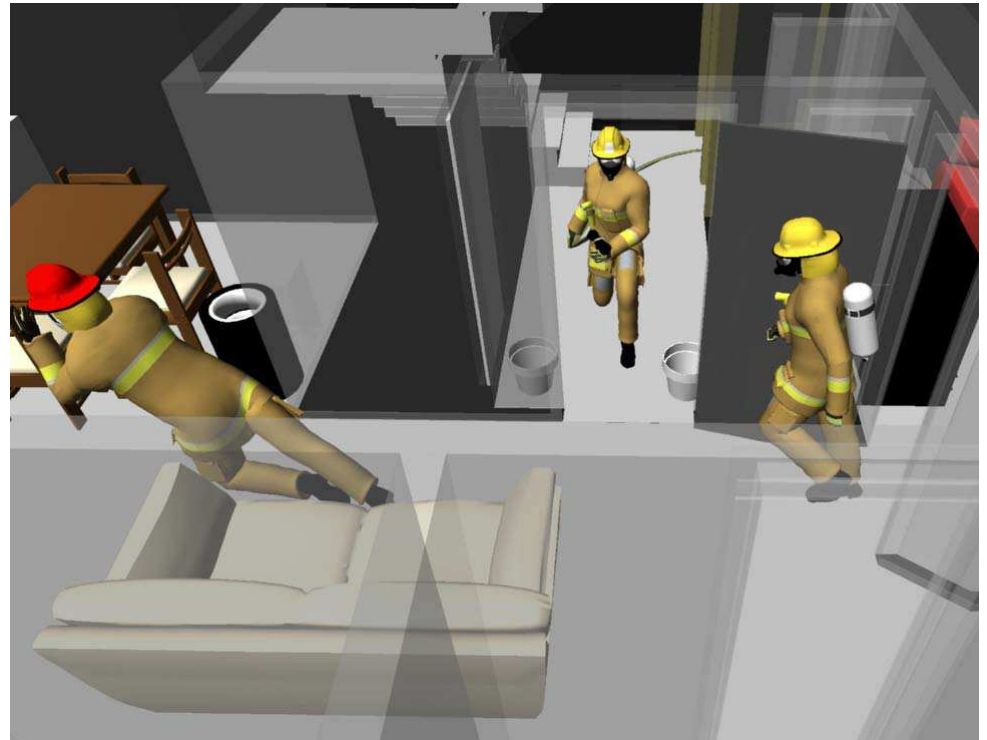
Upon moving the sofa, it evolved into a flaming fire, which ignited the curtains on the window and the smokey layer at the ceiling.

Two firefighters in the room escaped. However, a captain was overcome by the flash fire and died.

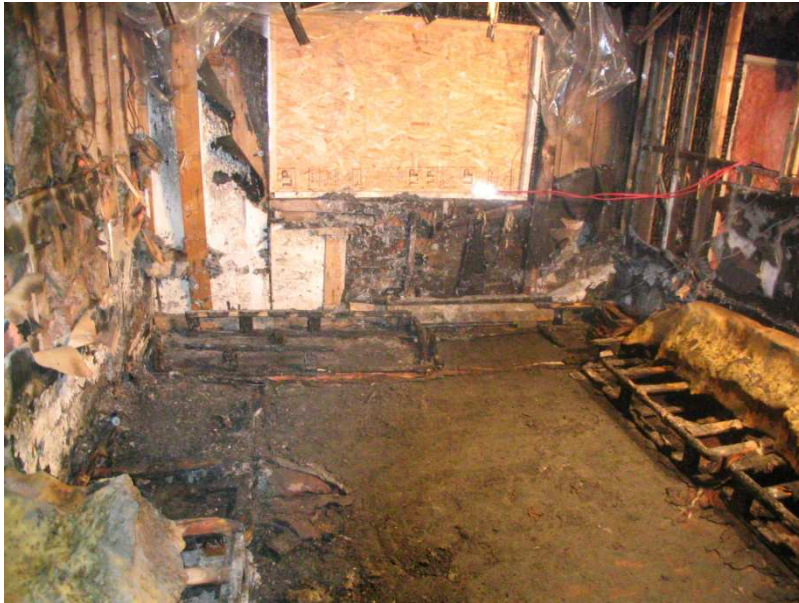
Cause of Fire

- The fire investigation concluded the fire was caused by a faulty baseboard heater from which the safety systems had been removed.
- The heater was in close contact with a Moroccan style sofa that consisted of a 1650 mm long, 395 mm high and 700 mm deep piece of polyurethane foam covered with a cotton textile material.
- The foam seat was mounted on a 89 mm high wood frame covered with the same textile material.

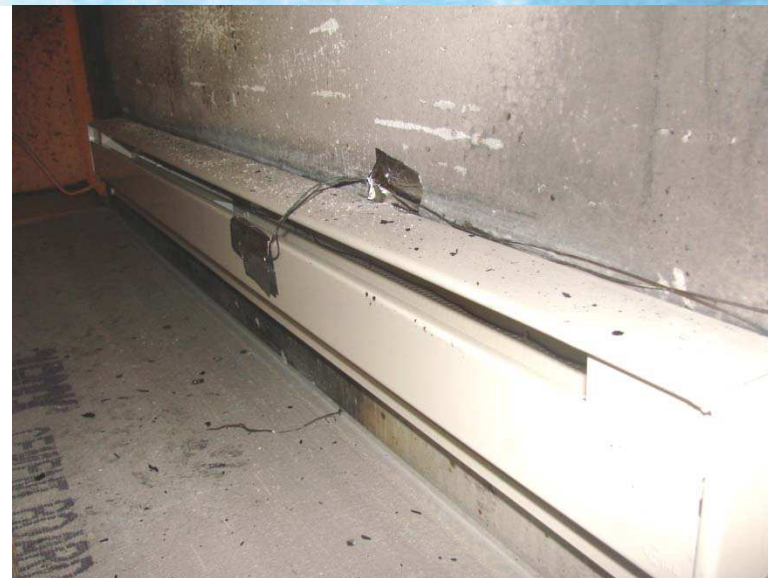
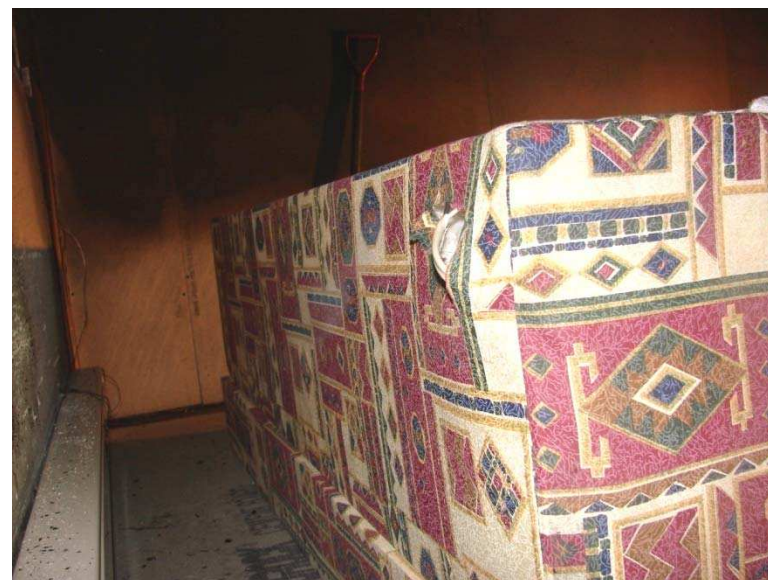
Fire Scenario - Smoldering Fire

- Scenario for full-scale experiments:
 - Sofa allowed to smolder for approximately two hours.
 - Methane used to produce upper flammable layer.
 - Methane layer and sofa ignited using a heated coils.
- Three experiments:
 - Test 1 – Methane ignited in room of fire origin + single sofa;
 - Test 2 – Single sofa fire;
 - Test 3 – Methane ignited in room of fire origin and propagated into entryway/kitchen + 4 sofas ignited.

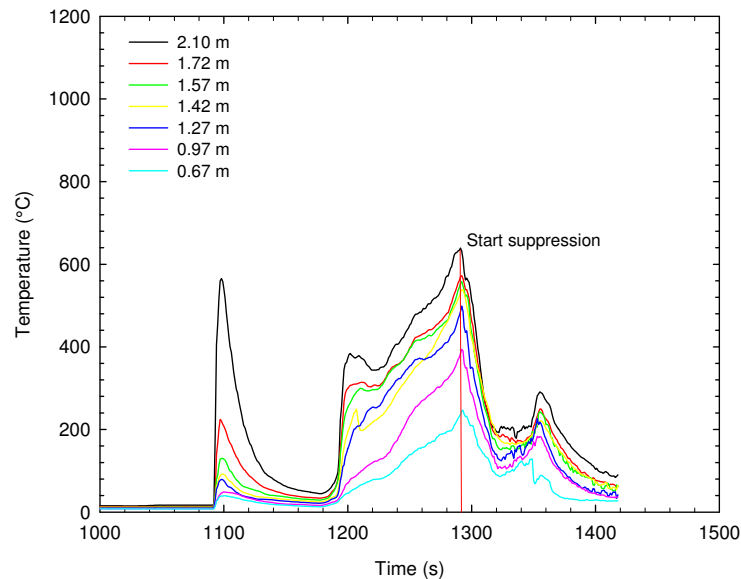
Test 1

Temperatures - Fire Compartment

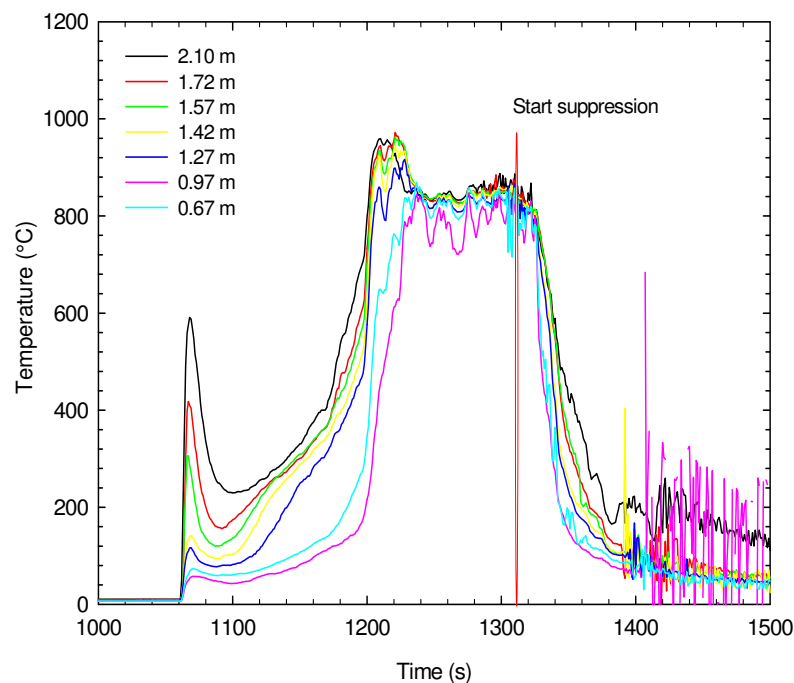
Results Suppression

- Temperatures in room of fire origin reduced to $< 200^{\circ}\text{C}$ in < 60 s.
- Temperatures reduced to $< 100^{\circ}\text{C}$ in < 100 s.
- Fire in room of origin could be suppressed swiftly and safely by applying water from main entrance door to apartment.

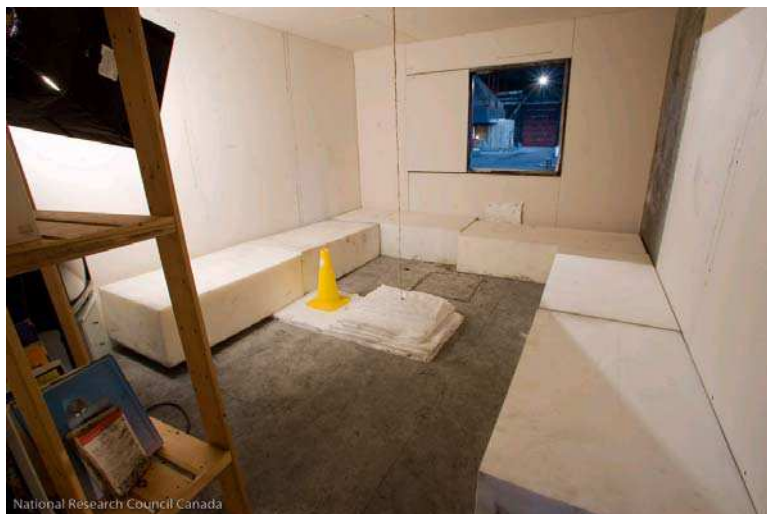
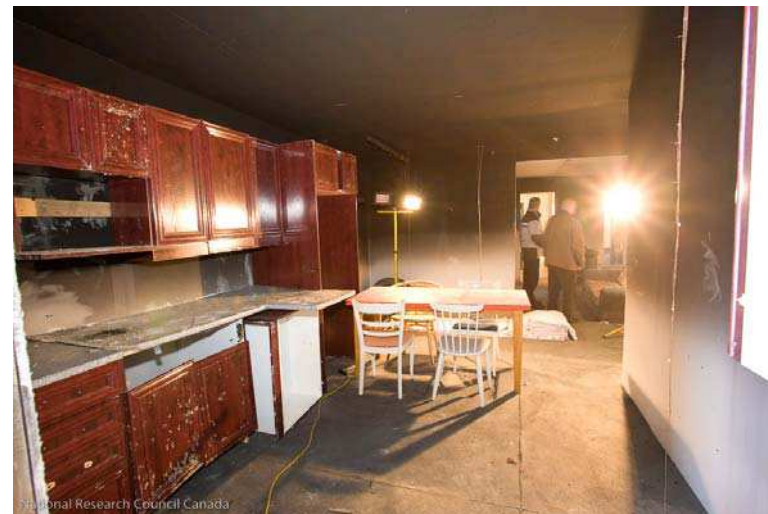
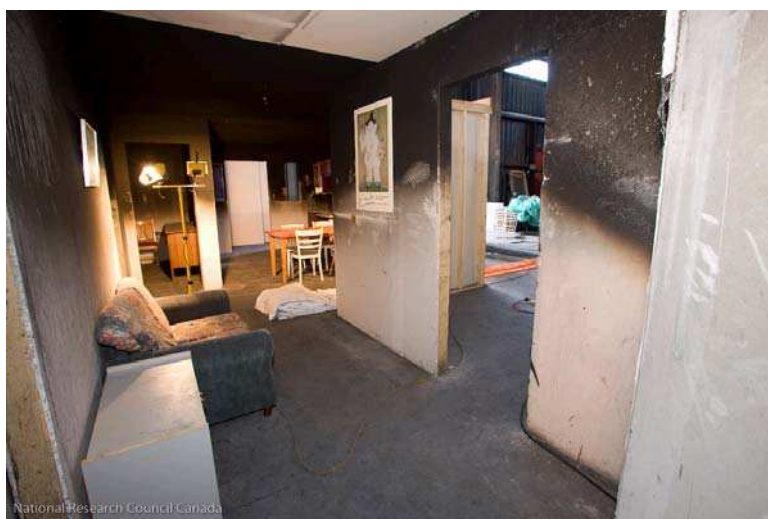
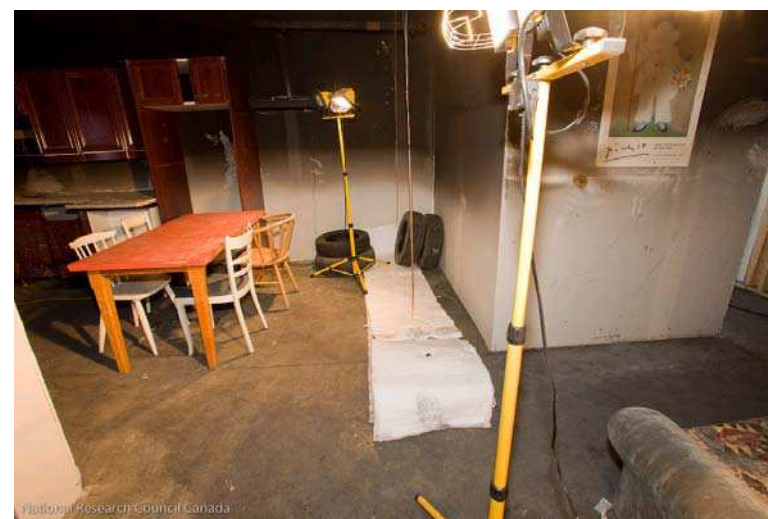
Fire Compartment and Kitchen

- First 3 experiments focused on early stage of fire.
- Fourth and fifth experiments conducted to investigate conditions in kitchen with extended fire.

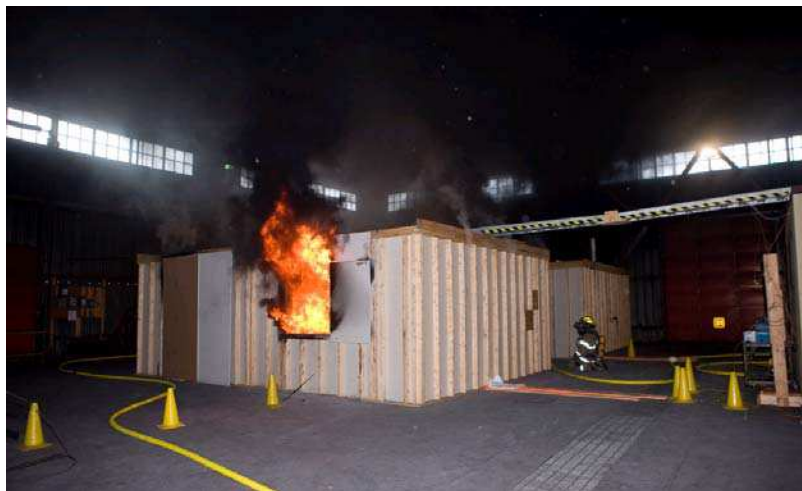
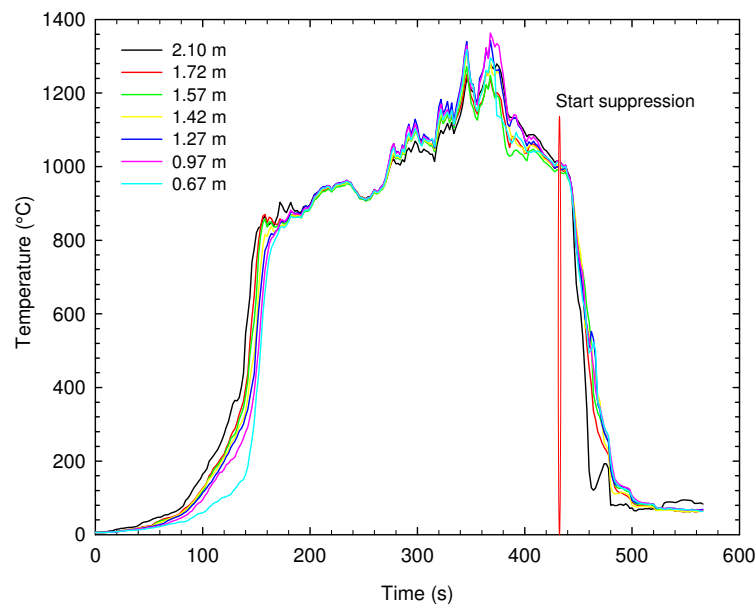
Results Experiment 4

- Propane T-burner used to ignite foam.
- Rapid fire growth.
- Initial temperatures approximately 900°C.
- Increased temperatures in later stages.

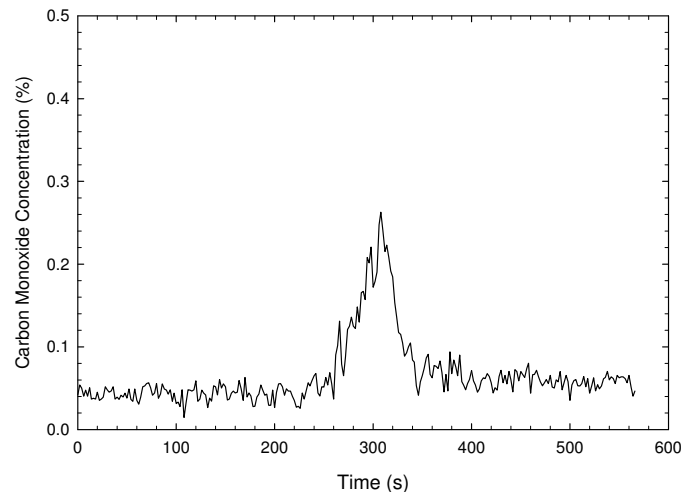
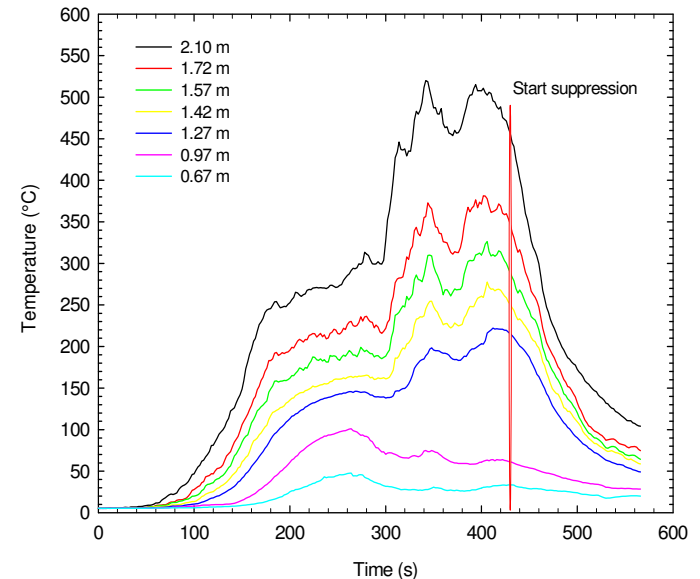
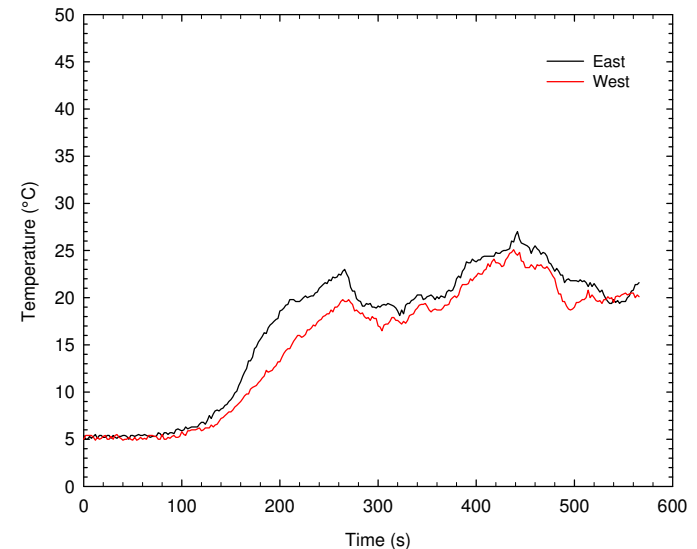
Results Experiment 4

- Fire did not propagate into entryway.
- Maximum temperatures in kitchen approximately 500°C.
- Minimal temperature and CO increase at floor level.

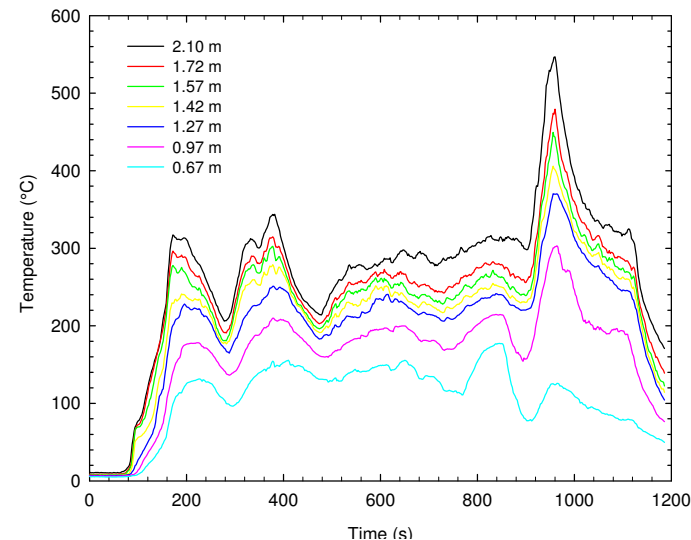
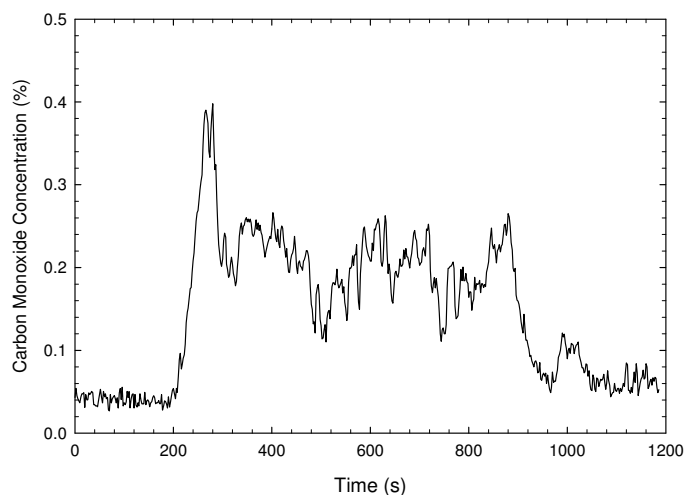
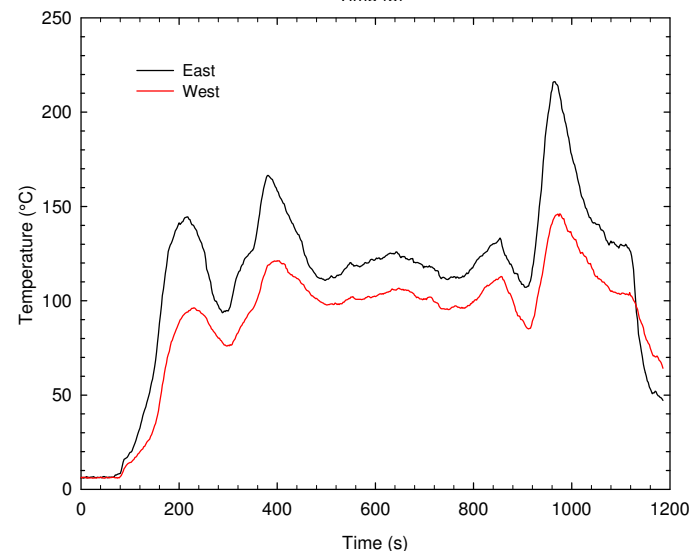
Experiment 5

- Single sofa in fire compartment. Same fuel load as experiment 4 in all other rooms.
- Sofa entryway sprayed with accelerant and ignited with propane torch. Sofa fire compartment ignited with propane burner.
