Design and performance of the Inuvik, N.W.T., airstrip

G.H. JOHNSTON

Geotechnical Section, Division of Building Research, National Research Council of Canada, Ottawa, Ontario, Canada K1A 0R6

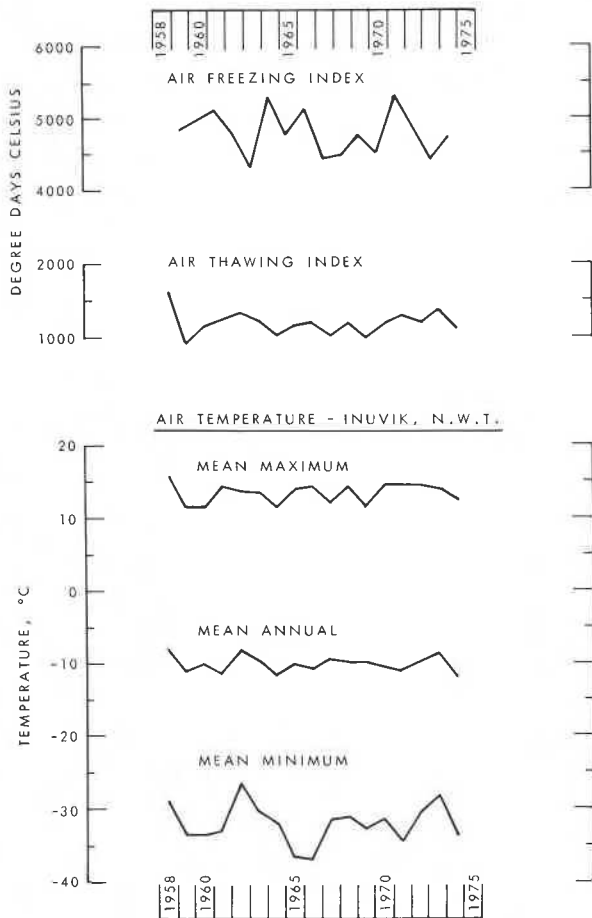
FIGURE 2. Inuvik air temperatures and freezing and thawing indices, 1958-74.

Average values of the air freezing and thawing indices for Aklavik during the period 1949 to 1959 are 4460 and 1255 degree days Celsius (DDC) respectively (Thompson 1966). Average values of the air freezing and thawing indices at Inuvik for the period 1958 to 1974 are 4825 and 1190 DDC, respectively. Annual maximum, minimum, and mean air temperatures and annual air thawing and freezing indices for Inuvik are provided for the same period (Figure 2).

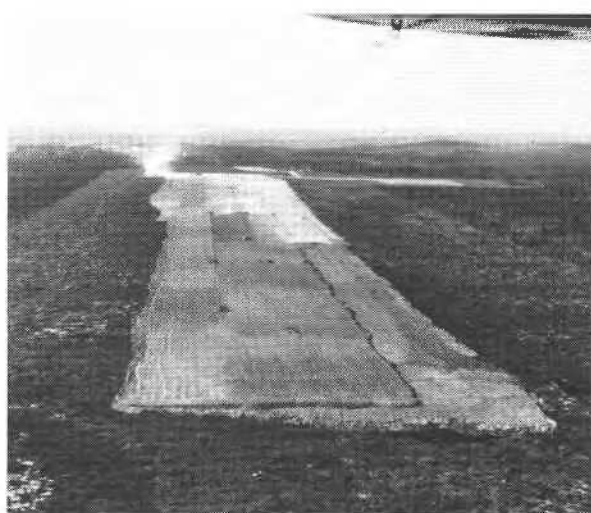
FIGURE 3. Air view to west of runway under construction, August 1957. Note small lake in foreground being back-filled; shadings on runway indicate different types of rock fill (shale, dolomite, quartzite) from quarry in distant background.

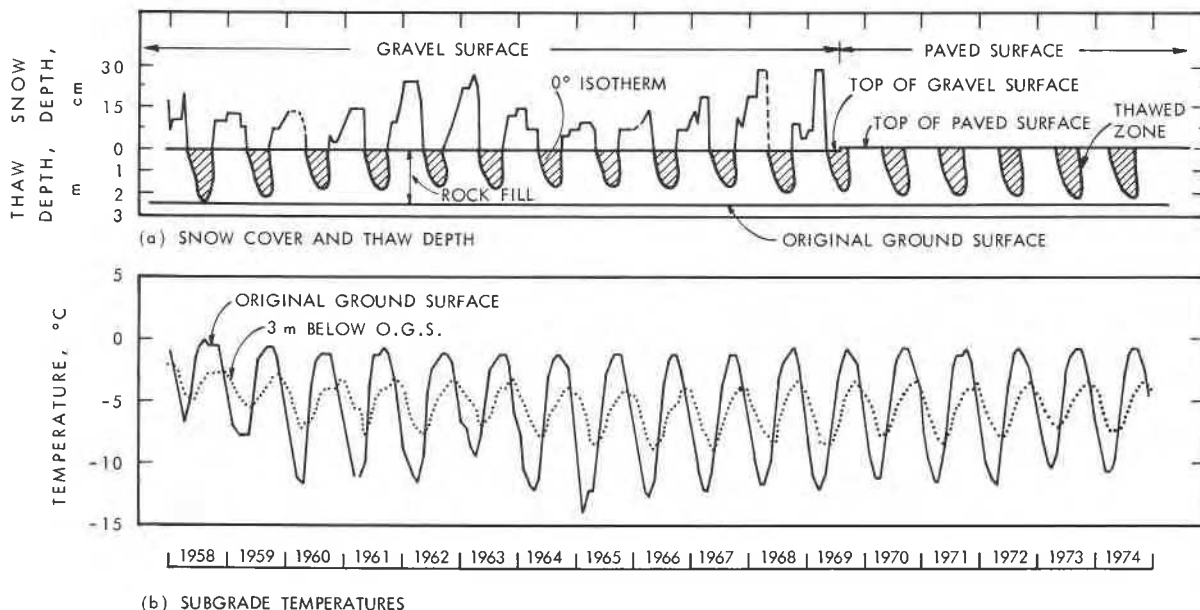
FIGURE 5. Snow cover, thaw depth, and subgrade temperatures — runway centre-line, west end, Inuvik airstrip.

The annual thaw pattern and variation in subgrade temperatures at two depths on the runway centre-line at the west end for the period 1958 to 1974 are shown in Figure 5. Also shown is the depth of compacted snow on the runway in the years prior to paving in 1969. The embankment at this location was about 2.5 m thick, the minimum permitted for the airfield. Similar plots (not shown) were obtained for the apron and east-end runway centre-line sites. The maximum thaw depths were determined each year from temperature measurements at the apron and all runway sites (Figure 6). Ground temperature envelopes show the average maximum, minimum, and mean temperatures for the ten-year period before, and the five-year period after, paving at each of the sites (Figure 7).
