# Canadian Building Digest

**CBD 143**

## Landslides in Clays

*W. J. Eden*

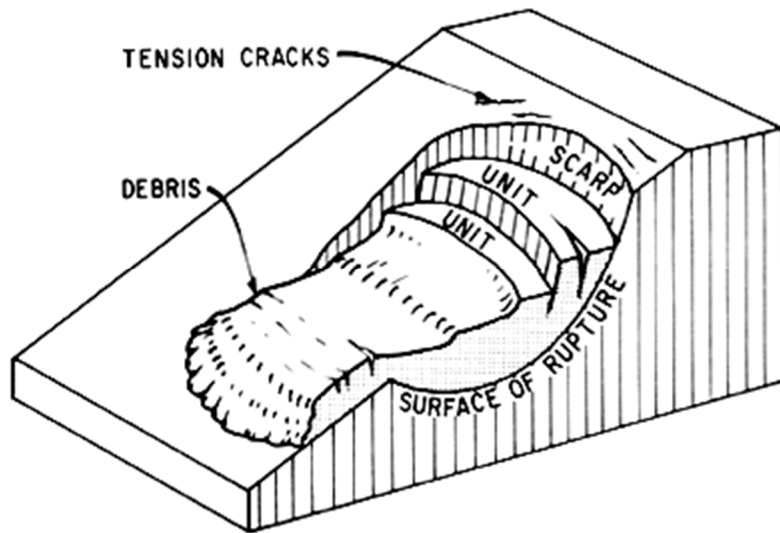
The term landslide denotes downward and outward movement of slope materials composed of natural or deposited soils. Figure 1 illustrates the main features of a landslide; the diagram indicates a very definite surface of rupture along which the material involved in the landslide moves over undisturbed material. The diagram also indicates that the surface of rupture extends to a considerable depth so that a landslide cannot be considered a surface phenomenon.

*Figure 1. Illustration of a Landslide*

In the early 19th century Alexandre Collin, a French engineer engaged in canal construction, noted that the failure surfaces formed by landslides in clay along canal banks followed a curved form like that illustrated in Figure 1. In 1846 he published a memoir in which he proposed a statical method of analysis based on a curved surface and measured shear strength of the soils. Since that time various analyses have been proposed, resulting finally in the slip circle method developed by Swedish harbour engineers that forms the basis of techniques in current use. The essentials of the method are illustrated in Figure 2, in which a failure surface in the form of a circular arc is assumed. Disturbing forces are compared with resisting forces to obtain a factor of safety for each assumed failure surface. Several trials are necessary before the most critical circle for a given slope can be located. Digital computers are specially useful in this process and are widely used. In some cases the structural geology requires stability analyses based on a combination of curved and plane failure surfaces. Information required for the stability analyses falls under three broad headings:

The second point concerns the behaviour of the fine grained soils when they are involved in an earth movement. They may lose a significant portion of their strength upon remoulding. The degree of loss is termed sensitivity, with high sensitivities denoting a great loss in strength. Referring to Figure 1, the debris of a landslide in highly sensitive soils may not remain at the foot of the slope but spread out and move away from the slope. At St. Jean Vianney the extremely sensitive soil liquefied completely and more than six million cubic yards flowed down a stream course to the Saguenay River. Hence fine grained soils which are sensitive to remoulding need special attention with regard to slope stability.

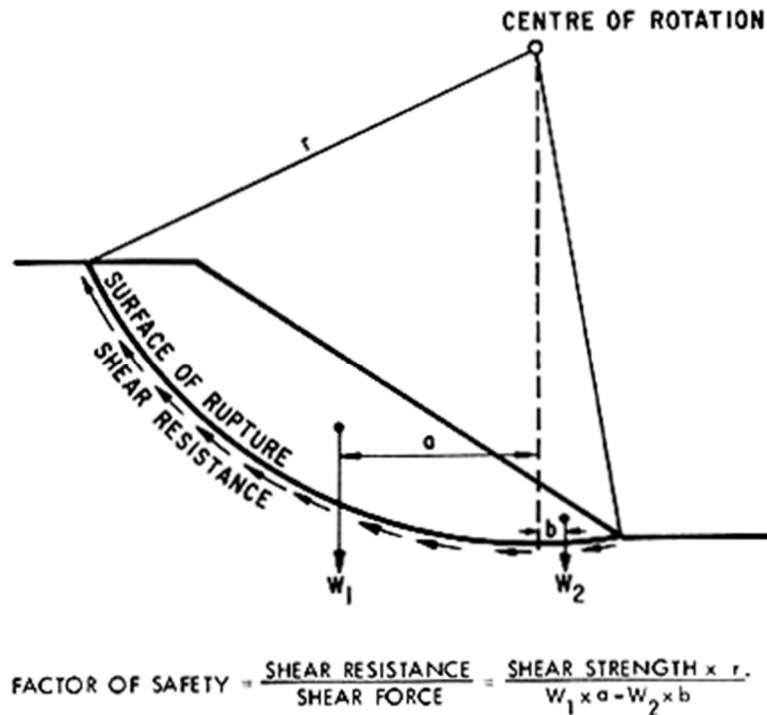
Figure 2. Stability analysis of slopes.

If it should become necessary to conduct earth works near a slope, such work should always be directed towards improving the stability moments, as shown in Figure 2. Weight added to the foot of the slope increases the stabilizing forces, as does material removed from the crest. In dealing with a natural bank, it is specially important not to excavate material from the foot of the slope; and in placing fills or berms at the foot of the slope the materials used should be free draining so that the level of the groundwater table is not raised.

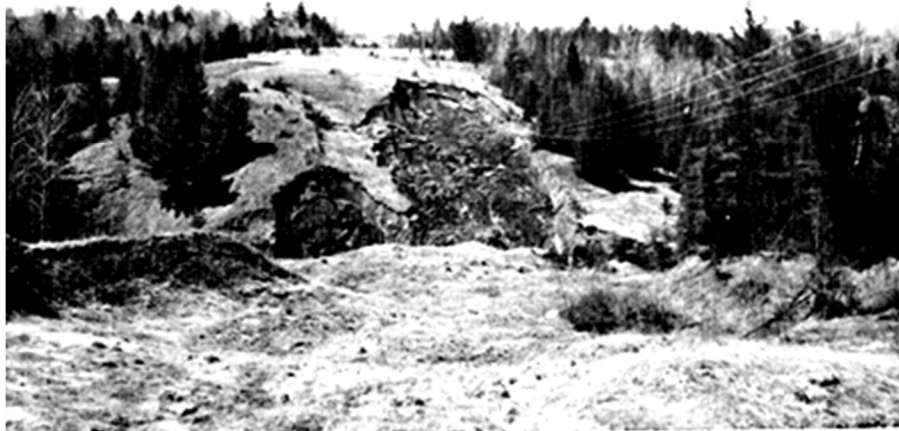
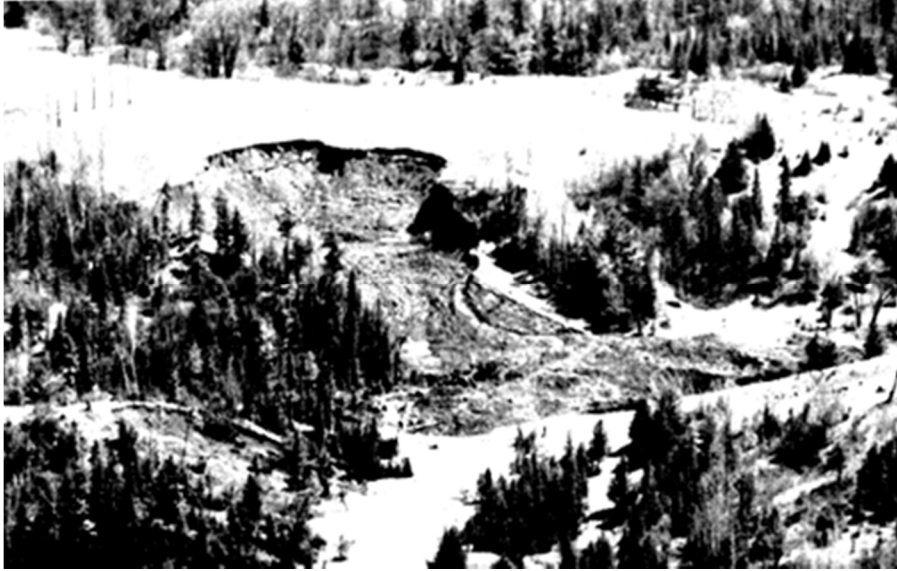
Figure 3. Landslides on Breckenridge Creek.  
 (a) View of two small landslides that occurred in spring of 1969.  
 (b) Aerial view of earthflow involving 30 000 cubic yards of clay that occurred on opposite bank in April 1963.
