Proceedings of the 9th International Conference on Offshore Mechanics and Arctic Engineering (OMAE '90), 4, pp. 161-167, 1990

CROWD INDUCED DEFLECTION OF DOW'S LAKE ICE COVER DURING WINTERLUDE FESTIVAL — 1985

N. K. Sinha

National Research Council of Canada
Ottawa, Ontario, Canada

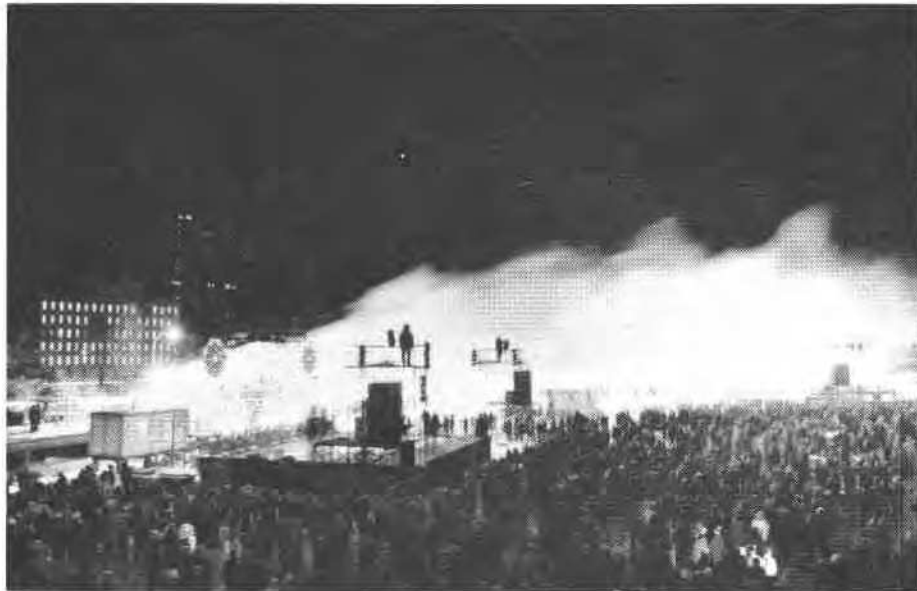
Figure 1 Crowd on Dow's Lake ice cover during the Winterlude opening night ceremony, Feb. 1, 1985 (Courtesy of Ottawa Citizen)

It was the largest crowd ever on the ice cover of Dow's Lake for the opening night ceremony of the ten-day long annual winter festival in Ottawa called "Winterlude". It was a family night - babies were snugly wrapped up in sleighs; children skating hand-in-hand with their brothers, sisters, friends, parents and grandparents. They danced around the 101 snow sculptures and clapped in rhythm to the tunes coming from huge and powerful speakers beside the two grandstands (Fig. 1) built on the ice cover - and the ice cover responded in harmony with the mass motion.

scaffolding could provide the necessary protection from the crowd. These two positions were designated as the measuring stations 1 and 2 as indicated in Fig. 2. The tower associated with Station 1 can be seen on the right hand side in Fig. 1.

The attraction was diverted to Stage 2 at 8:52 p.m., when a fake 'Michael Jackson' appeared and started "lip syncing" and dancing, with the associated blinding lights and deafening music, "Thriller". For six minutes the crowd depressed that ice zone while elevating the area near Station 1. Fireworks started at 9:30 and for 20 minutes the display of lights, colours and explosion of fireworks froze the crowd to wherever they stood as can be seen in Fig. 1.

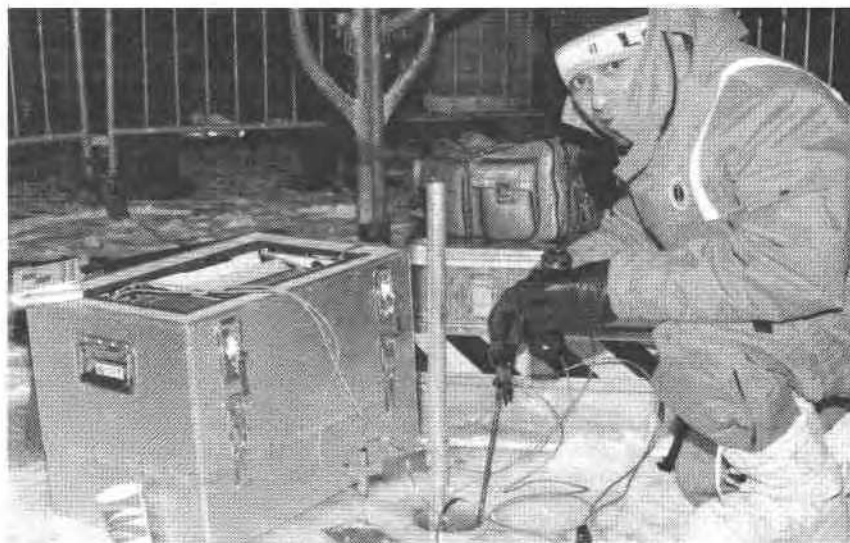
Figure 5

Ice deflection gauge after installation

An ice core, 76 mm in diameter, was taken from the central area at Station 1 for laboratory analysis of its structure at a later date. The ice thickness was 0.62 m and water depth below the ice was 1.55 m. The hole in the ice was used to install the deflection gauge (Fig. 5). The strain gauge, with a gauge length of 150 mm, was installed by freezing it onto the ice surface at a distance of 1 m from the hole, to avoid any localized deformation around the hole. Water and ice surface temperatures were measured with a thermistor probe.

At 6:30 pm the measuring system was fully operational and the surveyors were ready. Only half a dozen skaters were on the ice at that time so the initial no load readings were taken. The freeboard of the ice cover (depth of water level below the ice surface) was 0.06 m. There was a breeze 6-7 km/hr at an azimuth of 270° to 310° (Fig. 2), the air temperature was about -6°C and the ice surface and water temperatures were -3.5°C and 0.6°C, respectively. About a litre of kerosene was poured in the hole in the hope of preventing icing so that the reference metal tube would remain completely free from the ice sheet. However, in the later part of the evening icing occurred below the kerosene layer and it was necessary to break the ice from time to time as can be seen in Fig. 5; the photograph was taken at about 9 p.m.

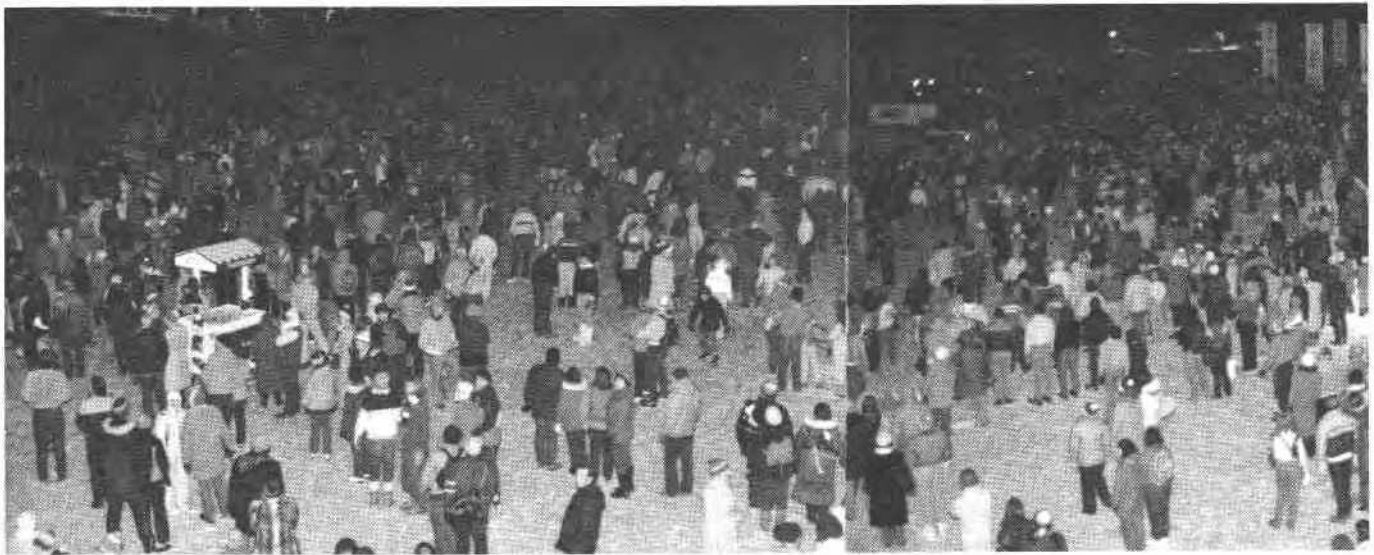
Figure 9 A small portion of the crowd on the ice cover during the fireworks display

where P is the average mass of a person. If it is assumed further that $P = 70$ kg, then a displacement of 40 mm gives a crowd density $N = 0.57 \text{ m}^{-2}$ or a crowd of 17,500 at the entertainment square of 100 m x 100 m. This estimation is on the high side because of the neglect of local depression. A person experienced in crowd control estimated the crowd to be about 10,000 in that area. Some justification for this estimation also comes from a series of photographs of the crowd taken from the top of the tower at the station 1. One of these photographs is shown in Fig. 9.
