### **Recent failures point out importance of snow loads on roofs**

Thorburn, H. J.; Schriever, W. R.

TECHNICAL PAPER NO. 71 OF THE DIVISION OF BUILDING RESEARCH  
OTTAWA  
JUNE 1959

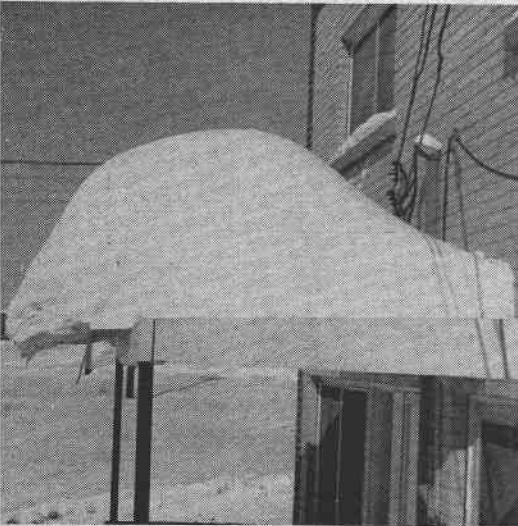
**NOTE DEFLECTION** of members between columns. This is a snow load of approximately 40 lbs. per sq. ft. on an entrance canopy.

**Another example is** the accumulation frequently found on porch roofs or entrance canopies situated at a lower level than the main roof.

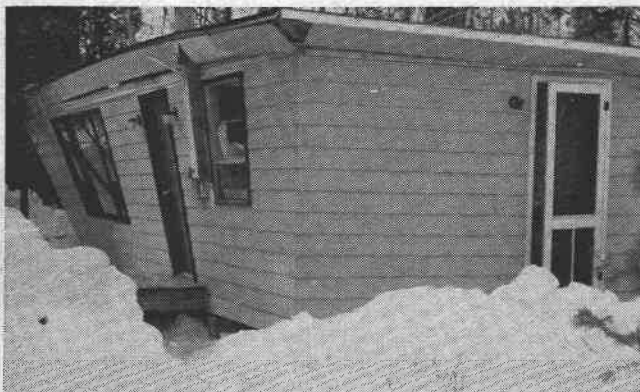
**A COTTAGE THAT FAILED** under a snow load of approximately 30 lbs. per sq. ft. because of poor ties.

A recent investigation by the Division of Building Research indicated that the majority of the summer cottage failures in the snow belt could be attributed to poor or inadequate construction.

The snow loads under which these cottages failed were substantial. They ranged between 25 and 40 pounds per square foot. But they were below the 60-70 pound per square foot load specified by the NBC.

The most frequent structural defect contributing to the failure of these cottages was the lack or weakness of ties (ceiling joists or collar ties) between the walls. Weakness of ties was generally the result of poor or insufficient nailing.

Such failures should and can be avoided by designing and constructing for proper snow loads.
