## **Fire Resistance Tests of Square Hollow Steel Columns Filled with Reinforced Concrete**

by J. Myllymäki, T.T. Lie and M. Chabot

Internal Report No. 673

Date of issue: December 1994

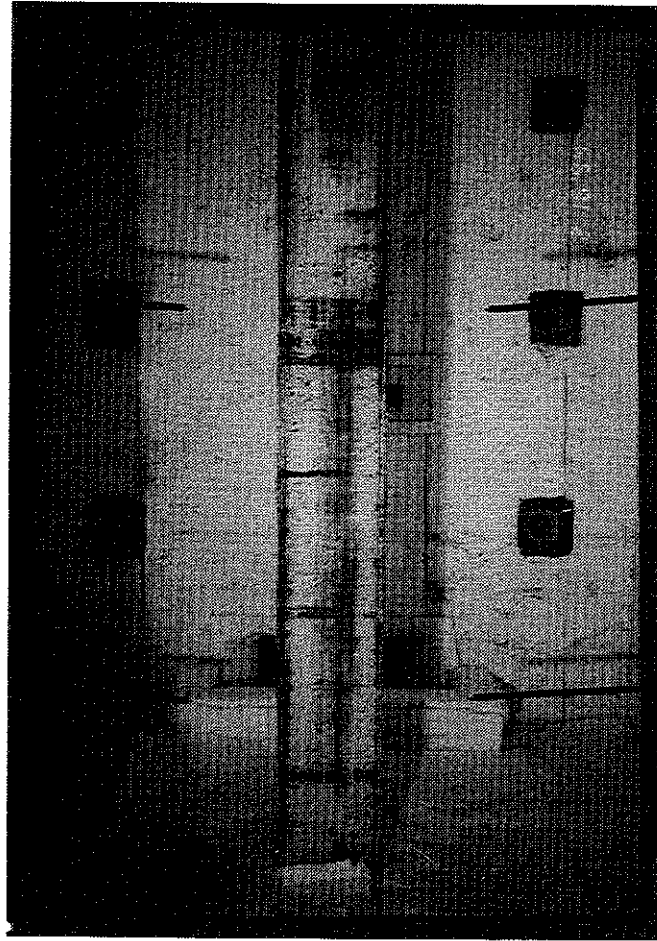
Figure 11  
Column No. 1 after test

At 14 minutes, expansion of the paint on the north side of the deflection meter was noticed. This was followed by bulging of the steel at this location. At 20 minutes, bulging occurred about mid-height on the east side. At 58 minutes, the column failed (Figure 11) due to buckling, resulting from the eccentric load at the maximum stroke, and the test was terminated. An examination of the post-test column was carried out by cutting the steel at several locations and no spalling was noticed. Temperature readings from a few thermocouples could not be recorded due to damage caused to the thermocouples while repairing and also due to some instrumentation problems.

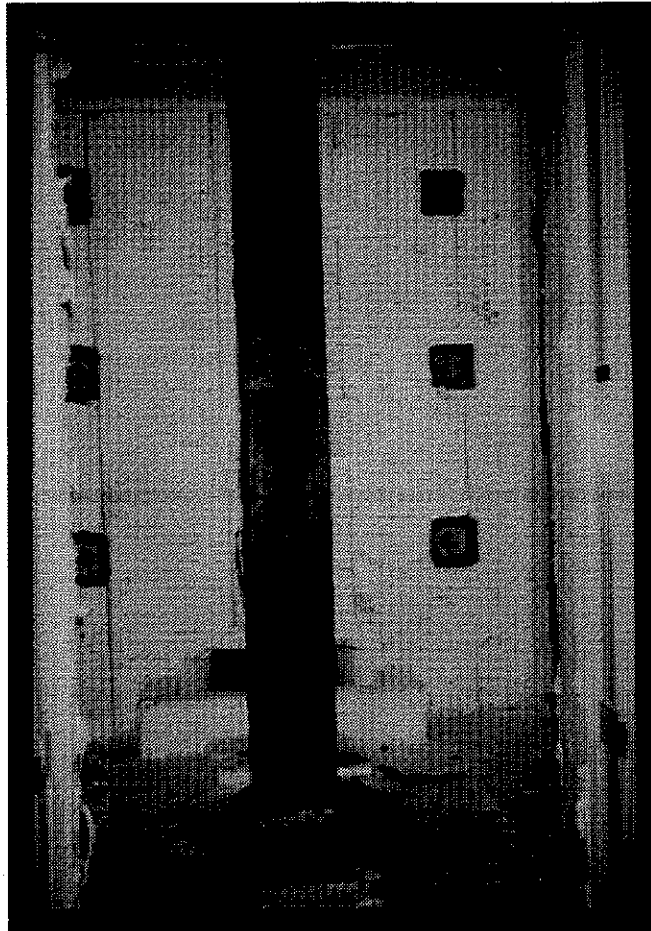
Figure 12  
Column No. 2 after test

A bang was heard at 54 minutes and the top displacement meter had to be reset. The deformation curve indicated that the connection between the eccentrically loaded arm and the column reinforcement was lost. This might have damaged thermocouple no. 20. At 126 minutes, the test was terminated once the maximum stroke of the axial load was reached. Column failure was through buckling. Figure 12 shows the view of the column after the test.
