Small-scale and intermediate-scale fire tests of flooring materials and floor assemblies for the fire performance of houses project

Research Report (National Research Council of Canada. Institute for Research in Construction); no. RR-211, 2007-10-31

Small-Scale and Intermediate-Scale Fire Tests of Flooring Materials and Floor Assemblies for the Fire Performance of Houses Project

IRC-RR-211

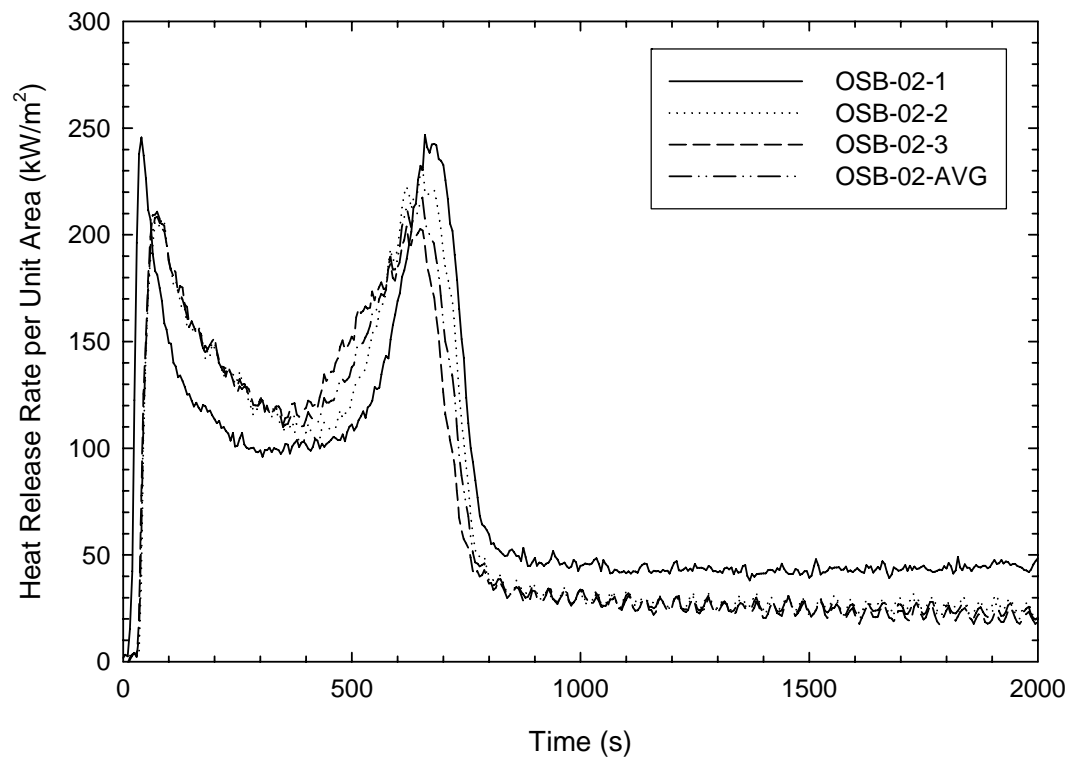
Figure A3. Heat release rate for OSB-02.

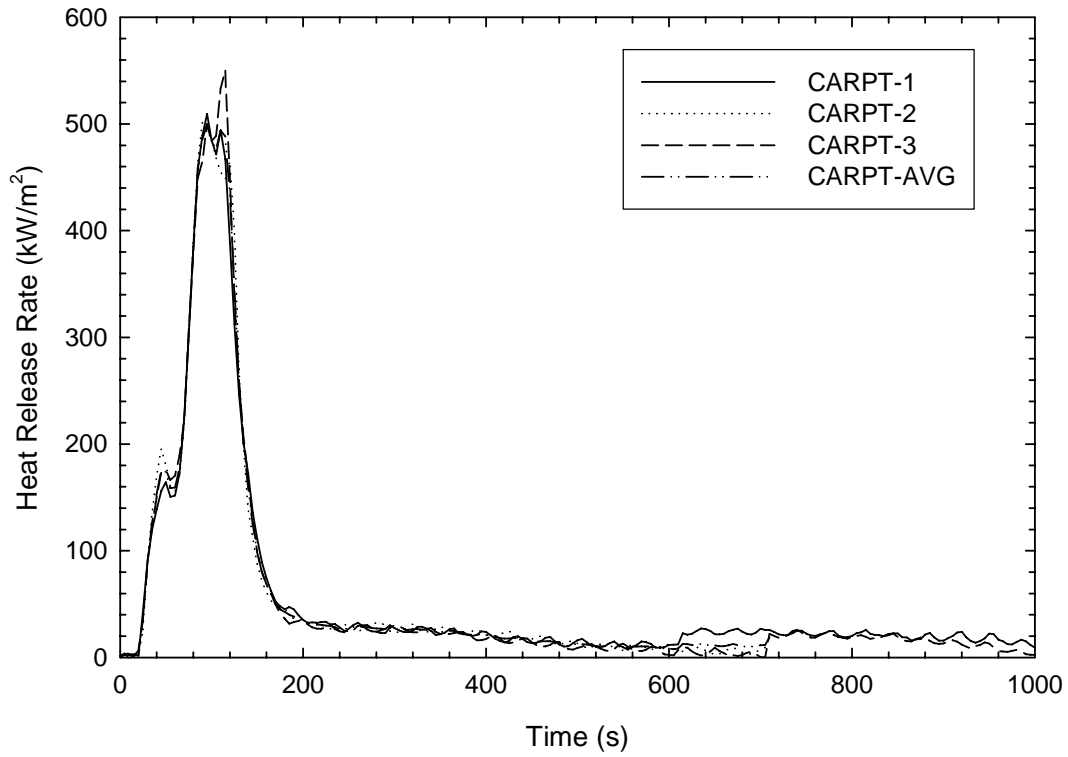
Figure B5. Heat release rate for carpet.

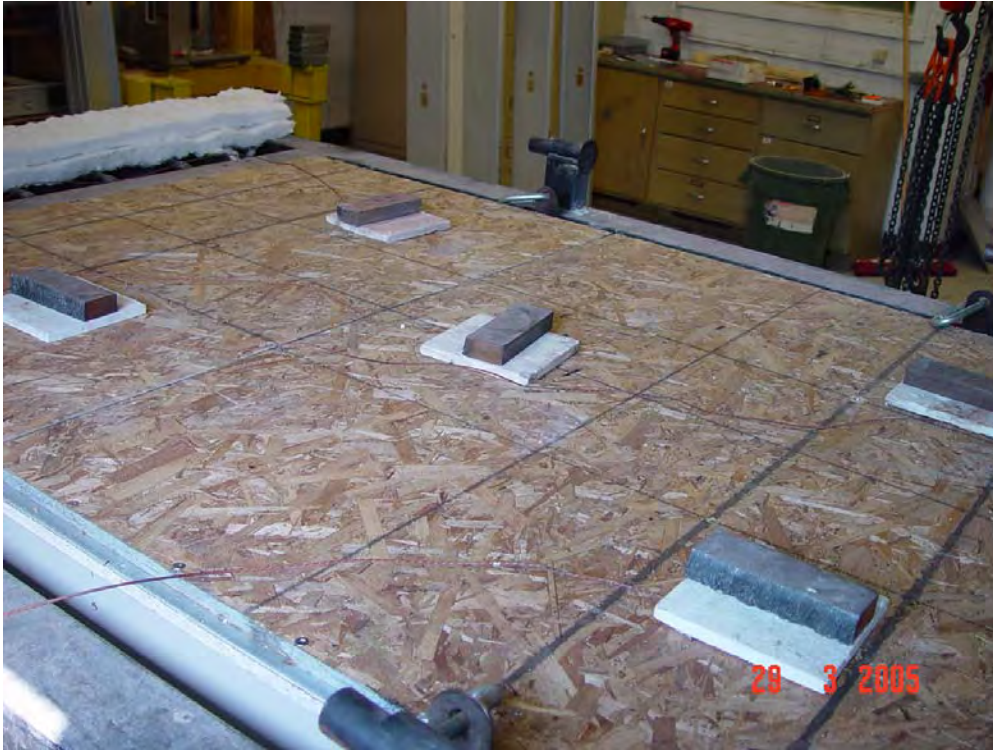
Figure C12. Typical floor assembly with tongue and groove joint (Test OSB-01A).

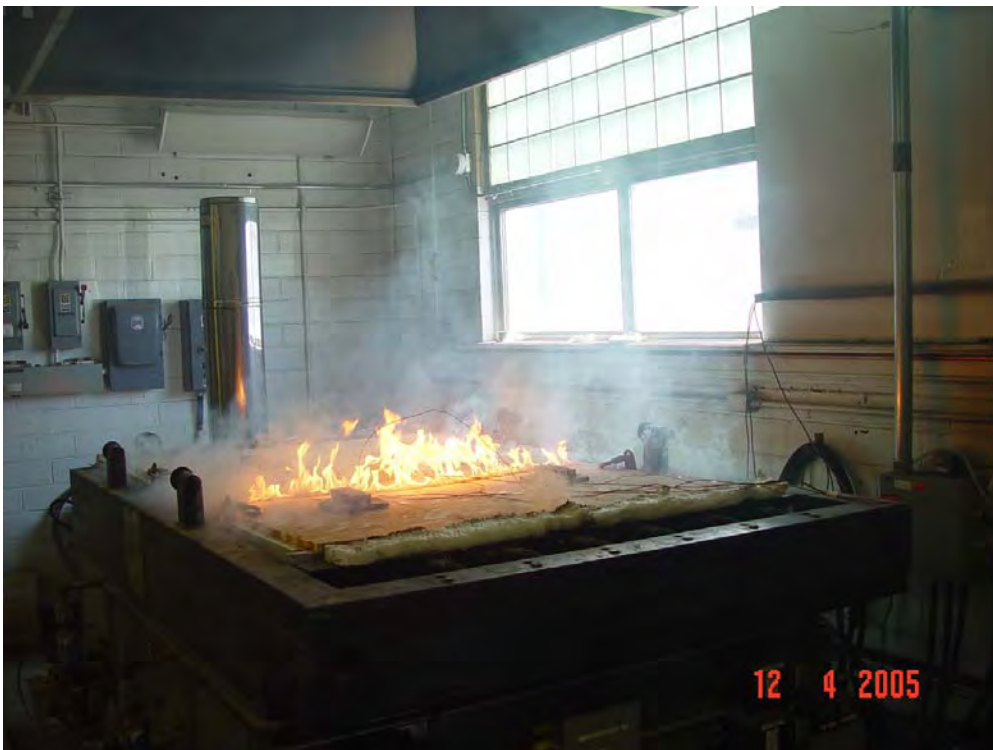
Figure C13. Flame penetration through tongue and groove joint (Test OSB-03A).

The typical test assembly with a tongue and groove joint was constructed with the joint running across the width of the floor assembly (Figure 3). It was observed during the tests that there was separation of the two OSB panels producing an open area in the assembly through which the flames eventually penetrated the subfloor (Test OSB-03A). One possible reason for the separation of the OSB panels was the elongation of the steel joists due to thermal effects.

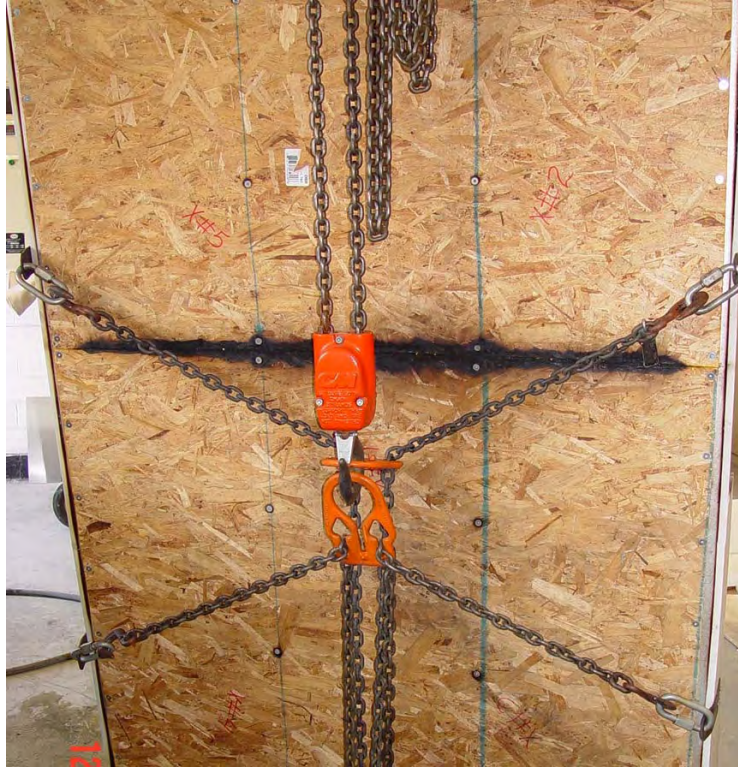
Figure C14. Damage to unexposed side of floor assembly (Test OSB-03A).

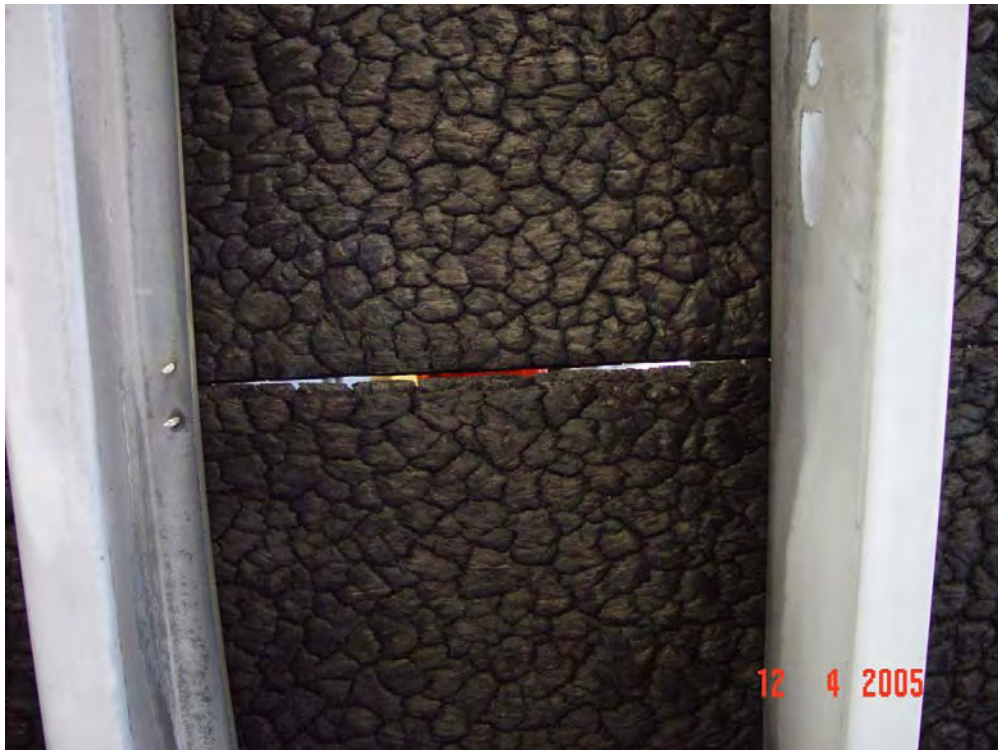
Figure C15. Damage to exposed side of floor assembly (Test OSB-03A).

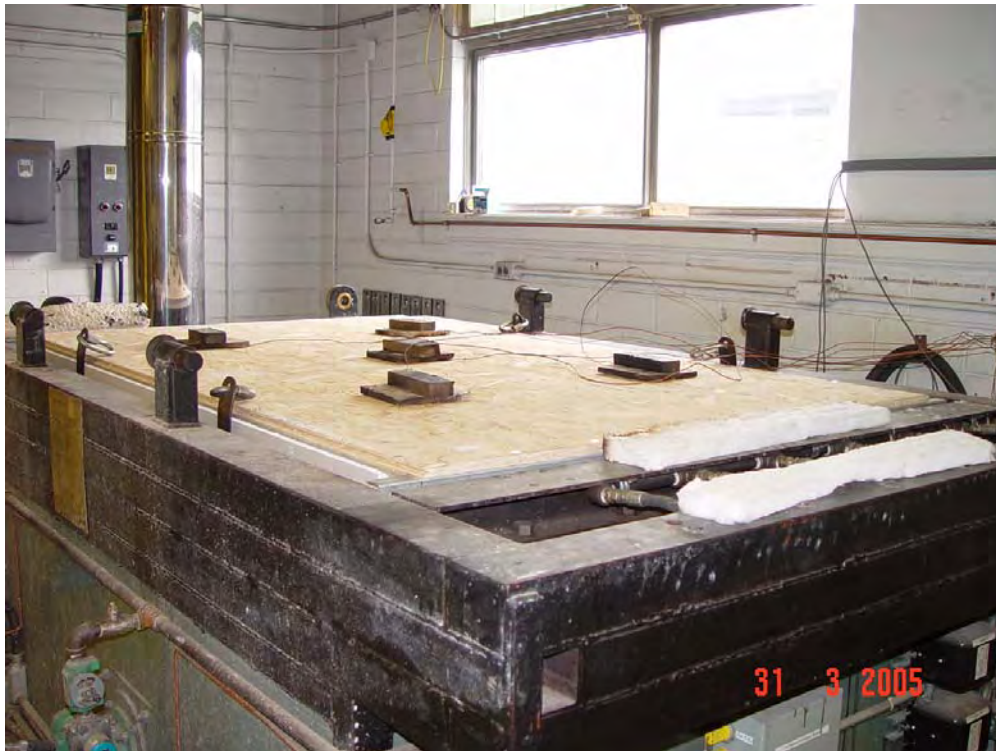
Figure C16. Typical floor assembly with full OSB panel (Test (OSB-02B)).

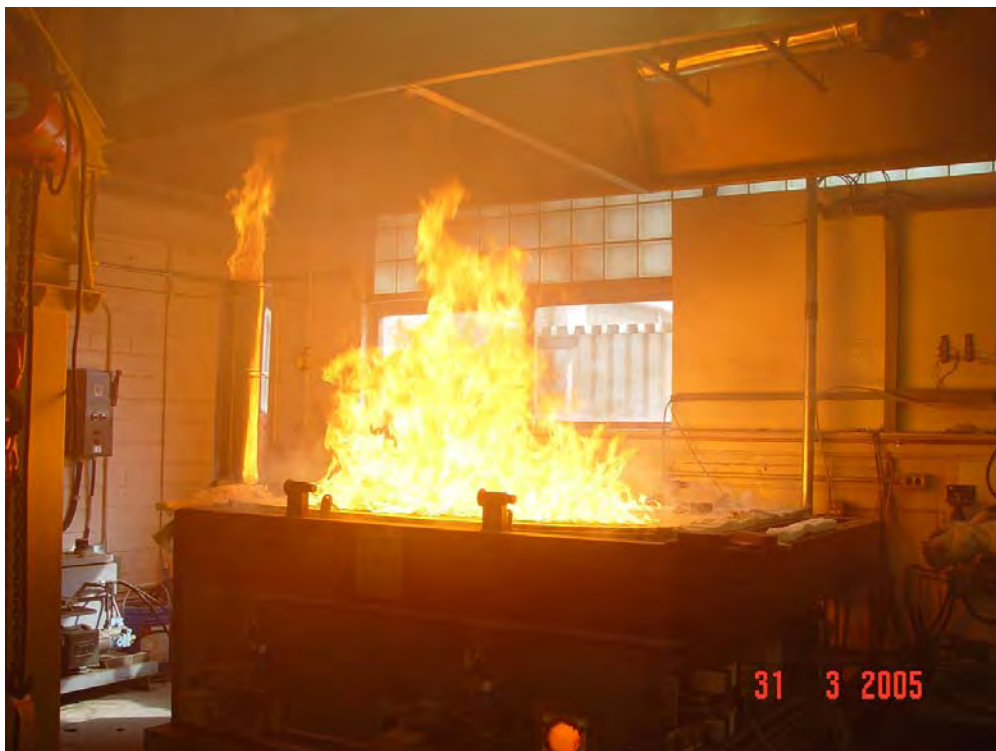
Figure C17. Flame penetration through test assembly (Test OSB-02B).

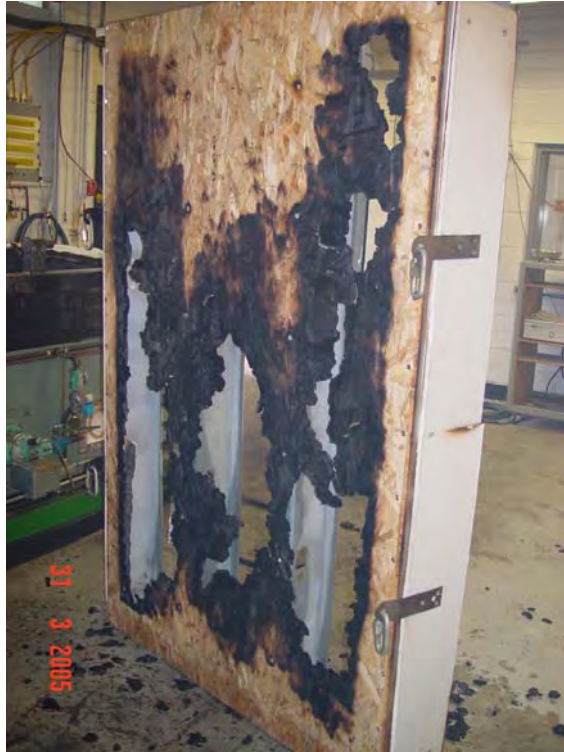
Figure C18. Damage to unexposed side of test assembly (Test OSB-02B).

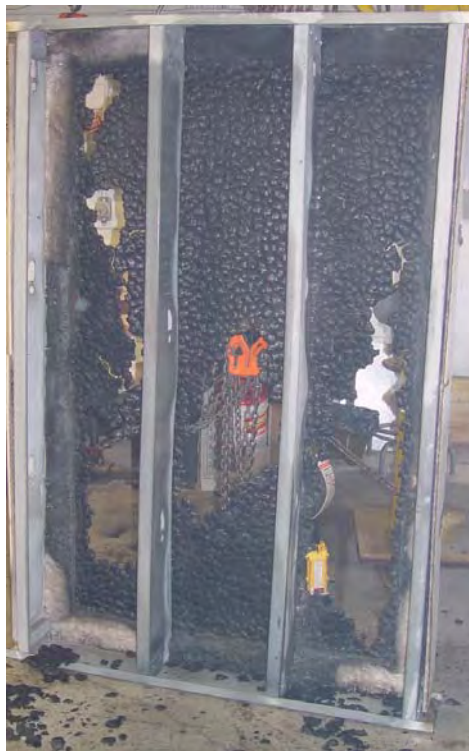
Figure C19. Damage to exposed side of test assembly (Test OSB-02B).

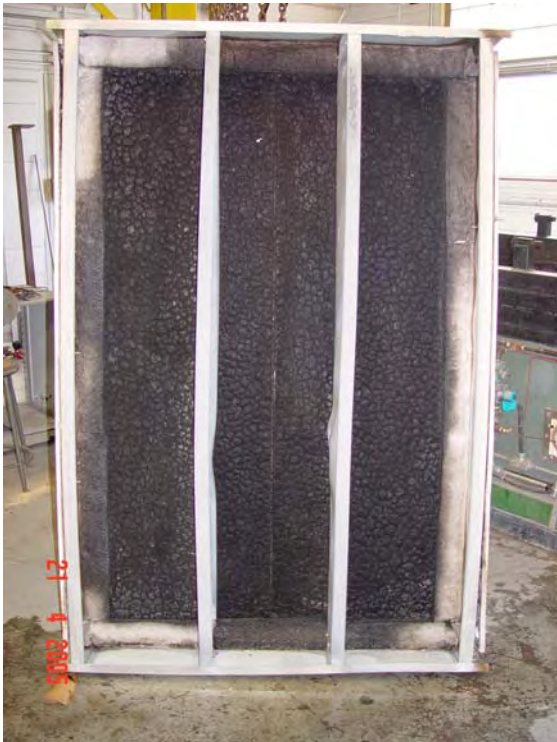
Figure D9. Flame damage Test OSB-03C.

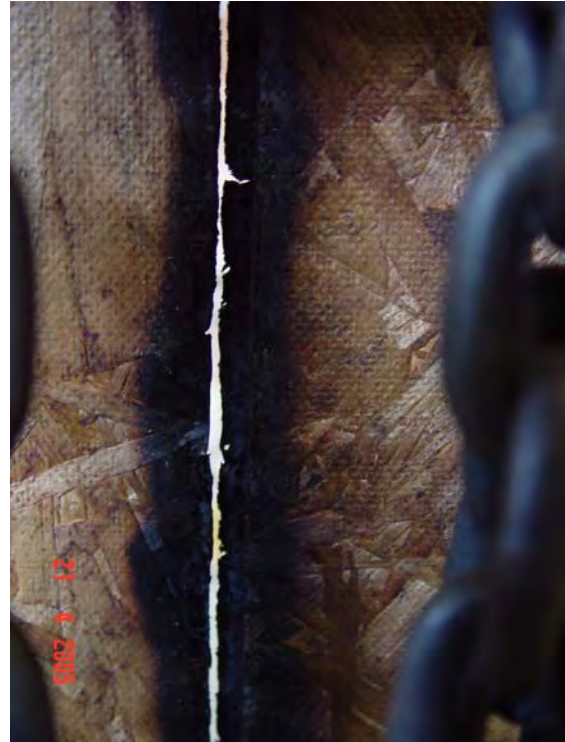
Figure D10. Damage joint Test OSB-03C.

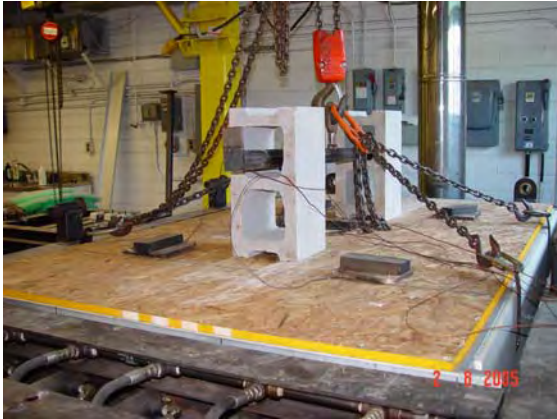
Figure D11. Test assembly Test OSB-03D.

Two concrete blocks were located on the centerline of the floor assembly for Test OSB-03D. The blocks were centered between two joists. The OSB subfloor was able to support the blocks until after the flames penetrated the OSB subfloor. However, a block did fall through shortly after flames were observed.

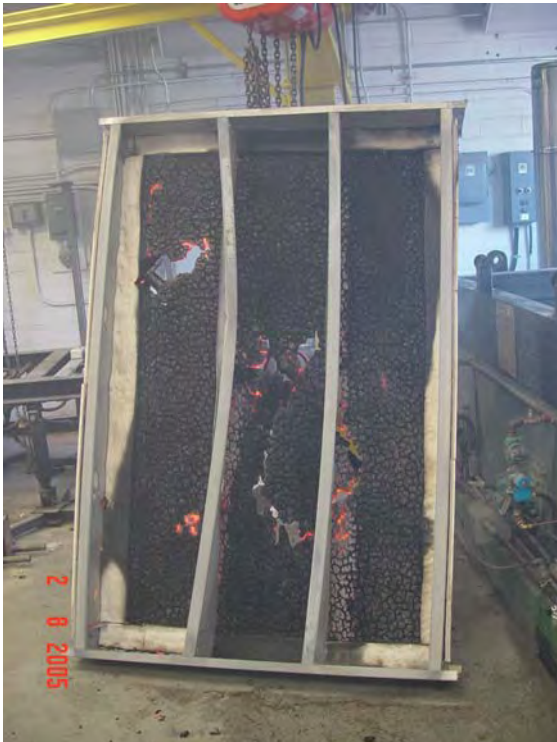
Figure D13. Damage Test OSB-03D.

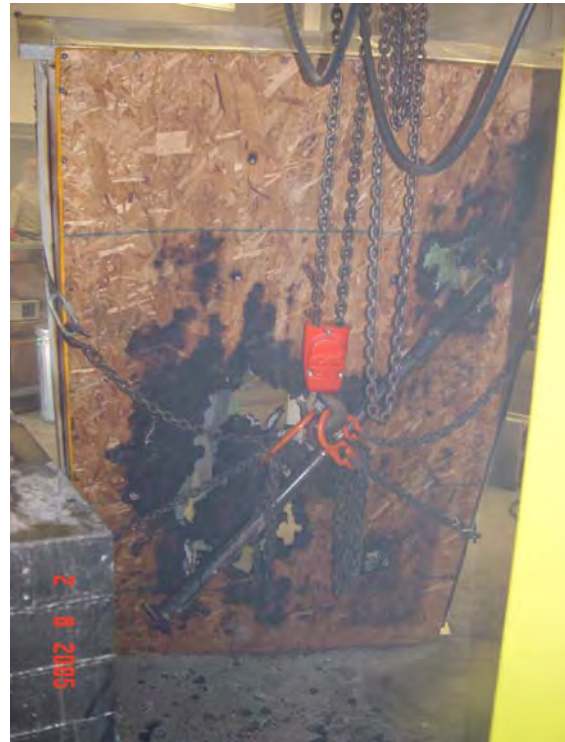
Figure D14. Damage Test OSB-03D.

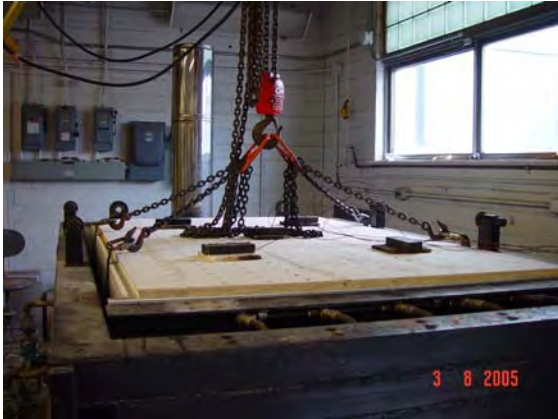
Figure D15. Test assembly Test OSB-03E.

For Test OSB-03E, a 6 mm thick poplar plywood underlay was added to the top of the floor assembly. The underlay panels were screwed to the OSB using the recommended screws and screw pattern for this application (Figure 5). The butt joint between the two underlay panels was offset from the tongue and groove joint in the OSB subfloor.

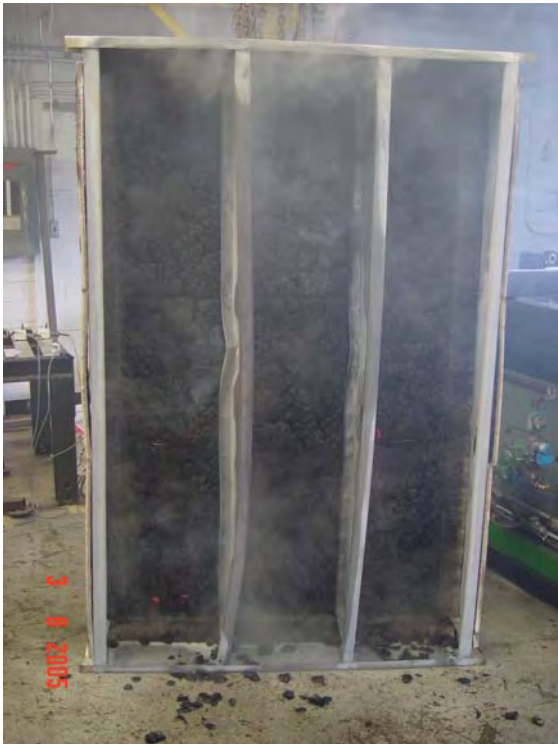
Figure D17. Damage Test OSB-03E.

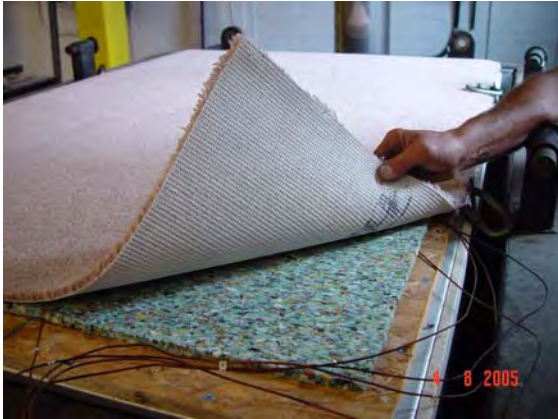
Figure D19. Test assembly Test OSB-03F.

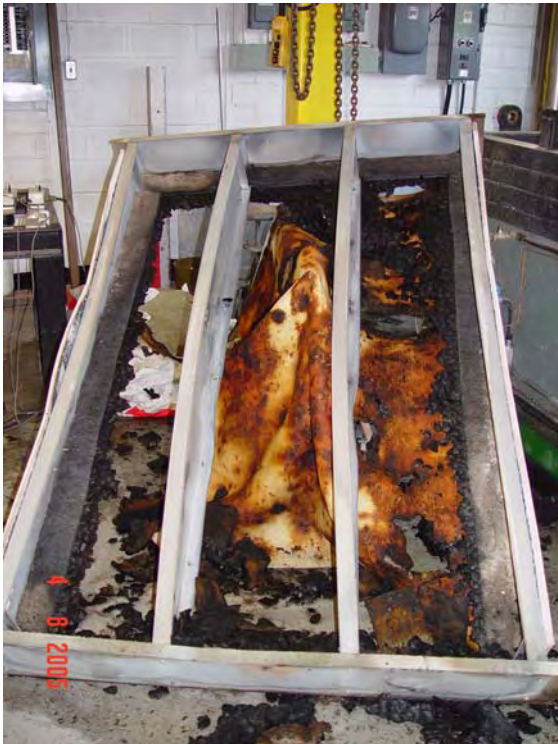
Figure D21. Damage Test OSB-03F.

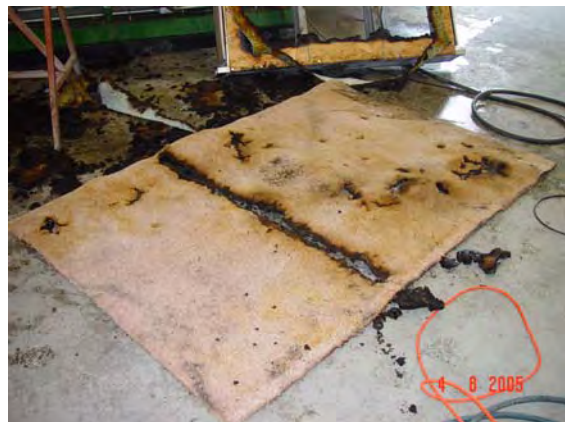
Figure D22. Damage Test OSB-03F.

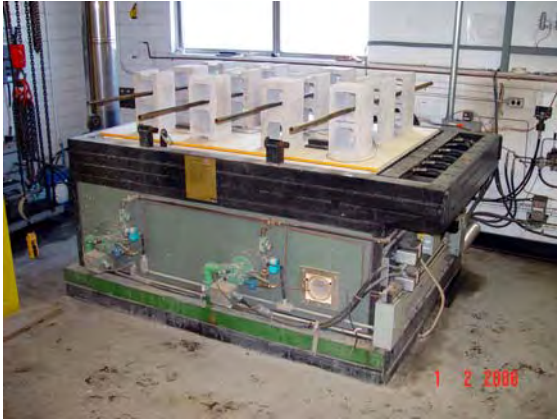
Figure D23. Test assembly Test OSB-03G.

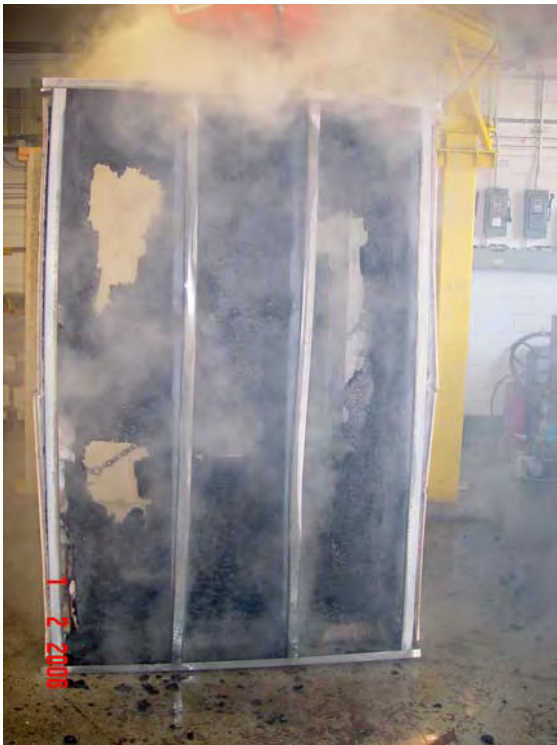
Figure D5. Flame damage Test OSB-03G.

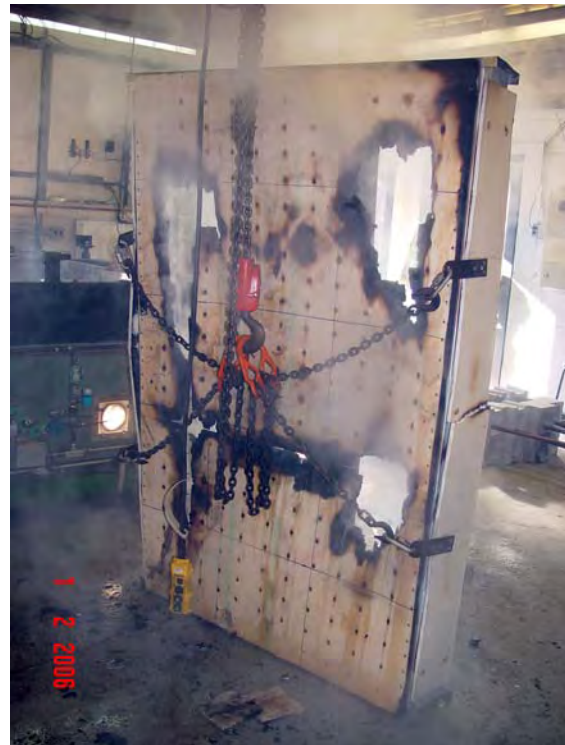
Figure D26. Damage Test OSB-03G.

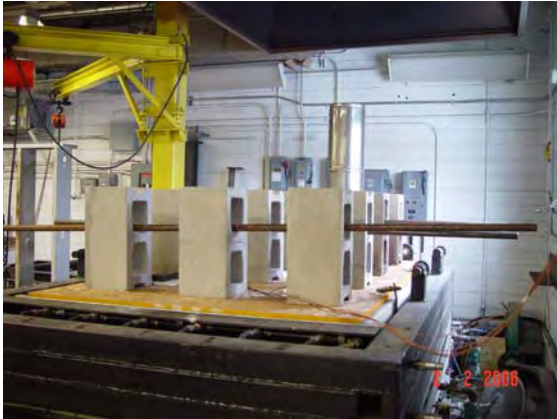
Figure D27. Test assembly Test OSB-03H.

For Test OSB-03H, the flames penetrated through the OSB at 616 s compared with 683 s for Test OSB-03B with the same floor assembly without a load. This indicates that the load may have some effect on flame penetration through the OSB subfloor. The OSB subfloor supported the concrete blocks until after the flames penetrated the subfloor. However, blocks did fall through shortly after the flames were observed.

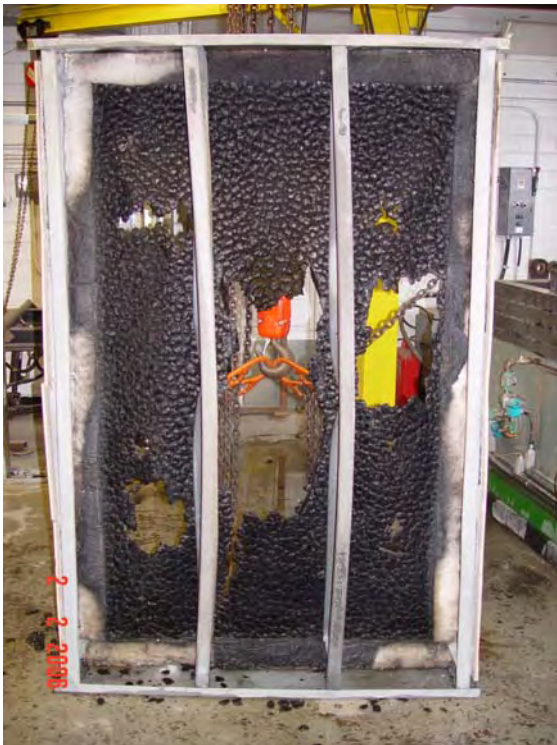
Figure D29. Damage Test OSB-03H.

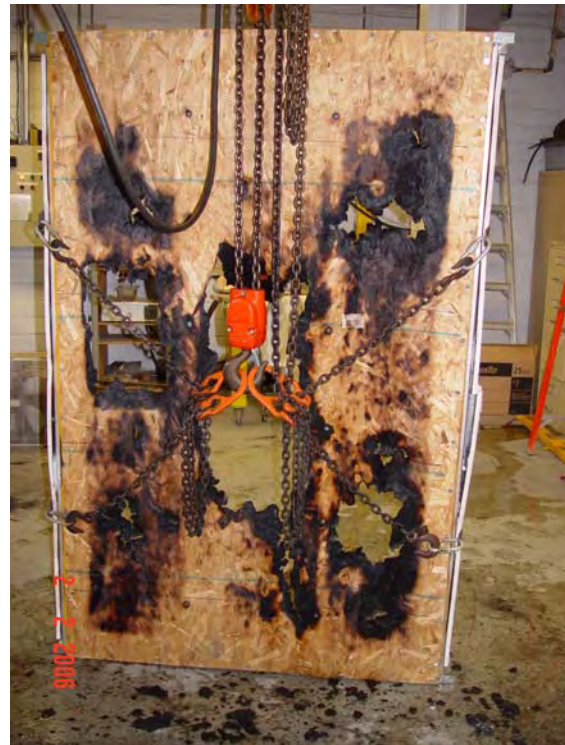
Figure D30. Damage Test OSB-03H.

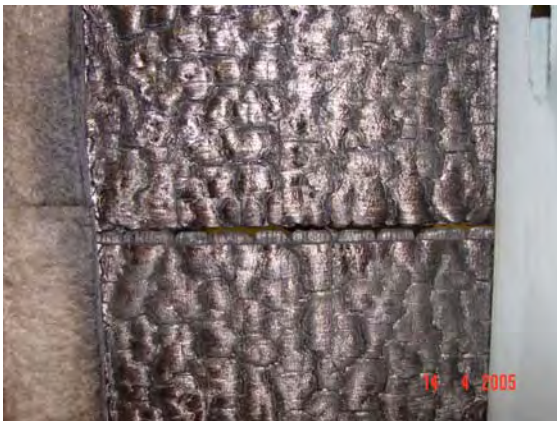
Figure E5. Flame damage Test PLY-01A.

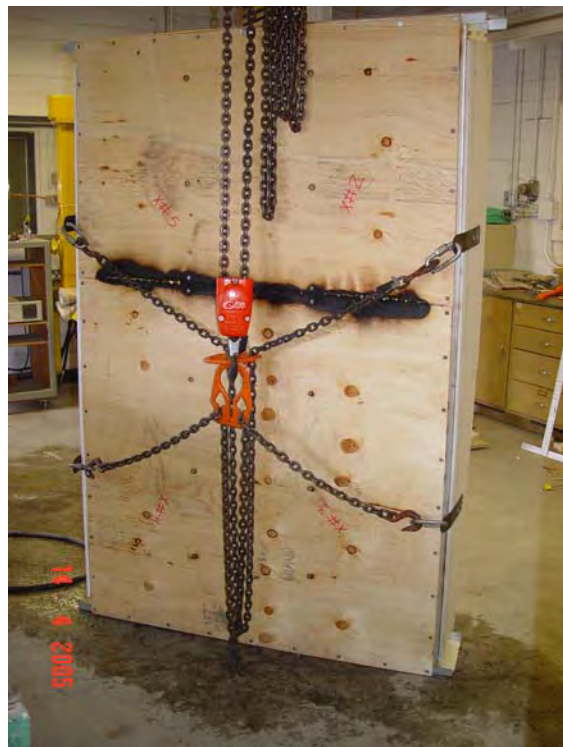
Figure E6. Damage Test PLY-01A.

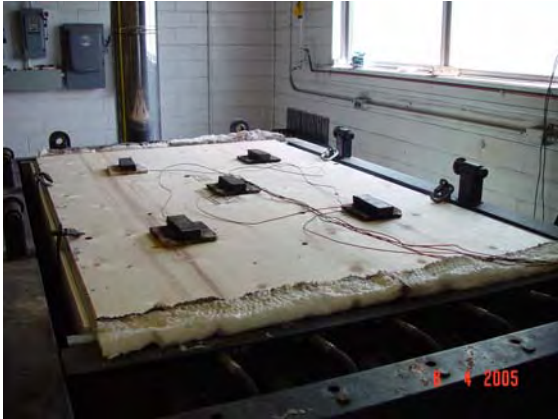
Figure E7. Floor assembly Test PLY-01B.

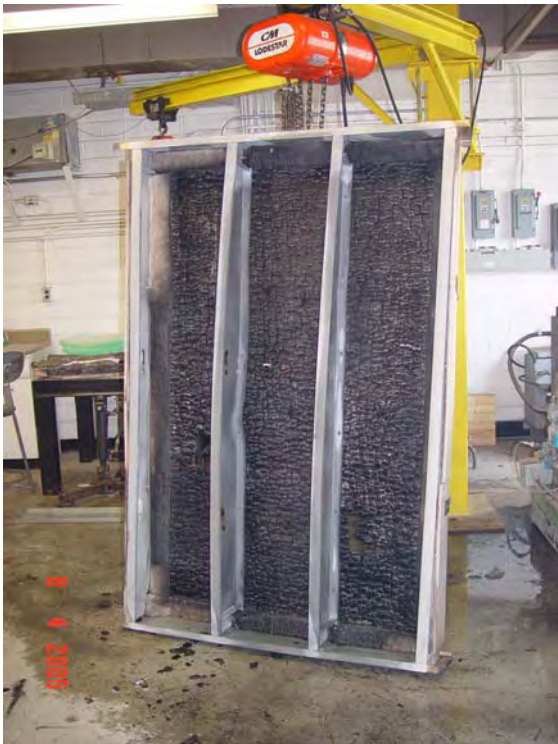
Figure E9. Flame damage Test PLY-01B.

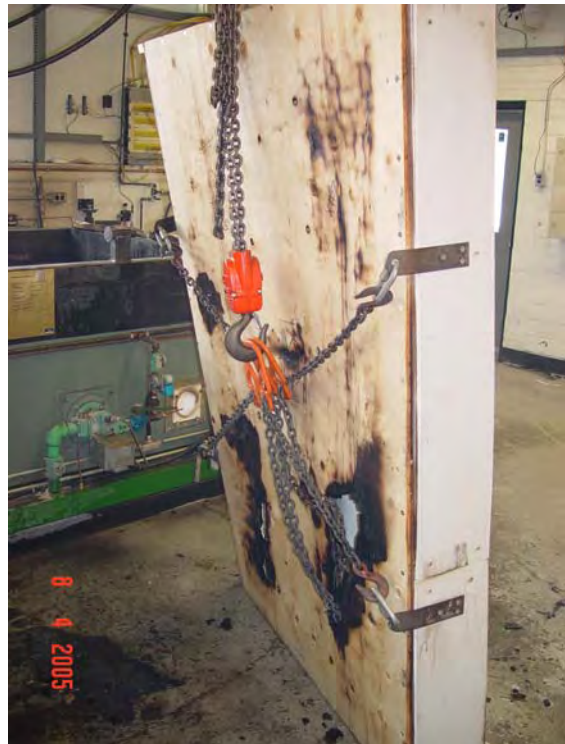
Figure E10. Damage Test PLY-01B.
