# **FULL-SCALE STANDARD FIRE RESISTANCE TEST OF A WALL ASSEMBLY FOR USE IN LOWER STOREYS OF MID-RISE BUILDINGS**

CLIENT REPORT: A1-004691.1

Report No. A1-004691.1  
Report date: December 31, 2014  
Contract No. A1-004691  
Prepared for Canadian Wood Council

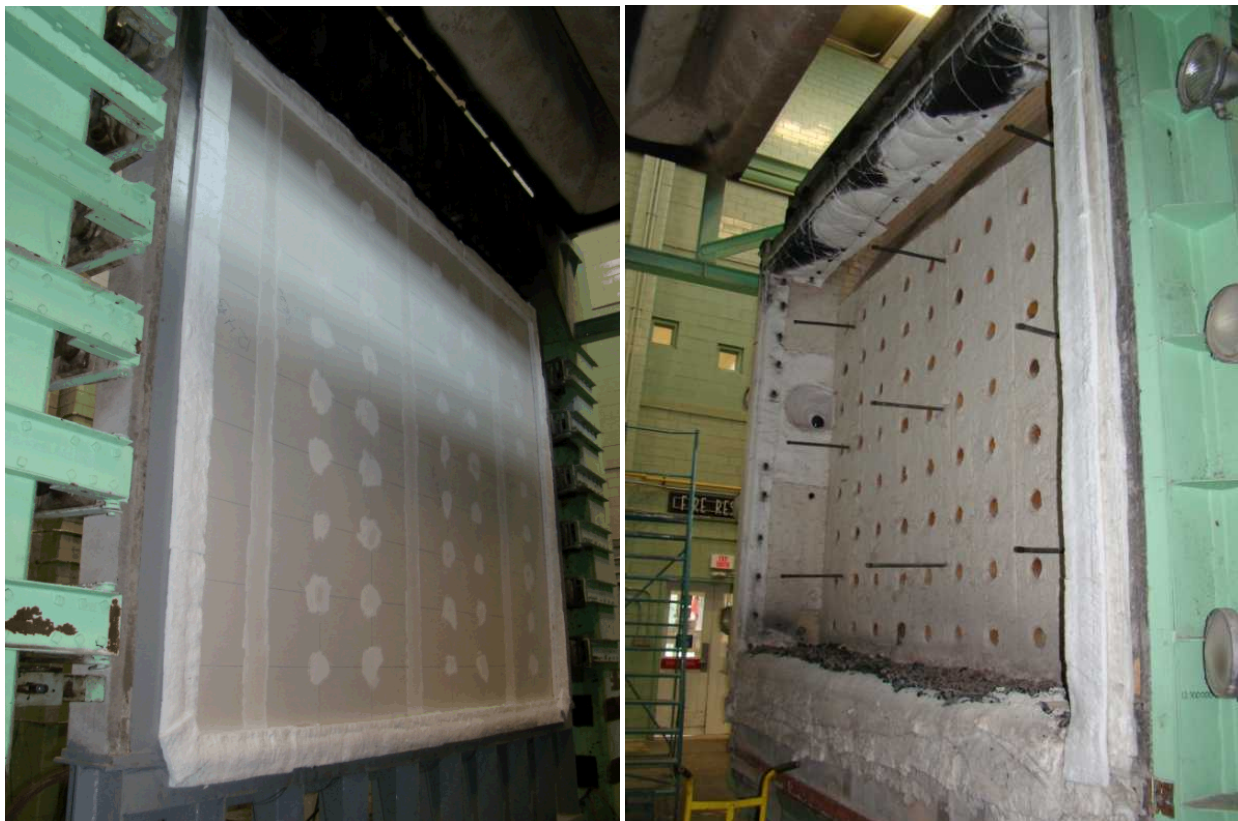
**Figure 1. Full-scale wall furnace used for fire resistance test.**

A full-scale furnace test was conducted to determine the fire endurance period for a generic encapsulated LWF assembly. The test was conducted in conformance with CAN/ULC-S101 [2], with additional instrumentation installed for research data collection. Figure 1 shows the wall furnace used for the fire resistance test.

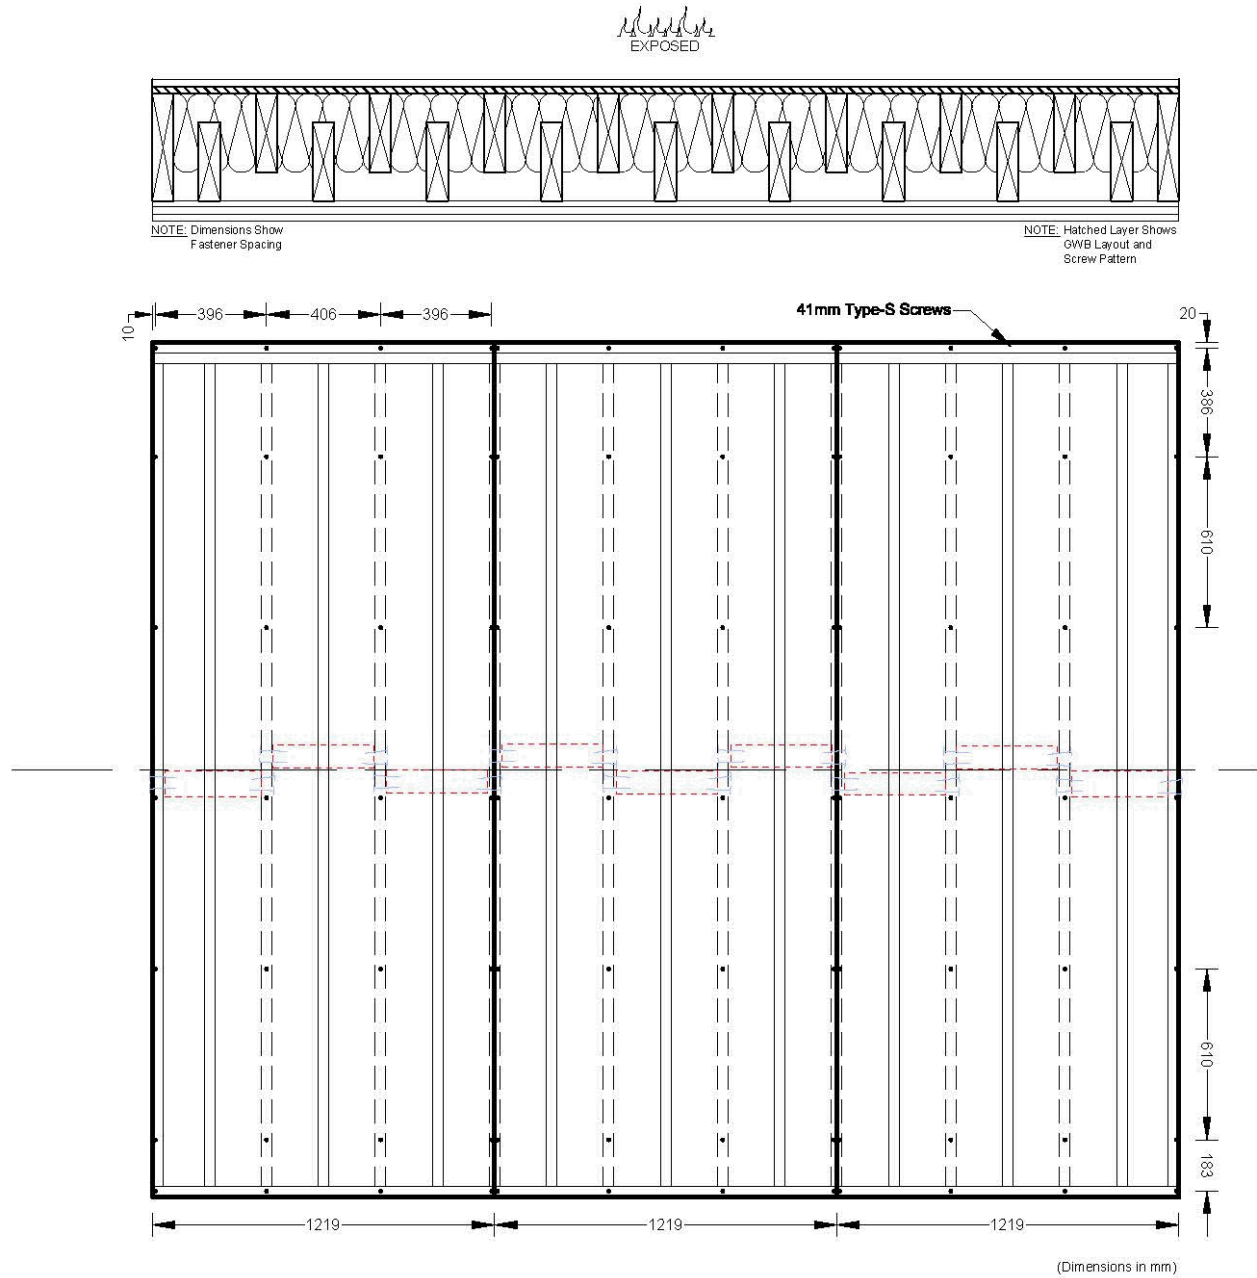
Exposed Base Layer - Gypsum Board Layout and Screw Pattern

**Figure 3. Base layer of gypsum board on exposed side of wall assembly with horizontal blocking at mid-height.**

2x4 (38 mm x 89 mm) wood material, was added at the mid-height of the wall assembly (see Figure 3 and Figure 5).

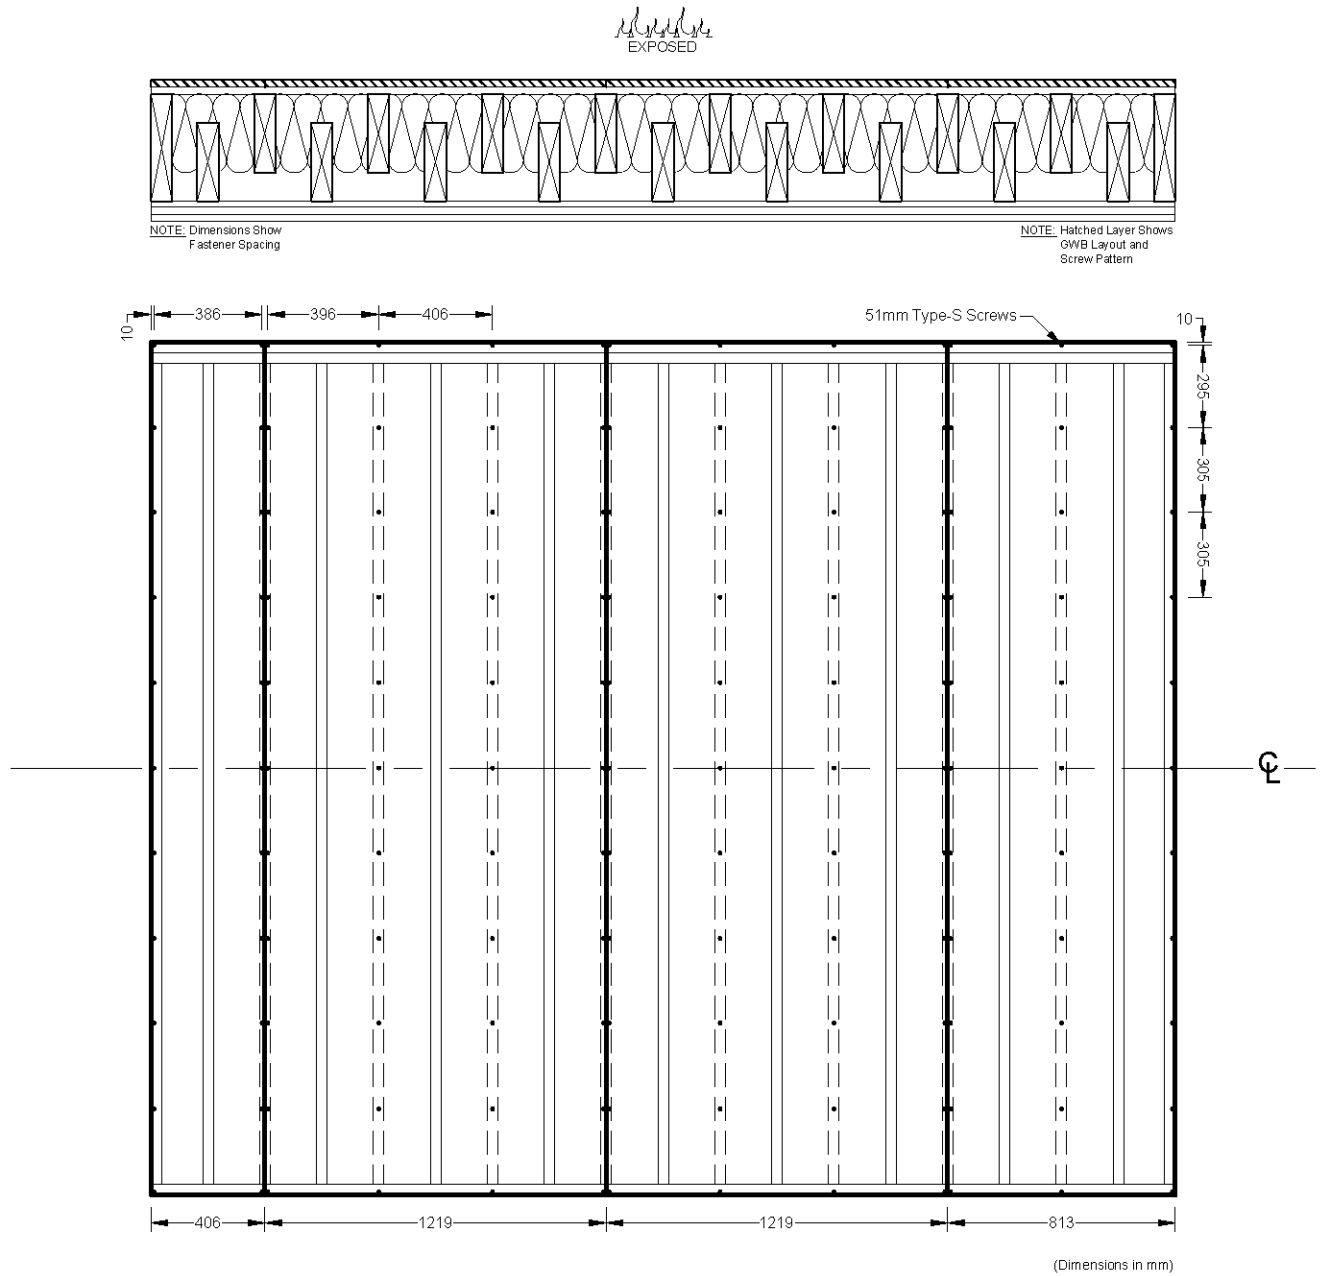
Exposed Face Layer - Gypsum Board Layout and Screw Pattern

**Figure 4. Face layer of gypsum board on exposed side of wall assembly.**

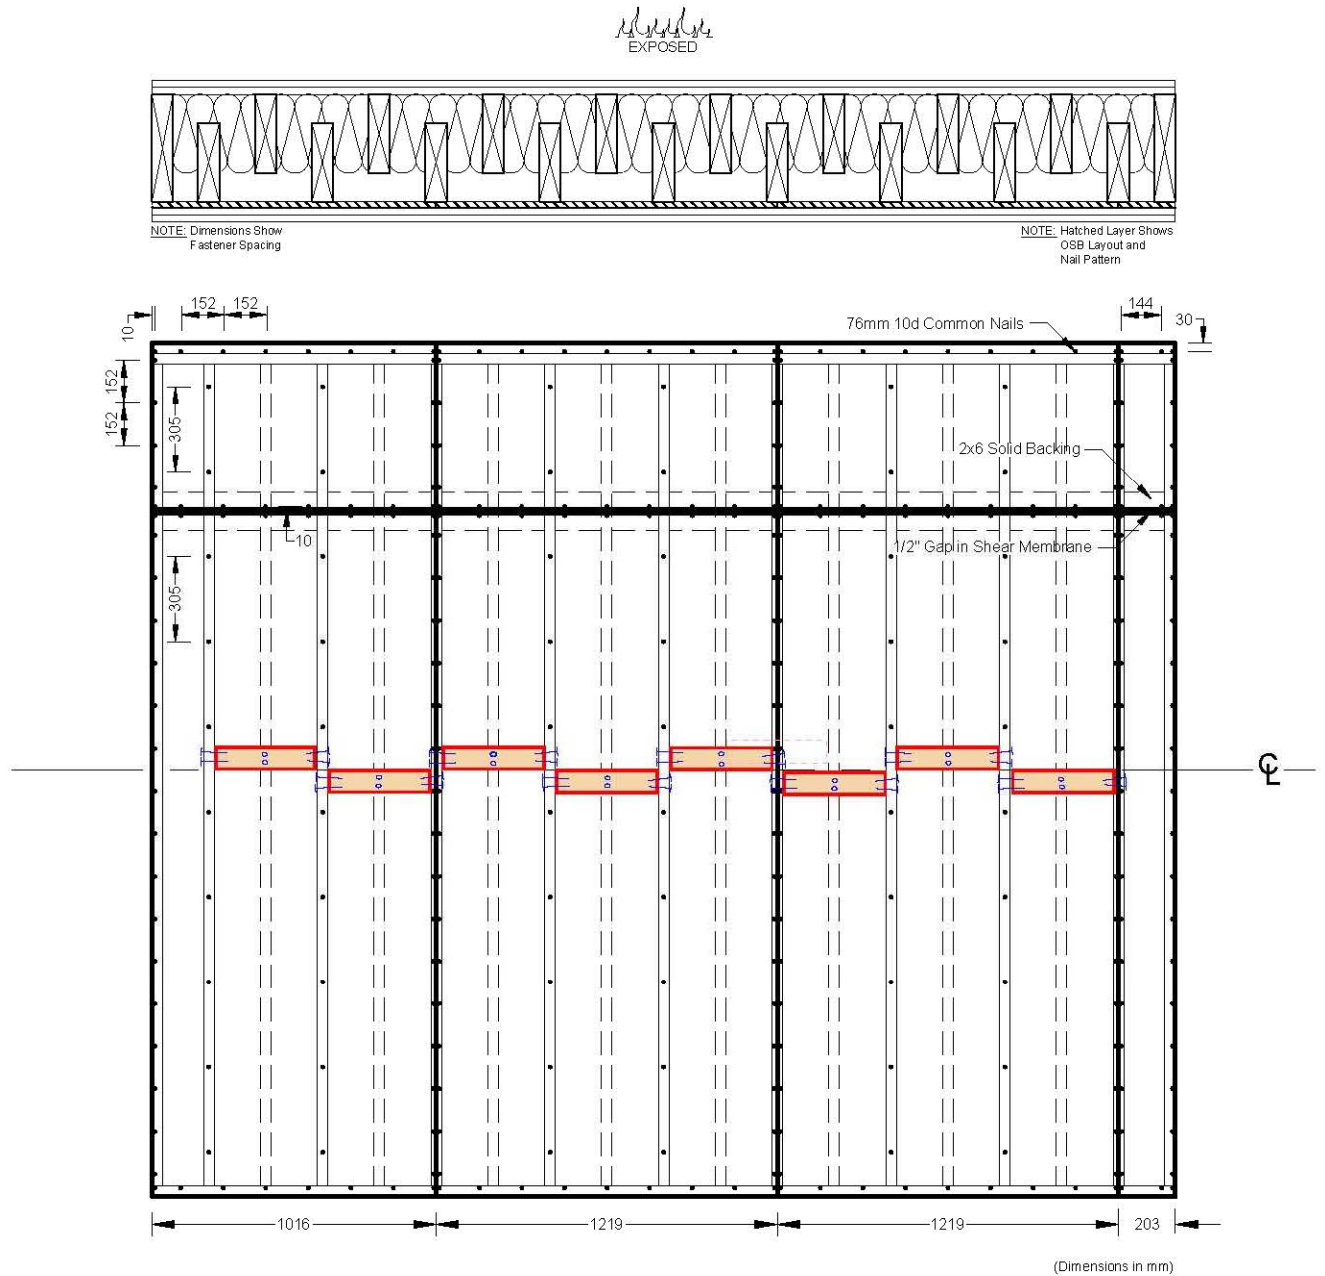
OSB Shear Layer Layout, Nail Pattern and 2x4 Bracing on Unexposed Side

**Figure 5. Shear membrane layer of OSB panel on unexposed side of wall assembly with horizontal blocking at mid-height.**

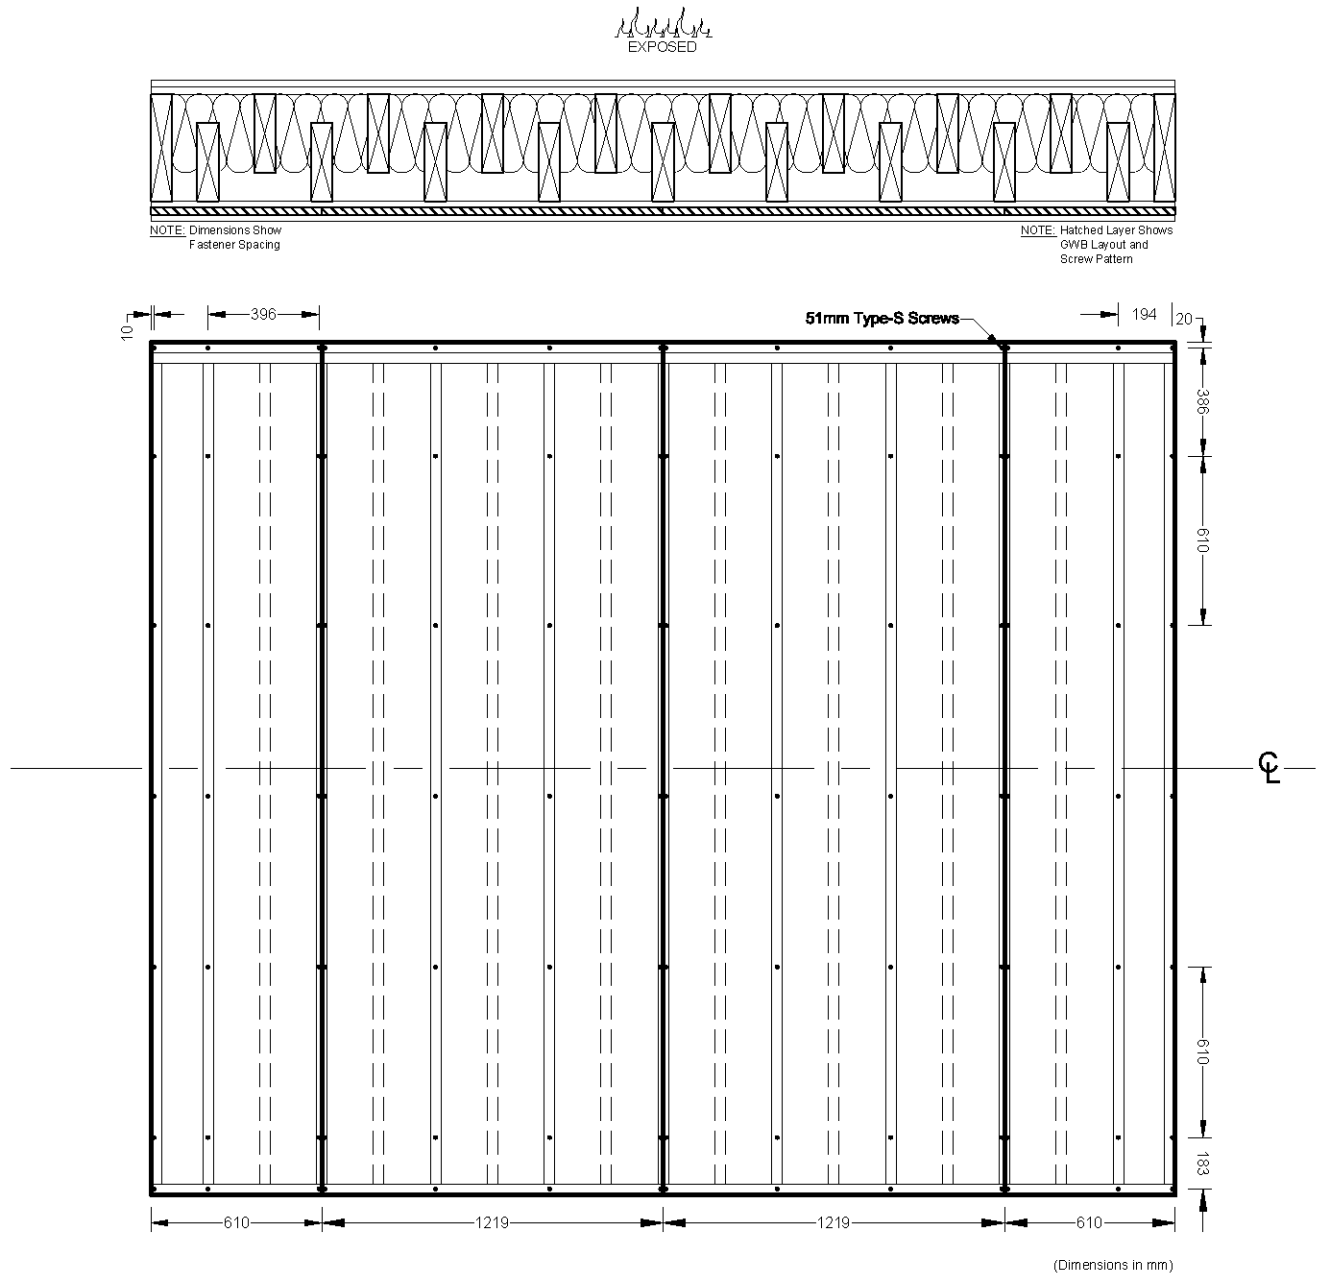
Unexposed Base Layer - Gypsum Board Layout and Screw Pattern

**Figure 6. Base layer of gypsum board on unexposed side of wall assembly.**

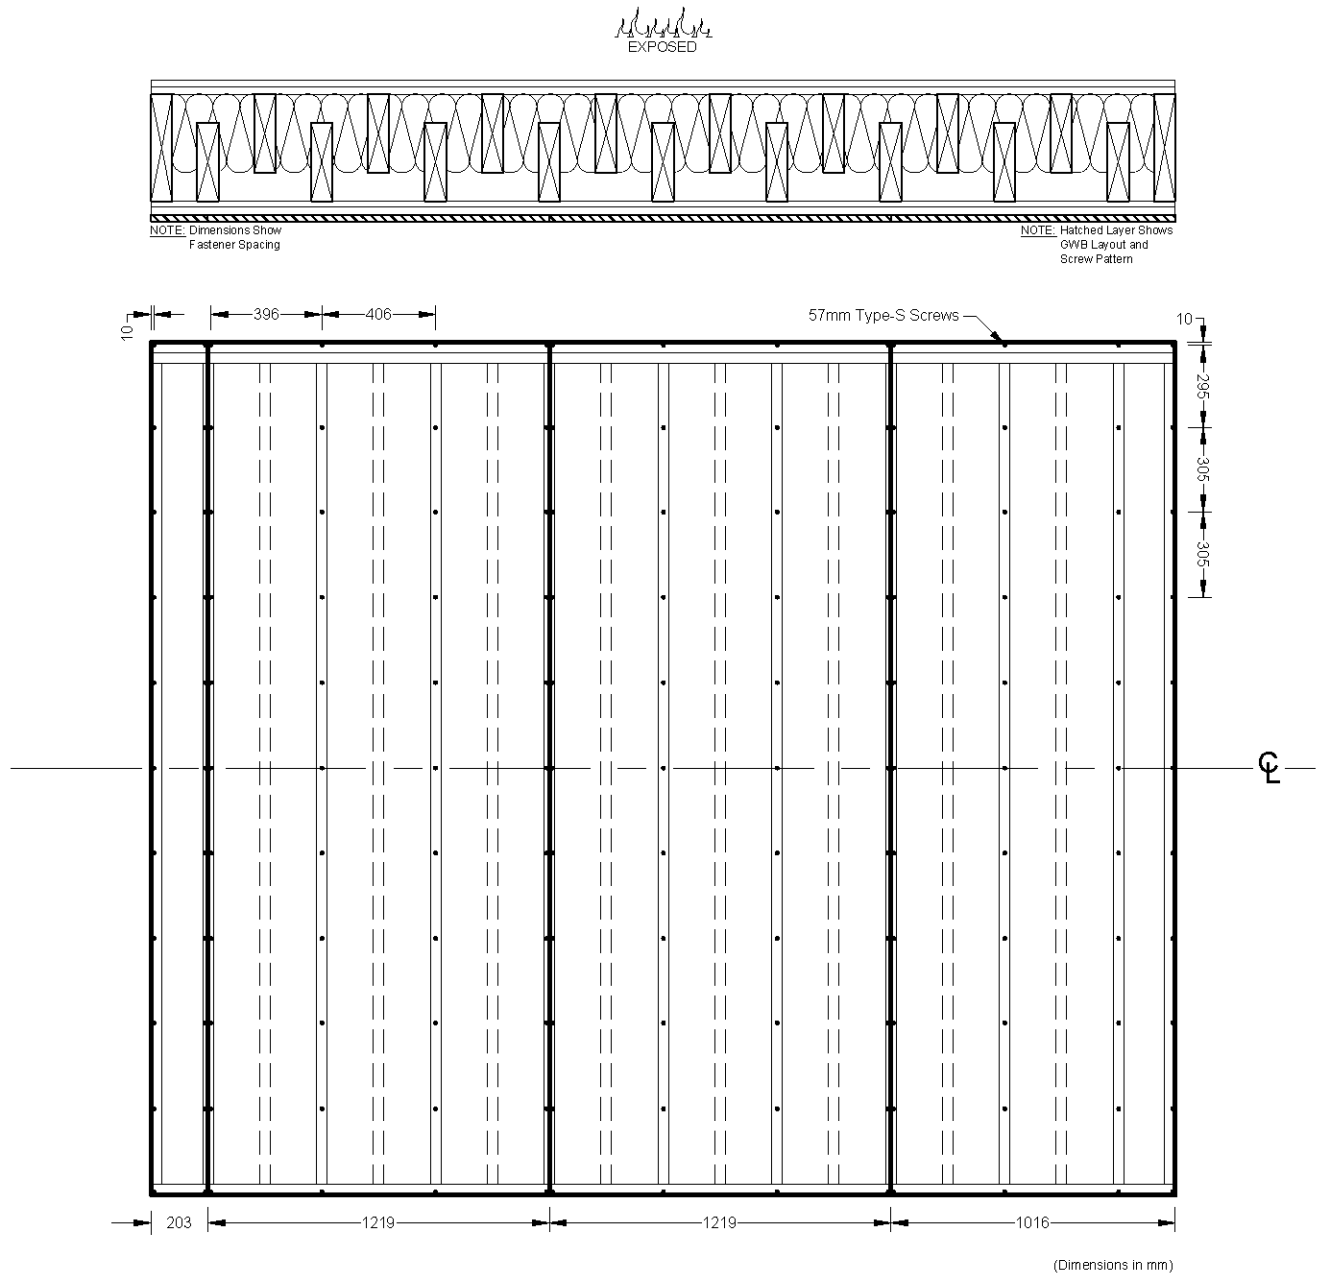
Unexposed Face Layer - Gypsum Board Layout and Screw Pattern

**Figure 7. Face layer of gypsum board on unexposed side of wall assembly.**

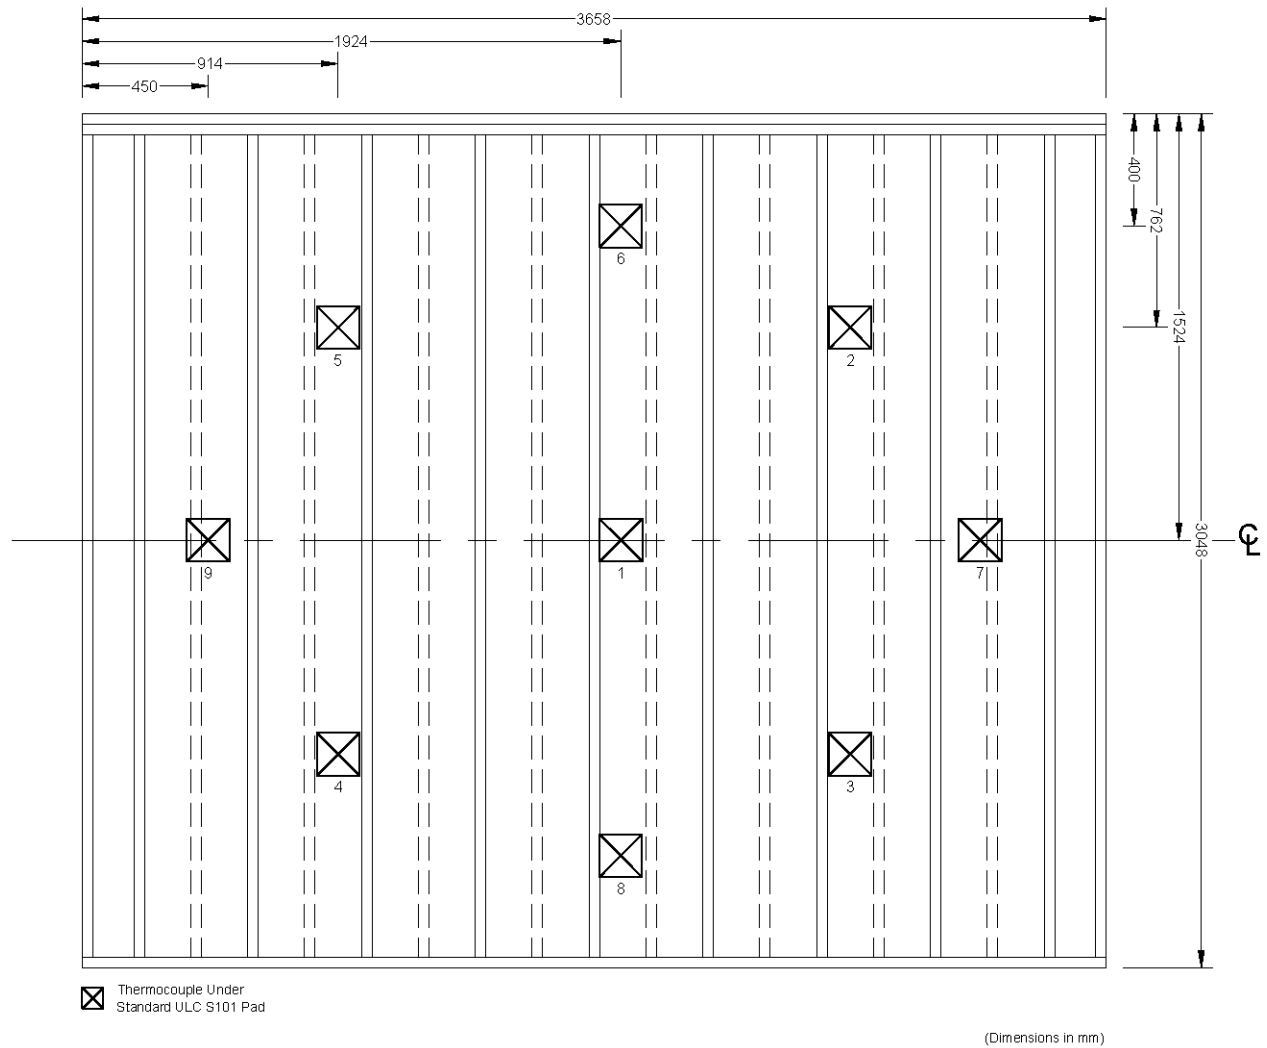
**Figure 8. Thermocouples on unexposed face of wall assembly.**

Figure 8 and Figure 9 show nine deflection gauges and nine padded thermocouples installed on the unexposed surface of the wall assembly. In addition, a set of 80 thermocouples were embedded at various interfaces across the wall assembly as shown in Figure 10, including gypsum board-gypsum board, gypsum board-stud, gypsum board-cavity, stud-cavity, cavity-OSB, stud-OSB and gypsum board-OSB interfaces.

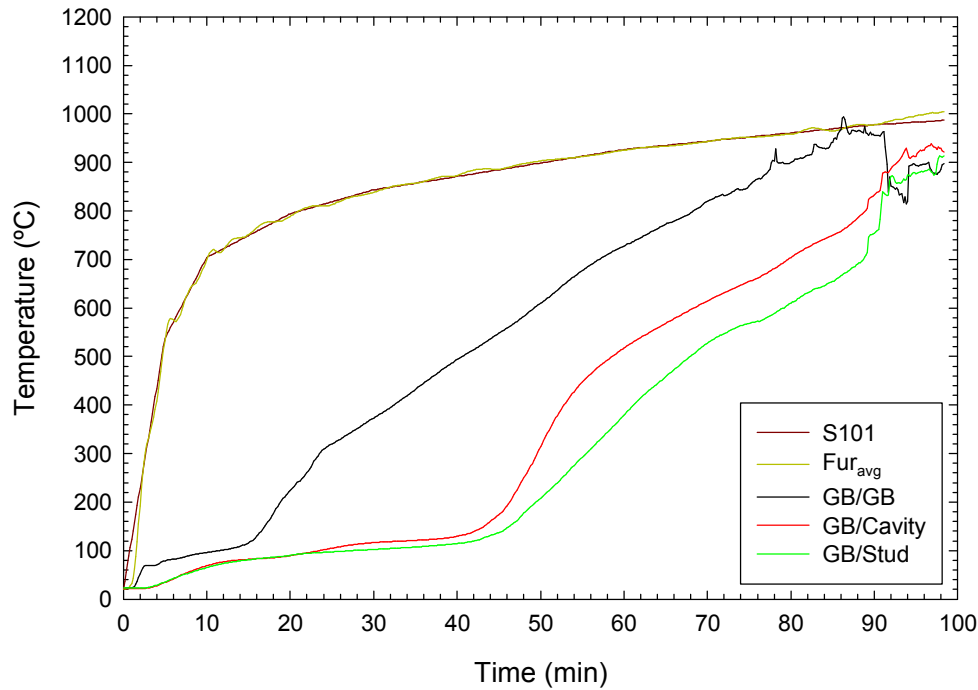
**Notes:** GB/GB is the average of TCs #10-21; GB/Cavity is the average of TCs #22, 25, 27, 28, 30 and 33; GB/Stud is the average of TCs #23, 24, 26, 29, 31 and 32.

**Figure 11. Furnace temperatures and average temperatures at interfaces on exposed side of the wall assembly.**

Figure 11 shows the average furnace temperature ( $F_{ur_{avg}}$ ) measured during the test. There is a good comparison between the measured temperature and the temperature specified in CAN/ULC-S101 [2].

Also shown in Figure 11 are the average temperatures measured at the interface between the face and base layers of gypsum board (GB/GB), the interface between the base gypsum board layer and the wall cavity (GB/Cavity), and the interface between the base gypsum board layer and the studs (GB/stud), on the exposed side of the wall assembly.

The average temperature at the interface between the face and base gypsum board layers was  $< 100^{\circ}\text{C}$  for 11.5 min and was  $> 300^{\circ}\text{C}$  after 23.5 min. After 11.5 min, there was a continuous increase in temperature until 85 min. After 85 min, the temperature was comparable to the temperature in the furnace. This suggests some of the face layer of gypsum board remained in place until near the end of the test.

Initially, there was a slow temperature increase at the interface between the base layer of gypsum board and the cavity and between the base layer and the studs, with the temperatures  $< 150^{\circ}\text{C}$  for 43.3 min. Subsequently, there was a more rapid temperature increase at both interfaces, with the fastest increase at the gypsum board-cavity interface. The average temperatures exceeded  $300^{\circ}\text{C}$  at the gypsum board-cavity and the gypsum board-stud interfaces at 49.7 min and 55.5 min, respectively. The temperatures were  $< 600^{\circ}\text{C}$  for 68.5 min. The average temperature measured at gypsum board-cavity and gypsum board-stud interfaces increased more rapidly after approximately 88 min indicating the base layer of gypsum board was falling off.

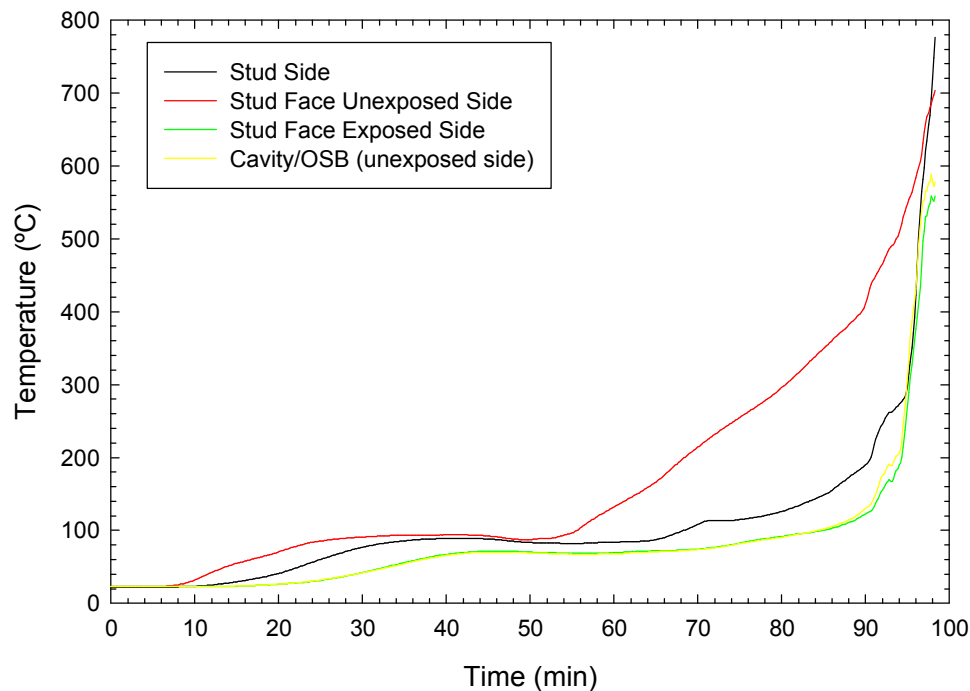
**Notes:** Stud Side is the average of TCs #34-45; Stud Face Unexposed is the average of TCs #46-51; Stud Face Exposed is the average of TCs #52-57; Cavity/OSB is the average of TCs #58, 59, 61, 62, 64 and 65.

**Figure 12. Average temperatures at stud-cavity and cavity-OSB interfaces for the wall assembly.**

Figure 12 shows the average temperatures at the interfaces between the studs and the wall cavity. The measurement locations were: the side of the studs on the exposed side of the wall (Stud Side), the face of the studs on the unexposed side of the wall assembly (Stud Face Unexposed Side), and the face of the studs on the exposed side of the wall assembly (Stud Face Exposed Side). Also shown is the average temperature at the interface between the cavity and the OSB shear membrane layer on the unexposed side of the wall assembly (Cavity/OSB).

There was a slow temperature increase on the sides of the studs on the exposed side of the wall assembly. The average temperature was  $< 100^{\circ}\text{C}$  for 68.5 min and  $< 300^{\circ}\text{C}$  for 95.0 min. The average temperature measured on the face of the studs on the unexposed side had a slow temperature increase with the average temperature  $< 100^{\circ}\text{C}$  for 55.7 min and  $< 300^{\circ}\text{C}$  for 80.5 min.

Comparable temperatures were measured on the face of the studs on the exposed side of the wall assembly and at the interface between the cavity and the OSB shear membrane layer on the unexposed side of the wall assembly.

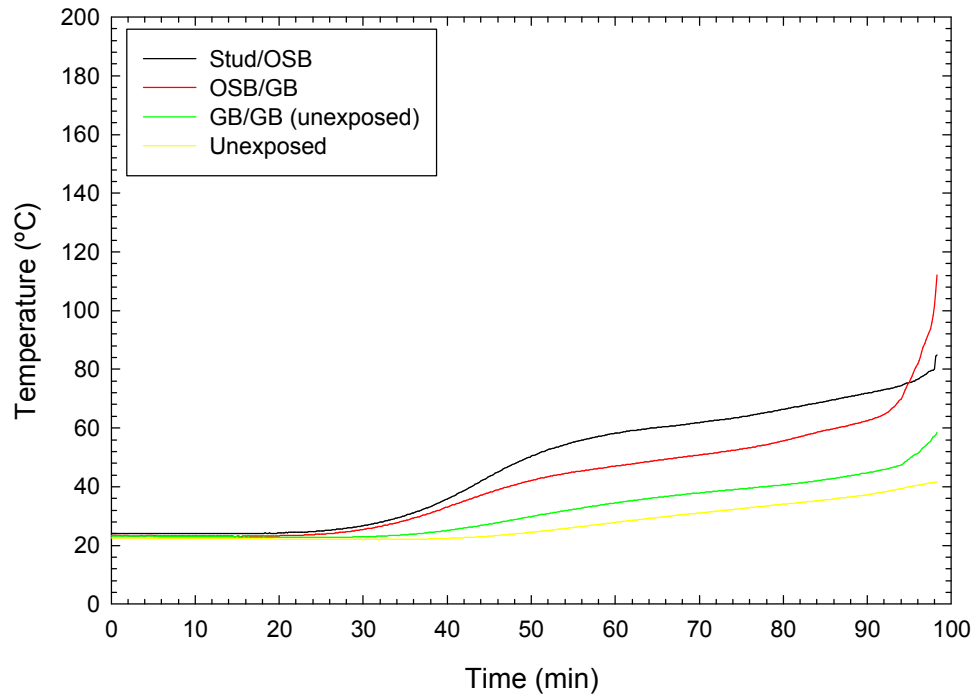
**Notes:** Stud/OSB is the average of TCs #60 and 63; OSB/GB is the average of TCs #66-77; GB/GB (unexposed) is the average of TCs #78-89; Unexposed is the average of TCs #1-9.

**Figure 13. Average temperatures on unexposed side of the wall assembly.**

The average temperatures measured on the unexposed side of the wall assembly are shown in Figure 13. This includes the average temperatures at the interface between the studs and the OSB shear membrane layer (Stud/OSB), at the interface between the OSB and the base

gypsum board layer (OSB/GB), at the interface between the base and face layers of gypsum on the unexposed side (GB/GB (unexposed)), and on the unexposed surface (Unexposed).

There was a gradual temperature increase at all locations beginning at approximately 15 min. The temperatures at all locations were 112.1°C or less at the end of the test. The highest temperatures were measured at the interface between OSB shear membrane and the gypsum board base layer.

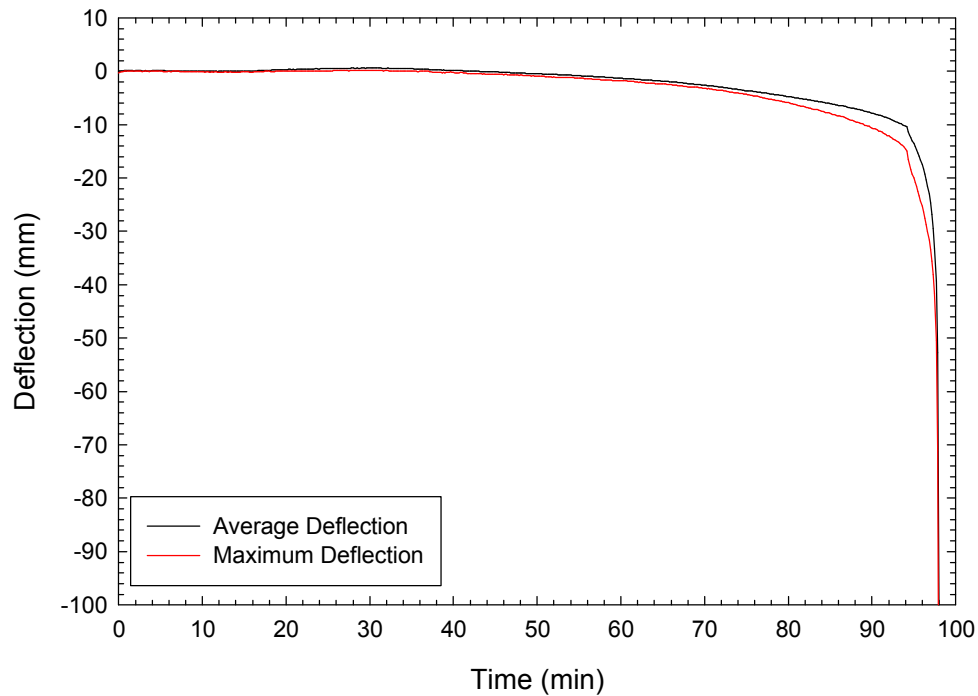
**Figure 14. Deflections the wall assembly.**

Figure 14 shows the average and maximum deflections measured during the test. The maximum deflection was measured by Deflection Gauge 5 located at the center of the wall assembly. There was minimal deflection for the initial 60 min. Subsequently, there was a continuous increase in the rate at which the assembly deflected until structural failure.

The wall assembly failed structurally at 98 min with the studs deforming perpendicular to the plane of the wall. The addition of the horizontal blocking limited the in-plane deformation of the studs. This resulted in a 17 min increase in the fire endurance period compared with the wall assembly without the blocking (Wall Assembly #5 in Reference [3]).

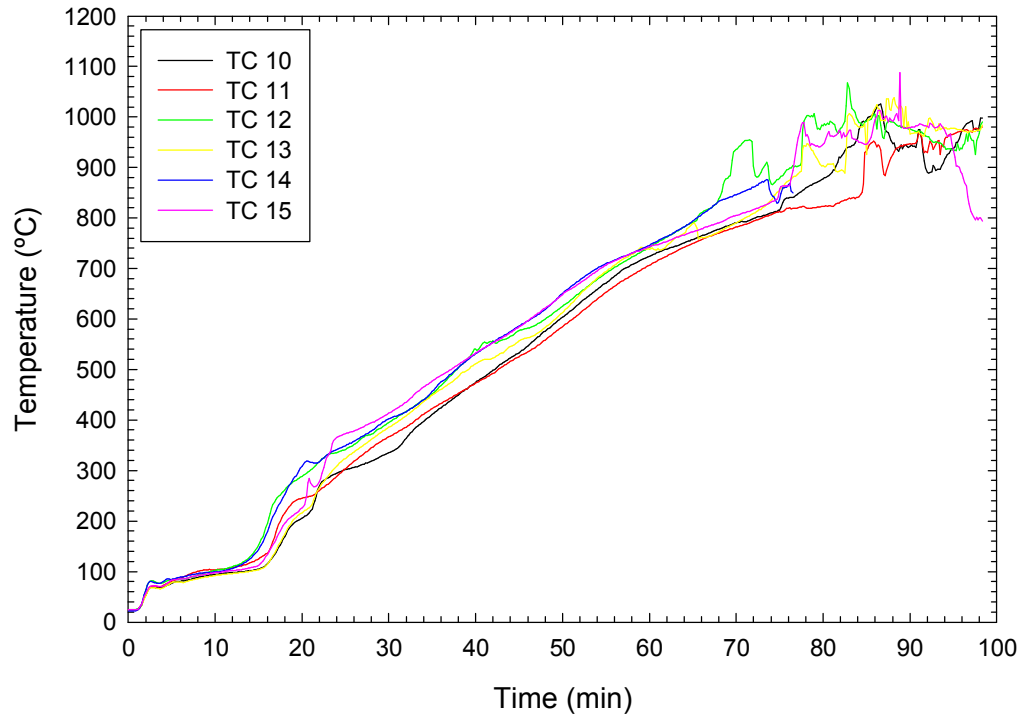
**Figure A-1. Temperatures measured at interface between face and base gypsum board layers at  $\frac{1}{4}$  height from top on exposed side of wall assembly.**

1. Figures A-1 and A-2 show the temperatures measured at the interface between the face and base layers of gypsum board on the exposed side of the wall assembly at the  $\frac{1}{4}$  and  $\frac{3}{4}$  heights from the top of assembly, respectively.

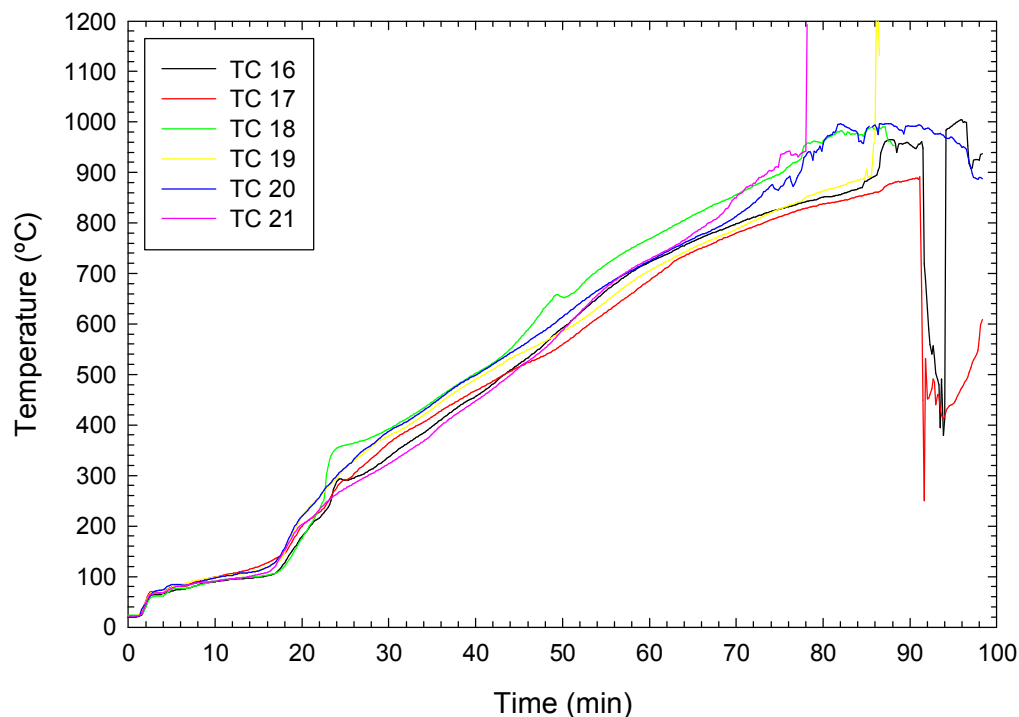
**Notes:** TCs#16 and 17 measured extreme temperature decreases towards the end of the test, which could be resulted from shielding by the base layer gypsum board falling from above.

**Figure A-2. Temperatures measured at interface between face and base gypsum board layers at  $\frac{3}{4}$  height from top on exposed side of wall assembly.**

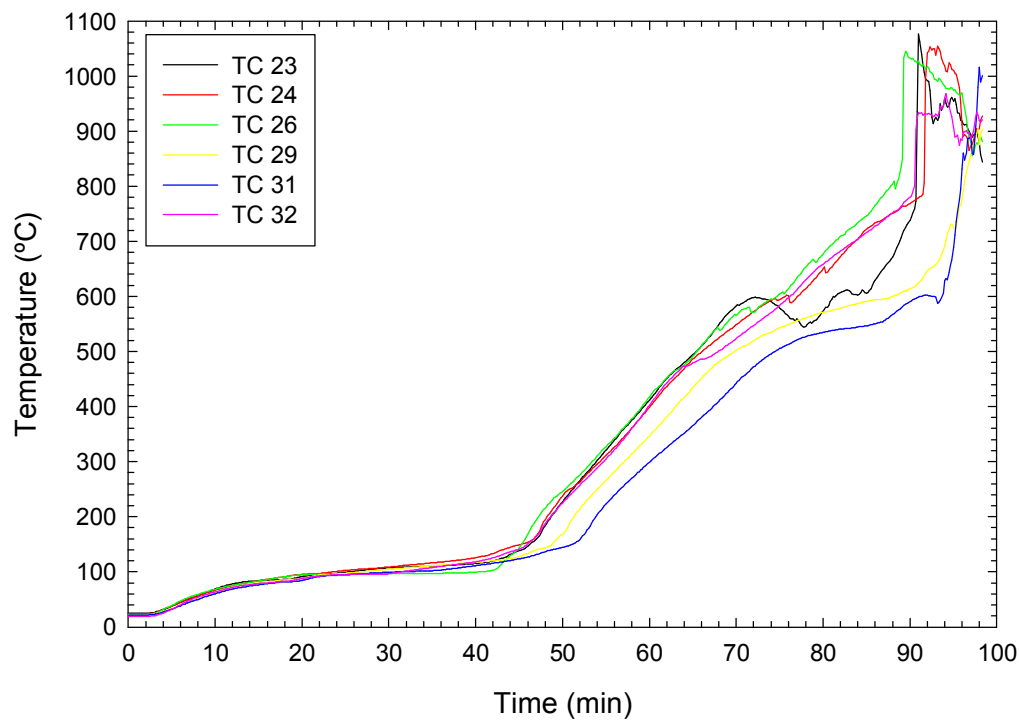
**Figure A-3. Temperatures measured at interface between base gypsum board layer and studs on exposed side of wall assembly.**

2. Figure A-3 shows the temperatures measured at the interface between the base layer of gypsum board and the studs on the exposed side of the wall assembly.

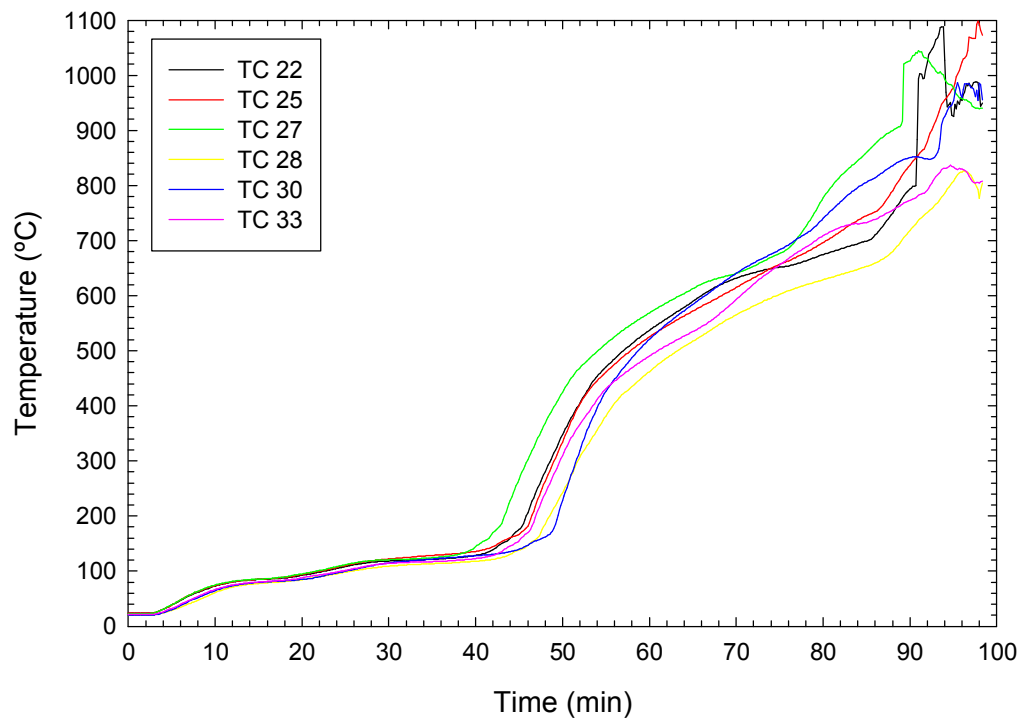
**Figure A-4. Temperatures measured at interface between base gypsum board layer and the wall cavity on exposed side of wall assembly.**

3. Figure A-4 shows the temperatures measured at the interface between the base layer of gypsum board and the wall cavity on the exposed side of the wall assembly.

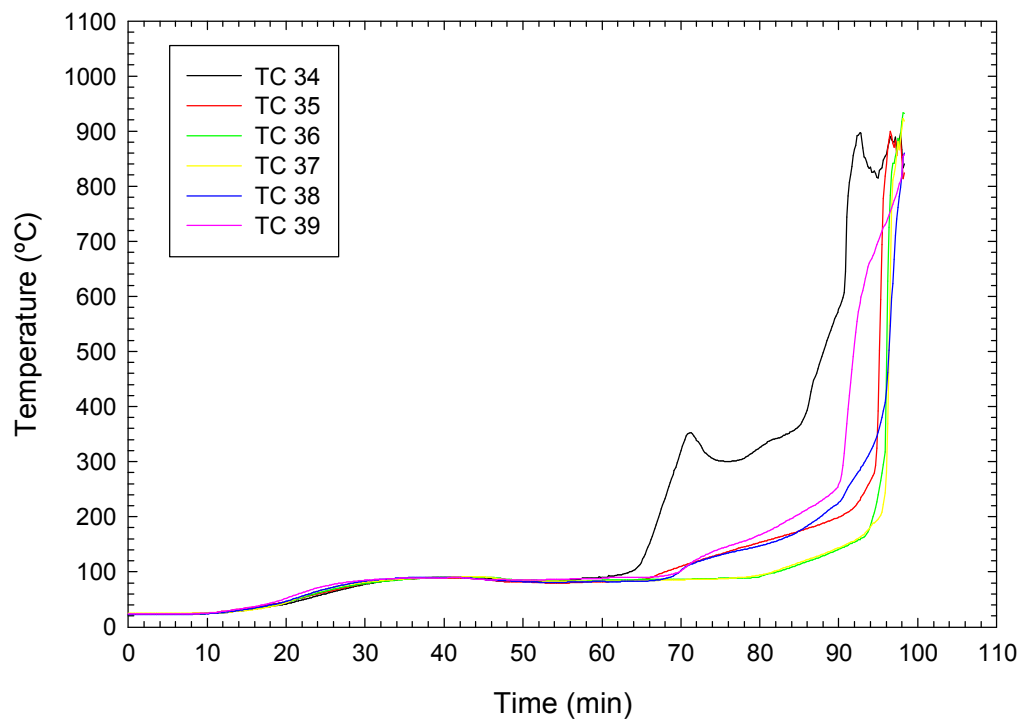
**Figure A-5. Temperatures measured on sides of studs on exposed side at 1/4 height from top of wall assembly.**

4. Figures A-5 and A-6 show the temperatures measured on the sides of the studs on the exposed side of the wall assembly at the  $\frac{1}{4}$  and  $\frac{3}{4}$  heights from the top of assembly, respectively.

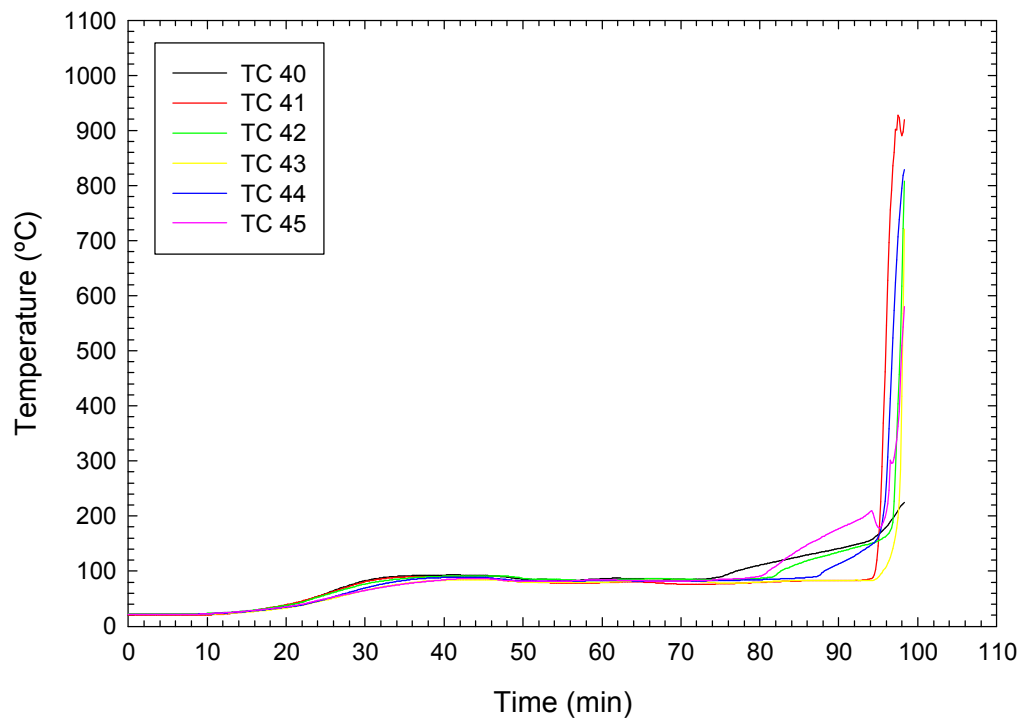
**Figure A-6. Temperatures measured on sides of studs on exposed side at 3/4 height from top of wall assembly.**

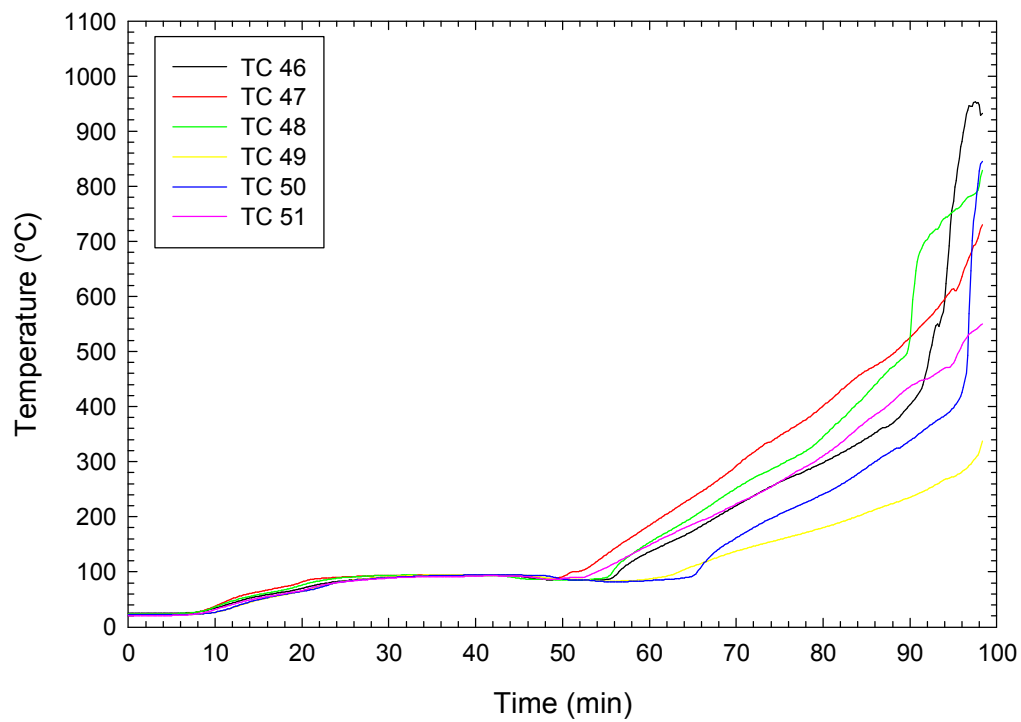
**Figure A-7. Temperatures measured on face of studs on unexposed side of wall assembly.**

5. Figures A-7 and A-8 show the temperatures measured on the face of the studs on the unexposed and exposed side of the wall assembly, respectively.
6. Figures A-9 and A-10 show the temperatures measured at the interface between the wall cavity and the OSB shear membrane layer and between the stud and the OSB shear membrane layer, respectively.

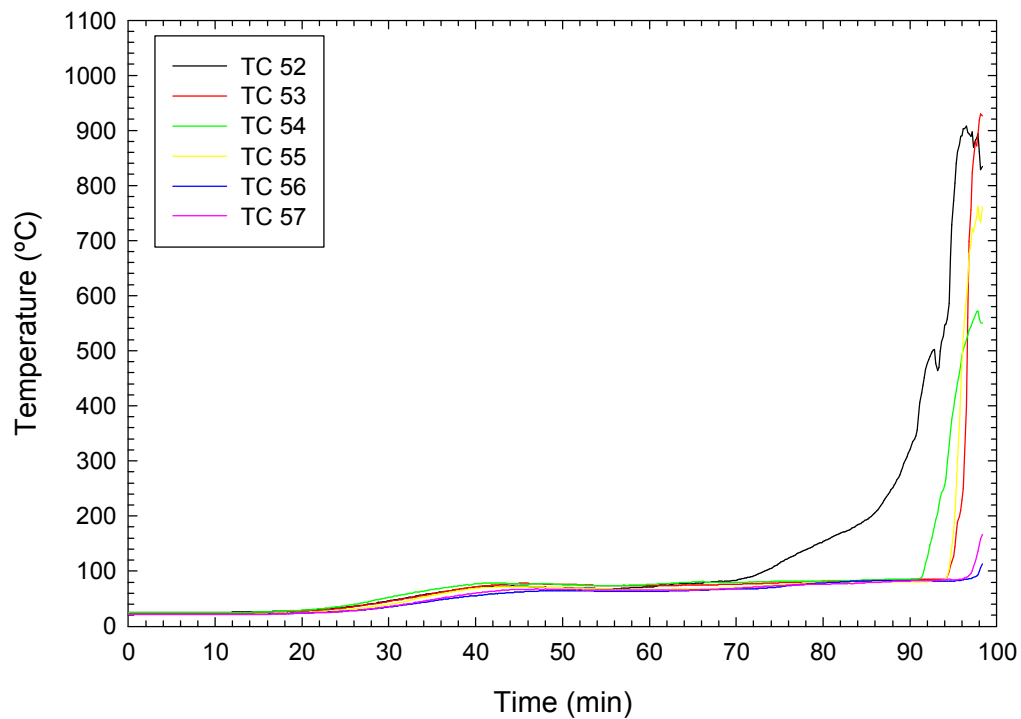
**Figure A-8. Temperatures measured on face of studs on exposed side of wall assembly.**

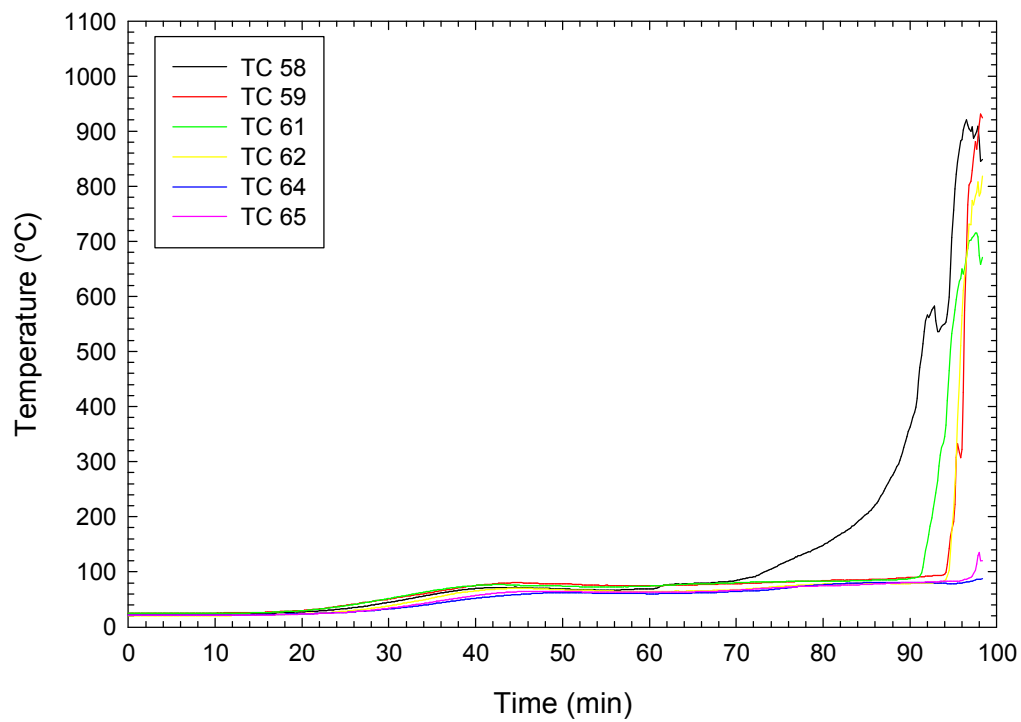
**Figure A-9. Temperatures measured at interface between wall cavity and OSB shear membrane layer on unexposed side of wall assembly.**
