# **FULL-SCALE STANDARD FIRE RESISTANCE TEST OF A WALL ASSEMBLY FOR USE IN LOWER STOREYS OF MID-RISE BUILDINGS**

CLIENT REPORT: A1-004691.1

Report No. A1-004691.1  
Report date: December 31, 2014  
Contract No. A1-004691  
Prepared for Canadian Wood Council

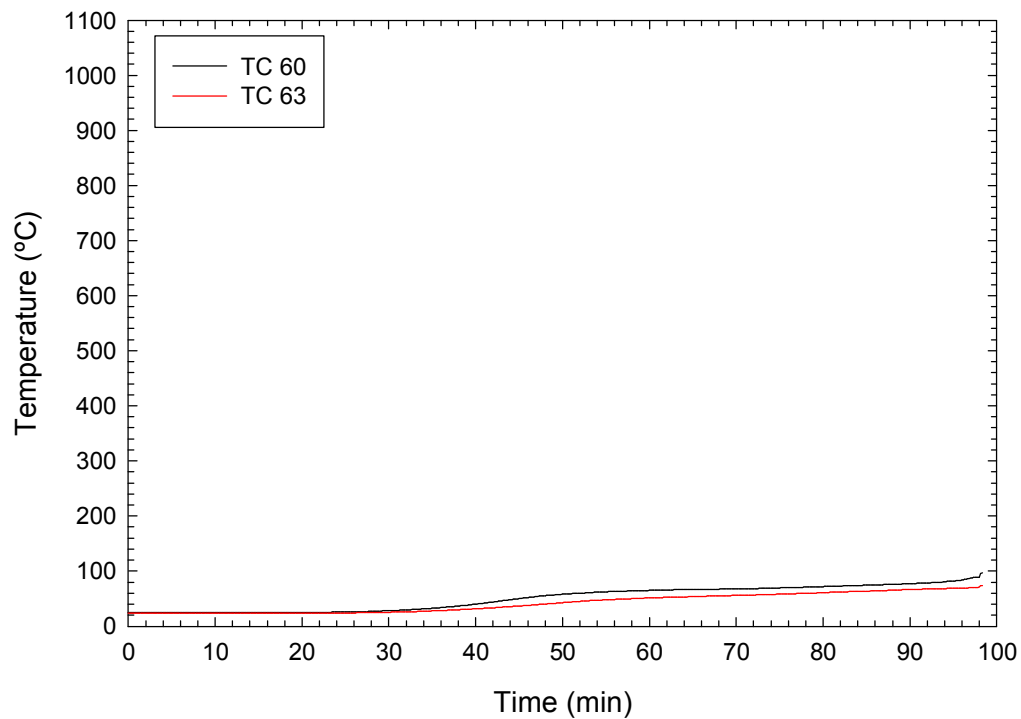
**Figure A-10. Temperatures measured at interface between stud and OSB shear membrane layer on unexposed side of wall assembly.**

5. Figures A-7 and A-8 show the temperatures measured on the face of the studs on the unexposed and exposed side of the wall assembly, respectively.
6. Figures A-9 and A-10 show the temperatures measured at the interface between the wall cavity and the OSB shear membrane layer and between the stud and the OSB shear membrane layer, respectively.

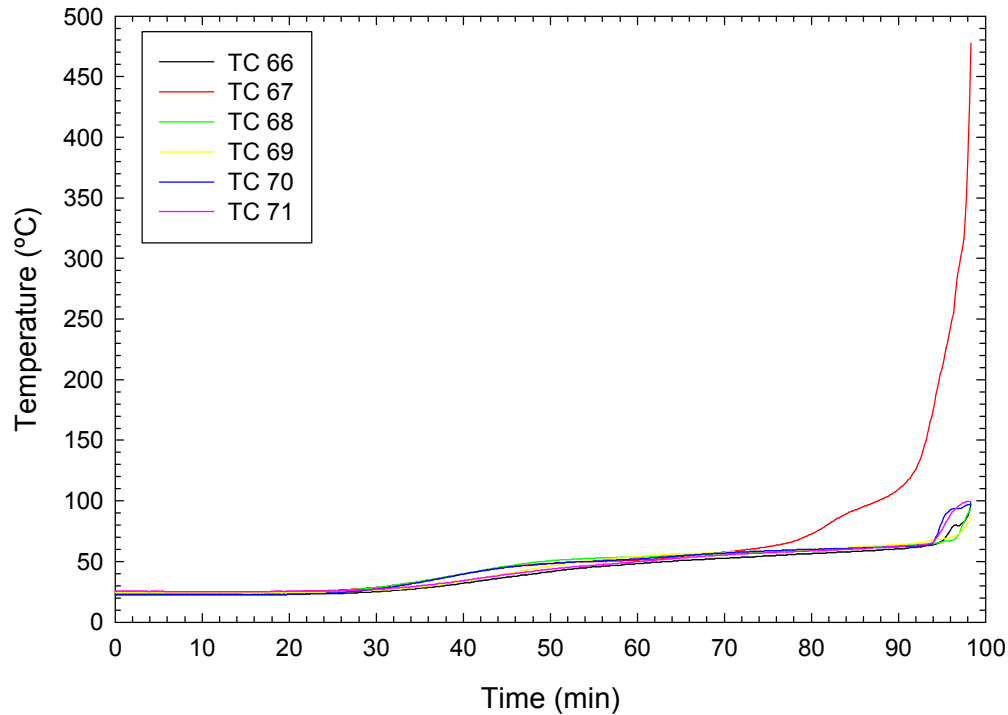
**Figure A-11. Temperatures measured at interface between OSB shear membrane layer and gypsum board base layer at  $\frac{1}{4}$  height from top on unexposed side of wall assembly.**

7. Figures A-11 and A-12 show the temperatures measured at the interface between the OSB shear membrane layer and the base gypsum board layer on the unexposed side of the wall assembly at the  $\frac{1}{4}$  and  $\frac{3}{4}$  heights from the top of assembly, respectively.

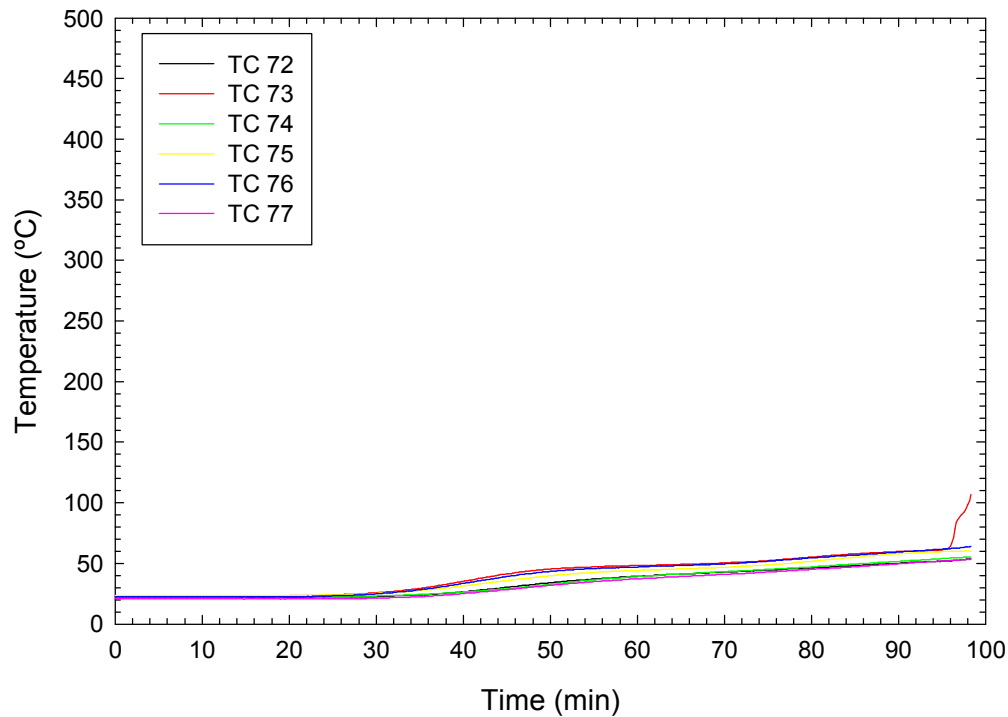
**Figure A-12. Temperatures measured at interface between OSB shear membrane layer and gypsum board base layer at  $\frac{3}{4}$  height from top on unexposed side of wall assembly.**

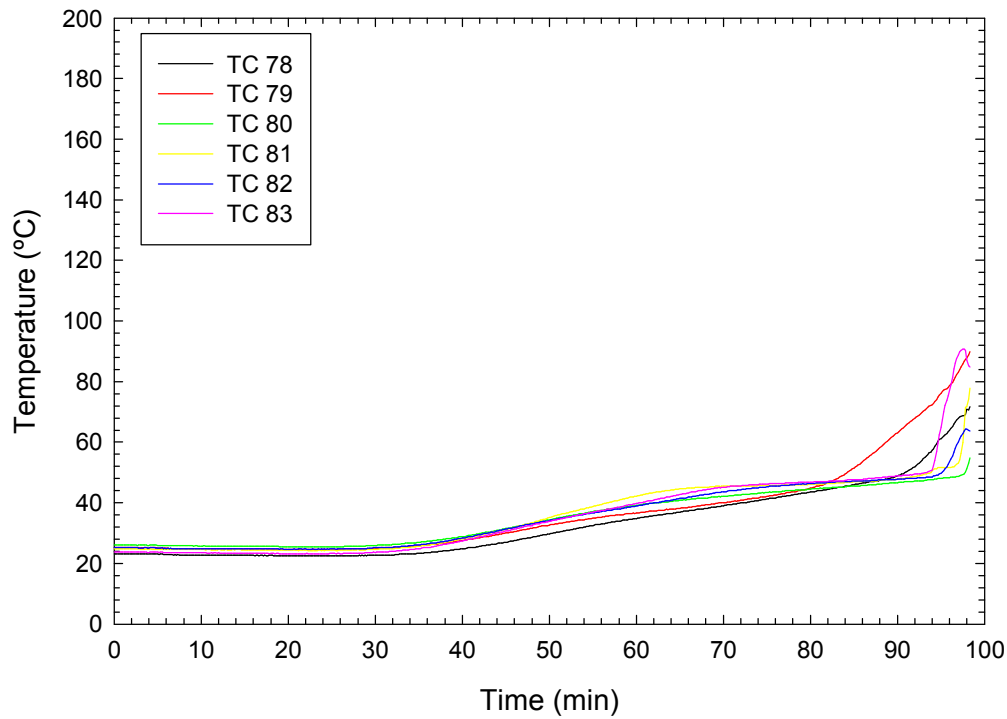
**Figure A-13. Temperatures measured at interface between base and face gypsum board layers at  $\frac{1}{4}$  height from top on unexposed side of wall assembly.**

8. Figures A-13 and A-14 show the temperatures measured at the interface between the base and face gypsum board layers on the unexposed side of the wall assembly at the  $\frac{1}{4}$  and  $\frac{3}{4}$  heights from the top of assembly, respectively.

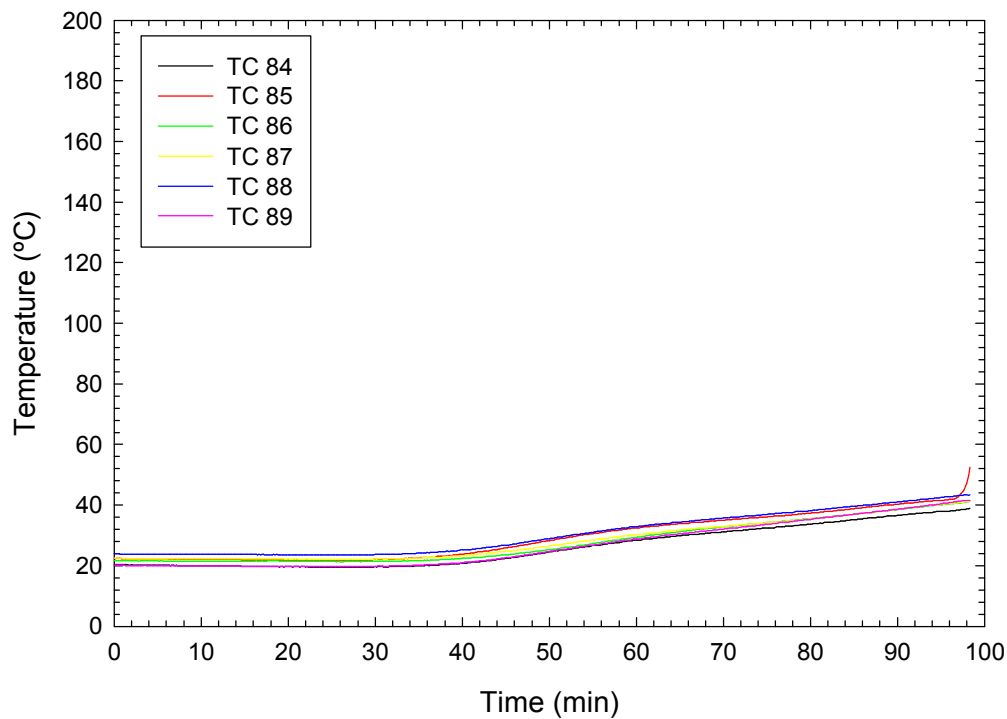
**Figure A-14. Temperatures measured at interface between base and face gypsum board layers at  $\frac{3}{4}$  height from top on unexposed side of wall assembly.**

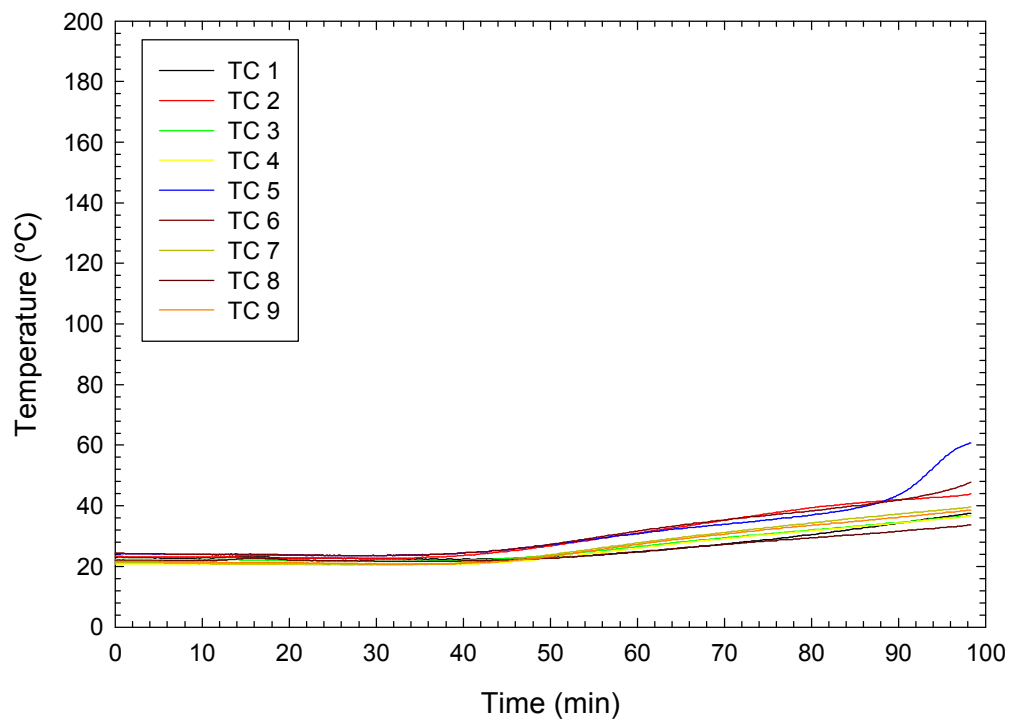
**Figure A-15. Temperatures measured on unexposed side of wall assembly.**

9. Figure A-15 shows the temperatures measured on the unexposed side of the wall assembly.
10. Figure A-16 shows the average furnace temperature measured during the test.

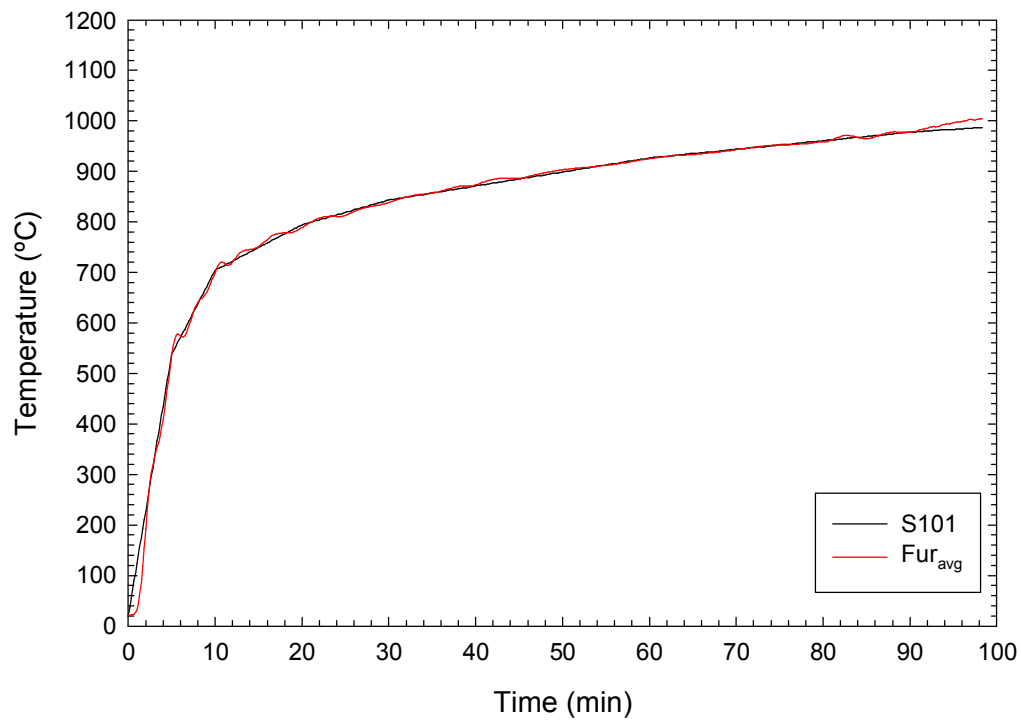
**Figure A-16. Average temperature measured by furnace thermocouples.**

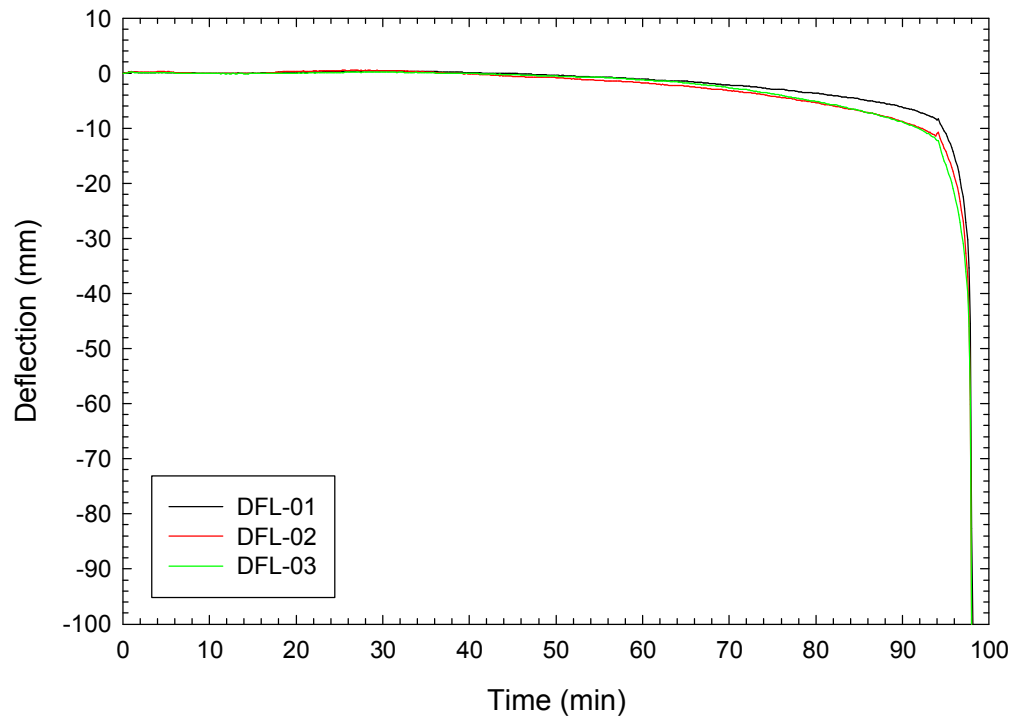
**Figure A-17. Deflections measured at ¼ height from top of wall assembly.**

11. Figures A-17, A-18 and A-19 show the deflections measured at the  $\frac{1}{4}$ , mid- and  $\frac{3}{4}$  heights of the test assembly, respectively.

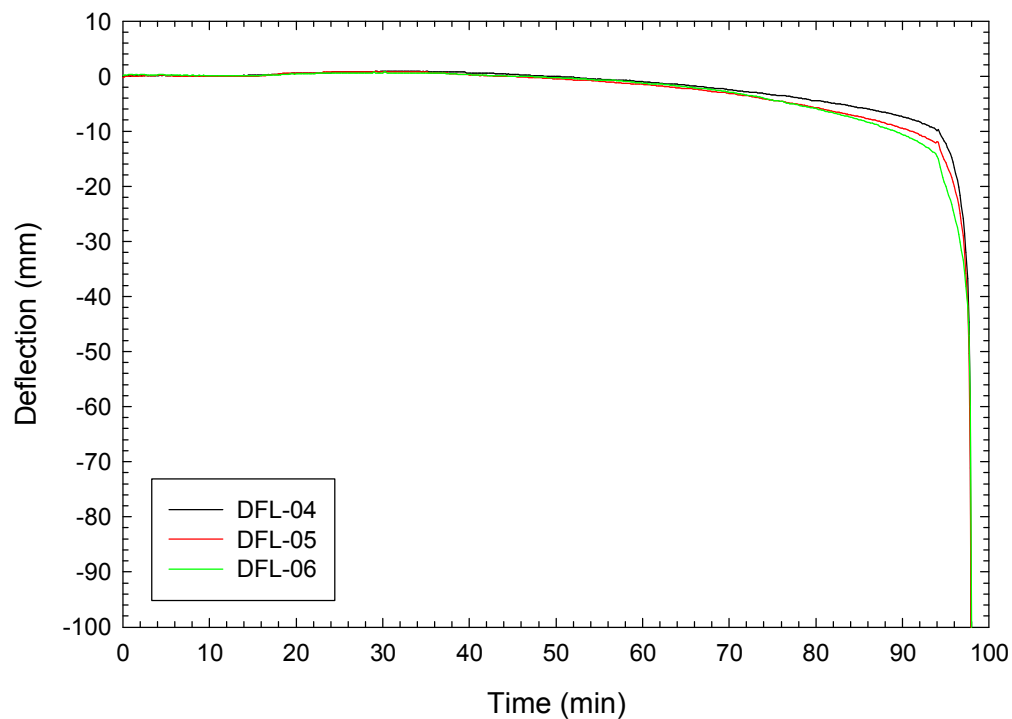
**Figure A-18. Deflections measured at mid-height of wall assembly.**

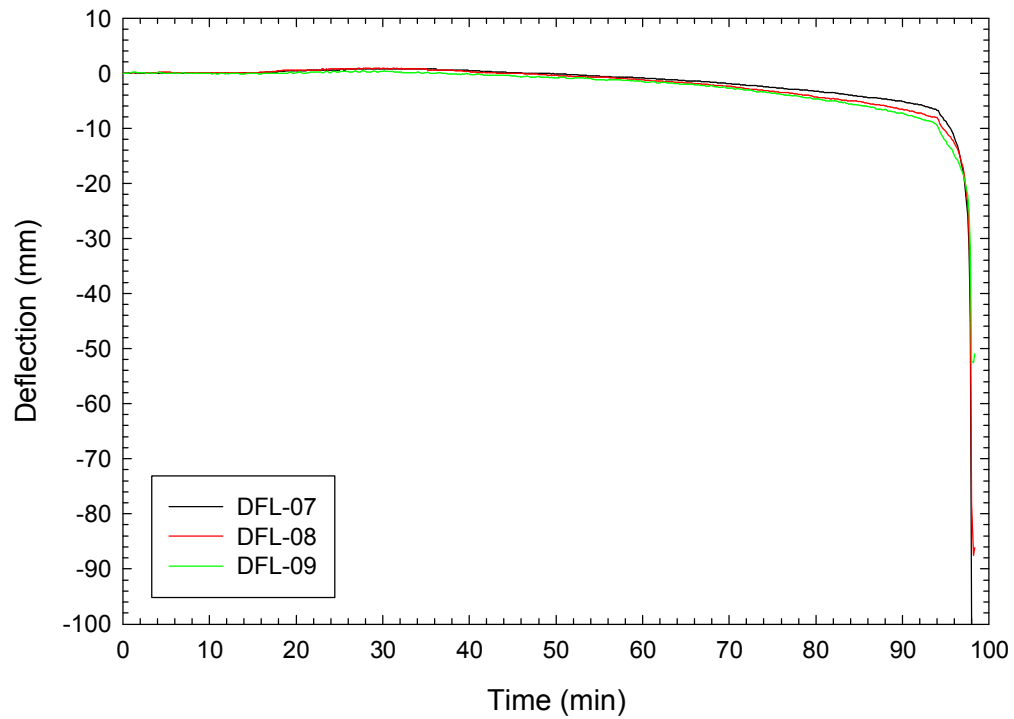
**Figure A-19. Deflections measured at  $\frac{3}{4}$  height from top of wall assembly.**
