SNOW ACCUMULATIONS IN CANADA CASE HISTORIES: II

by D. A. Lutes and W. R. Schriever

Technical Paper No. 339
of the
Division of Building Research

Ottawa
March 1971

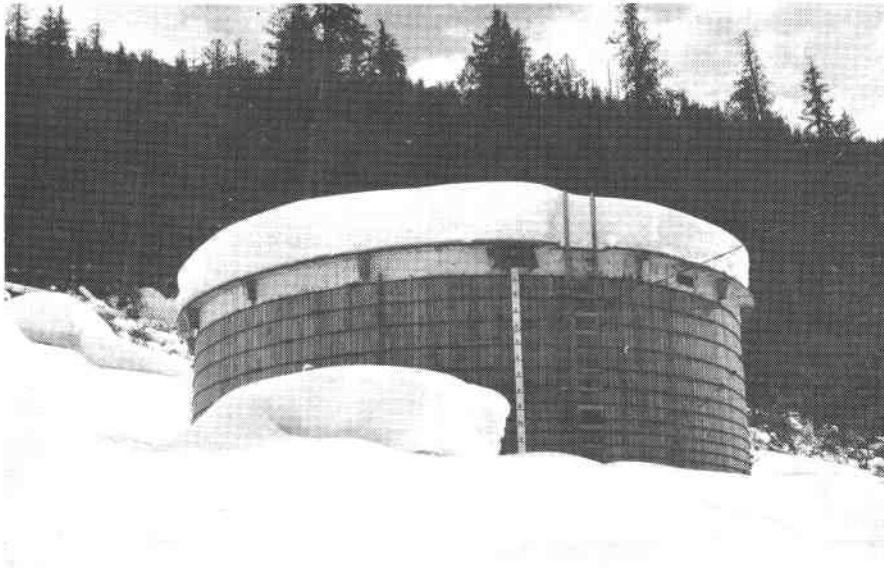
67-23 Very uniform snowcover on circular water tank in calm mountain area. Slope 1:10
(Courtesy CASECO Consultants Ltd.)

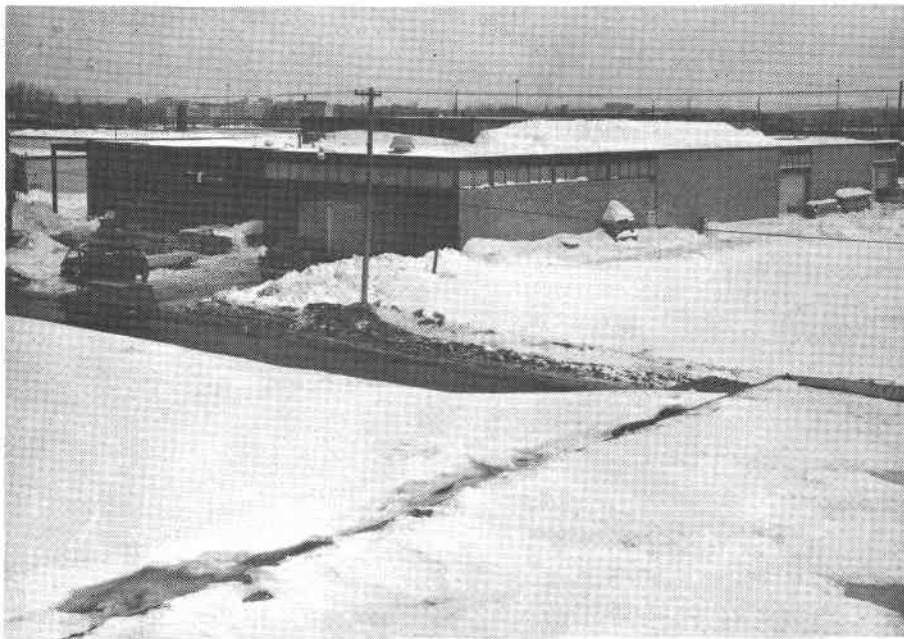
67-24 Triangular drift 6 ft deep on main roof adjacent to large raised portion.

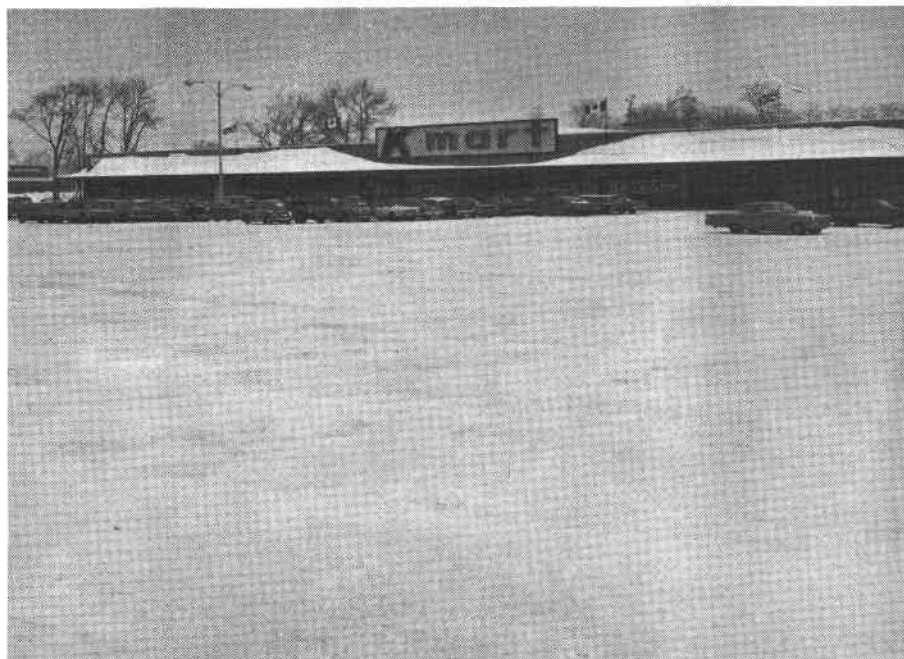
67-30 Front view of large drifts on canopy
adjacent to higher main roof. Note
effect of sign on snow accumulation.

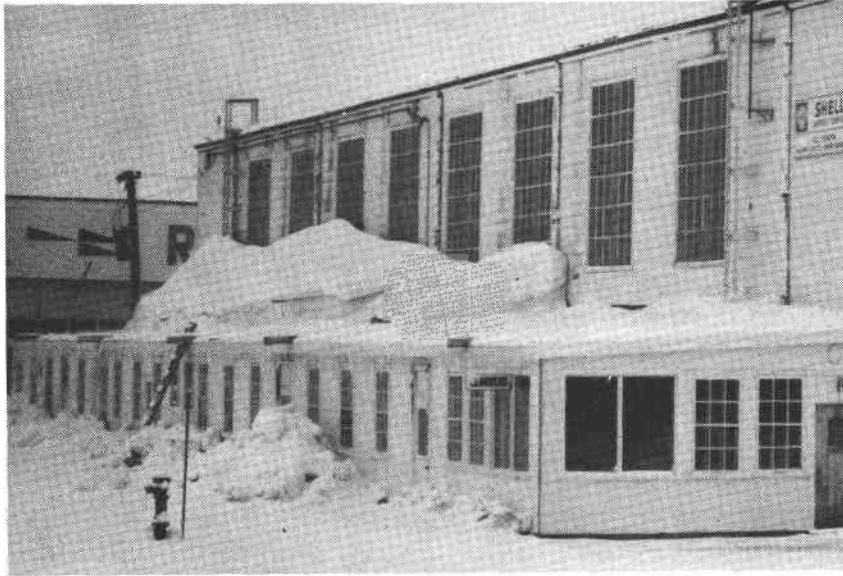
69-1 Drifts up to 10 ft on lean-to roof adjacent (west) to higher main roof. (Courtesy of M. Drouin.)

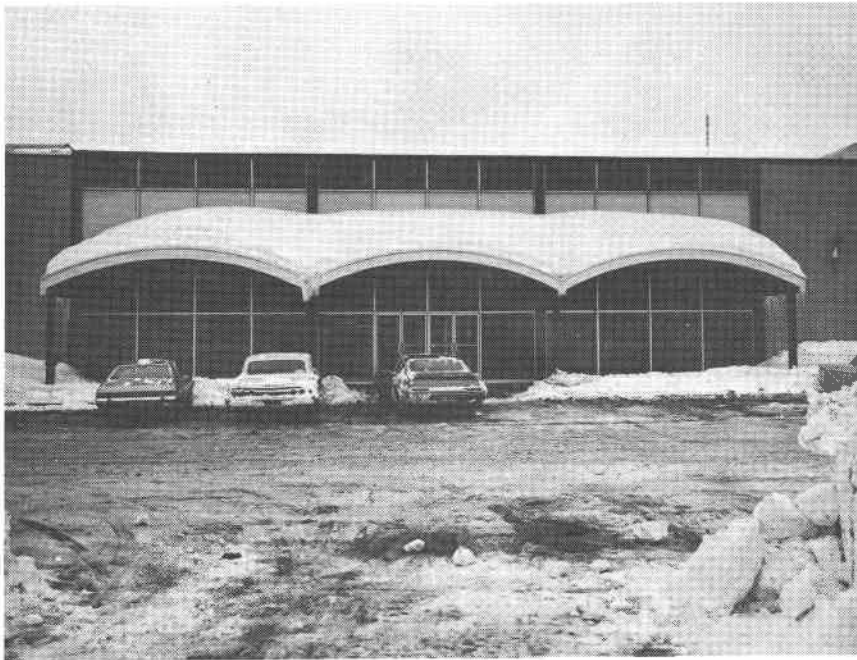
70-4 Large drifts on barrel canopies adjacent to higher, very large flat roof.
