Solutions for Mid-Rise Wood Construction: Second Apartment Fire Test with Encapsulated Lightweight Wood Frame Construction

CLIENT REPORT: A1-004620.1

December 31, 2014

G.D. Lougheed and J.Z. Su

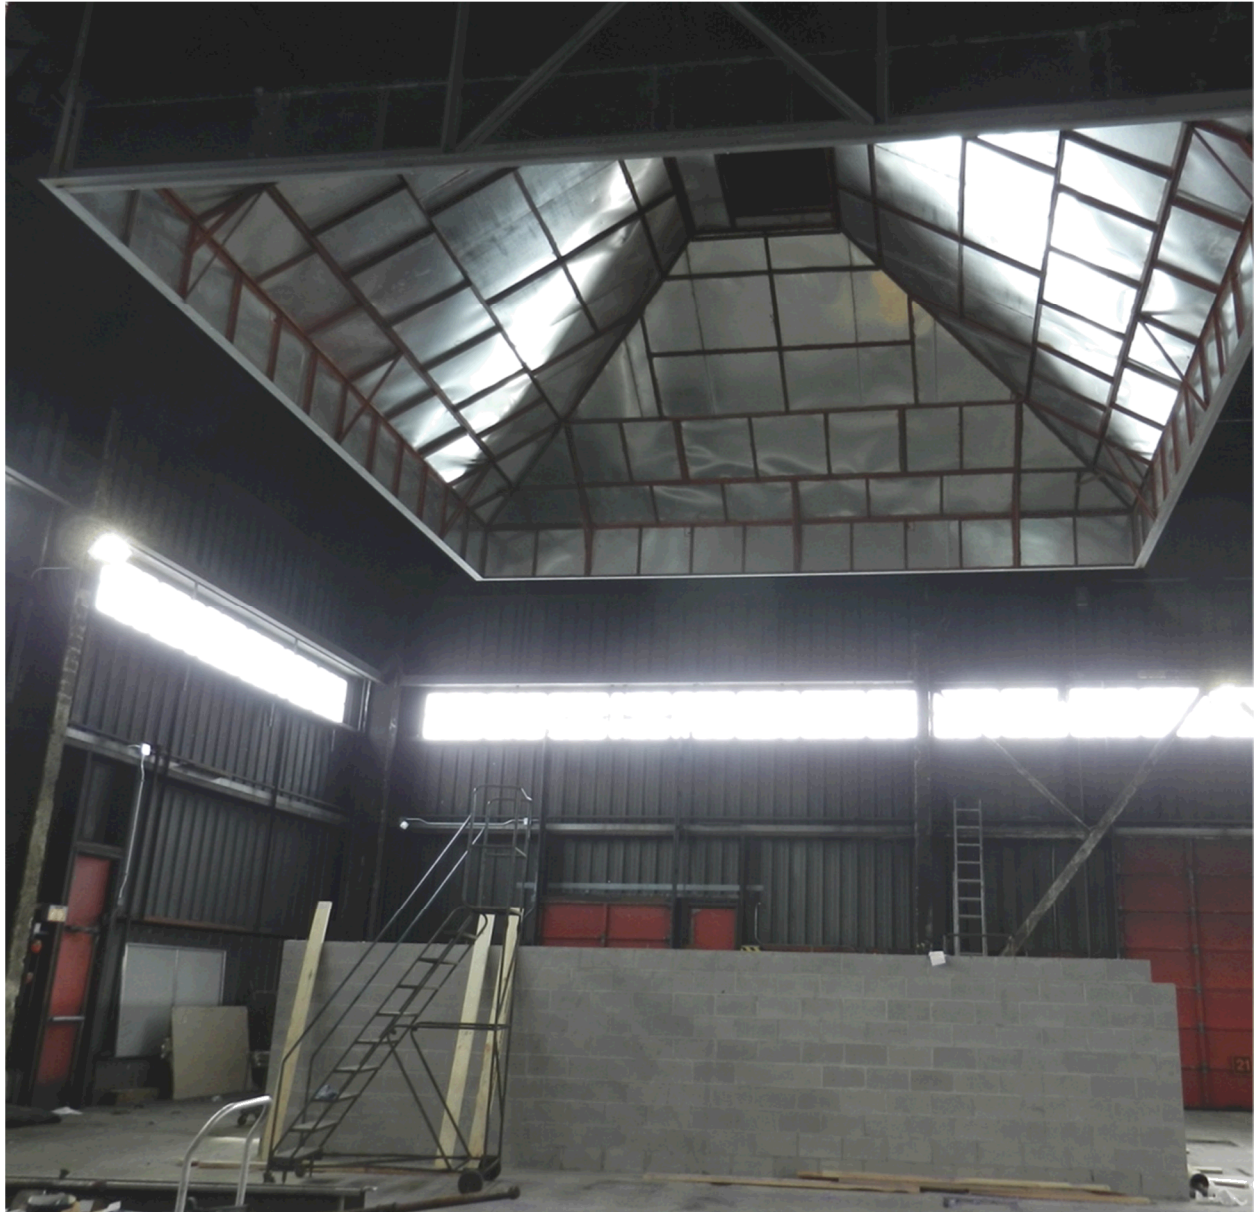
Figure 1. Photograph showing lowest (first) storey concrete block walls and exhaust hood.

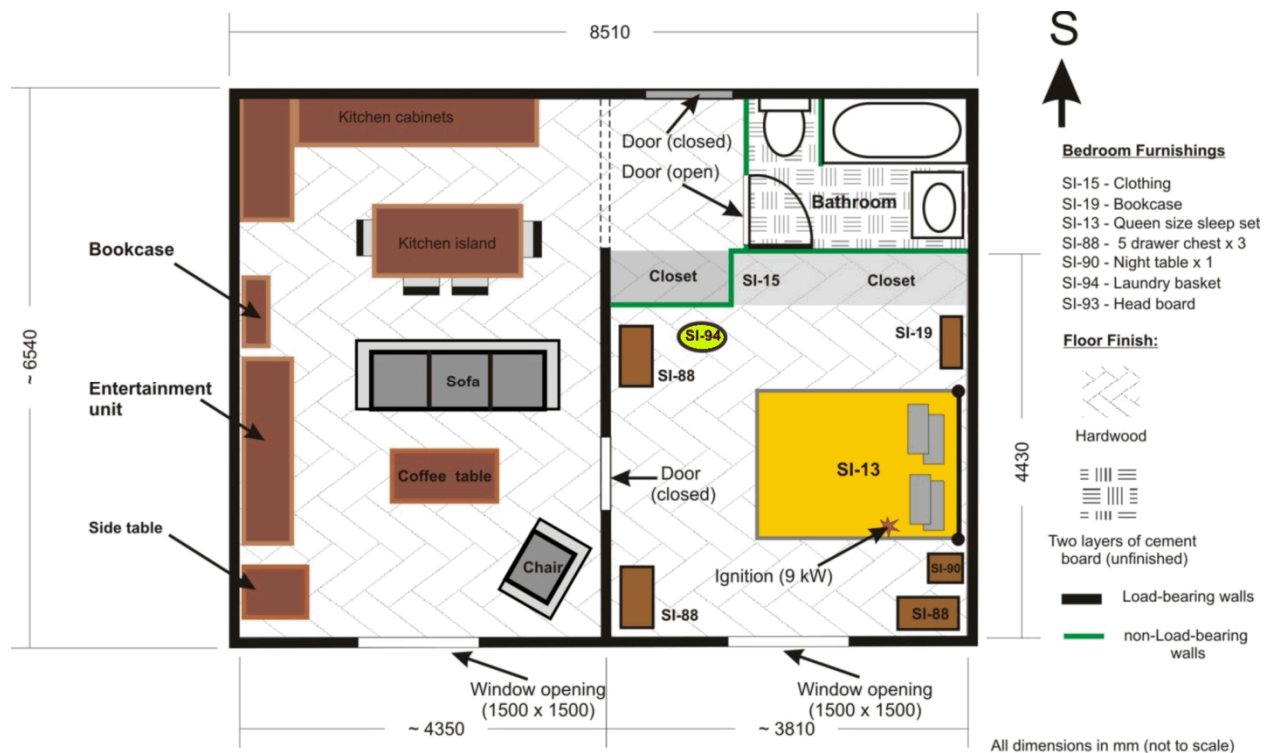
Figure 6. Fuel load.

The bedding on the bed assembly was the first item ignited. It was ignited using a 9 kW T-burner that was positioned at a distance of 470 mm from the head of the bed (Figure 6). The same ignition scenario was used in the full-scale bedroom fire tests discussed in Reference [10].

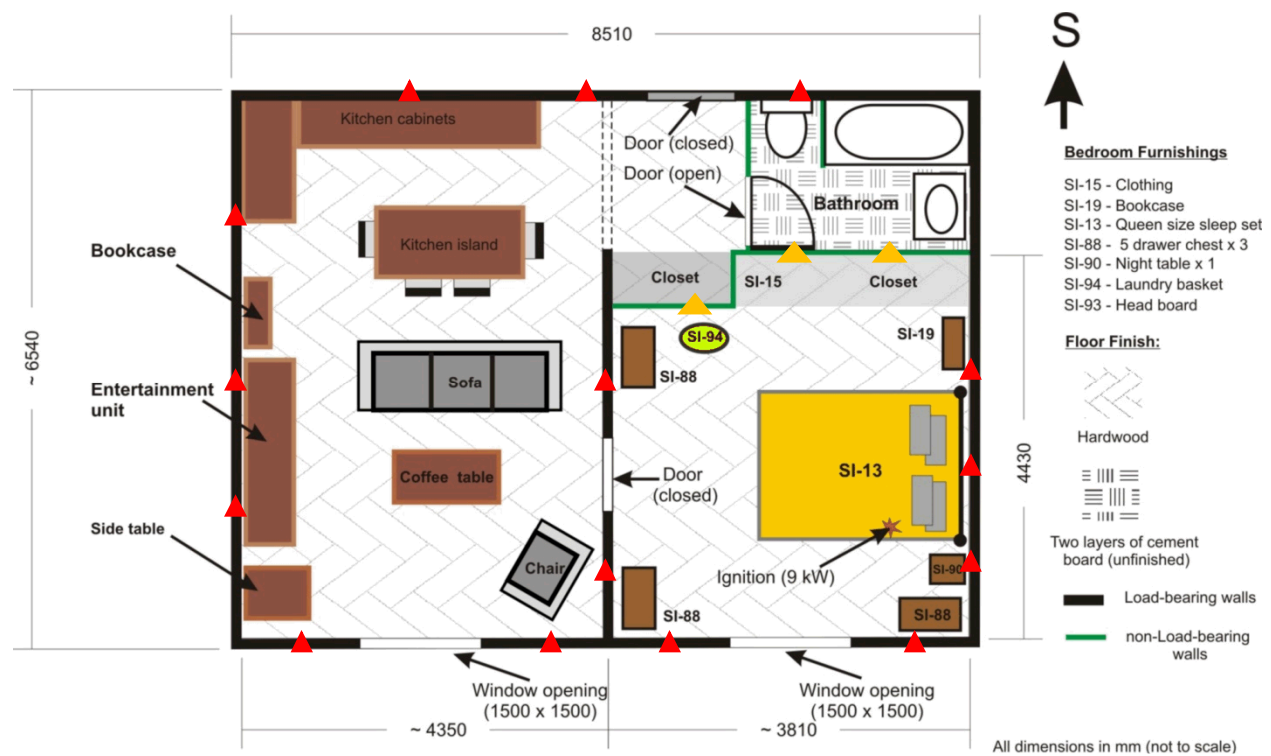
Figure 8. Sketch showing locations of thermocouples in wall cavities. (The locations indicated by ▲ had thermocouples located at the 0.6, 1.2 and 1.8 m heights. The locations indicated by ▲ had a single thermocouple at the 1.8 m height.)
