### **Fire Performance of Houses. Phase I. Study of Unprotected Floor Assemblies in Basement Fire Scenarios. Part 4 - Results of Test UF-05 (Metal-Plate Wood Trusses)**

## **Fire Performance of Houses**

### **Phase I**

### **Study of Unprotected Floor Assemblies in Basement Fire Scenarios**

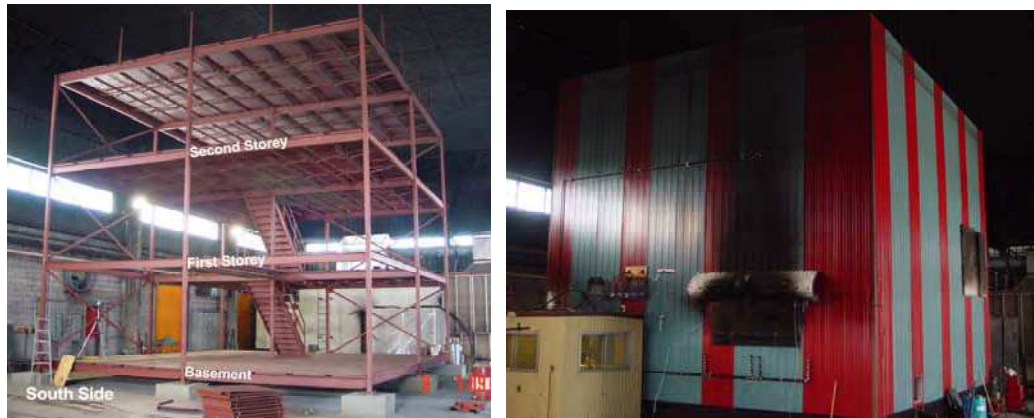
To undertake this research, NRC-IRC constructed a three-level experimental facility, representing a typical two-storey detached single-family house with a basement. The facility allows the study of structural fire performance, as well as smoke movement and tenability under fire conditions for single-family houses. The facility has a total floor area of approximately 95 m<sup>2</sup> per storey and is shown in Figure 2.

**Figure 2. Three-storey facility**

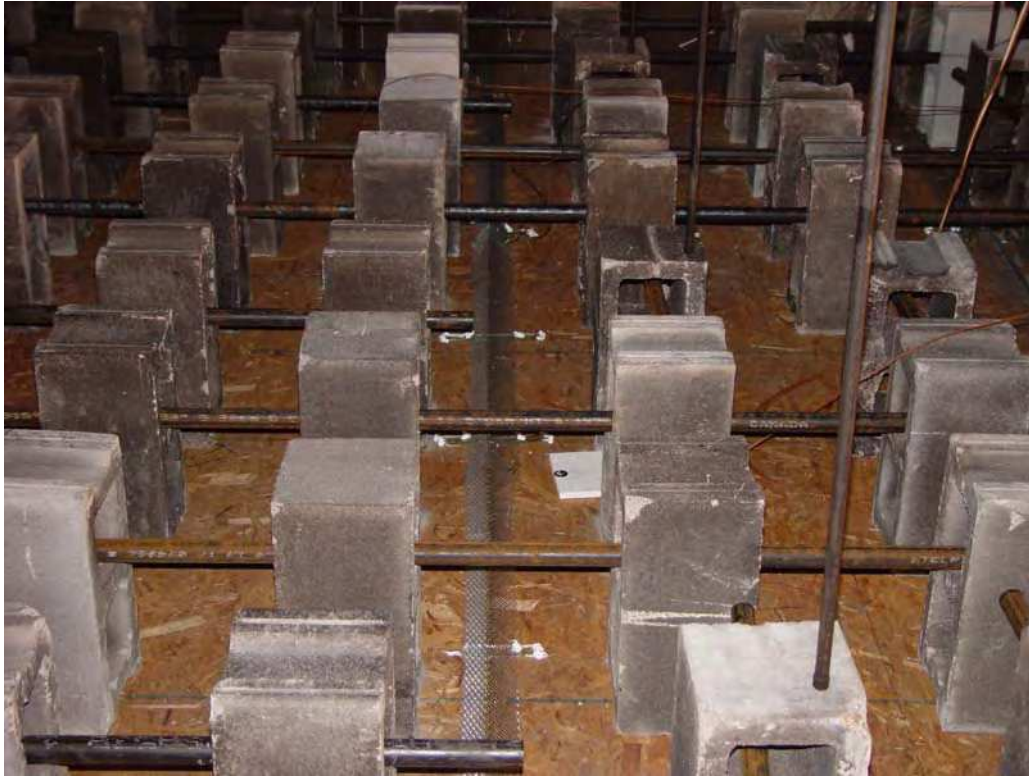
the basement and causing any damage, a restraining system was designed using a series of pipes attached to beams on both ends, which were secured to the steel frame of the 3-storey house, as shown in Figure 19. The pipes were inserted through the hollow cores of the concrete blocks prior to the fire test. The weight of the pipes was included in the total imposed load.

**Figure 19. Device to hold the loading blocks**
