Roof temperatures and ice dams

DBR INTERNAL REPORT NO. 426

ROOF TEMPERATURES AND ICE DAMS

by J.K. Latta

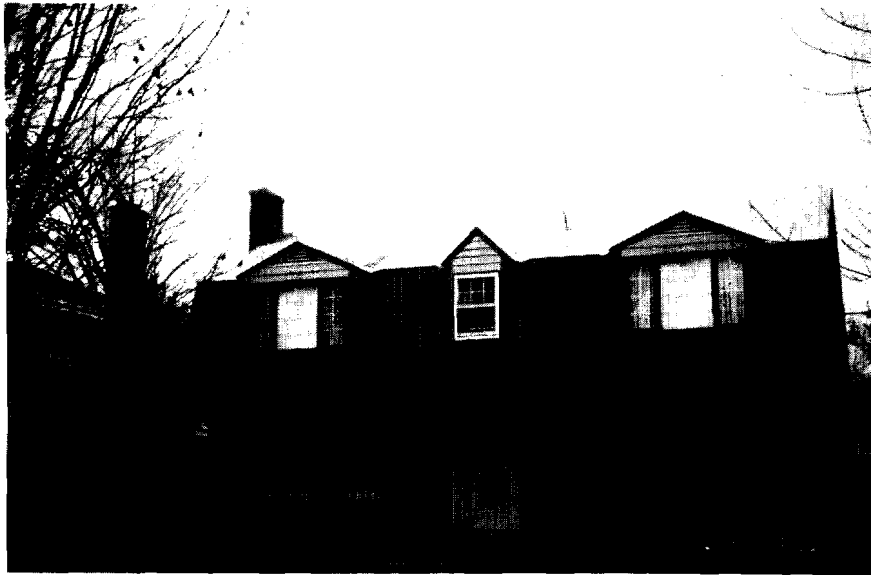
FIGURE 1 FRONT ELEVATION OF HOUSE

Figures 1 to 8 illustrate front and rear elevations, a cross section of the house, some details of construction, and the location of the thermocouples. These were installed at the time of construction on the outside of the roof deck or roof/wall sheathing before the application of the underlay and shingles. The leads were run down to the basement where they were connected to a 16 point speedomax recorder. The front of the house faced 12° west of north. The slope of the upper roof was $25\frac{1}{2}^{\circ}$, and that of the back (south facing) roof/wall was 67° from the horizontal. (The slope of the front roof/wall was slightly steeper.) The sun's rays, therefore, would strike the upper roof approximately at right angles in mid-summer and the rear roof/wall approximately at right angles in mid-winter.

In passing, it may be observed that the tunnel under the snow, which can be seen in Fig. 9, was caused by an air leak which allowed hot air to flow up the rafter space and warm the roof sheathing along this line as is shown by the pattern of frost on the roof seen in Fig. 1.

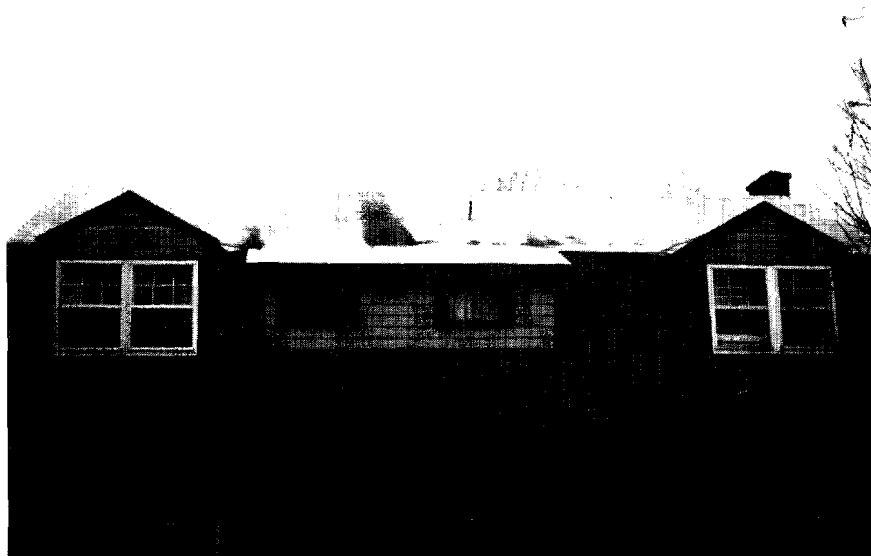
FIGURE 2 REAR ELEVATION OF HOUSE

The temperatures recorded in the ventilation space on the south side of the extension did not correspond to those in the space on the original house. They were consistently higher by 10 or even 20 F deg during the night and peaked at about 60°F during the day as compared to 30 to 35°F in the original house. This, as noted earlier, leads one to the conclusion that the air in this space on the extension was being warmed to some extent by a convective leakage of air from inside the house. This theory is supported by the absence of frost on the roof to the right of the left dormer as seen in Fig. 2.

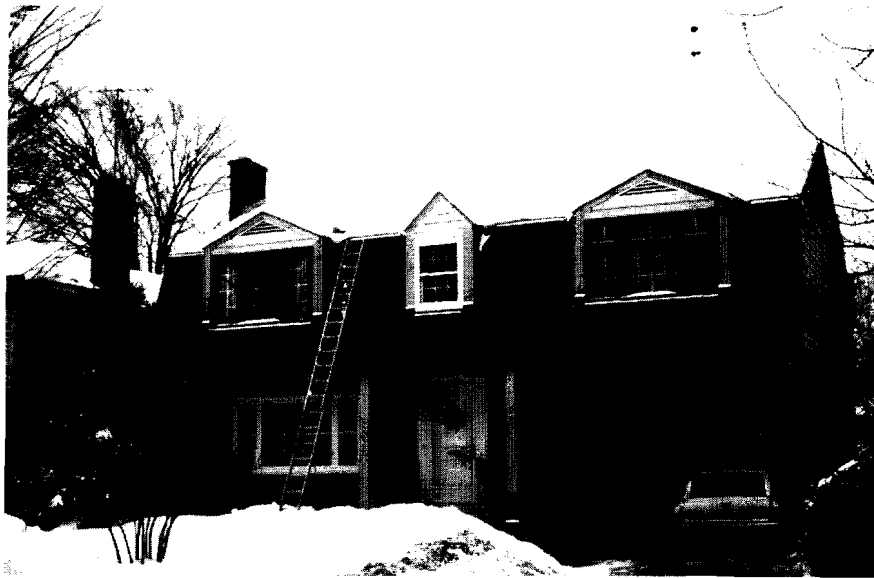
FIGURE 9 SNOW COVER ON NORTH ROOF 24TH DECEMBER 1972

Consider the conditions on 6th, 7th and 8th January 1973. There is no record of the depth of snow on the roof but a photograph taken on 24th December 1972 (Fig. 9) shows about 6 in. on the north roof; a second one taken on 3rd January 1973 (Fig. 10) shows slightly more snow. A third photograph, also taken on 3rd January 1973 (Fig. 11), shows about 3 in. of snow on the south roof. The weather records for Ottawa International Airport show that December 1972 was a month of more than average snowfall. The following snowfalls were recorded between 24th December and 6th January:

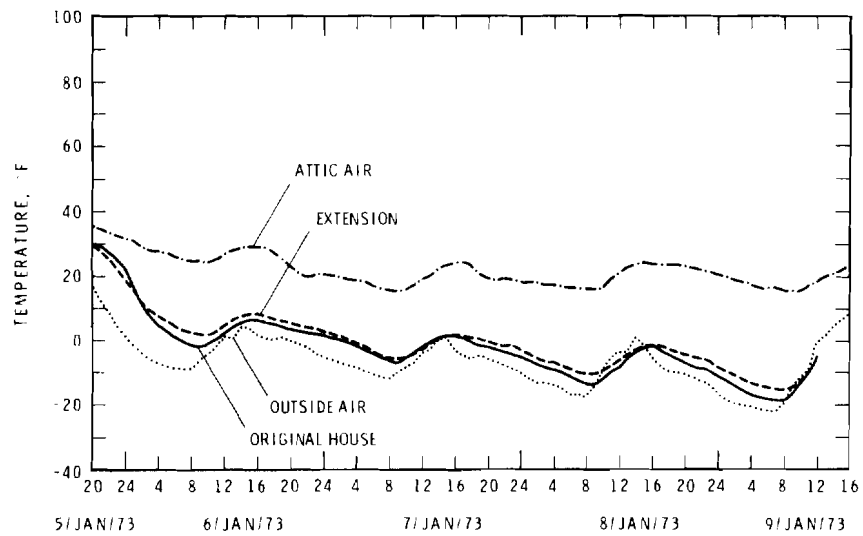
FIGURE 12
SHINGLE TEMPERATURE 1 FOOT FROM EAVE, NORTH SIDE

- (1) Shingles 1 ft. from eave on the north side (Fig. 12).

There was no great difference between the temperatures of the shingles on the original house and the extension, the maximum difference being less than 4 F deg between 0800 and 0900 hr on the 6th. The temperatures were between 0 and 10 F deg warmer than the outside air. They also lagged behind the air temperature by 1 to 2 hr and so tended to be closest to it shortly after noon when the air temperature was at its maximum.

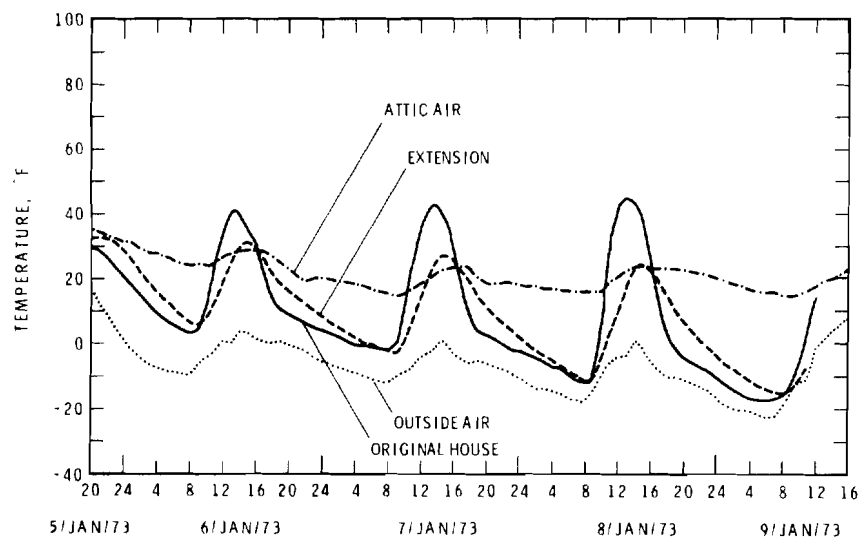
FIGURE 13
SHINGLE TEMPERATURE 1 FOOT FROM EAVE, SOUTH SIDE

- (2) Shingles 1 ft. from eave on south side (Fig. 13).

The temperature of the shingles rose well above the ambient air temperature and, in fact, above the attic temperature on both the original house and the extension. Those on the original house reached a maximum of 43°F at 1330 hr on the 7th, compared to a maximum attic temperature of 24°F which was not reached until 1600 hr. The differences in temperature were not so great on the extension, being 3°F above attic temperature at 1500 hr. No definite explanation can be offered for the difference between the two thermocouples. It may be noted, however, that the ventilation space in the wall of the original house is connected to the attic just below the location of the thermocouple. It is possible that air in this space was warmed by the sun and rose to flow over the underside of the roof boards. The maximum temperature recorded in the ventilation space was about 5 to 10 F deg cooler than the maximum shingle temperature, but it preceded the shingle temperatures slightly. The photograph taken on 3rd January (Fig. 11) shows that there was more ice along the conventional eave of the extension where that thermocouple was located than on the

original house. The sun, therefore, may not have been able to warm the roof at that point as easily as on the original house. It may be noted also that the maximum temperature recorded each day for the shingles on the original house rose slightly day by day despite a falling air temperature. The peak temperatures of the attic and the shingles at the other locations tended to fall.

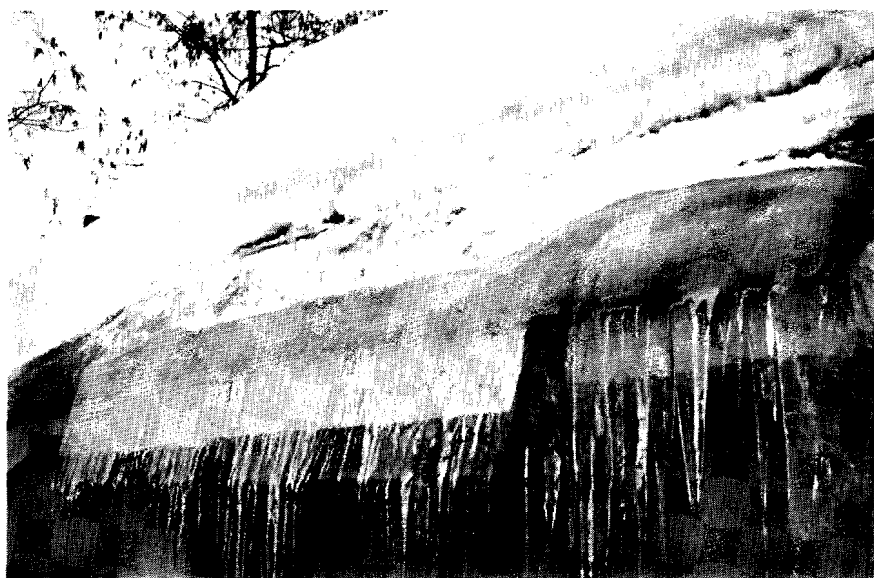
FIGURE 17 REDUCTION AND ICE ACCUMULATION OVER
MODIFIED WEST-FACING EAVE

It would seem that considerable benefit in the control of ice dams could be obtained on southerly exposures if the edge of the roof could be kept clear of snow. The presence of an eaves trough to contain the snow would probably prevent this edge clearing occurring by natural means and also hinder any attempt by the owner to clear the roof edge manually. It is unlikely that a similar clearing on the north eave would have any effect. In an endeavour to verify the effect of a snow-free edge on the roof, a small steeply-sloping extension to which the snow would not stick was built onto half of the eave over the bathroom and the snow and ice accumulations on the two halves were compared during the winter of 1974-75. It was found that the icicle formation below the extension was much greater than that on the unmodified eave (Fig. 14). It was found later that there was no ice on the roof above the extension (Fig. 15) whereas a small ice dam had started to form on the other half (Fig. 16). In the early part of the winter, however, the conditions were such that many icicles were formed but later conditions were not conducive to the formation of large ice dams. The evidence is therefore not conclusive. Earlier studies conducted during the winter of 1972-73 on the west facing eaves of other houses indicated that only slight benefit could be obtained from similar eave extensions (Fig. 17).

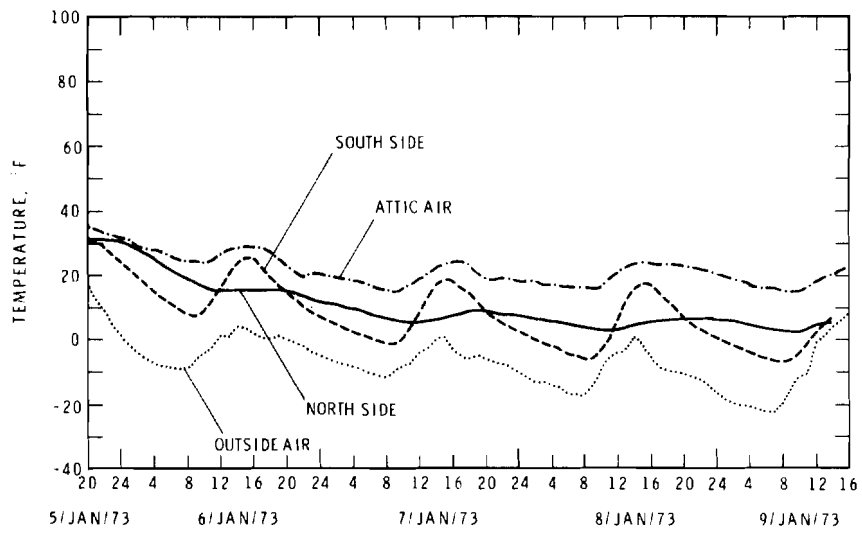
FIGURE 18
SHINGLE TEMPERATURES, 4 FEET FROM RIDGE ON THE ORIGINAL HOUSE

(3) Shingles 4 ft. from the ridge (original house) (Fig. 18).

The temperatures of these roof shingles were between those of the outside air and the attic. They fluctuated in sympathy with the changes in the other two and that on the south side responded also to the effects of solar radiation

The north side shingle fluctuated in temperature less than either the outside air or the attic, varying less than 5 F deg compared with 8 or 9 F deg for the attic and 15 to 25 F deg for the outside air.

Maximum temperatures were also reached at different times: 1400 to 1500 hr for the outside air, 1500 to 1700 hr for the attic and 1800 to 2200 hr for the shingle, which remained at or near its maximum temperature for longer periods of time.

On the south side, the shingle temperature fluctuated much more than that on the north side owing to the influence of the sun. It varied through a range of 20 to 25 F deg and although it peaked after the outside air temperature, this peak sometimes preceded that of the attic air temperature. At no time during the period under consideration did it exceed the attic temperature indicating that, with about 8 in. of snow on the roof, the heat flow was always outwards. In other words, no heat was transferred to the attic through solar radiation penetrating the roof. It should also be noted that of the six roof shingles whose temperatures were recorded, only the temperature of the shingles 1 ft from the eave on the south side of the old house rose above attic temperature to any appreciable degree and for any length of time. Thus the direct solar heat gain to the attic through this depth of snow on the roof may well be minimized. The rise in attic temperature would therefore seem to be the result of a balance between a more or less constant heat loss from the house and ventilation with outside air. In the case of this particular house with its somewhat unusual roof and wall construction it is possible that solar heat gain through the shingles on the lower roof/wall into the ventilation space also affected the attic temperature. This space, however, covered only 13 ft on the south side out of a total length of 39 ft.

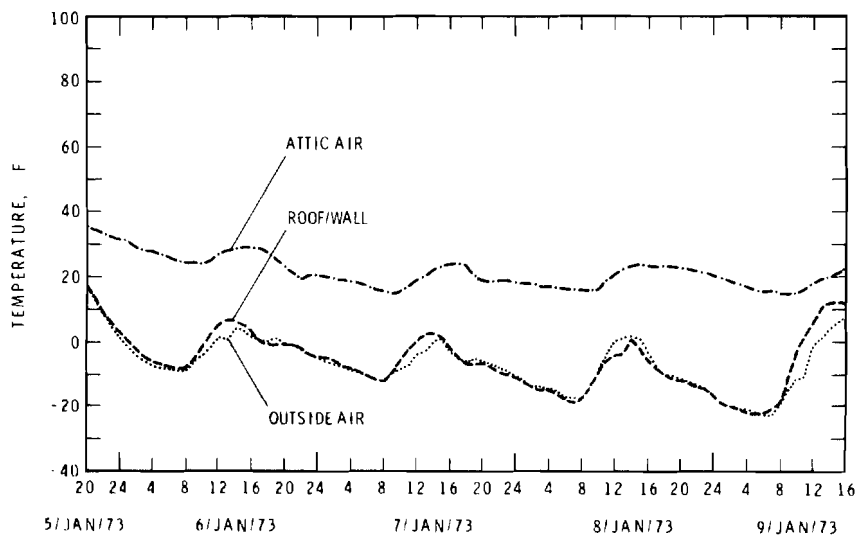
FIGURE 19
ROOF/WALL SHINGLE TEMPERATURE, NORTH SIDE, ORIGINAL HOUSE

- (1) Roof/Wall shingles on the north side (Fig. 19).

The shingles on both the old house and the extension followed almost identical temperature patterns, which were also very similar to those of the outside air. During the day, the shingle temperature rose more rapidly than the air temperature and was two or three degrees warmer about midday when the air temperature was close to 0°F. Overnight, there was very little difference between the shingle and air temperatures although the shingles tended to be a degree or so colder.
