Fire Performance of Houses. Phase I. Study of Unprotected Floor Assemblies in Basement Fire Scenarios. Part 5 - Results of Tests UF-06, UF-06R and UF-06RR (Wood I-Joists B)

Part 5 – Results of Tests UF-06, UF-06R and UF-06RR (Wood I-Joists B)

Research Report: IRC-RR-250

Date: March 31, 2009

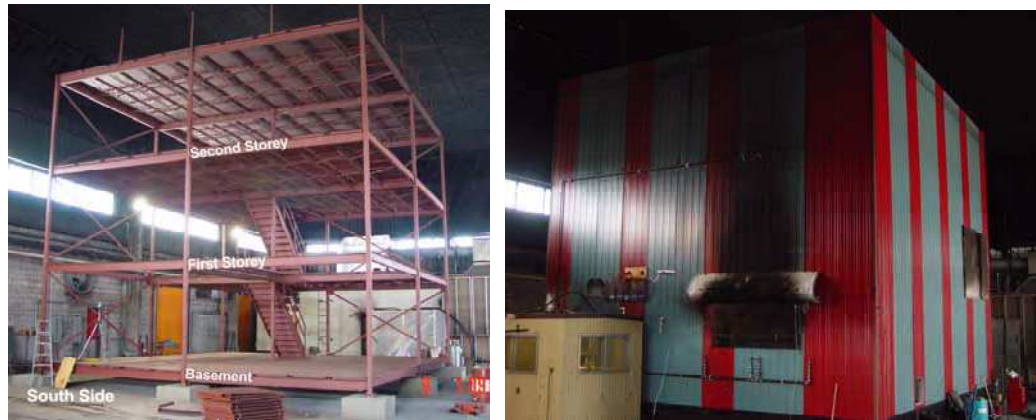
To undertake this research, NRC-IRC constructed a three-level experimental facility, representing a typical two-storey detached single-family house with a basement. The facility allows the study of structural fire performance, as well as smoke movement and tenability under fire conditions for single-family houses. The facility has a total floor area of approximately 95 m² per storey and is shown in Figure 2.

Figure 2. Three-storey facility

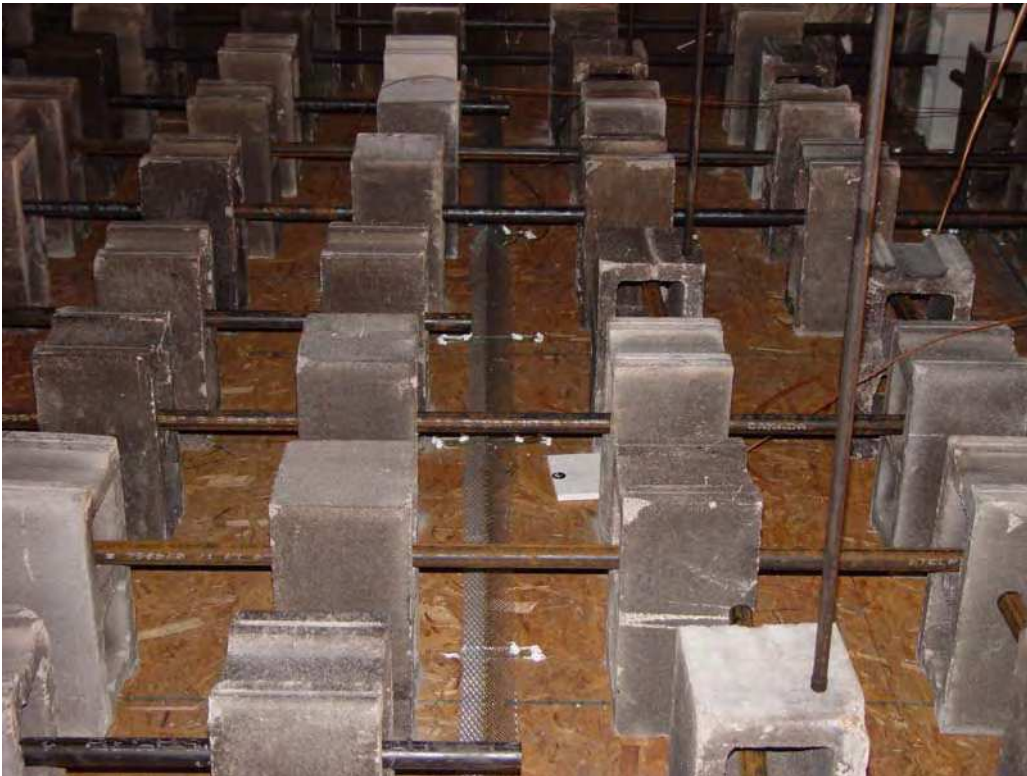
The loading method consisted of 144 concrete blocks (totalling 2490 kg) distributed uniformly on the floor as shown in Figure 18. The blocks were 190 x 190 x 390 mm (nominal 8" x 8" x 16") and weighed 17.3 kg each. To prevent the blocks from falling into the basement and causing any damage, a restraining system was designed using a series of pipes attached to beams on both ends, which were secured to the steel frame of the 3-storey house, as shown in Figure 19. The pipes were inserted through the hollow cores of the concrete blocks prior to the fire tests. The weight of the pipes was included in the total imposed load.

Figure 19. Device to hold the loading blocks
