MODEL TESTING OF AN EVACUATION SYSTEM IN ICE-COVERED WATER WITH WAVES

**CHC TECHNICAL REPORT
CHC-TR-025**

PERD/CHC Report 61-6

JULY 2004

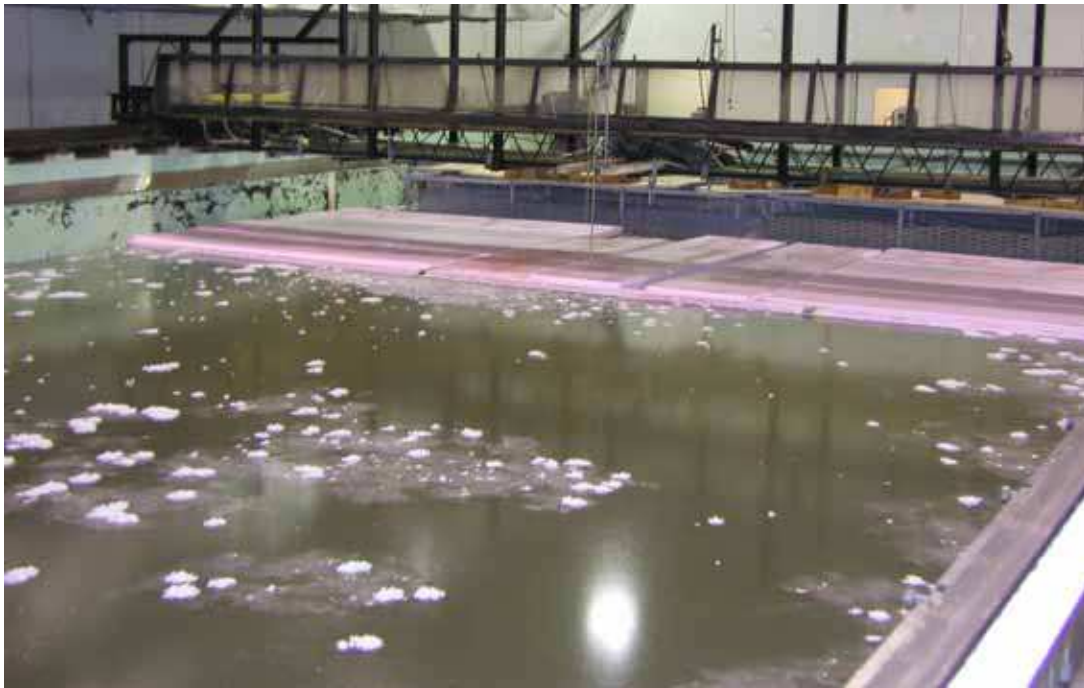
Figure 2 Preparing an ice sheet. Rigid insulation covers the water surface in order to control the concentration of ice in the tank.

In order to achieve the desired concentration of ice in the tank, large sheets of rigid insulation were laid across the tank prior to freezing. At 8/10ths concentration, 14 sheets of insulation were required and these were laid on top of the water (Figure 2). On the morning of testing with the 50 mm thick ice, the temperature in the ice tank chamber was raised to hover around 2°C. The rigid sheets of insulation were removed, and staff randomly broke the ice using rakes and hoes in order to break up the ice sheet into floes. A photograph of the ice sheet after being broken into floes is shown in Figure 3. Figure 4 shows an example of an average piece size (approximately 20 cm). In order to achieve a lower concentration of ice on the second day of testing, wave action alone succeeded in lowering the concentration by the end of the first day of testing. However some additional ice was melted by raising the holding temperature of the ice tank overnight.

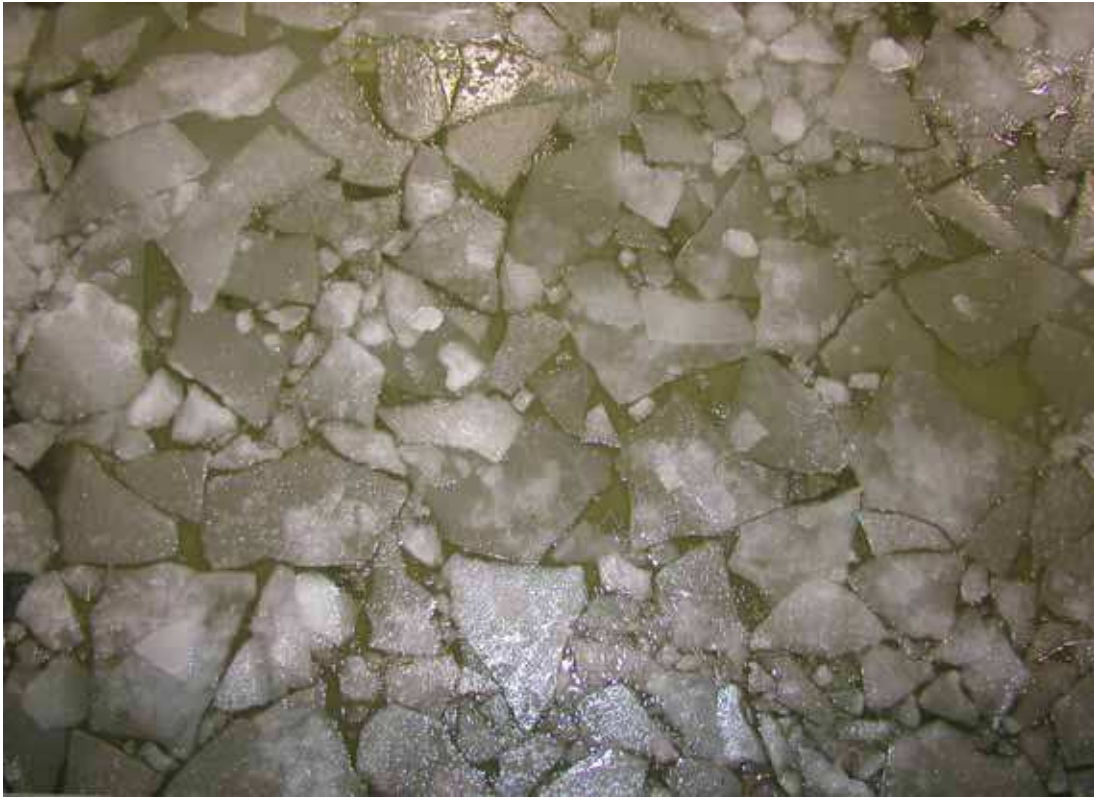
Figure 3 Piece size distribution after breaking up an ice sheet.

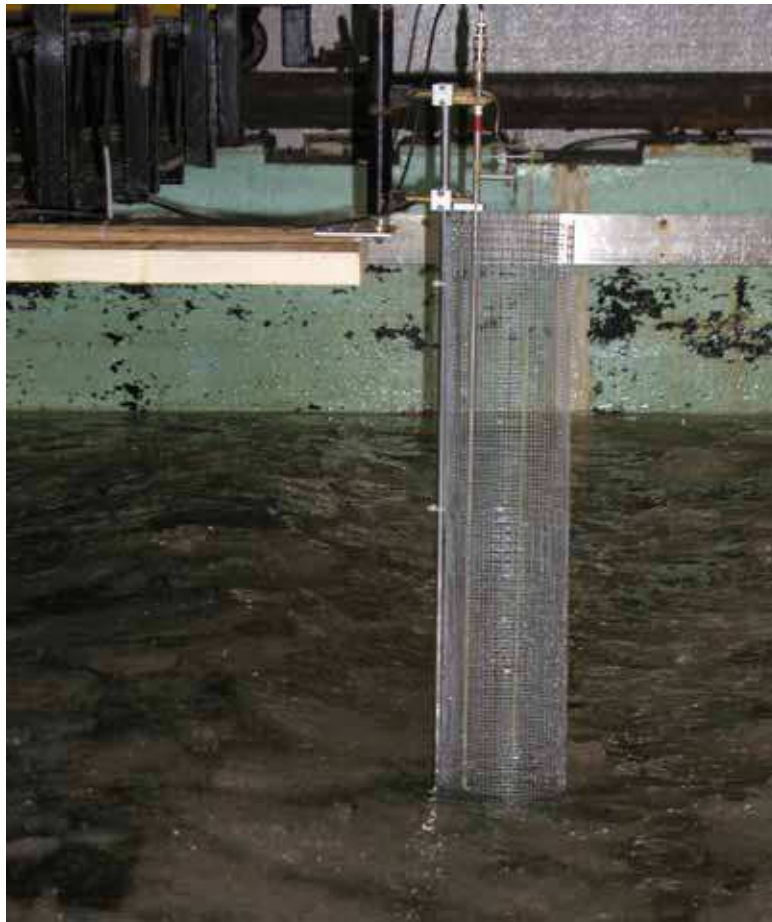
Figure 7 Wave probe with protective cage.

The probes operate by sensing the change in capacitance that occurs as a portion of the insulated wire becomes wetted. The output signal is directly proportional to the percentage of wire that is wetted, regardless of whether the wetting is continuous or intermittent (as with spray). These gauges have been used on many previous occasions and are known to exhibit highly linear and stable water level-to-voltage response. However, they have not been used in ice-covered water conditions. As such, protective coverings made of wire mesh were constructed in order to prevent ice from directly interacting with the probes. It was not always possible to prevent this occurrence however, and by the end of the test program, ice was routinely becoming stuck in the protective cages. The probes were sampled at a rate of 50 Hz. The data acquisition system was controlled using software (GEDAP) developed by CHC. The data from each test were stored in a single binary data file.

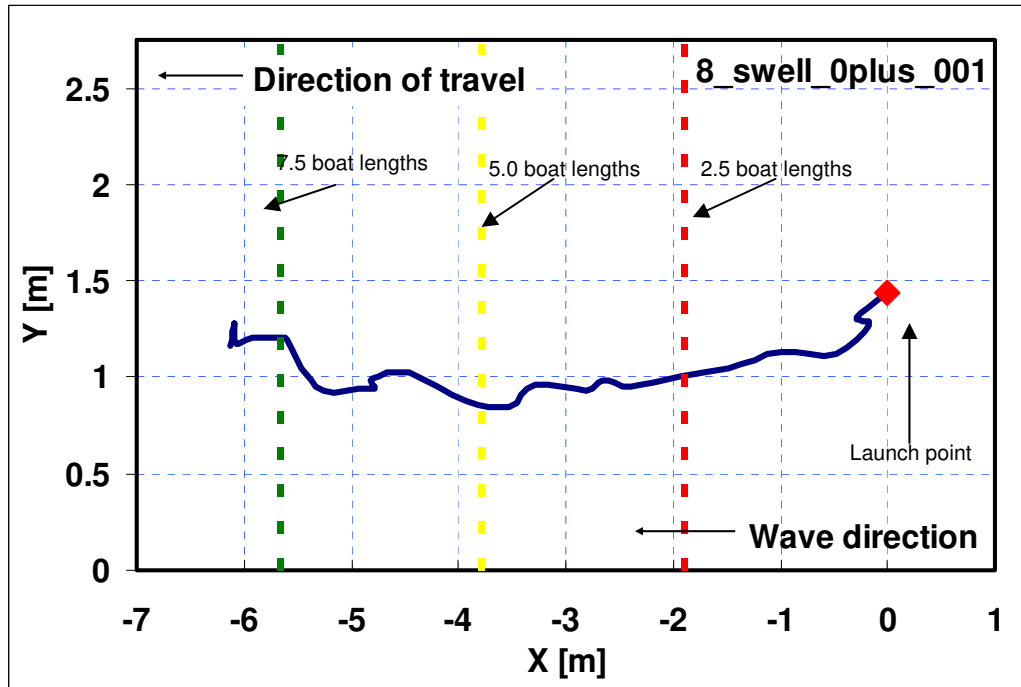
Figure 11 Example x-y output from video analysis. Note that the direction of travel is the intended direction, which not necessarily the heading the vessel achieved.

The data manipulation in Excel was straightforward. There was a correction that had to be made to the data for each test before plotting. The two overhead cameras were in a line, such that the vessel traveled from one camera's field of view into the other. Although the initial video analysis for each camera is separate, the same initial reference point is used for each. This causes the two sets of data to be superimposed rather than continuous. To this end, a correction factor was calculated for camera B videos; a set value was added to the x- coordinates, to account for where the field of view of camera A ended and B should start. Also, the plotting order of the points from camera A and camera B depended on the direction of travel of the vessel. For motion in the positive direction (i.e. with the waves) data from camera B had to be listed before camera A and for a negative vessel direction (into the waves) data points for camera A were plotted before camera B. An example of a typical output plot is shown in Figure 11. The coloured, dotted lines indicate the location of 2.5, 5.0 and 7.5 boat lengths of travel distance. The red diamond indicates the launch location. Note that the direction of travel indicates the intended direction for the lifeboat, either into or with the waves, not the direction that the lifeboat may have ended up traveling.

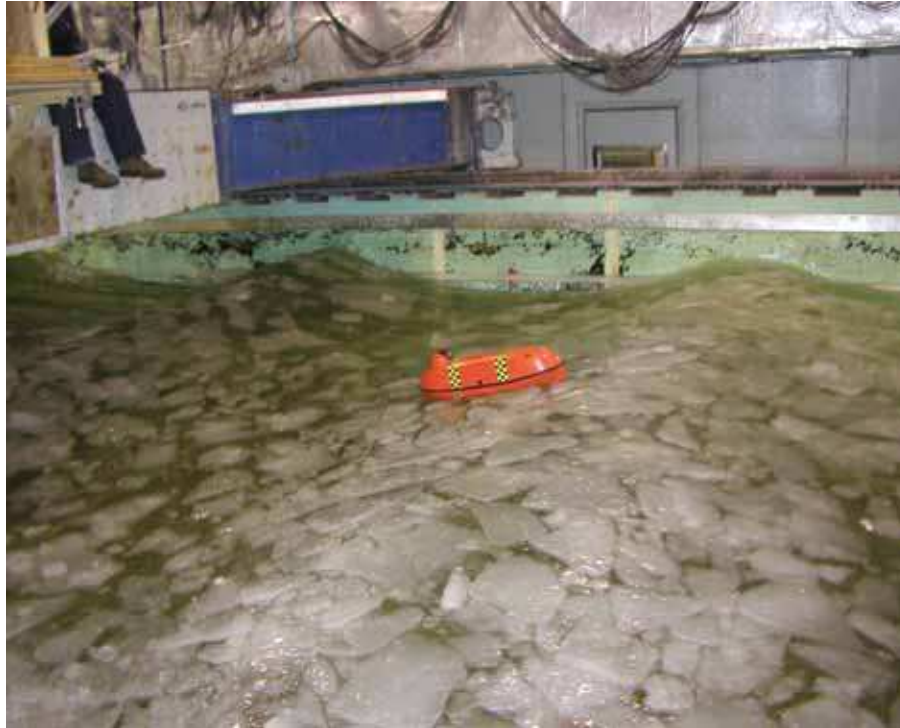
Figure 12 Photograph taken from the side of the tank of TEMPSC traveling through swell waves.

While most tests had at least one overhead video, test 7_swell_0minus had none available for analysis. In most cases, however, video taken from the side of the tank was available to provide qualitative observations of the test, such as whether the pass/fail criterion was met. Figure 12 shows a photograph of the TEMPSC traveling through typical swell conditions, taken from the side of the tank.

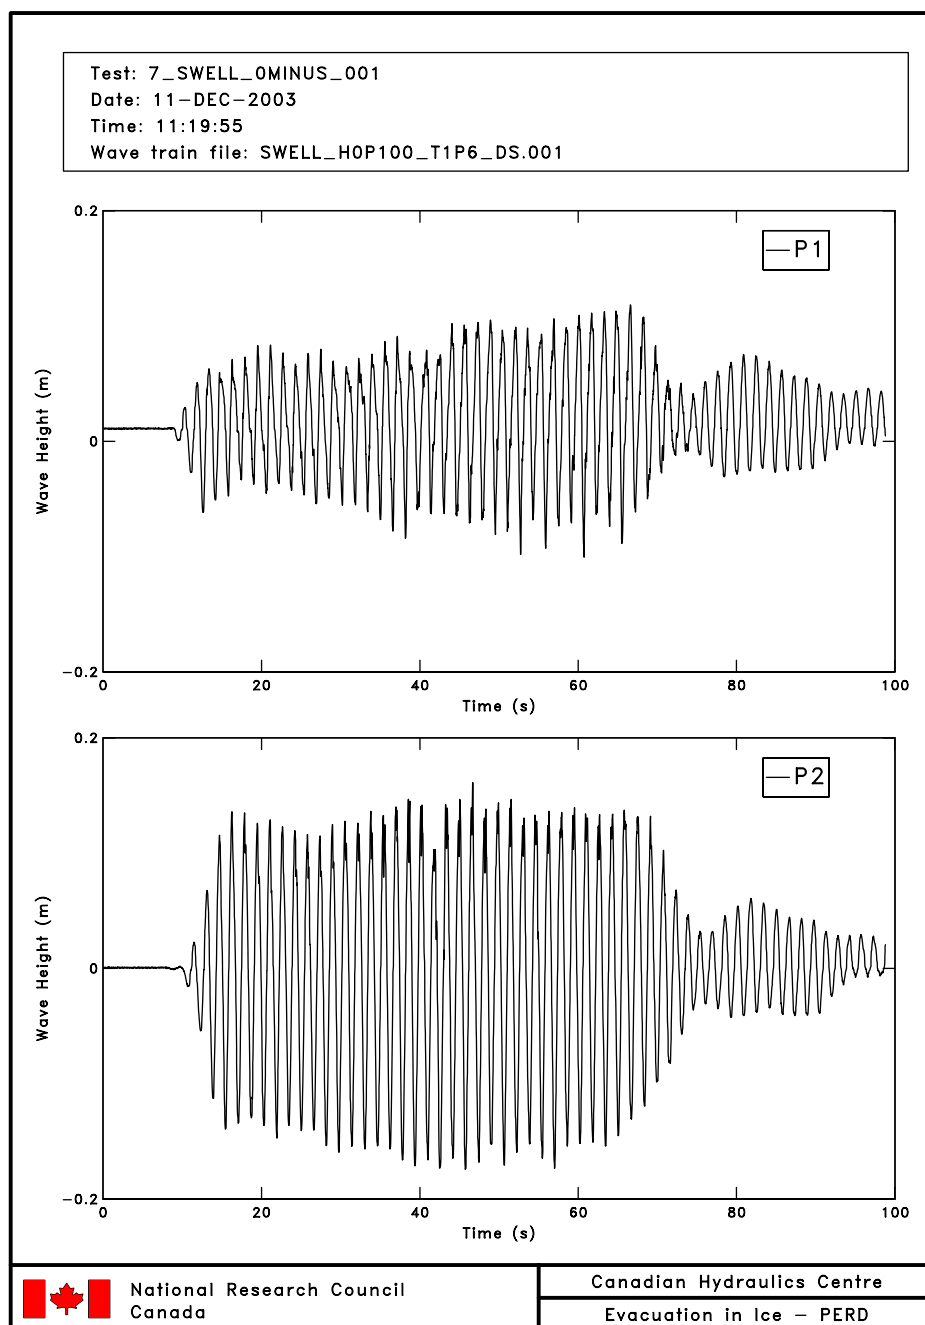
Figure 13 Example of wave analysis output plot.

Plots of the wave probe data after it had been analysed can be found in Appendix E. Instances where the probes were not in the water are indicated in Table 4. An example of the output is shown in Figure 13, which includes the calculated significant wave height for each test (model scale). After the raw data were converted into binary files, basic statistical analysis was performed on the data. Zero-crossing and variance spectral density analysis were performed and a rectangular bandpass filter was applied to the signal. This filter removes all energy in the signal that occurs at frequencies below and above two specified frequencies. A Fourier transform of the input signal was computed and the rectangular bandpass filter was applied in the frequency domain. An inverse FFT was then used to obtain the filtered output signal.

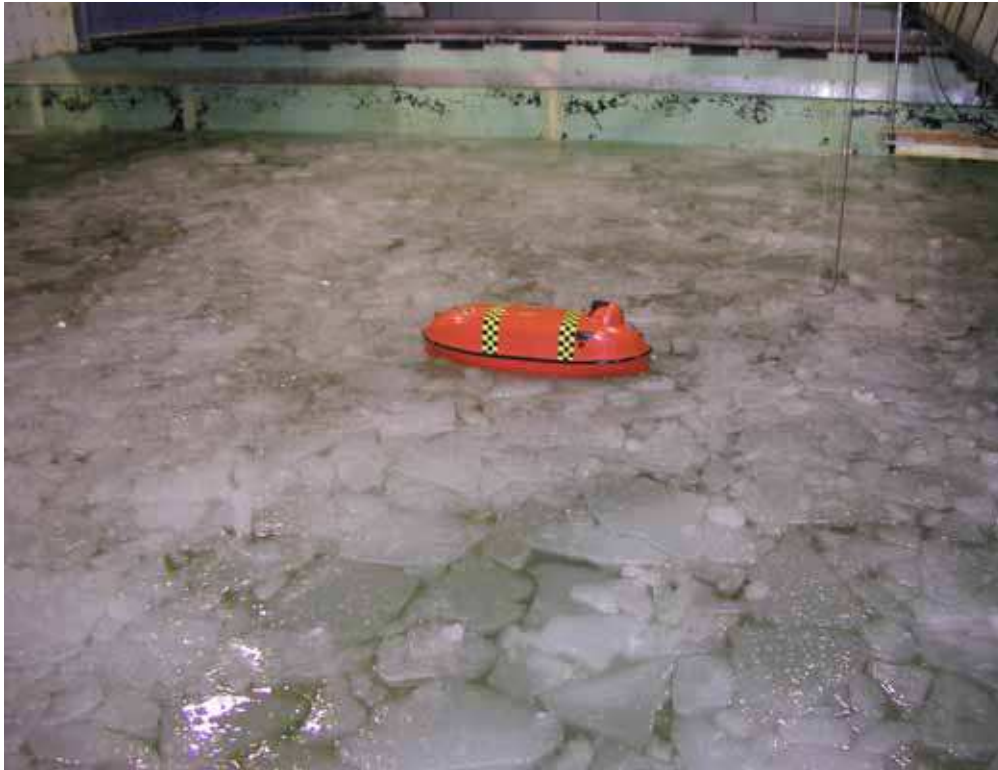
Figure 14 Photograph during a test, showing the rafting and dense concentration of ice at the end of the tank.

It should be noted that unlike the previous test series in ice, where all tests of the same configuration received the same grade (i.e. all tests with small floes at 7/10ths concentration and 25 mm ice thickness passed), this was not the case in the present series. Results with an underscore (_) indicate that there were one or more tests where the TEMPSC became trapped in the ice. This occurred during the testing program because the ice rafted up quickly at the end of the ice tank, limiting the amount of time the TEMPSC could travel through a relatively uniform concentration of ice. Not surprisingly, near the end of every test, the TEMPSC became trapped in what was essentially rafted (2-3 layers of ice), 10/10ths ice and could not move under its own power. This unfortunately resulted in a number of tests where the TEMPSC might have achieved a pass, had there been more room for the vessel to travel. This can be seen by comparing Table 6 with Table 7. In Table 7, the pass/fail criterion is changed to 5.0 boat lengths – note that this clearly illustrates the division between the trials where the TEMPSC successfully traversed the required distance and those where it did not. Figure 14 shows the TEMPSC trapped in ice at the end of a test.

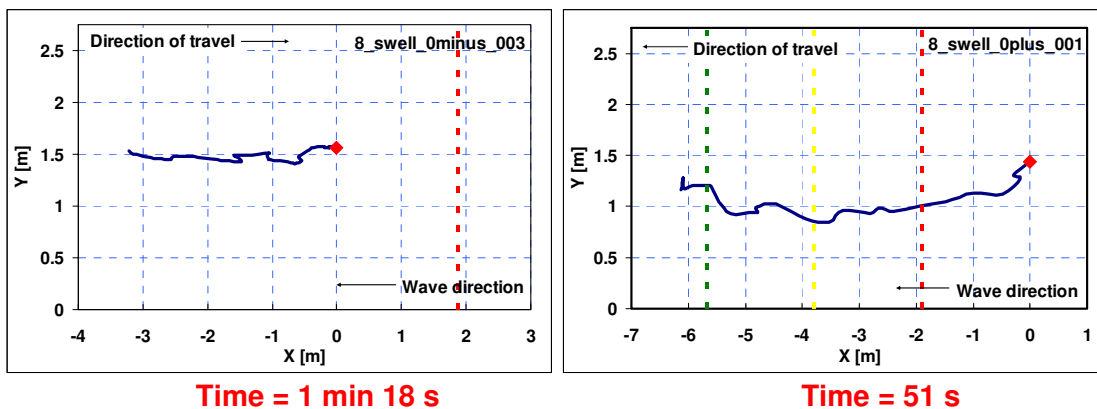
Figure 15 Comparison of travel path in swell conditions.

In attempting to travel into the waves, the equivalent safe distance in the other direction was never achieved, as the boat could not make any headway due to the ice. Consequently the TEMPSC sometimes ended up achieving the safe distance in the opposite direction, as it drifted with the waves. As previously mentioned, this was still considered a fail situation. Figure 15 and Figure 16, for swell and storm tests respectively, illustrate the differences in travel path that occurred when the vessel traveled into or with the waves. Recall that the direction of travel is the intended direction of travel, which was not necessarily the direction that the vessel ended up traveling.

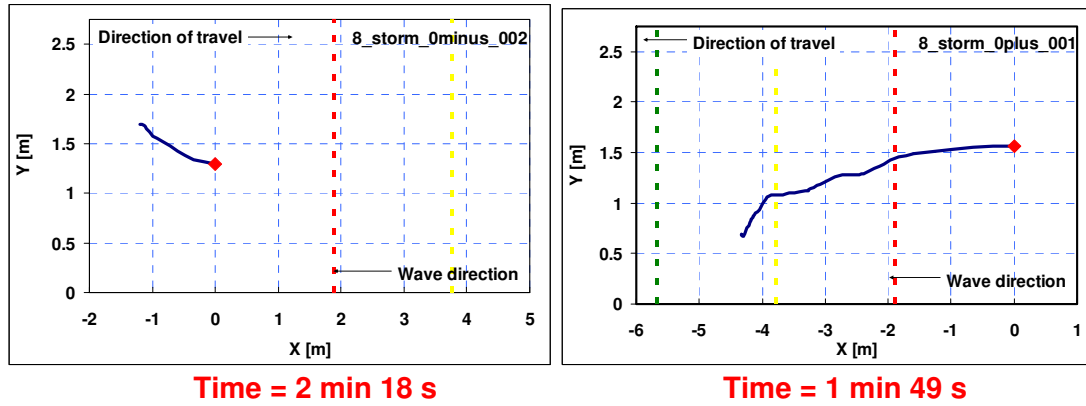
Figure 16 Comparison of travel path in storm conditions.

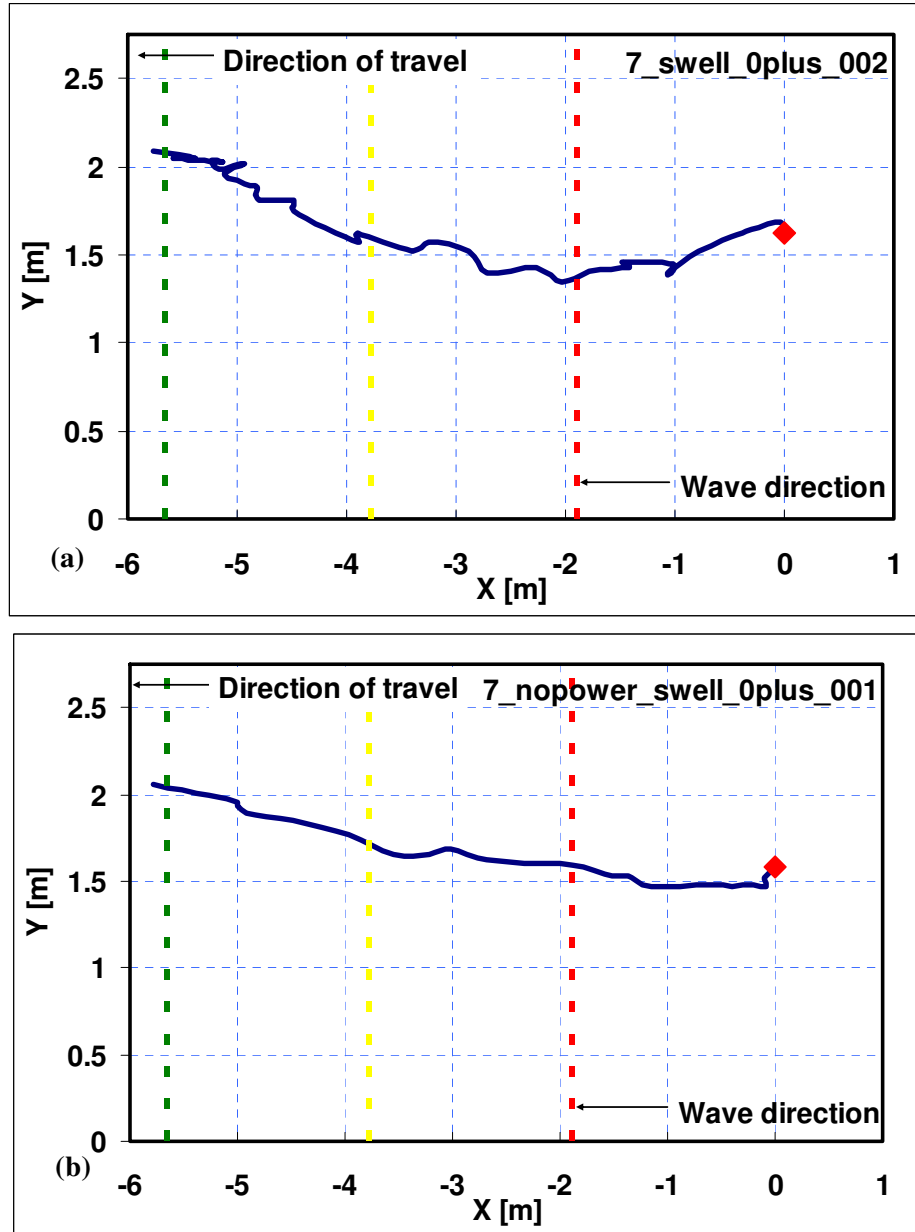
Figure 17 Plots comparing a test (a) with power with the same test (b) without power.

Traveling with the waves, the TEMPSC almost always achieved an arbitrary safe distance from the structure. However, as shown during the test series with no power to the TEMPSC, this was achieved regardless of whether there was any power. While only one of the tests with no power appeared to pass, it should be noted that the overhead cameras did not document the launch of the TEMPSC. Therefore, it was likely that this test, like the other test with no power, was actually a pass. The duration may have taken slightly longer for the tests with no power, compared to those with power, but there was generally no question that the lifeboat would achieve the safe distance. This comparison is shown in Figure 17. As can be seen in these two plots, not only was the safe distance achieved in both tests, but the path through the ice was similar. The test time for the trial with power was approximately 30 s, while that without power was approximately 40 s.

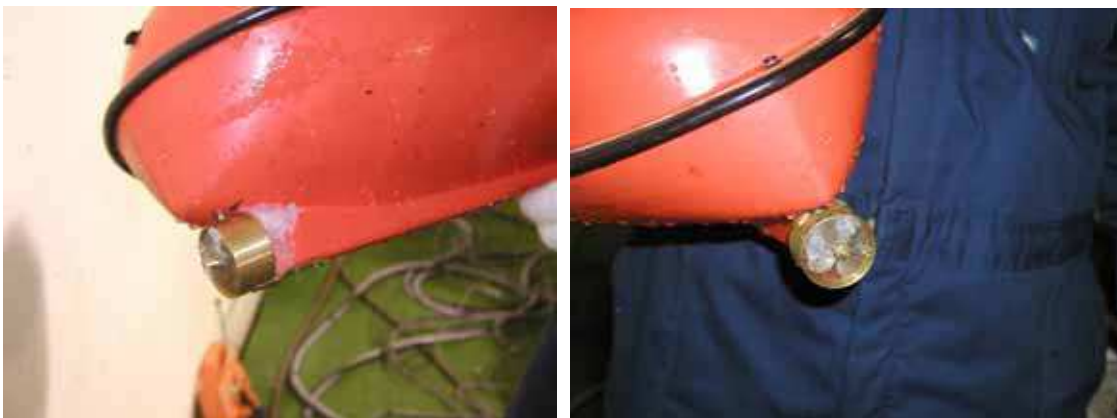
Figure 19 Photographs showing ice lodged in the propeller after some tests.

Propeller problems occurred at least five times throughout the test series (out of the forty total runs). These failures generally happened when the TEMPSC was travelling with the waves, especially during the later stages of testing. At that point in the test series, the ice had been broken into smaller pieces, and was also weaker and “slushy”. The waves essentially pushed the ice into the propeller, which quickly became choked. Figure 19 shows the propeller jammed with ice on two different occasions. This led to a loss of rudder control almost immediately and in turn often led to problems with screw and tie wraps letting go, nuts backing off and similar problems with the inner mechanisms of the TEMPSC. A sketch of these problem locations is shown in Figure 20.

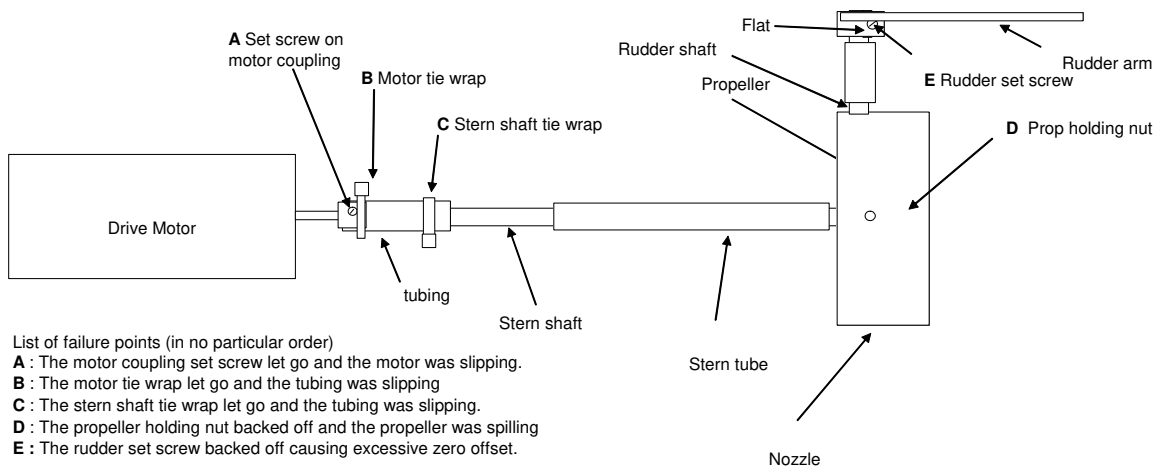
Figure 20 Sketch showing the list of failure points due to ice jamming in the propeller.

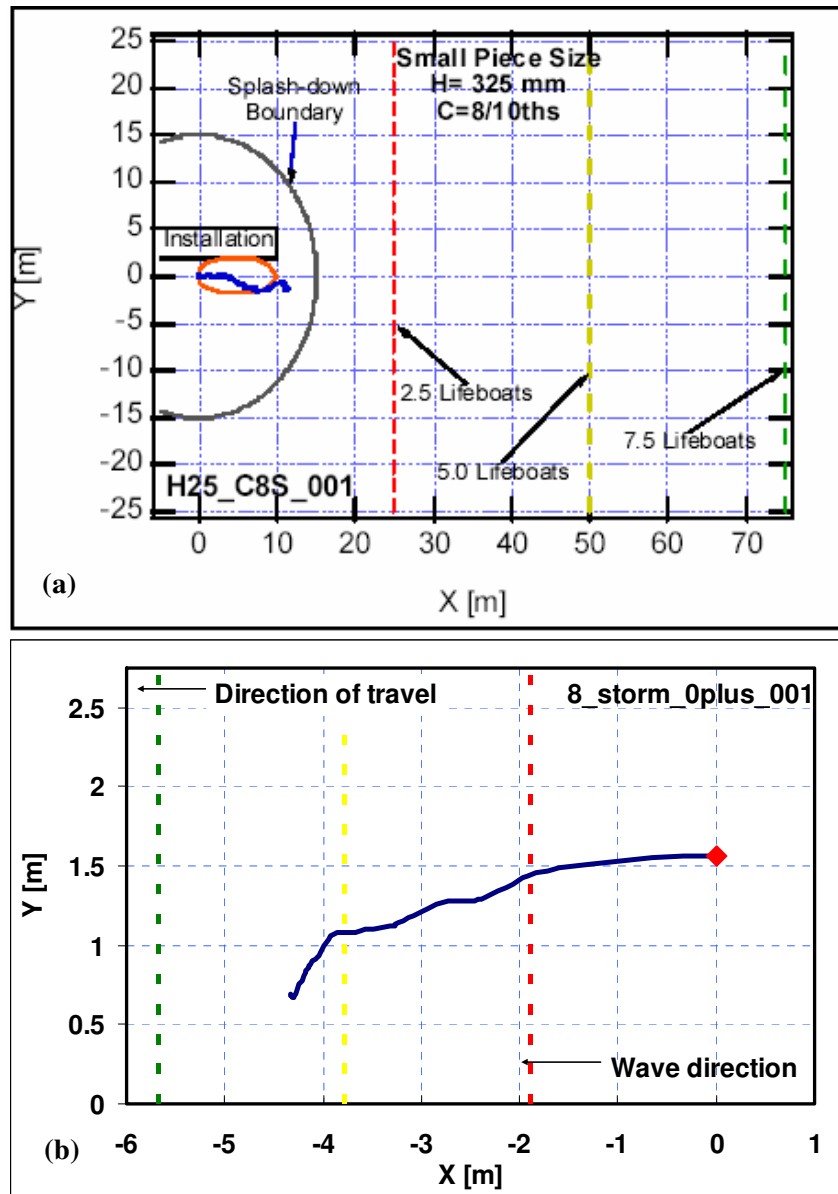
Figure 21 Comparison of travel distance in ice (a) with and (b) without waves

The present test series demonstrated that the TEMPSC was able to travel through 7/10ths and 8/10ths ice with waves in the direction of travel, where in previous tests little or no headway was achieved at these concentrations. An example of this is shown in Figure 21. Although the TEMPSC did not achieve a pass for the present test series in the example shown here, it was still able to travel considerably further than the previous test series with ice and no waves. However, it is noted that this was only the case for tests where the TEMPSC direction of travel coincided with the wave direction.

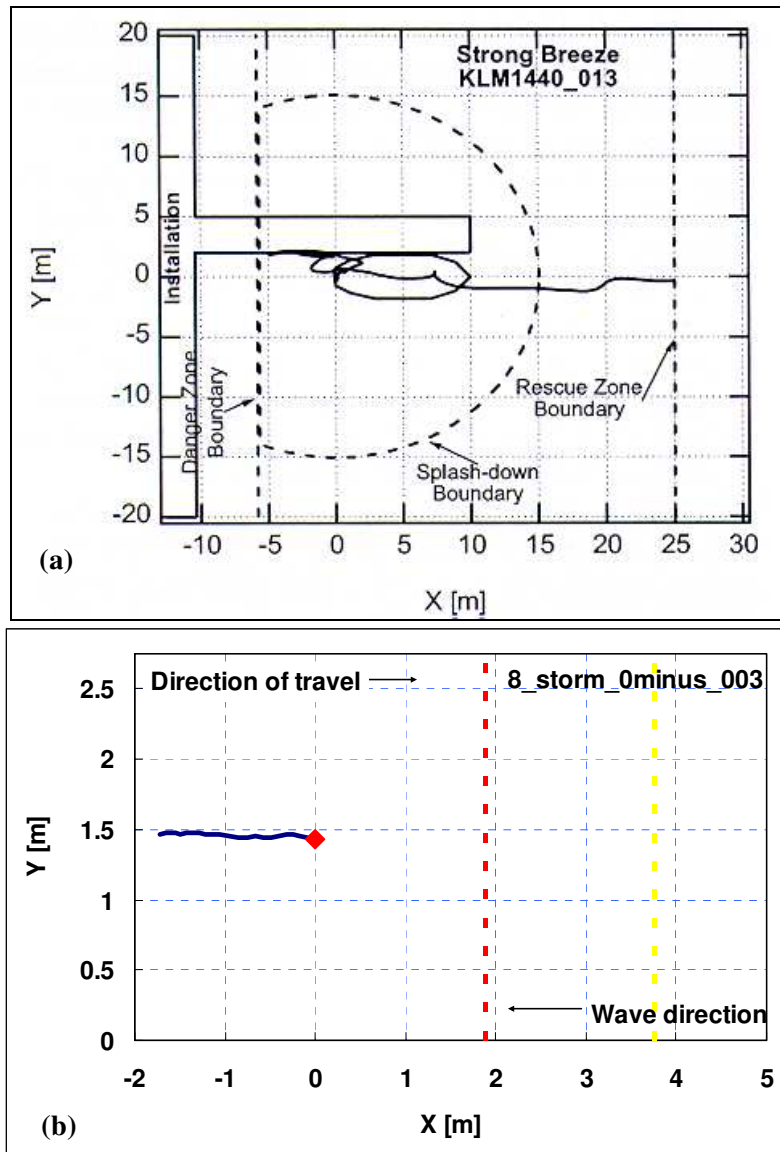
Figure 22 Comparison of tests with waves and (a) without and (b) with ice

However, when comparing the present tests with the previous test series with waves but no ice, a different picture emerges. In this comparison, shown in Figure 22, it can be seen that the ice hindered vessel performance compared to waves alone. In the previous test series, the TEMPSC was able to make headway into the waves, in Beaufort-scale strong breeze conditions (i.e. average full-scale wave height 1.95-2.93 m). In the present series, headway was only achieved into the waves at a low ice concentration, with thin ice. Even then, it was difficult for the TEMPSC to meet the pass criterion.

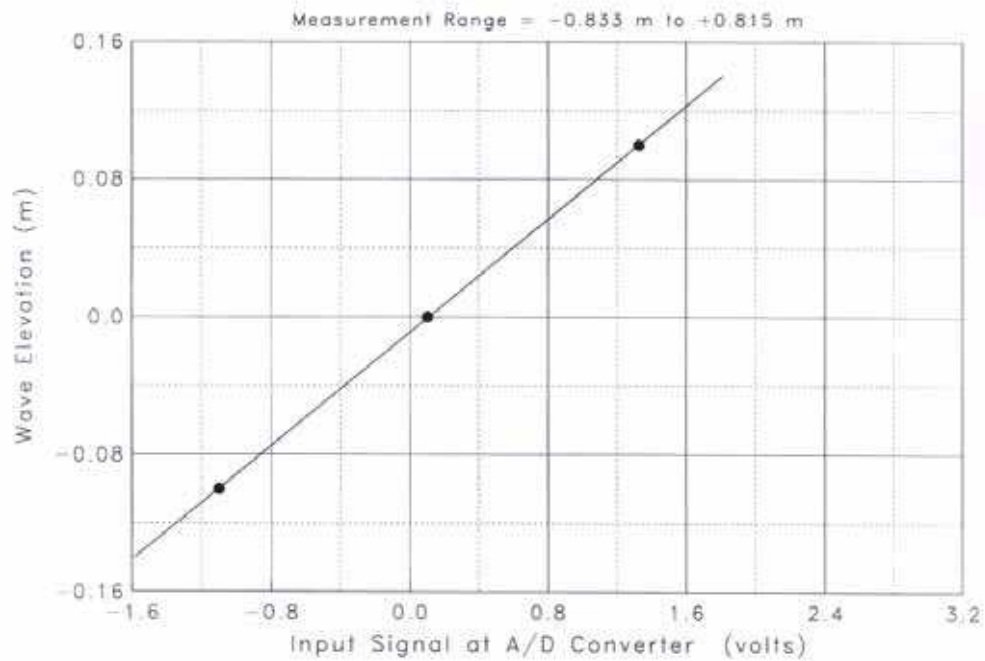
Calibration of PCI6031E Channel 2

$$Y = C_0 + C_1 V$$

where $Y(t)$ = Wave Elevation (m)
 $V(t)$ = Input signal at A/D converter (volts)
 $C_0 = -0.00908940$ m
 $C_1 = 0.0823928$ m/volt

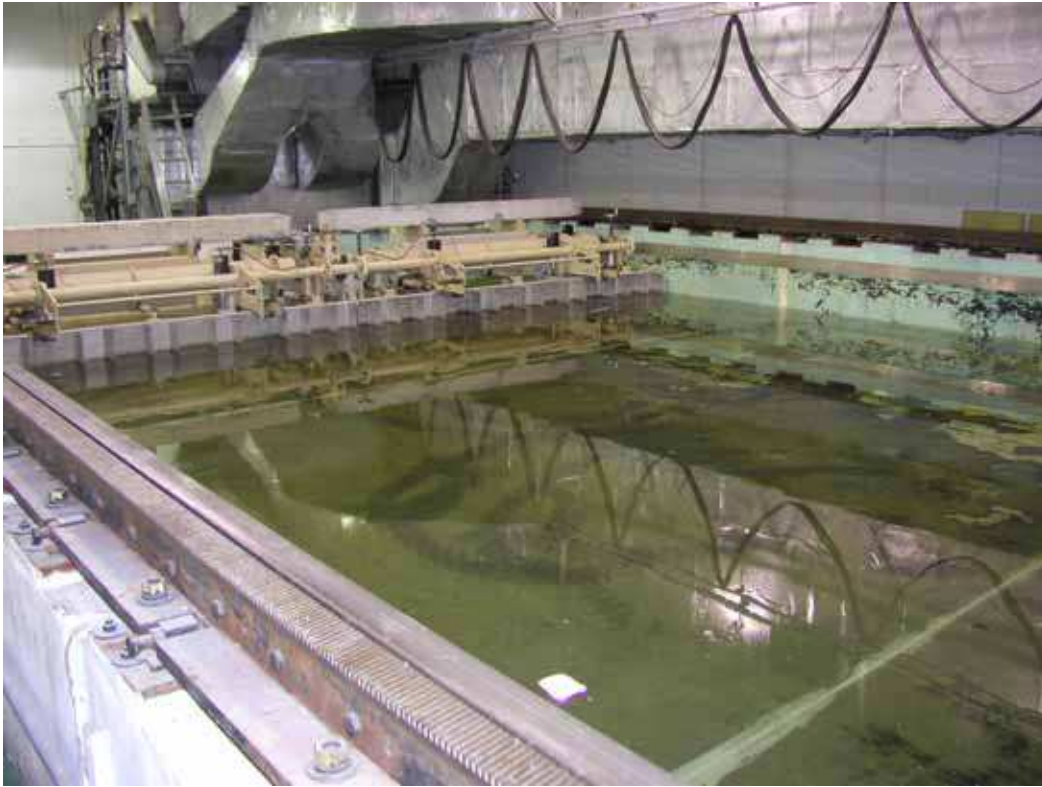
Ice tank with wave machines

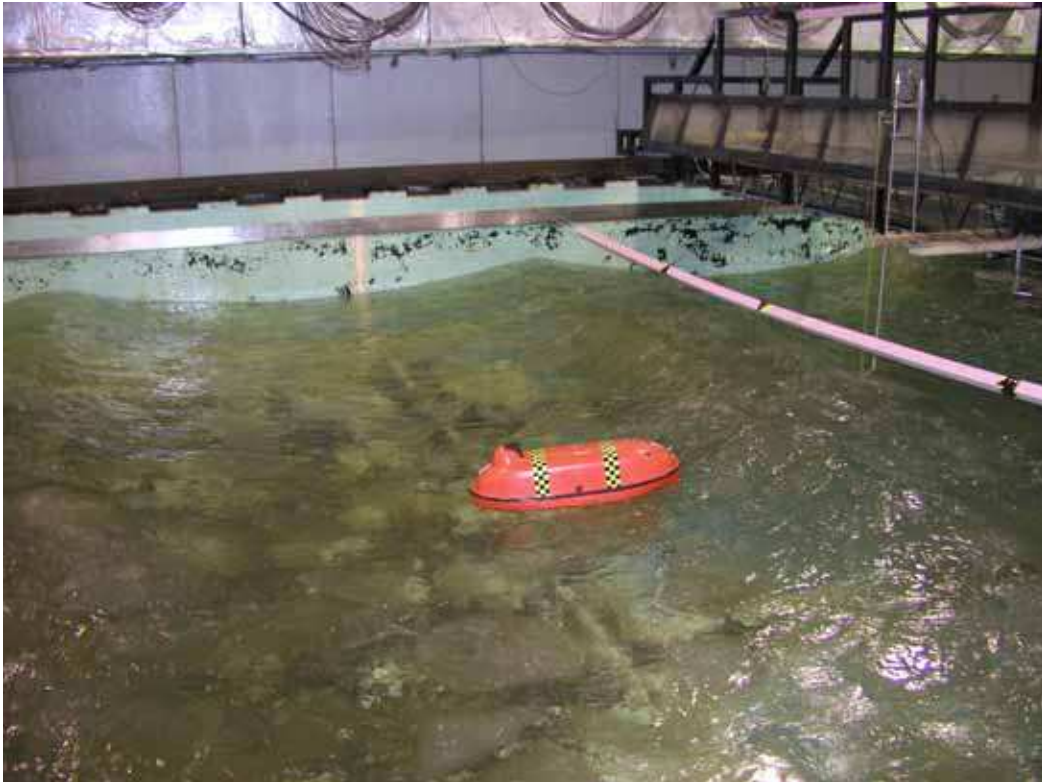
TEMPSC in 5/10ths ice concentration, 25 mm ice thickness, swell wave conditions

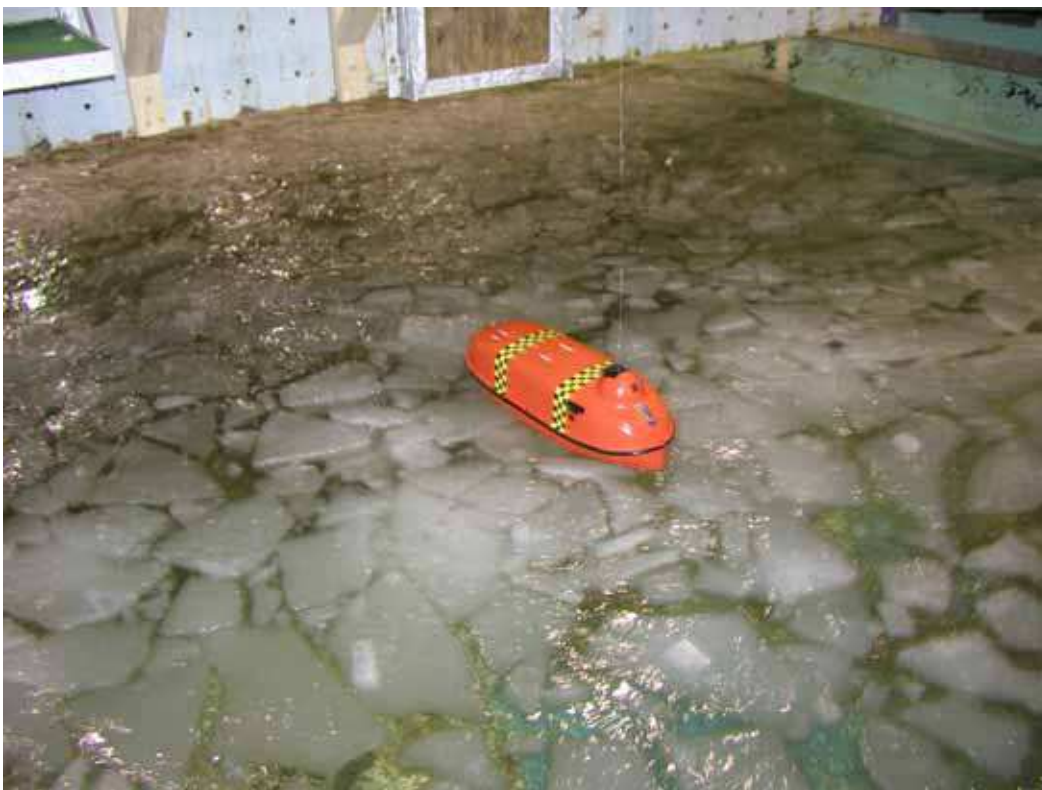
Test deployment in 8/10ths ice concentration, 50 mm ice thickness

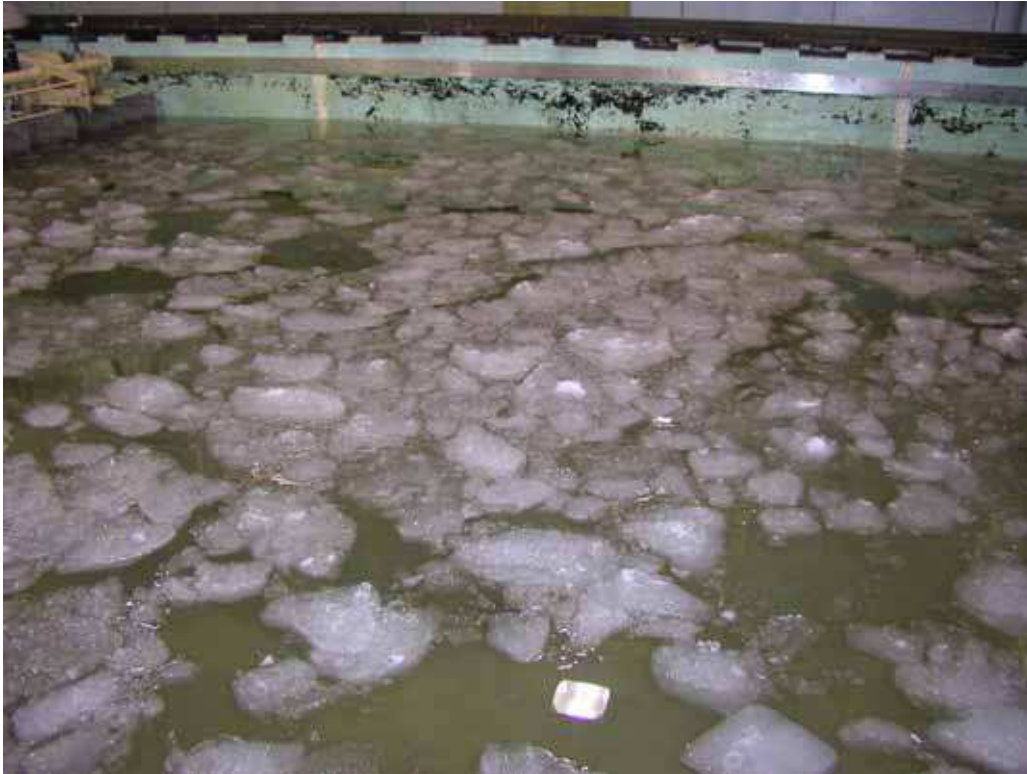
Ice conditions near the end of the second day of testing – note slushy ice

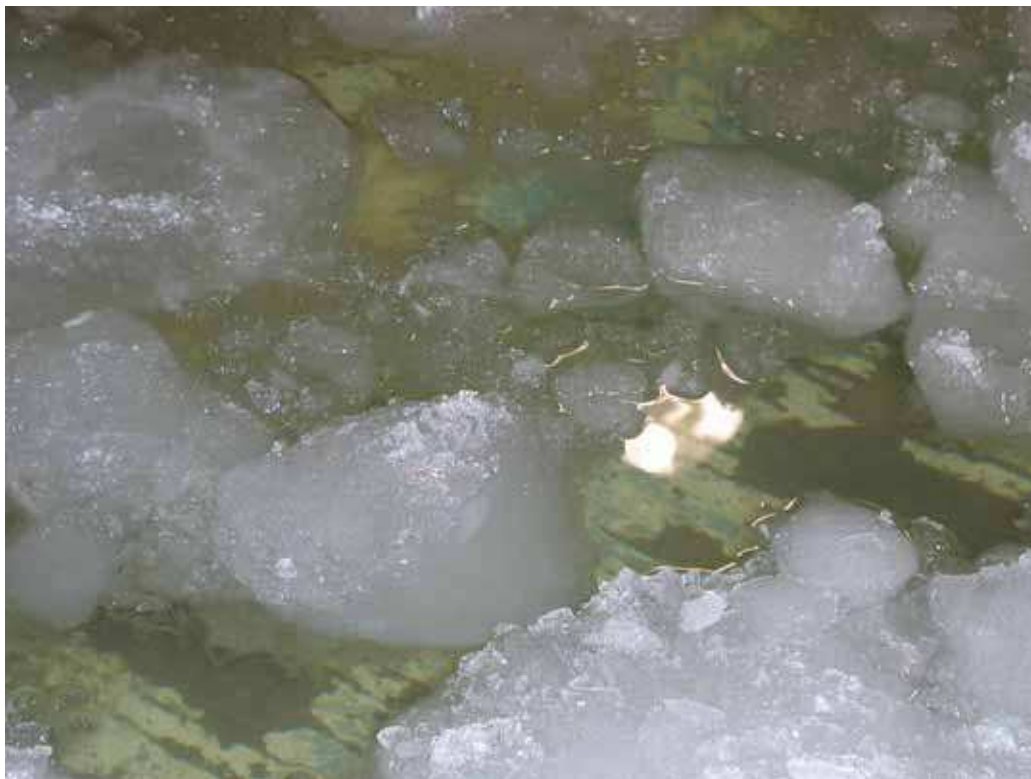
Ice conditions near the end of the second day of testing – note slushy ice

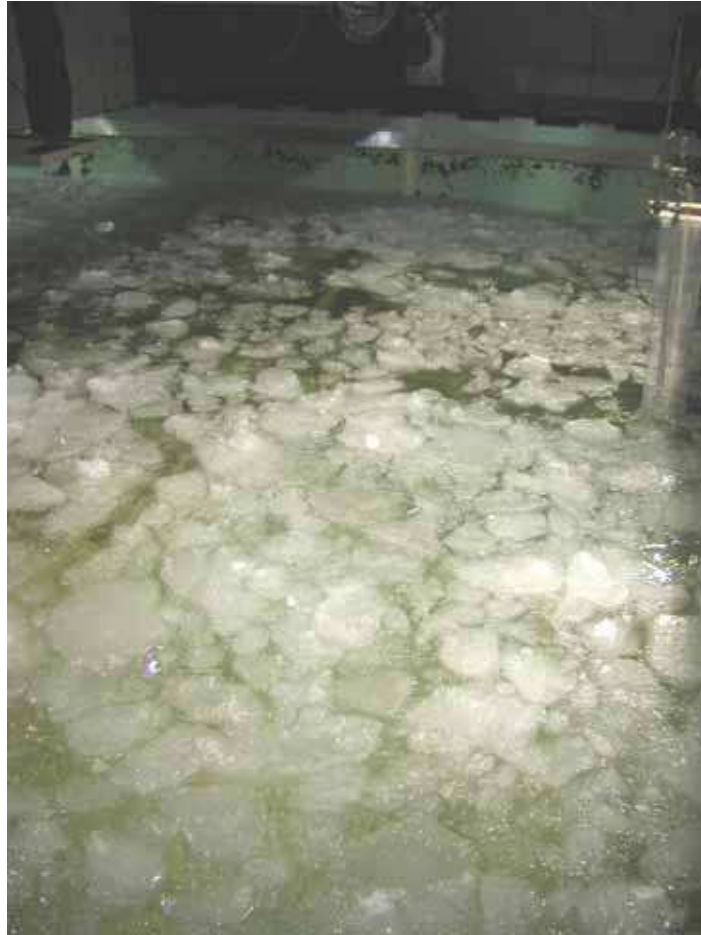
Ice conditions near the end of the second day of testing – note slushy ice
