Loading tests on conventional and trussed roof constructions (third progress report)

LOADING TESTS ON CONVENTIONAL AND TRUSSED
ROOF CONSTRUCTIONS
(Third Progress Report)

Report No. 119
of the
Division of Building Research

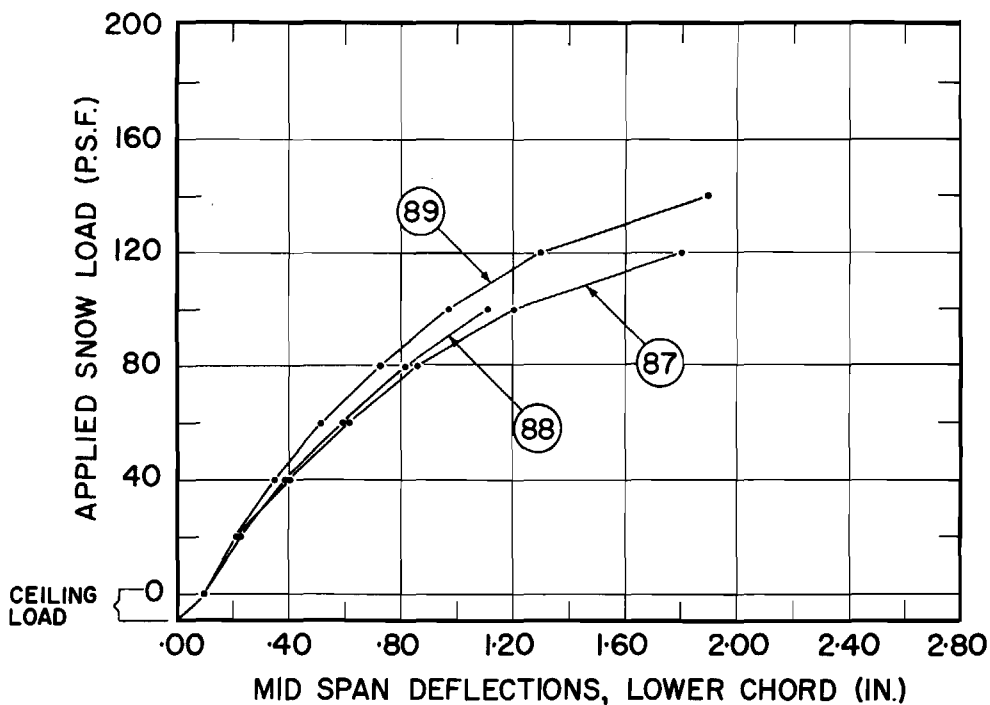
FIGURE 10
LOAD VS. DEFLECTION CURVES 26' SPAN NAILED
"W" TRUSS $4\frac{1}{2}$ SLOPE, SPACED 2'-0" O.C.
(TESTS No. 87, 88, 89)

The mid-span deflections of the lower chords are shown for the various applied loads for each test in Figs. 7 to 13. The curves do not show the residual deflections of the trusses after removal of the 40 p.s.f. snow loads during the first phase of the test, as the inclusion of these deflections complicates the curves. The residual deflections are recorded, however, in terms of per cent recovery, in Table I. The per cent recovery was calculated using the following formula:

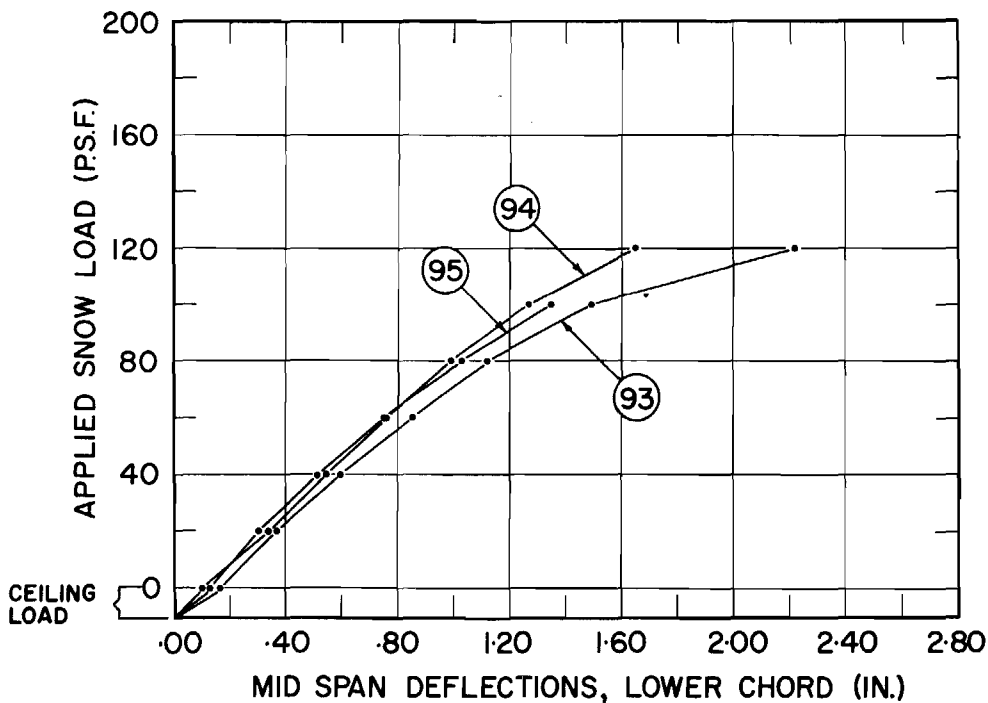
FIGURE 12
LOAD VS. DEFLECTION CURVES 28' SPAN NAILED
"W" TRUSS $\frac{4}{12}$ SLOPE, SPACED 2'-0" O.C.
(TESTS No. 93, 94, 95)

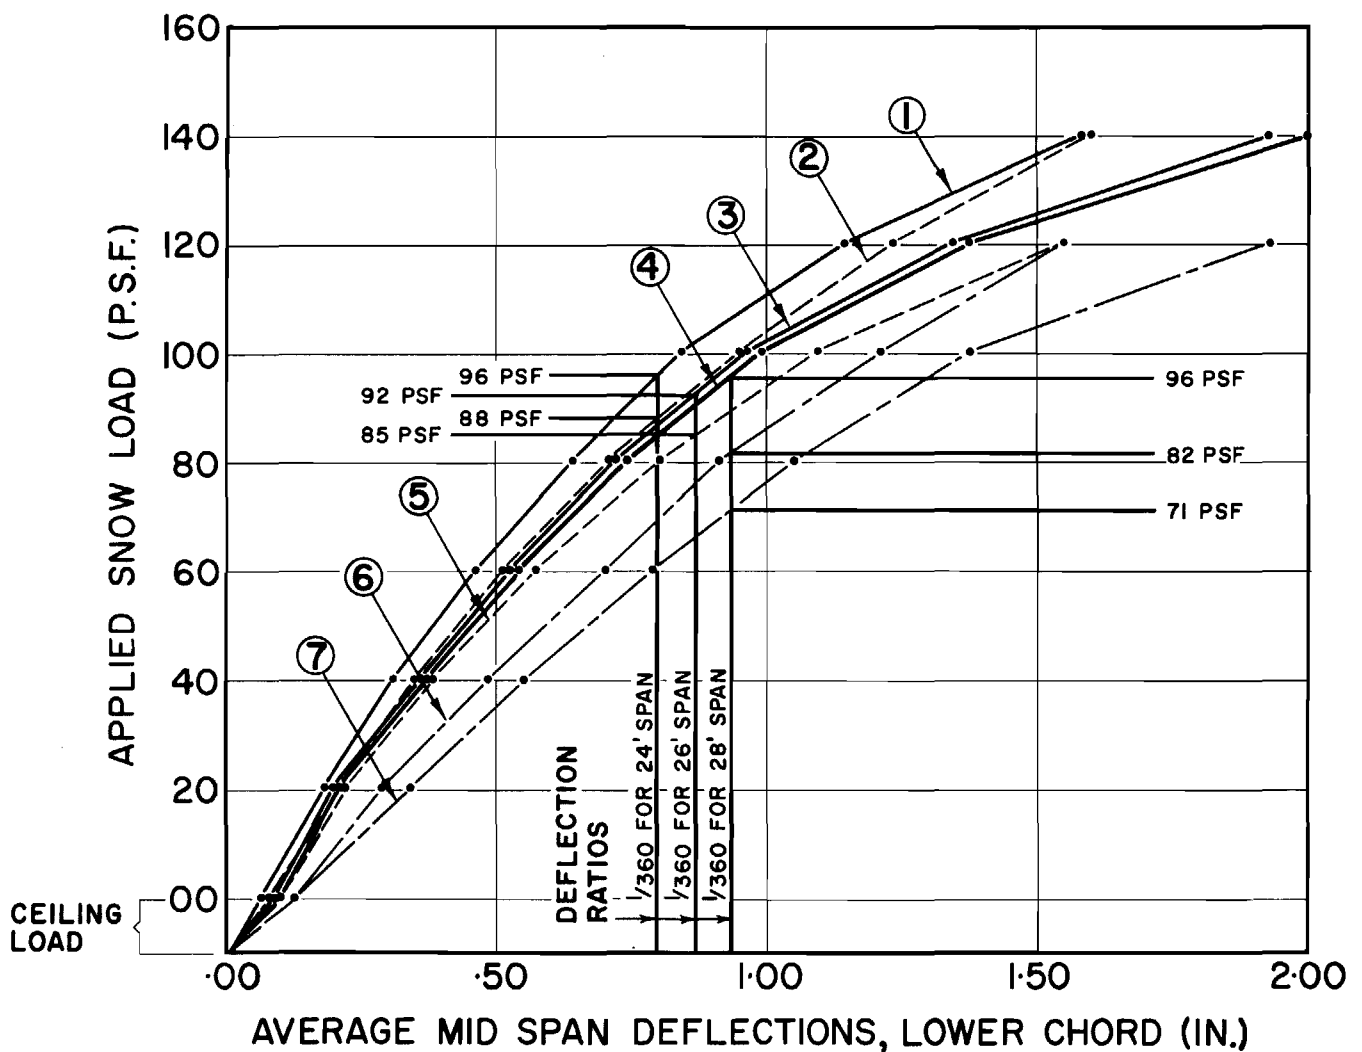
FIGURE 14
LOAD VS. DEFLECTION CURVES OF AVERAGE
DEFLECTIONS FOR VARIOUS SPANS AND
SLOPES FOR 5 MIN. LOAD APPLICATIONS.

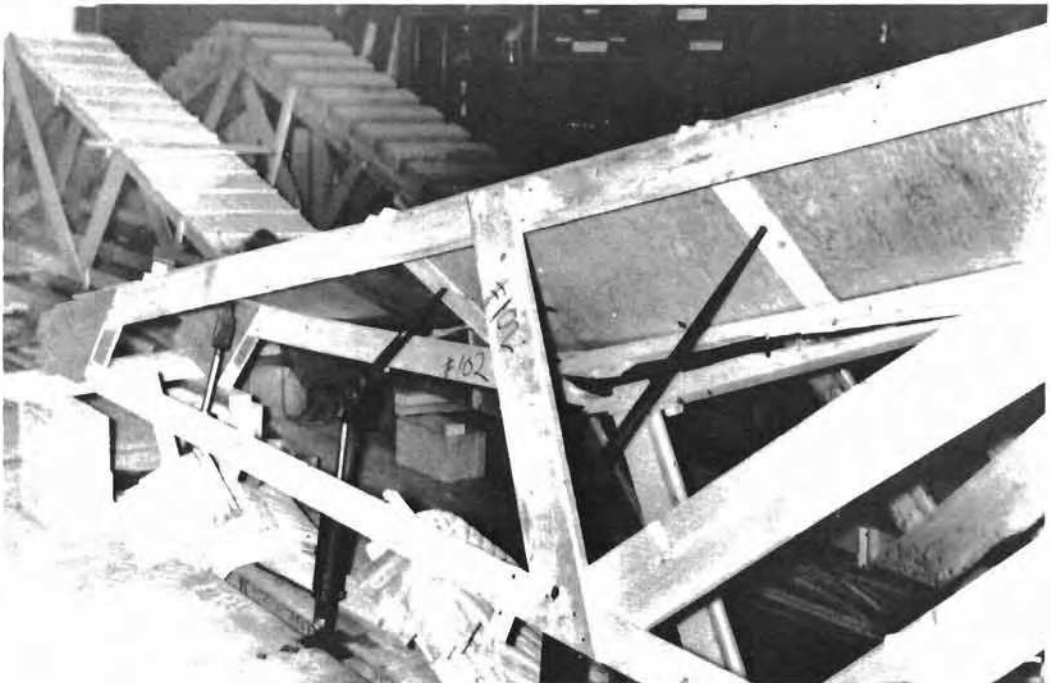
Figure 43. Failure in Test No. 102 caused by the lower chord breaking in tension near the heel joint. The upper chord broke immediately afterward.

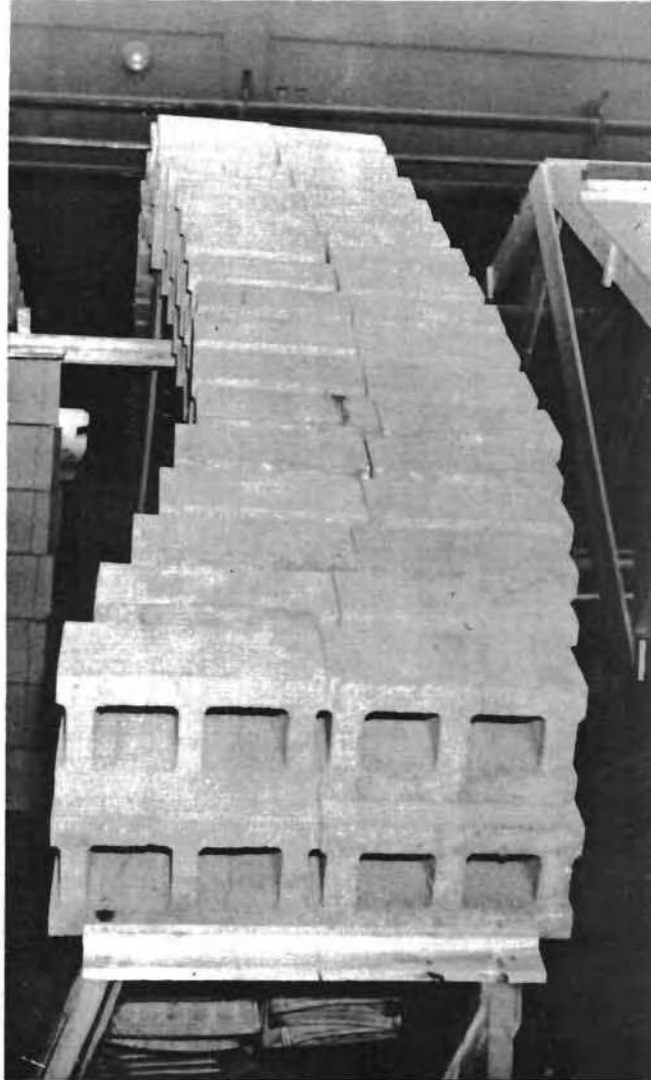
Figure 45. Collapse of trusses
loaded with 60 p.s.f. snow load
after 22 days loading. Failure
due to lateral instability.

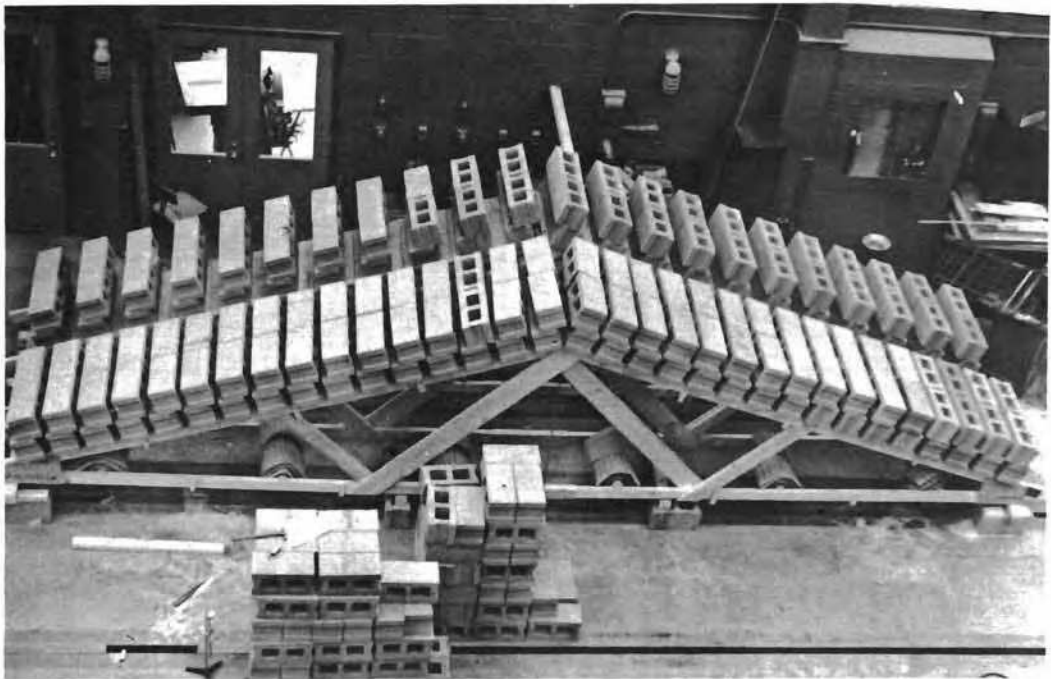
Figure 46. Photo showing trusses loaded with 60 p.s.f. snow load (front pair) and 40 p.s.f. snow load (rear pair).

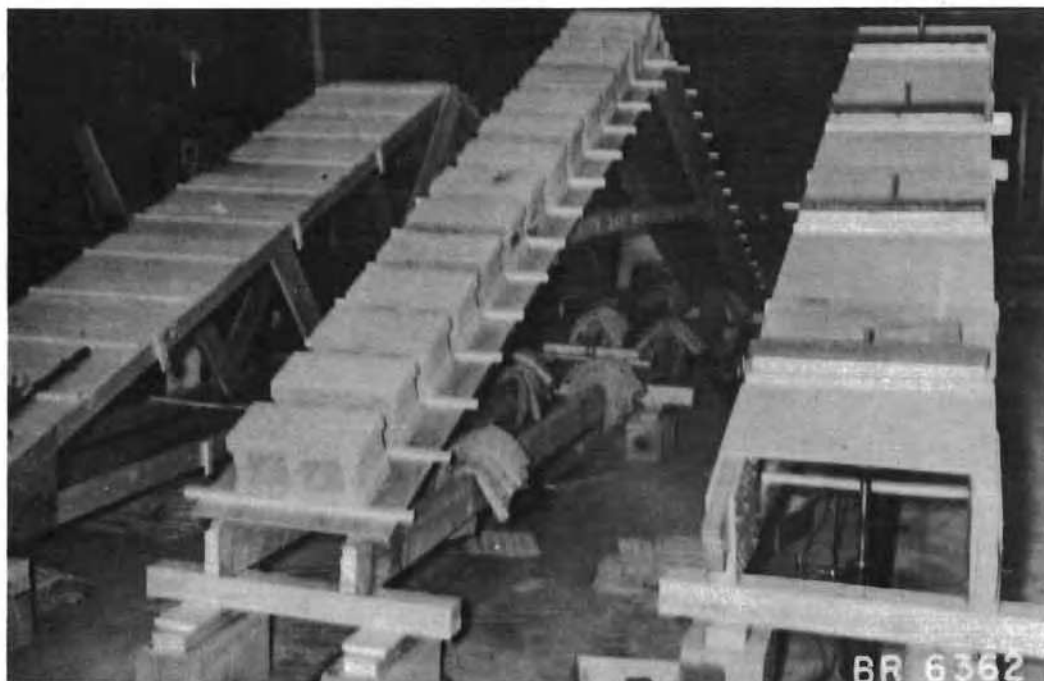
Figure 48. Photo showing conventional construction loaded with 20 p.s.f. snow load (centre of photo).
