In-situ Performance Evaluation of Exterior Insulation Basement System (EIBS) – Spray Polyurethane Foam Summary Report

Internal Report No. 820

Date of Issue: November 2000

National Research Council of Canada
Institute for Research in Construction
Ottawa, Ontario
Canada
K1A 0R6

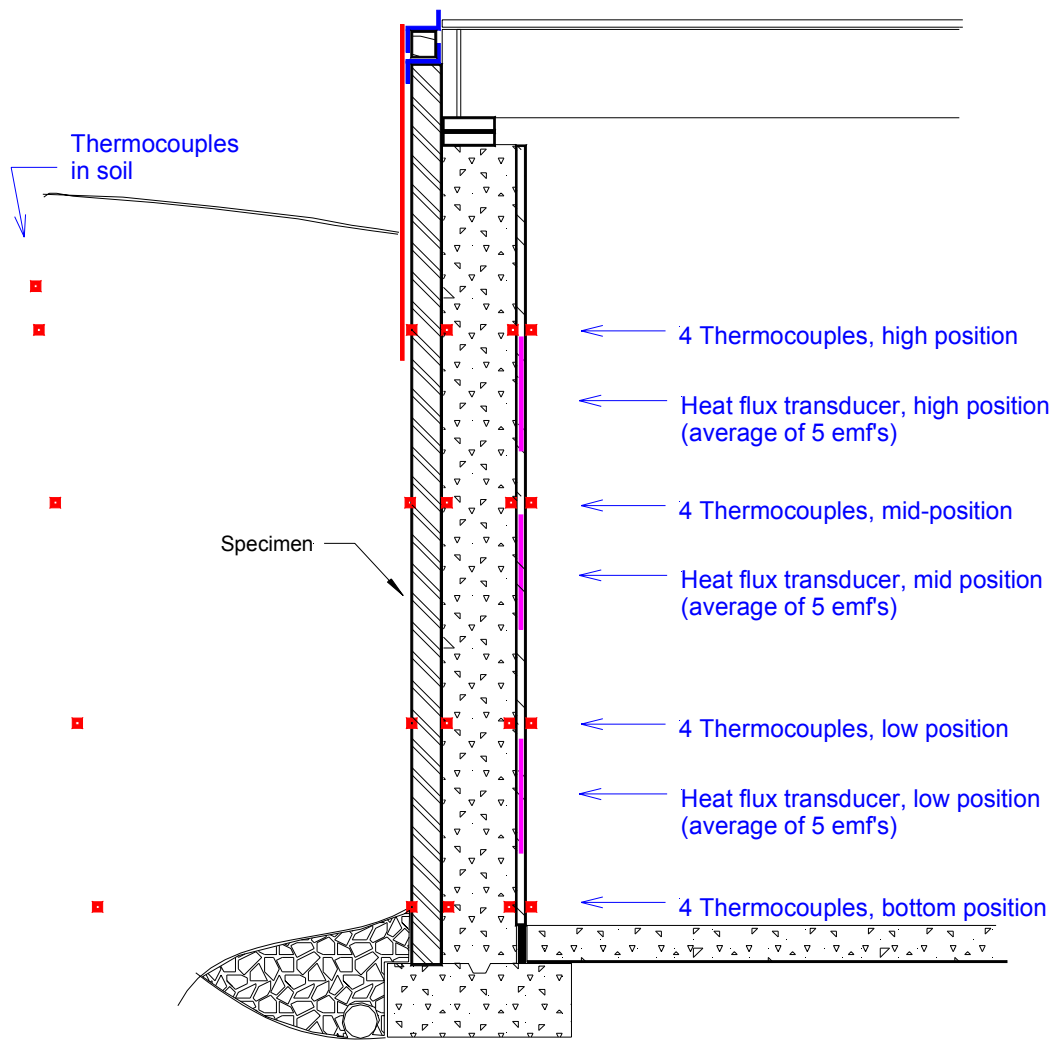
Figure 1. General Layout of Insulation Specimens and Sensors

The SPF specimens were sprayed over the full height of two 1220 mm wide segments of the exterior basement wall of Test Hut #1, at NRC's main Campus in Ottawa. Their performance was monitored using a strategy developed to monitor the in-situ thermal performance of roof insulation^{2,3}. A thermally calibrated, 25 mm layer of expanded polystyrene board was installed over the entire surface of the interior of the basement wall. Thermocouples were systematically placed at the surface of each element in the wall, in a vertical array consisting of 16 points per specimen. A schematic diagram of this arrangement is shown in Figure 1. As well, heat flux transducers were installed at three vertical locations.

The field experiment consisted of installing an SPF specimen on each of the east and west basement wall of Test Hut #1. The specimens were instrumented as shown in Figure 1.

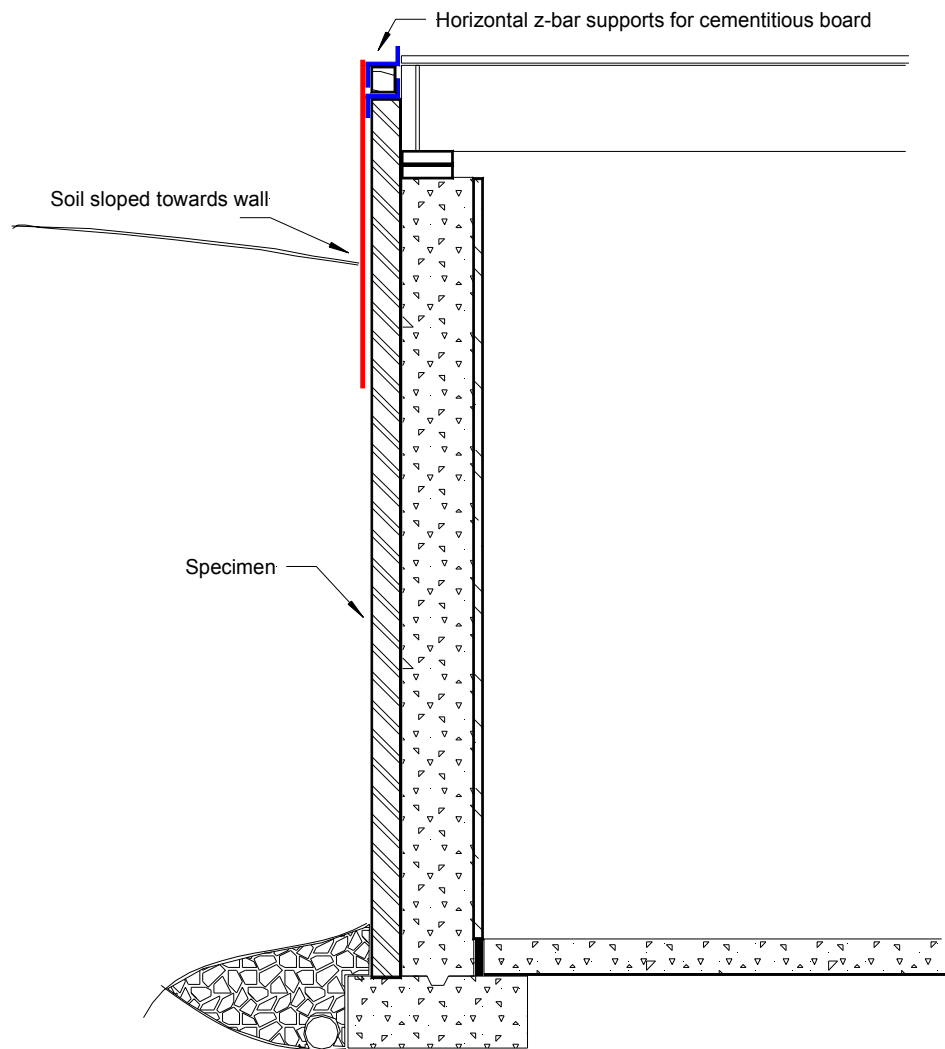
Figure 2. Installation System 1 for the Above Ground Protective Assembly - West Wall.

Two different installation methods were used on the east and west wall configurations, labelled System 1 and System 2 respectively. System 1 on the west wall (Fig. 2) featured two horizontal rows of metal z-bars, separated by a wood spacer, all fastened to the header. Once the insulation was in place, the cementitious covering boards were fastened to the z-bars and wood space. No other fasteners were used, so the cementitious board was effectively

'cantilevered' over the insulation specimens. The soil was sloped at 5% grade towards the wall, to simulate a settled condition.

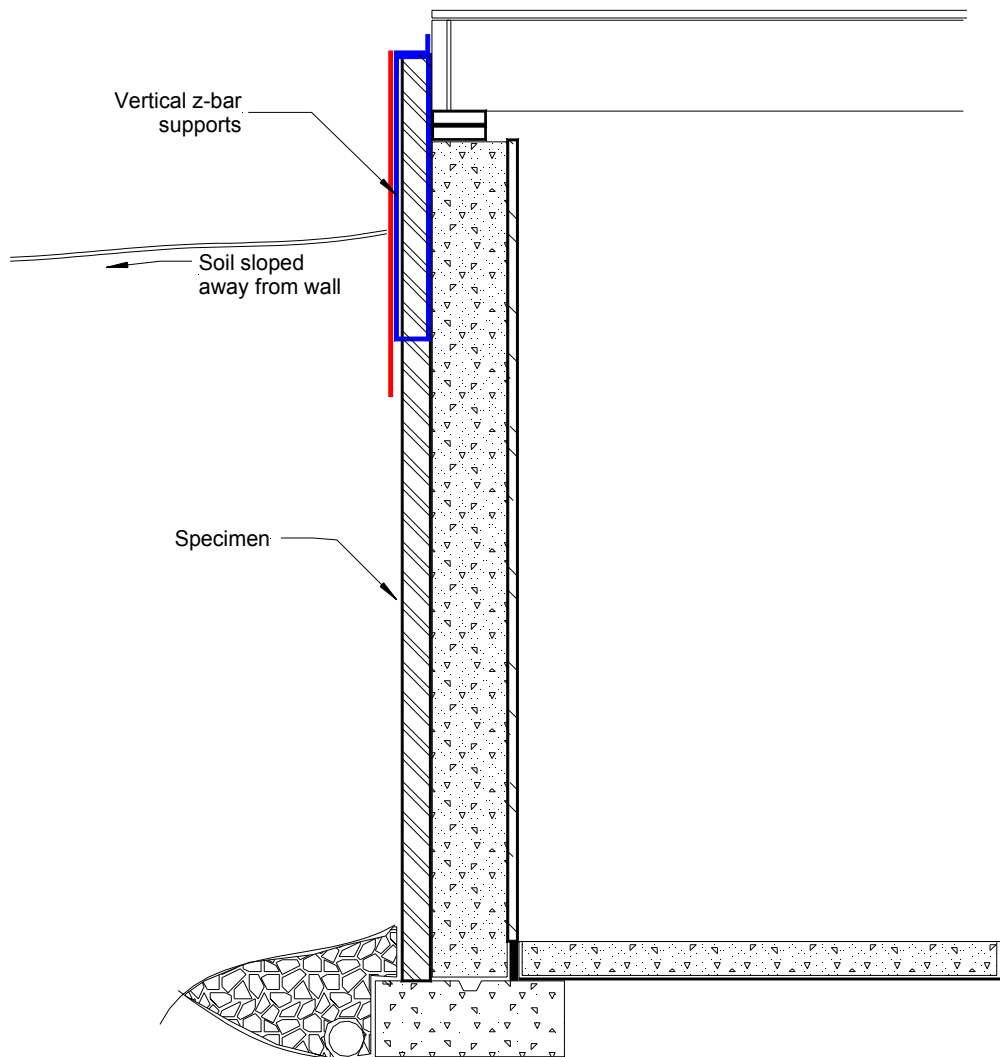
Figure 3. Installation System 2 for the Above Ground Protective Assembly - East Wall

System 2 on the east wall (Fig. 3) featured metal z-bar supports placed vertically between each insulation specimen. The z-bars were fastened directly to the concrete wall and wood header on the inside, and fastened to the cementitious board on the outside. Each metal z-bar was therefore a thermal bridge around the insulation. System 2 also featured an initial 5% sloped grade away from the basement wall.

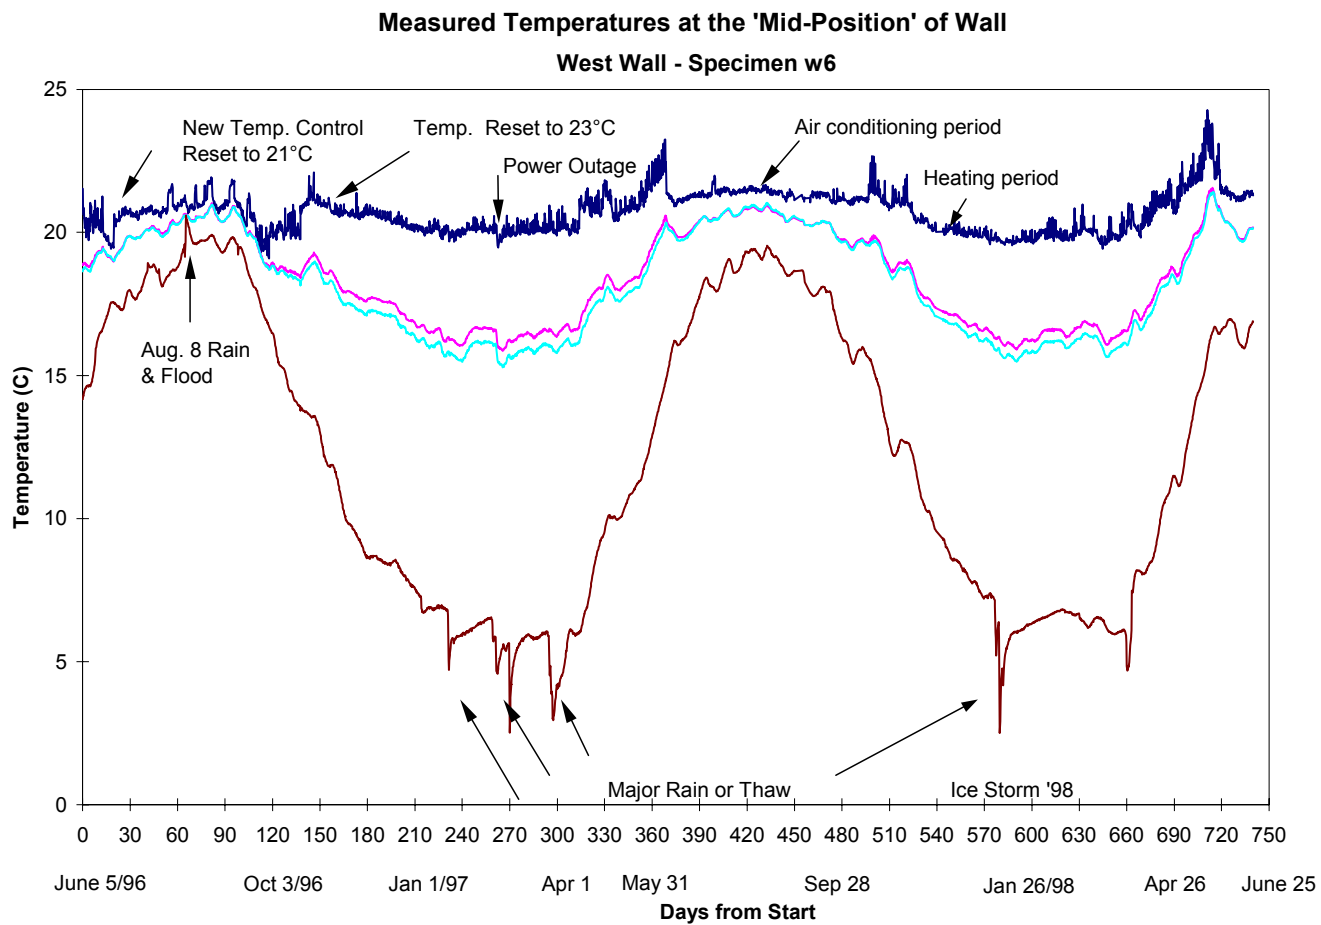
Figure 4. Temperature Profiles at the Mid-Position of Specimen W6 on the West Wall

Figure 4 shows the two-year temperature record at four locations through the wall at specimen W6: the interior surface, both sides of the concrete, and the exterior surface of the specimen in contact with the soil. The inner surface of the wall is kept near 21°C, with small variations throughout the two years. Main control events such as power outages and changes from heating to air conditioning and back are evident from these temperature readings. The temperature at both sides of the concrete are quite close to one another (concrete being a poor thermal insulator), and these vary from 15°C to 20°C, from winter to summer.

The lowest curve in the graph is the temperature record for the insulation/soil interface. These vary between about 5°C in winter up to a maximum of about 20°C in summer.

The periodic 'spikes' in this curve correspond to recorded events of heavy precipitation or winter thaws. The August 8, 1996 rain was a 1 in 75 year event for Ottawa, which caused local flooding around the test hut. During this storm, the temperature at the insulation/soil interface deflected upwards, apparently due

to warm rainwater moving down the wall. Such deflections were observed at the mid, low and bottom thermocouple positions during the same period, tracing the path of the water. These deflections were much less noticeable at the high position, where the soil temperature would be closer to the temperature of the moving water.

The temperature deflections in the winter at the soil/insulation interface are downward because the melt water temperature is initially 0°C, which cools the soil and insulation at the interface.

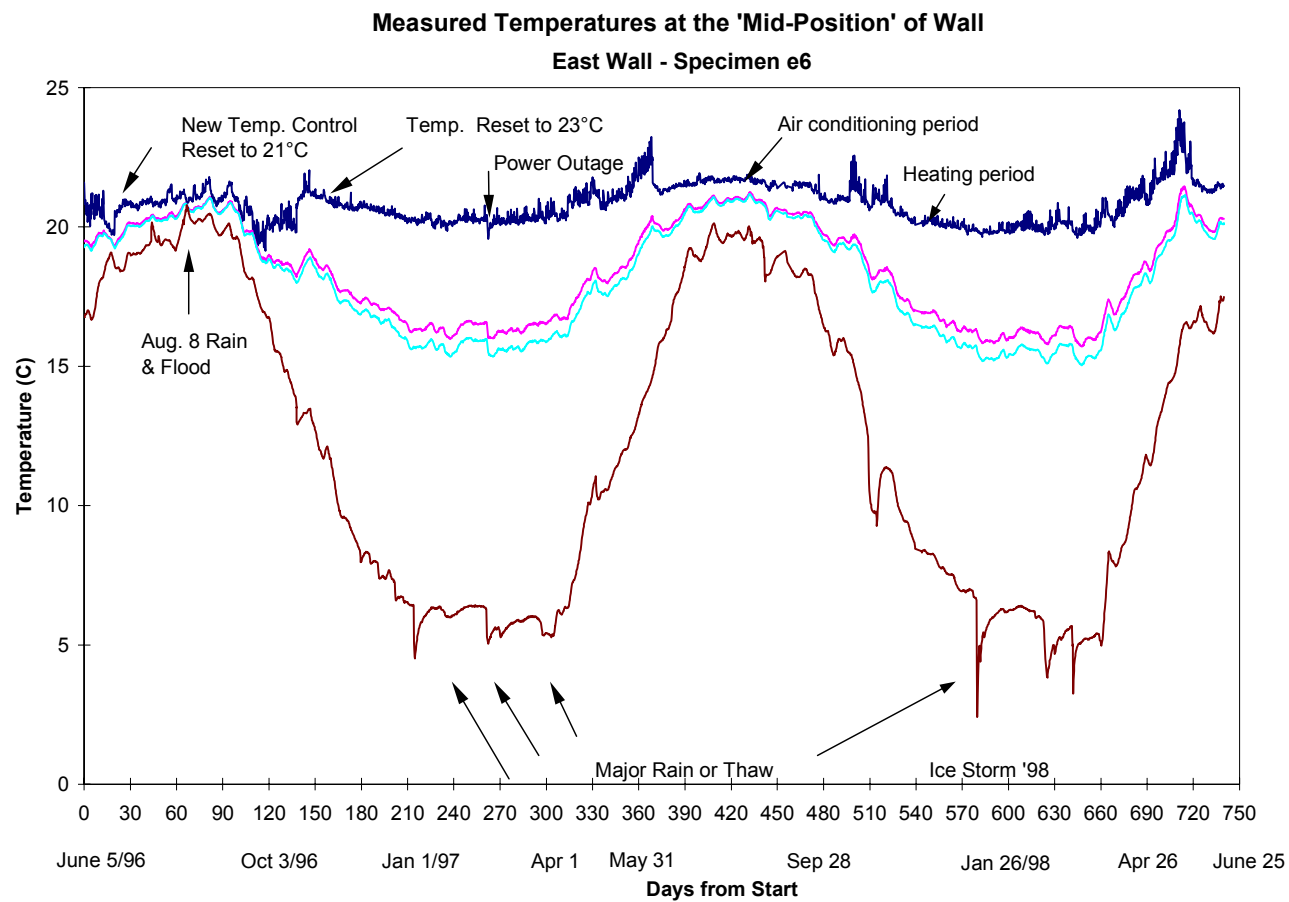
Figure 5. Temperature Profiles at the Mid-Position of Specimen E6 on the East Wall

Figure 5 shows temperature measurements on the east wall of the test hut for the same insulation product that was shown on the west side in Figure 4. In the first year, these periodic temperature deflections were often smaller or absent on the east wall where the ground surface was properly graded outward. This relative absence of temperature deflections can be observed in Figure 6 for the first winter.

In the second year however, the differences between east and west were less noticeable, and the temperature deflections were then quite noticeable. A final review of soil slopes near the wall revealed that by the end of the second year, most of the slopes had settled on the east wall. These slopes were now mostly inward.

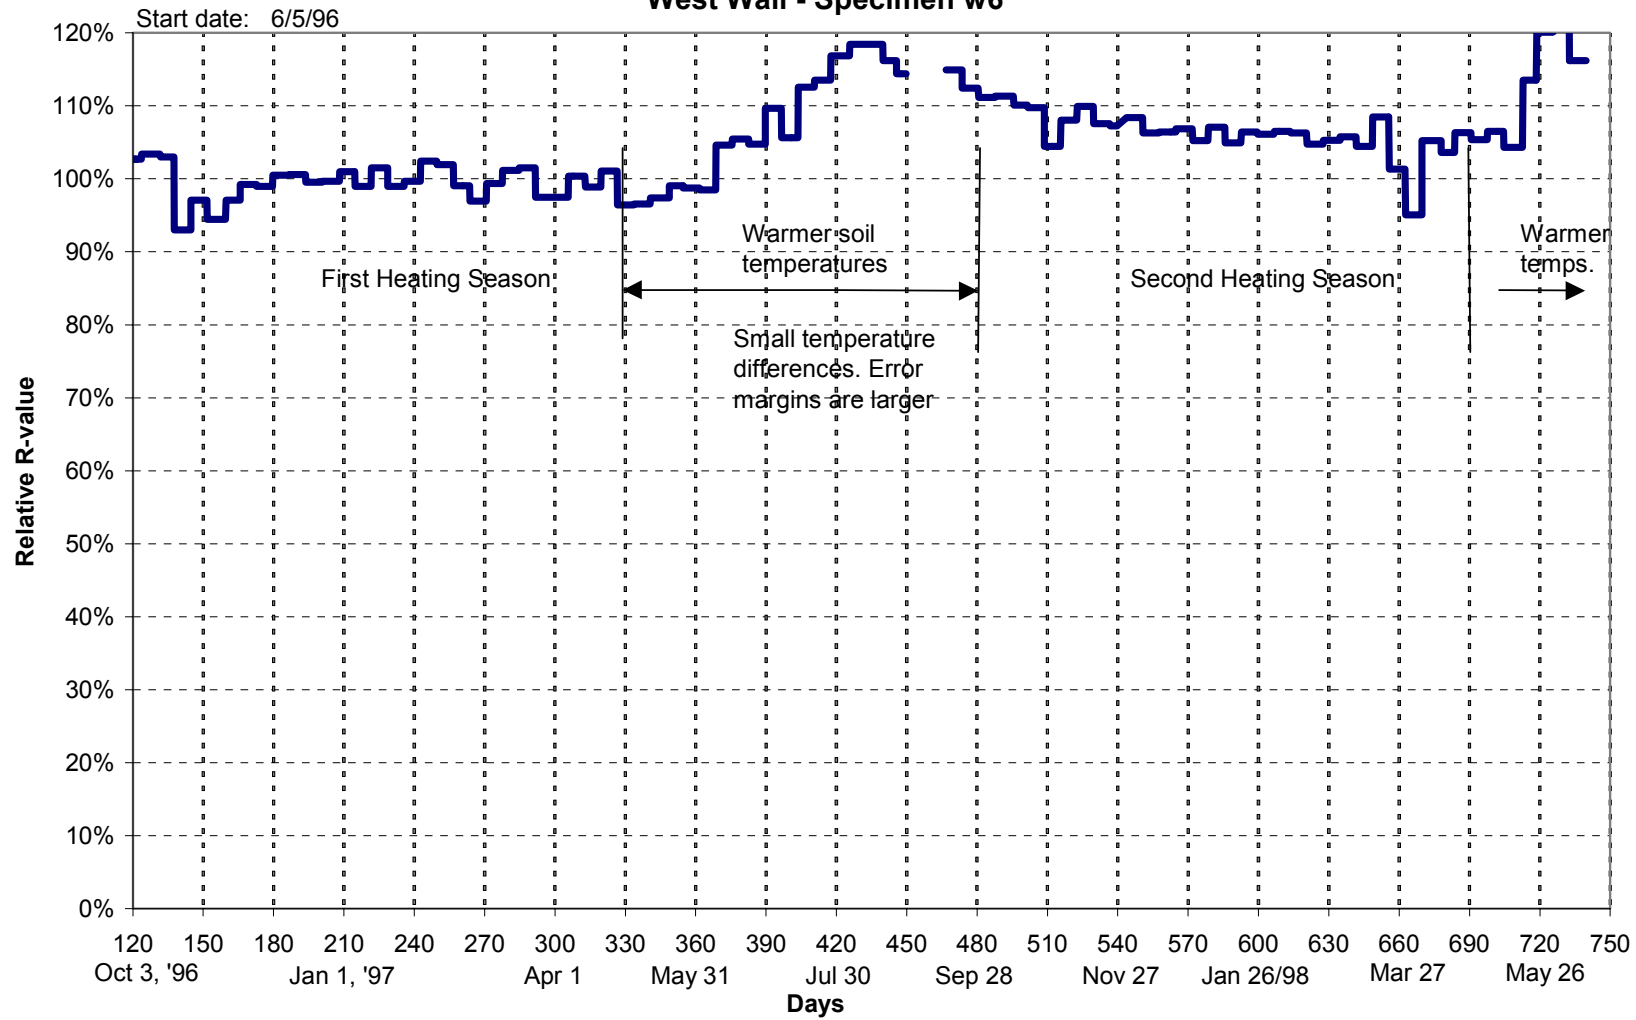
Weekly Average R-value of the Specimen Relative to the R-value for October 1996

West Wall - Specimen w6

Figure 6. Trend in R-value for Two Heating Seasons.
(Normalized to Initial R-value for October 1996)

Figures 6 and 7 show the resulting thermal performance plots for the specimens on the west face (a) and the east face (b). The change in thermal resistance adjustment is shown on a weekly basis over two heating seasons. Key observations are as follows:

- all specimens show relatively steady performance through the heating seasons
- the second heating season shows equal or improved performance for all specimens
- the results for the warm periods are unreliable, since the temperature difference across the specimens are very small ($< 0.5^{\circ}\text{C}$). During such periods, thermocouple errors can be as large as the actual temperature difference.
- On day 215, modifications were made to faulty controls on the sump pump. Water levels around the footing were lowered over time. The sump pump connection is nearest specimens W5 & W6.
- Major rain and thaw periods do not appear to significantly affect the thermal performance of the specimens during these episodes.

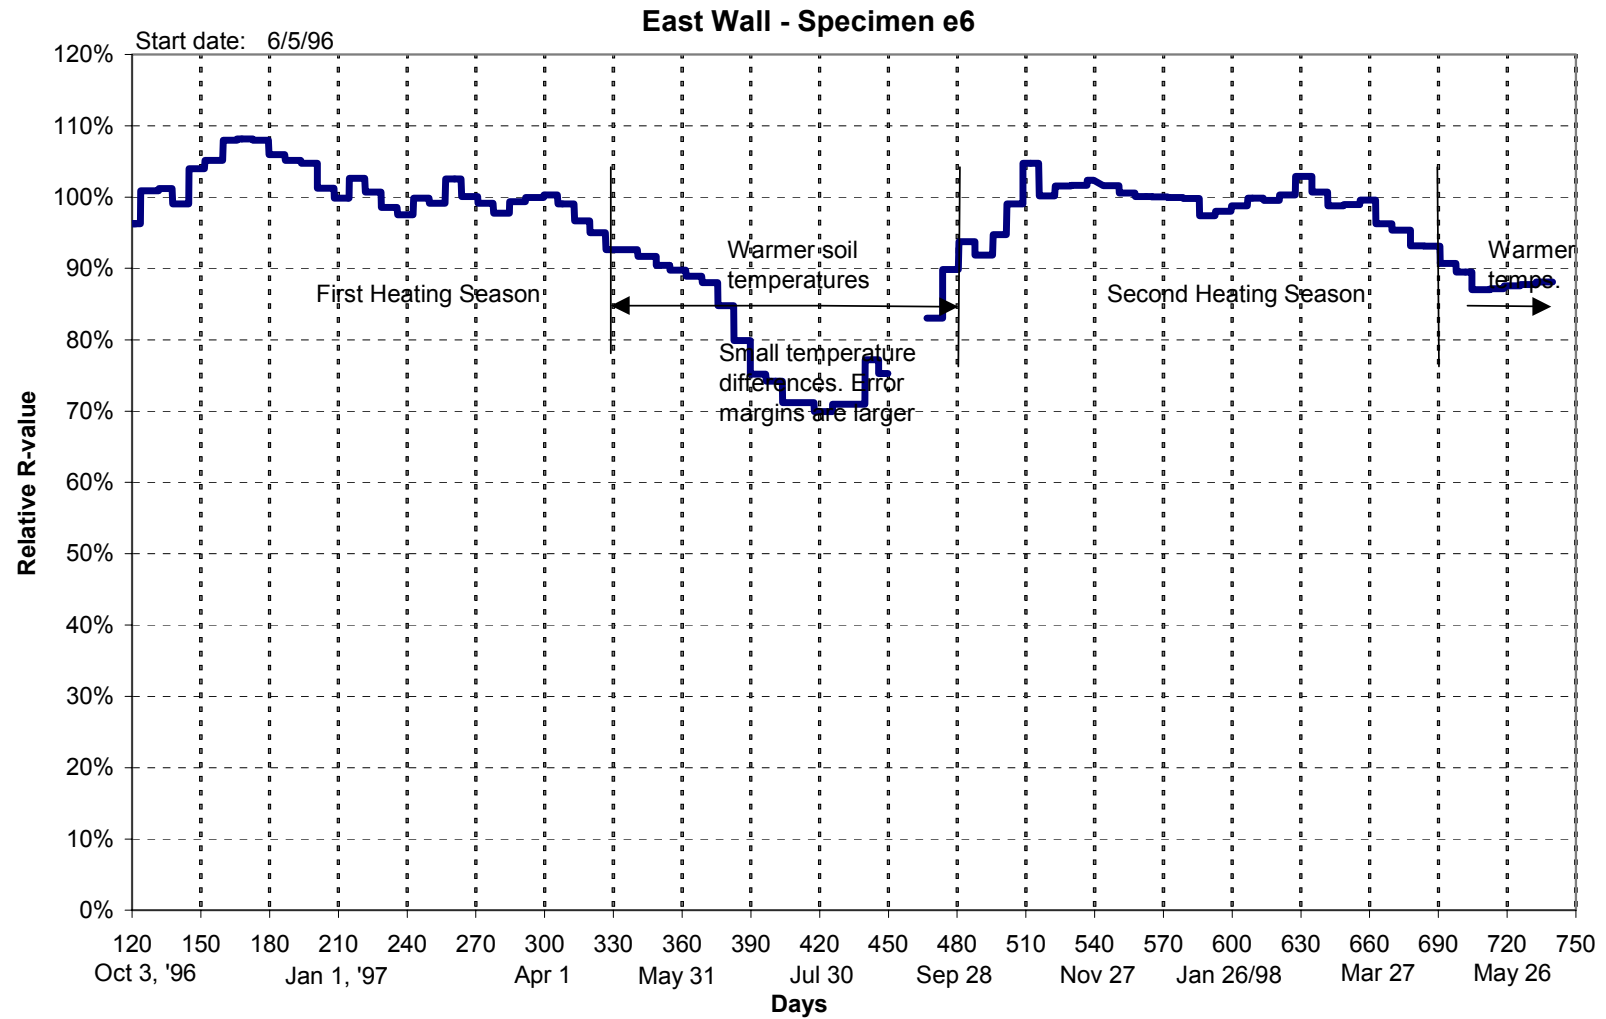
Weekly Average R-value of the Specimen Relative to the R-value for October 1996

Figure 7. Trend in R-value for Two Heating Seasons.
(Normalized to Initial R-value for October 1996)
