Solutions for Mid-Rise Wood Construction: Full-scale Standard Fire Test for Exterior Wall Assembly using a Simulated Cross- Laminated Timber Wall Assembly with Interior Fire-Retardant-Treated Plywood Sheathing (Test EXTW-4)

CLIENT REPORT: A1-100035-01.7

December 31, 2014

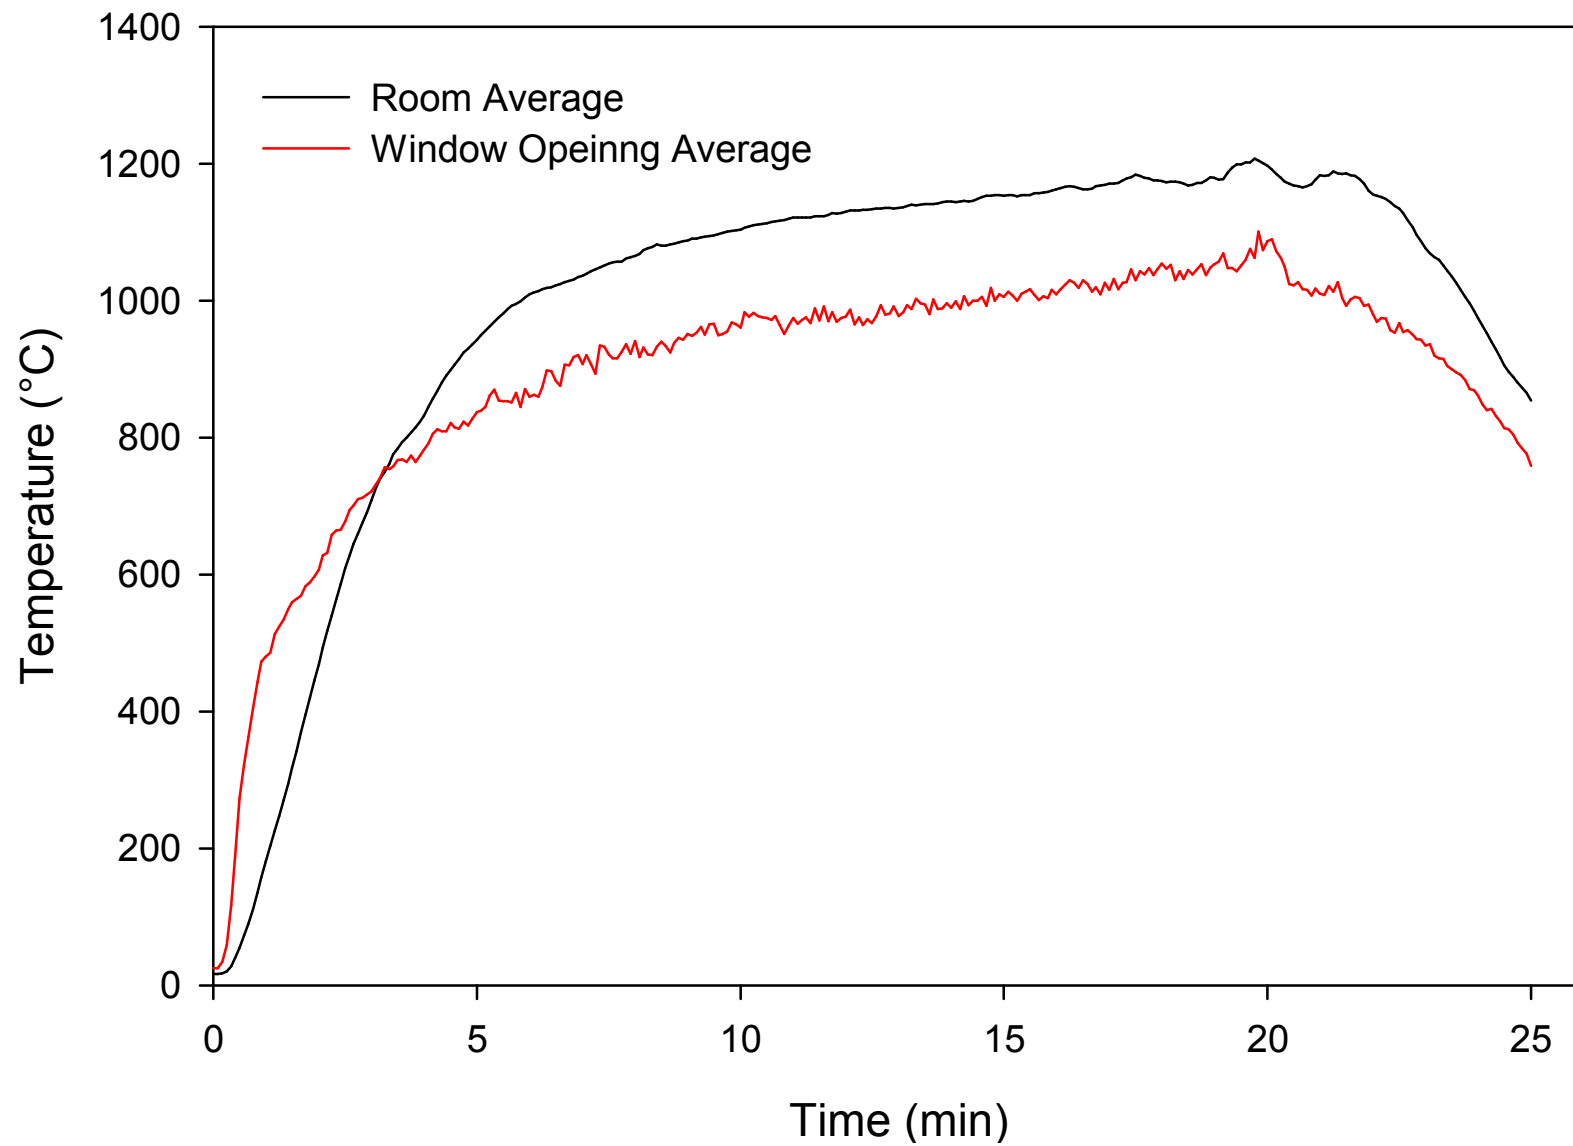
Figure 5. Average Room and Window OpeningTemperatures.

Room Temperatures – The average gas temperature in the burn room (average of six thermocouples) was as shown in Figure 5.

Window Opening Temperatures – The average temperature of the fire gases emerging from the window opening was as shown in Figure 5.

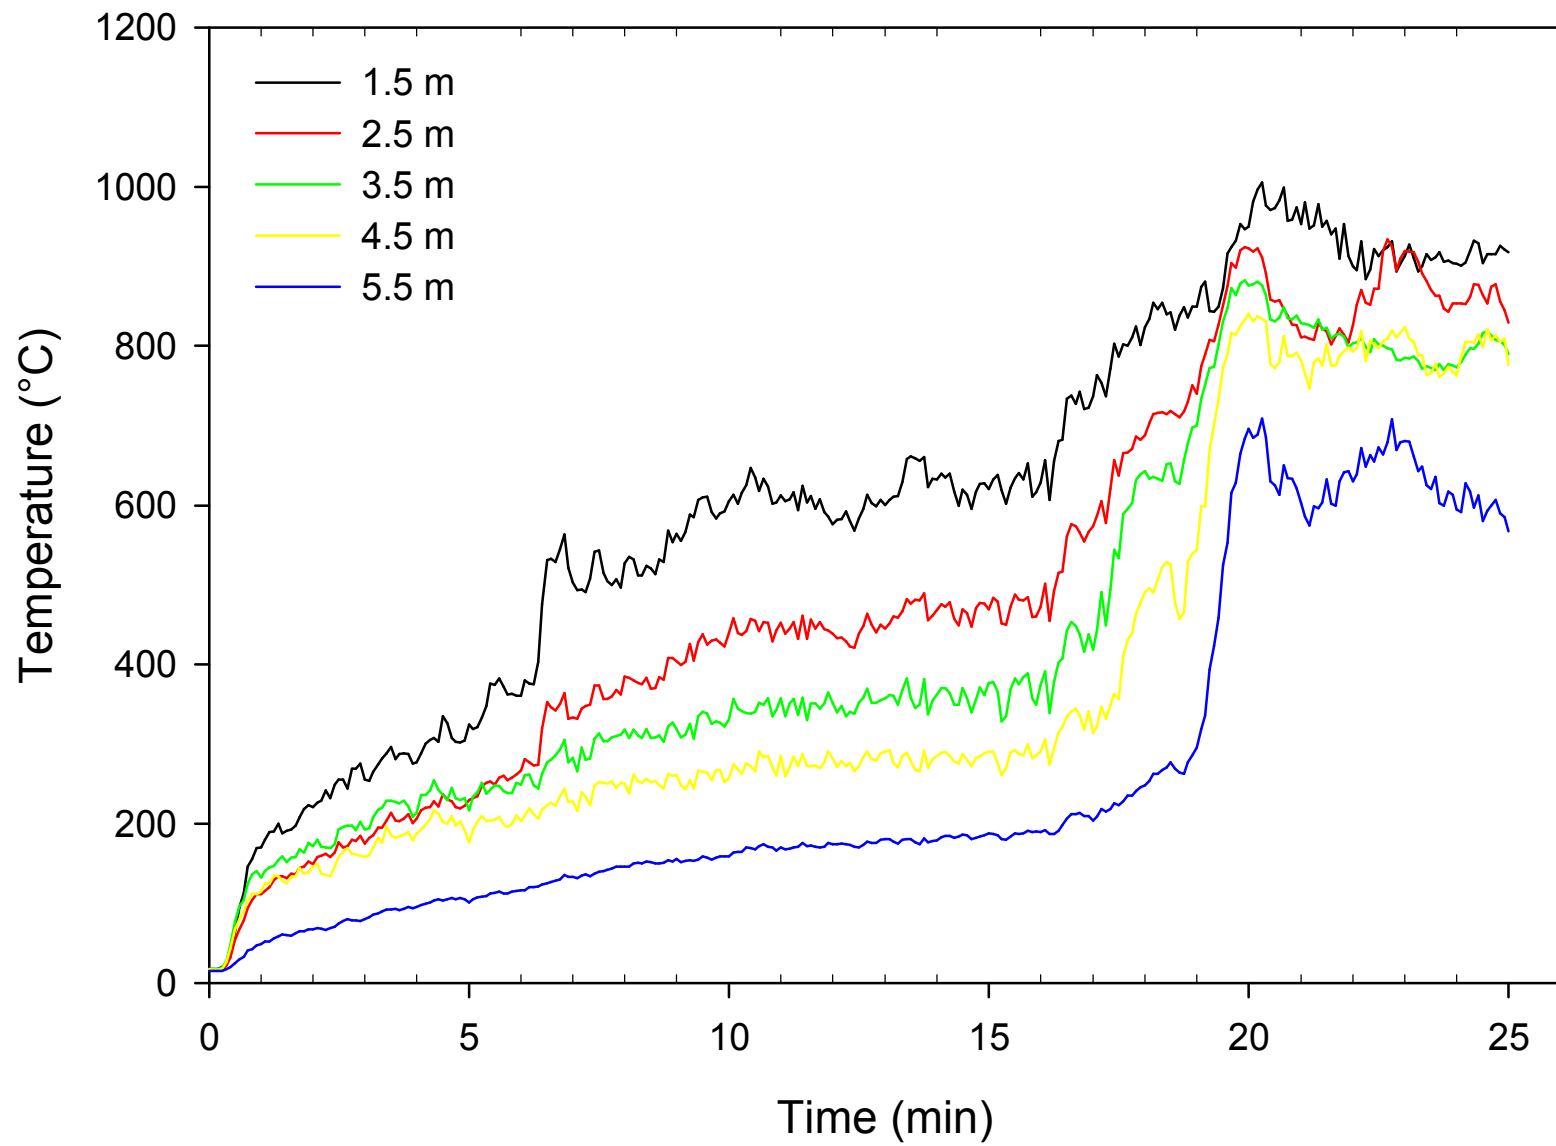
Figure 6. Temperatures on Surface of Wall.

Wall Temperatures – The temperatures recorded on the outer surface of the test assembly are shown in Figure 6. The temperatures reached a peak of 1005°C at 1.5 m above the window opening, 920°C at 2.5 m above the window opening, 878°C at 3.5 m above the window opening, 840°C at 4.5 m above the window opening and 709°C at 5.5 m above the window opening. The peak temperatures occurred at approximately 20 min at all heights.

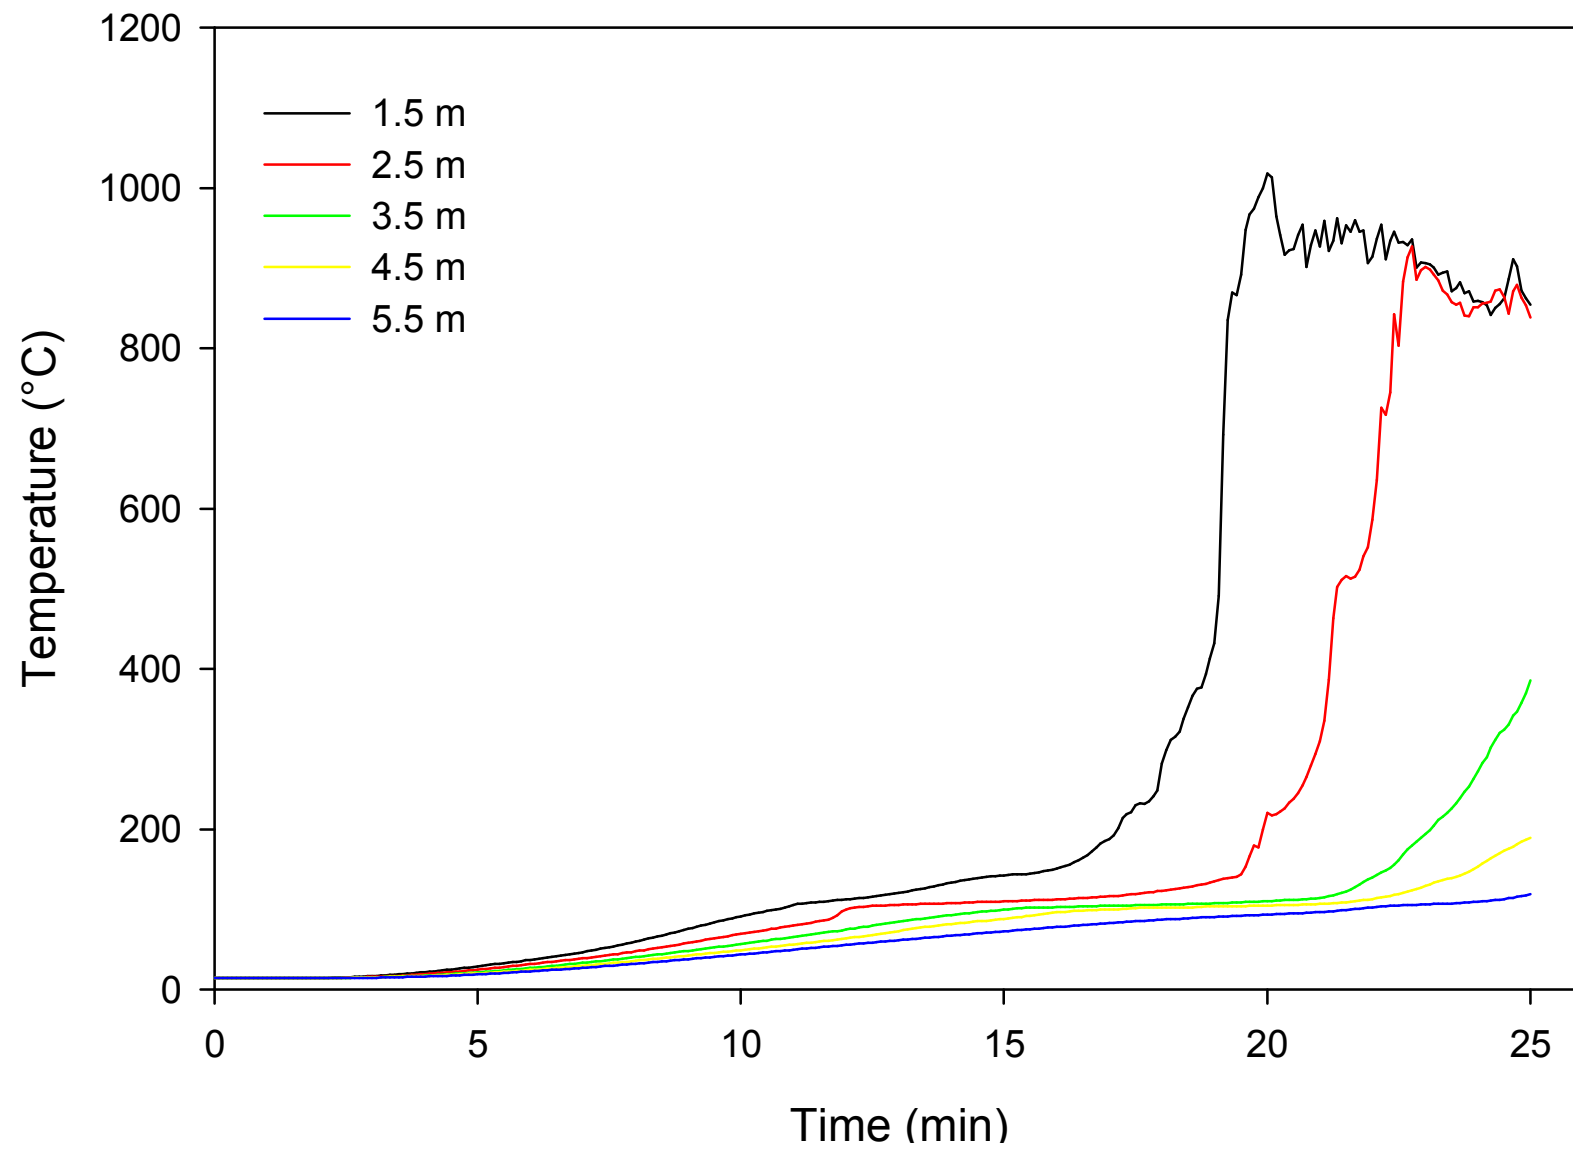
Figure 7. Temperatures Behind the Sheathing.

The temperatures recorded by the thermocouples within the assembly between the FRT plywood sheathing and the XPS foam insulation are shown in Figure 7. The temperatures reached a peak of 1019°C at 1.5 m above the window opening, 927°C at 2.5 m above the window opening, 386°C at 3.5 m above the window opening, 188°C at 4.5 m above the window opening and 119°C at 5.5 m above the window opening.

There was a rapid increase in the temperature measured between the FRT plywood sheathing and the XPS foam insulation at the 1.5 m height after 15 min. At 20 min, the temperature inside the test assembly was comparable to the temperature measured on the outside of the assembly, indicating that the FRT plywood sheathing had fallen off up to this height.

Similarly, there was a rapid increase in temperature between the FRT plywood sheathing and the XPS foam insulation beginning at approximately 20 min at the 2.5 m height. By approximately 23 min, the temperature measured by the thermocouple inside the assembly was comparable to that measured on the exterior, indicating the FRT plywood sheathing had fallen off up to the 2.5 m height.

Once the FRT plywood fell off, the insulation was burned by the fire, producing the initial peak heat output in the cavity at approximately 20 min at the 1.5 m height and at approximately 23 min at the 2.5 m height (Figure 7). With the burn through of the foam insulation, there was a rapid increase in temperatures to greater than 800°C measured on the WRB. These temperatures were sustained until the end of the test, suggesting the WRB and subsequently the simulated CLT were ignited and continued to burn.

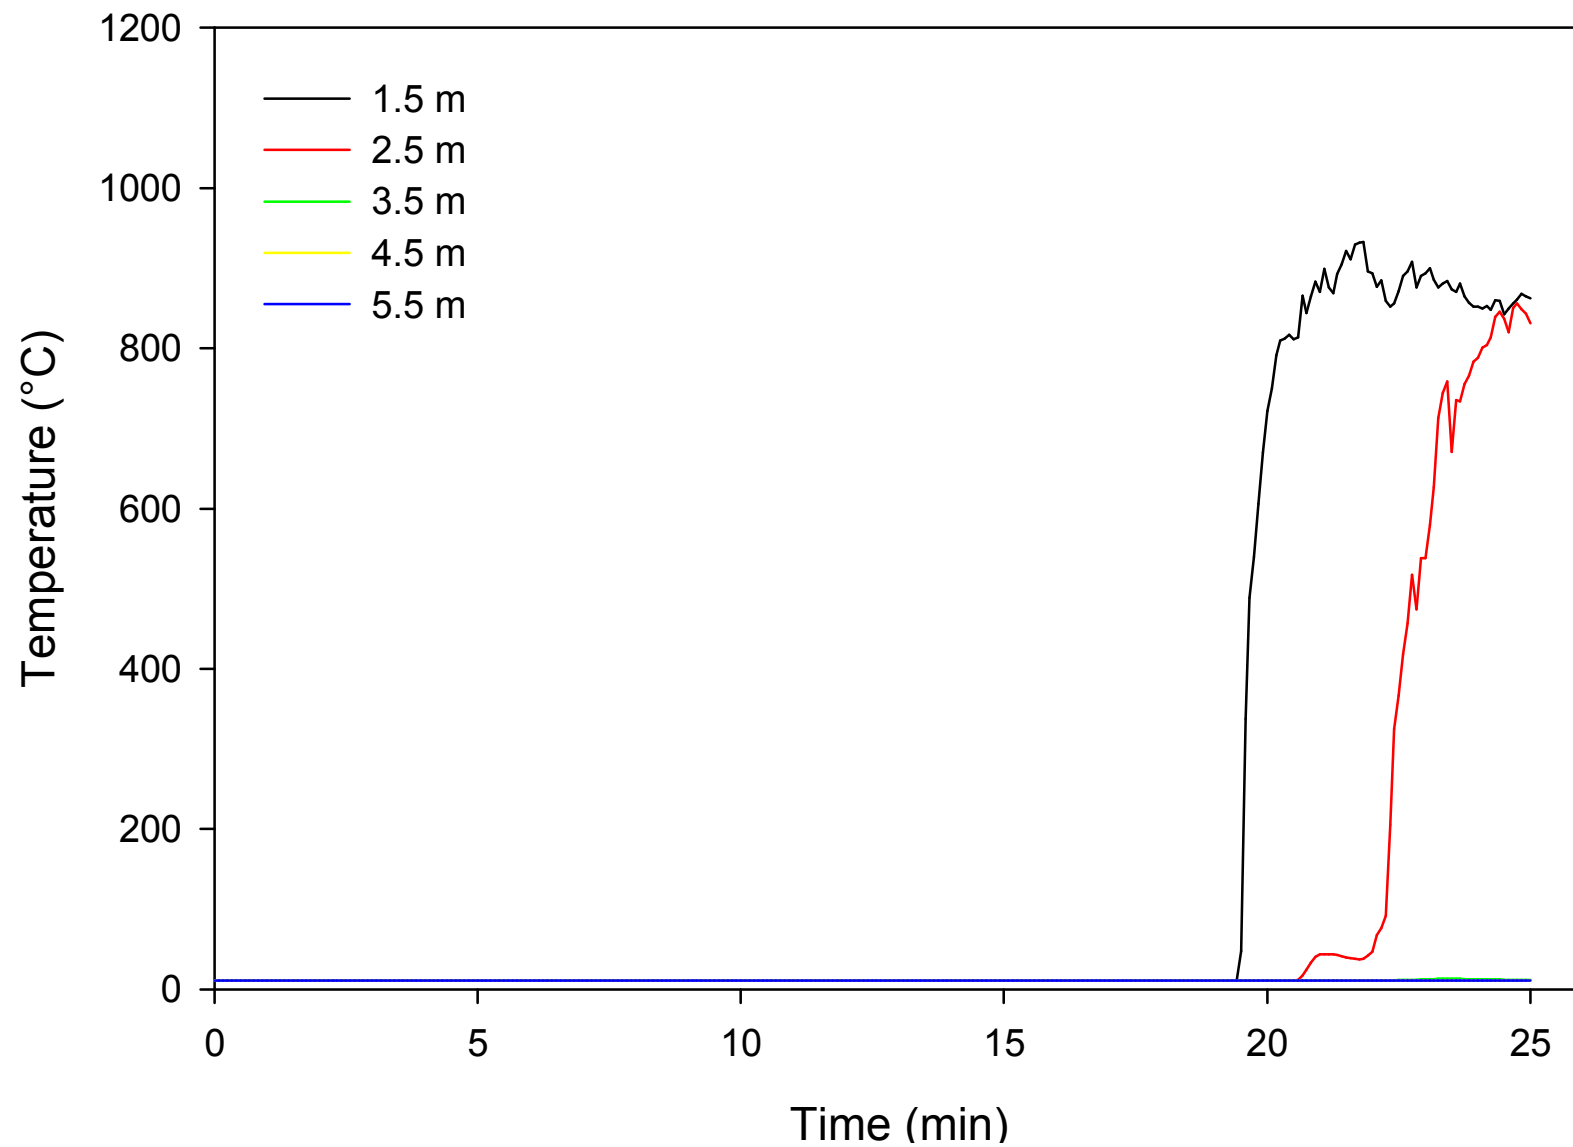
Figure 8. Temperatures on Surface of WRB.

Temperatures recorded by the thermocouples behind the XPS foam insulation, on the surface of the WRB, are shown in Figure 8. Only the thermocouples at the 1.5 m and 2.5 m heights indicated a rise in temperature. The test ended before the fire could progress to the other thermocouple locations.

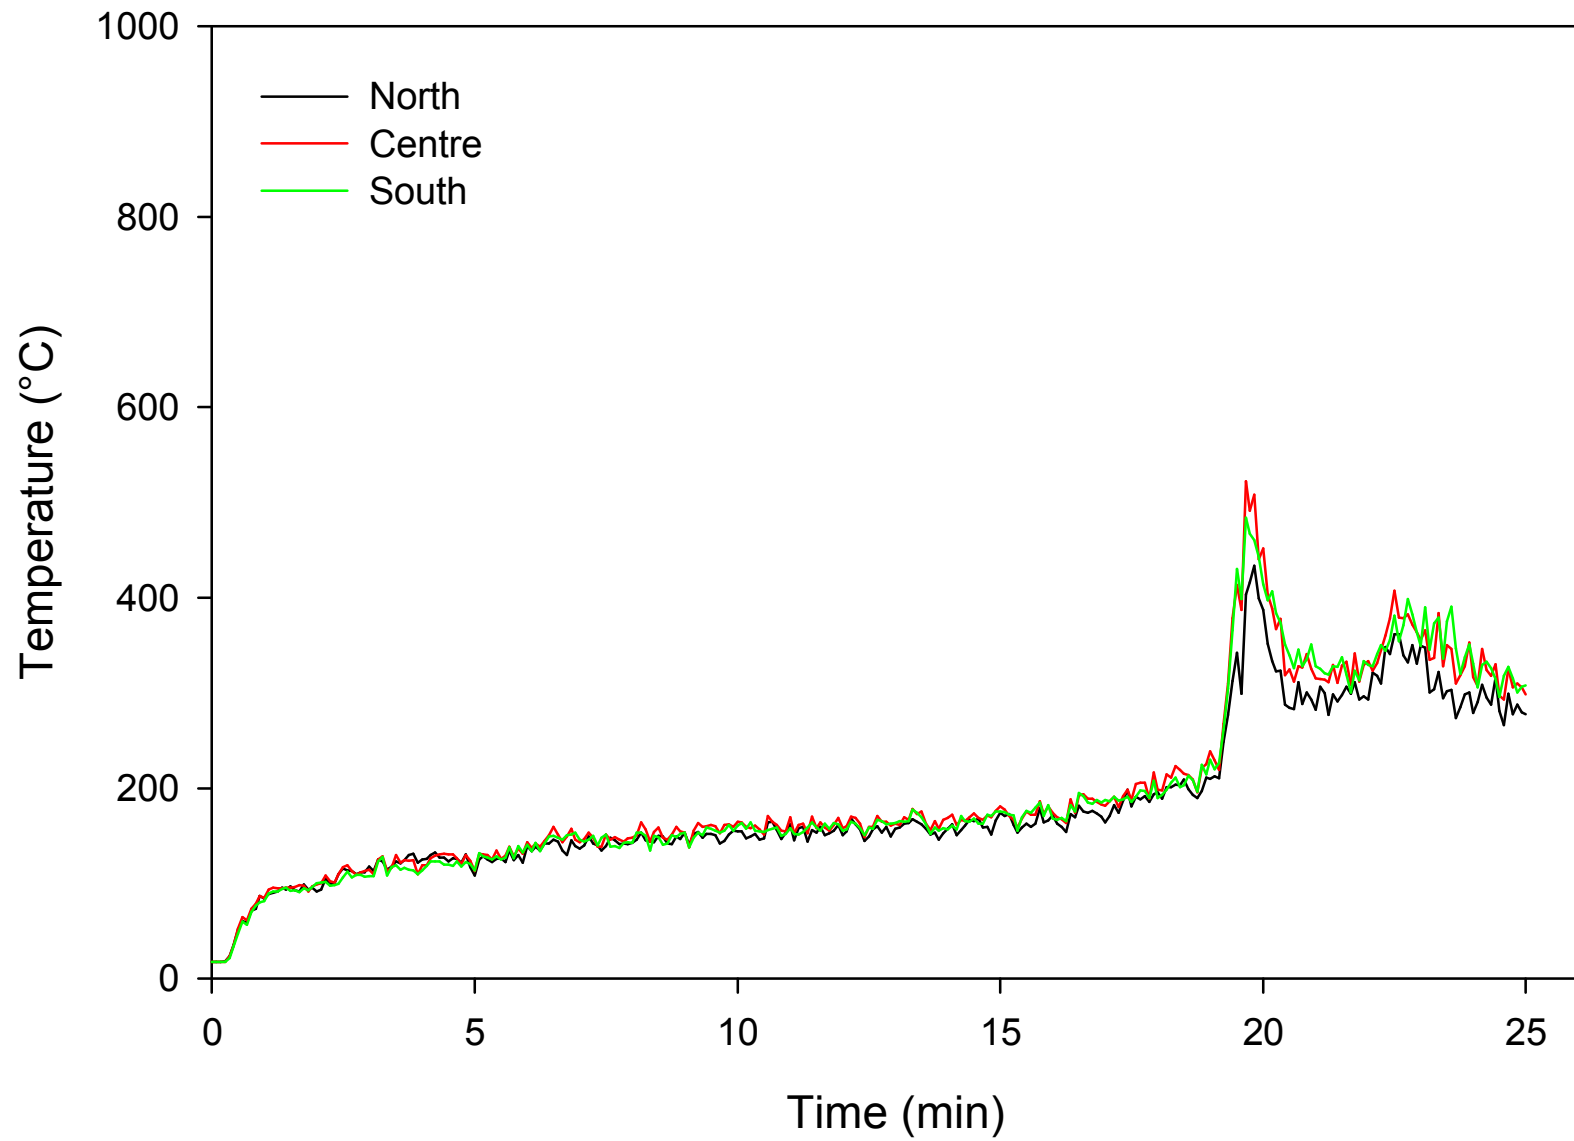
Figure 9. Temperatures at Top of Wall.

The fire plume temperatures measured at the top of the wall are shown in Figure 9. The temperatures at the top of the wall reached a maximum of 522°C at approximately 20 min. The initial peak temperature was most likely due to the burning of the XPS foam insulation. The initial peak was followed by sustained temperatures of 300 – 400°C until the end of the test.

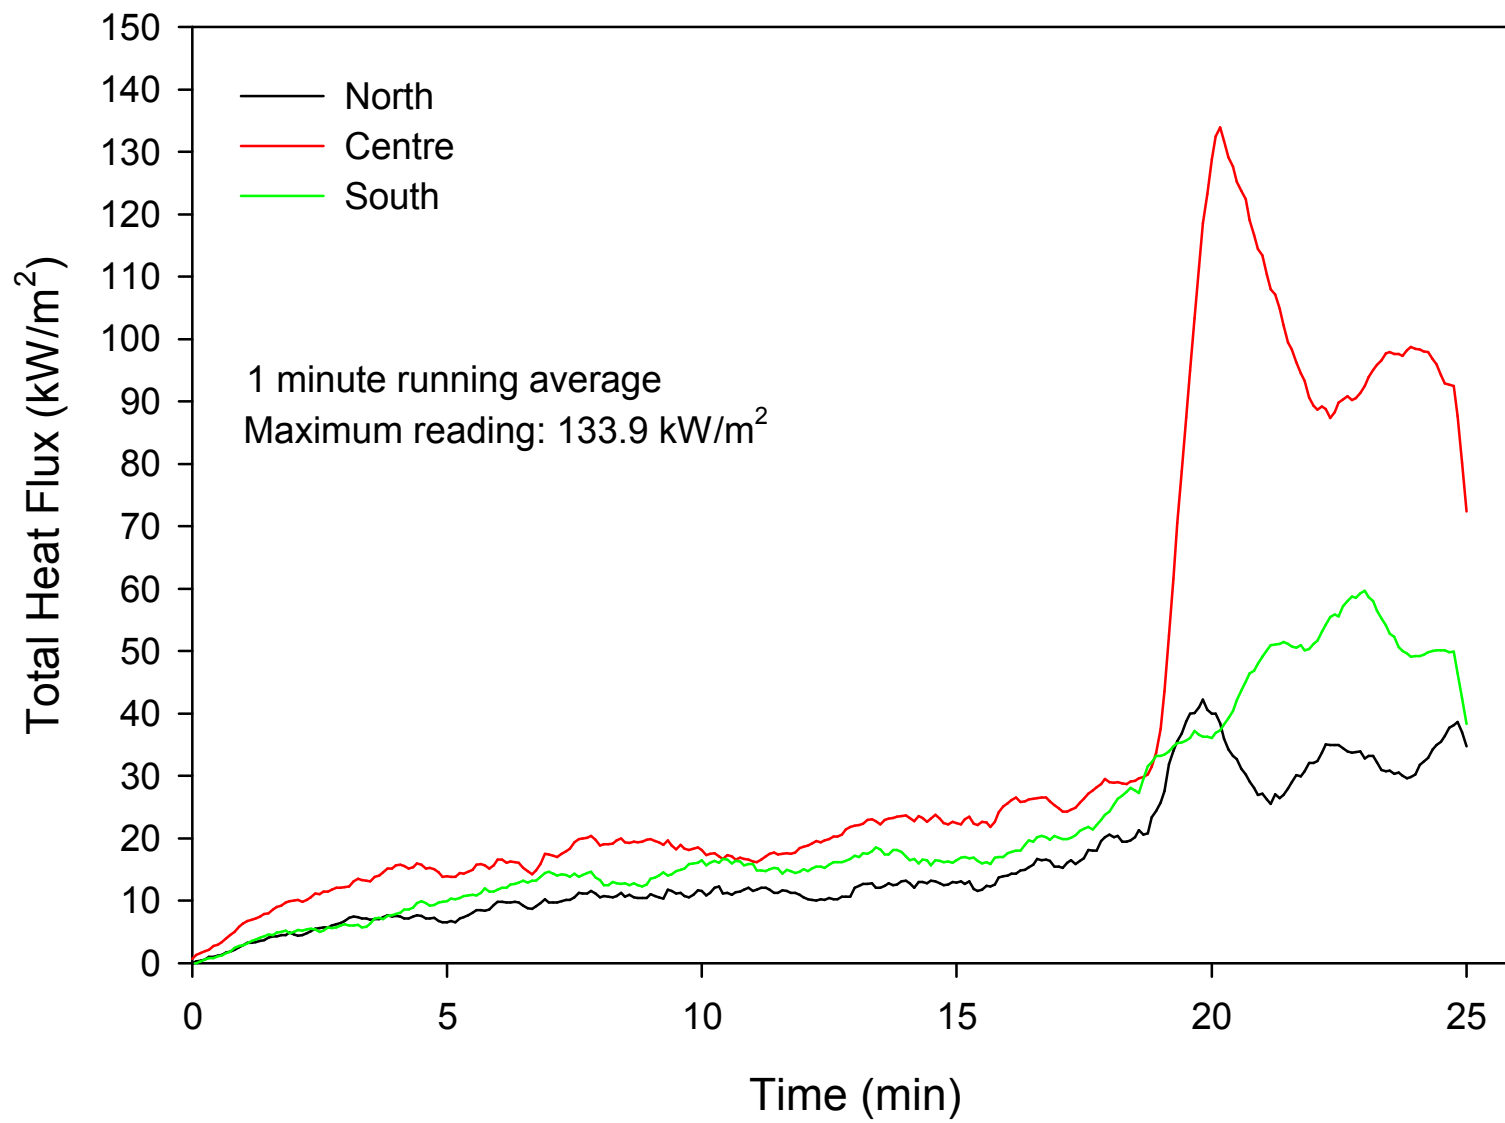
Figure 10. Heat Flux on Wall.

Heat Flux – The total heat flux to the wall, as measured 3.5 m above the top of the window opening, is shown in Figure 10. The data shown in this figure has been smoothed using the procedure of a running average over one minute.

The heat flux values at all three locations showed a steady rise in exposure over the first 5 minutes. Between 5 and 15 min, there were fluctuations in the measured heat flux values but they were typically < 25 kW/m² on the centerline of the test assembly and < 20 kW/m² at the north and south heat flux meters. After 15 min, there was an initial steady increase in the heat flux values measured by the three devices followed by a rapid increase beginning at approximately 17 min. The maximum one-minute averaged values recorded at the 3 locations were 133.9 kW/m² at the centre location, 42.2 kW/m² at the north location and 59.27 kW/m² at the south location. The peak heat flux values measured by the devices at the centre and north locations were at approximately 20 min and most likely corresponded to the burning of the foam insulation. The peak exposure at the south device occurred at approximately 23 min.

After the peak heat flux, there was a reduction in the measured heat flux. However, high heat flux values were measured by the three devices until the end of the test.

The maximum one-minute averaged value of the total heat flux on the test wall at 3.5 m above the top of the window opening was 133.9 kW/m². This is more than the 35 kW/m² specified in Sentence 3.1.5.5.(4) of the 2010 NBC [1]. For comparison, the value for a noncombustible wall (Marinite) is 16 kW/m². (Note: Marinite is a thermal structural board insulation, which is formed from calcium silicate with inert fillers and reinforcing agents. This material was used to provide the noncombustible wall, which was used for calibration and reference purposes in the initial test series used to develop the test method [5]).

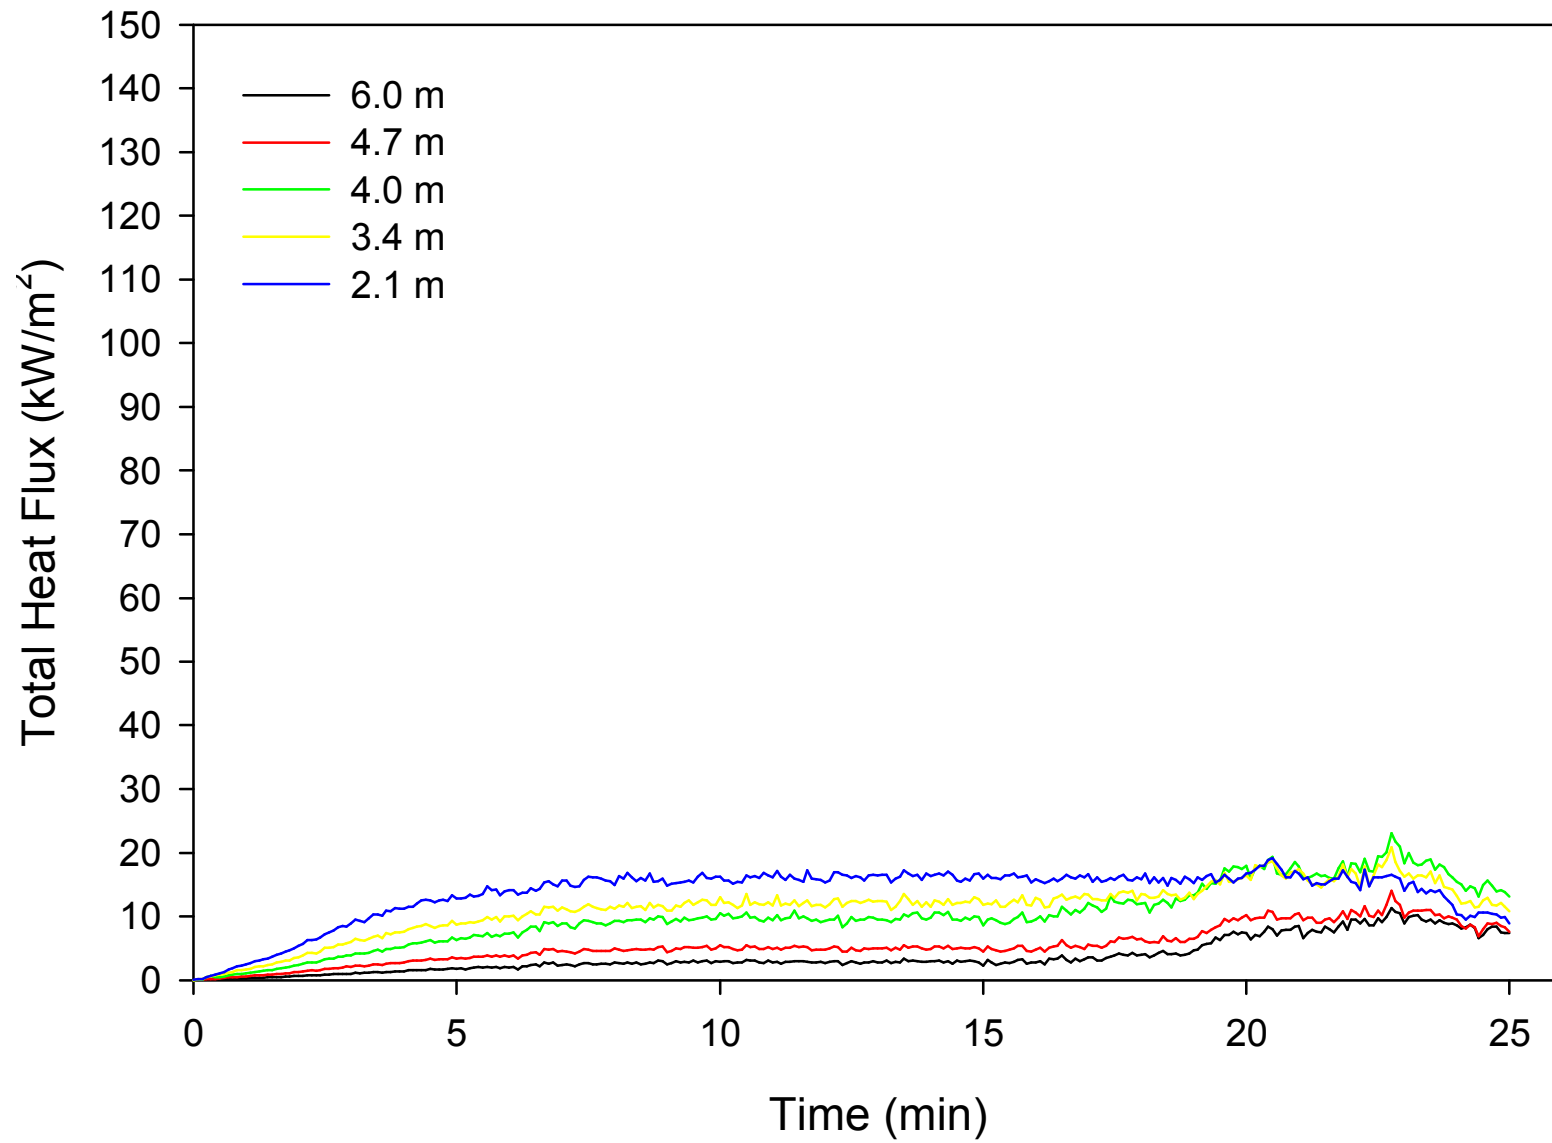
Figure 11. Heat Flux at Mast.

The heat flux values measured by the heat flux meters installed on the mast are shown in Figure 11. The heat flux at the 2.1 m height reached 19.1 kW/m², at the 3.4 m height it reached 20.9 kW/m², at the 4.7 m height it reached 14.0 kW/m² and at the 6.0 m height it reached 11.3 kW/m². The heat flux at 2.4 m from the wall at the 4.0 m level reached 23.1 kW/m².

There was an initial increase in the heat flux values measured by all the devices as the fire inside the fire compartment developed during the initial 5 min. Subsequently, the heat flux values at each location remained steady until approximately 15 min, after which there was an increase in the measured heat flux values to an initial peak at approximately 20 min. However, for all devices except the one located at the 2.1 m height, the highest exposure levels were at approximately 23 min. and were the result of the fire burning upwards on the wall.

The heat flux values at the 3.4 m height and 3 m from the wall assembly and at the 4.0 m height and 2.4 m from the wall assembly exceeded 20 kW/m². At these heat flux

values, autoignition can occur for combustible materials if the exposure is sustained for a sufficient time.

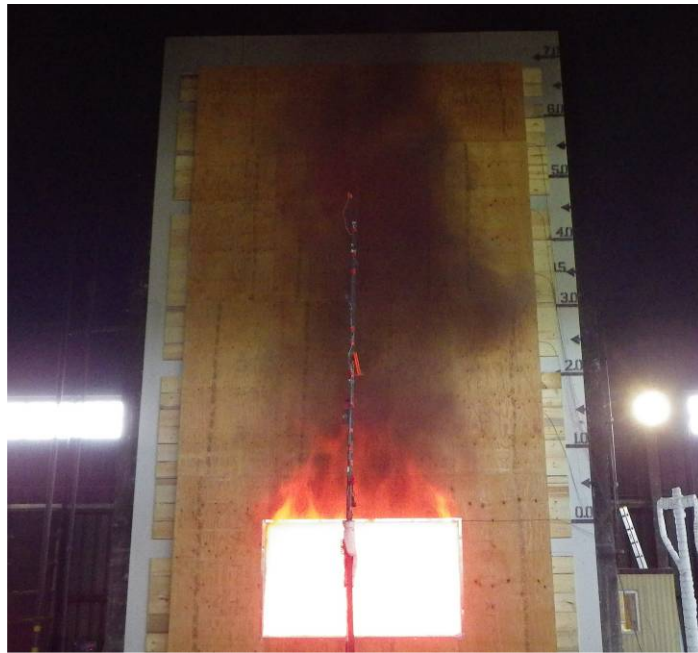
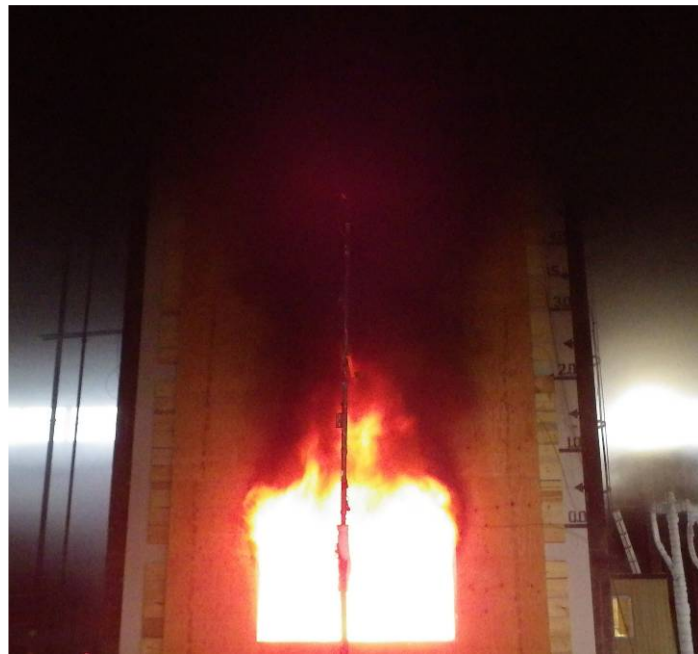
Figure 12. Wall Sample During the Fire Exposure.

Figure 12 shows the wall assembly at two different times during the fire exposure.

(a) 4 Minutes After Ignition.

(b) 11 Minutes After Ignition.

There were minimal events in the first 16 minutes of the test. At this time, a small piece of FRT plywood fell off the face of the sample. This gave the fire access to the inside cavity and the insulation. The fire began to grow at a fast pace and kept up its fast growth well after gas reduction had begun. The flames reached the top of the test wall and were suppressed at 25 minutes to avoid damage to the facility.

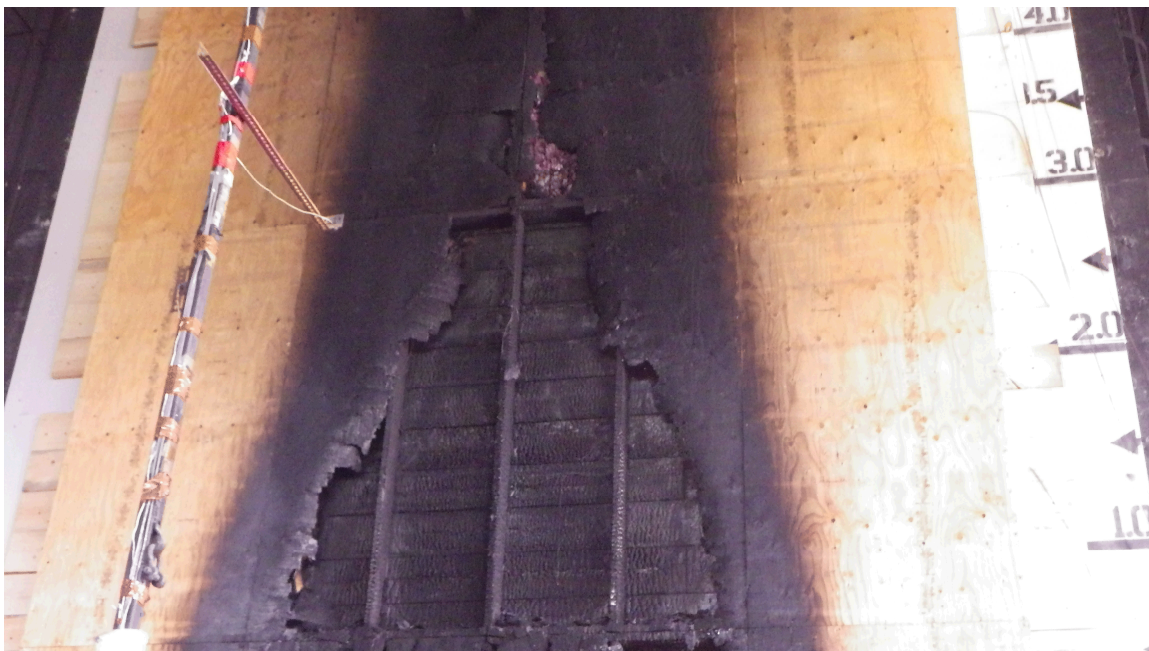
Figure 13. Wall Sample after Fire Exposure.

Figure 13 shows the extent of the damage to the wall sample after the test.

4. The fire was suppressed at 25 minutes to avoid damage to the facility.
5. There was damage to the CLT up to 3.0 meters.
6. Most of the elevated values for heat-flux happened after the gas reduction began at 20 minutes.
