Experimental blasting studies on structures

Edwards, A. T.; Northwood, T. D.

APRIL 1, 1959

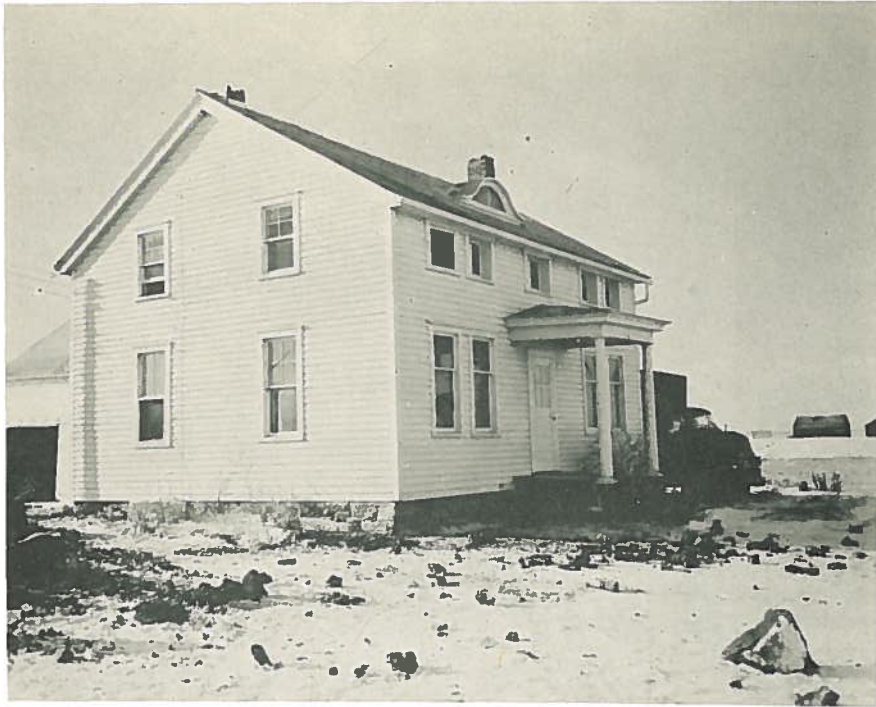
Fig. 1. Building R (after Test R3)

The structures are briefly described and designated in Table /1/. Photographs of buildings R, E, C and F are given in Figs. /1/ to /4/. All were in good condition except for quite localized areas in one or two of them. Building R and part of Building F were of frame construction above the masonry basement walls. In the other buildings structures above ground level were mainly of 12 inch solid brick which was in good condition except that the bond between the bricks and the mortar was weak in two of the buildings. House E had a 45 degree crack across the front wall which had been patched up and which was said to have been caused by the Cornwall earthquake of 1945. The crack can be seen in Fig. 3. Rock was encountered about 15 feet down at House F.

Building R:- No damage occurred until Test R3 when some horizontal cracks, up to about 1/32 inch wide, developed in the basement walls. These extended into the two walls, longitudinal with the blast, about 12 feet from the rear wall. Nearly all the tell-tales across original cracks broke although none were opened up. Somewhat fewer tell-tales broke in the walls normal to the blast. Most of the windows in the ground floor longitudinal walls broke while those in the walls normal to the blast remained intact. The top section of the chimney was sheared through.

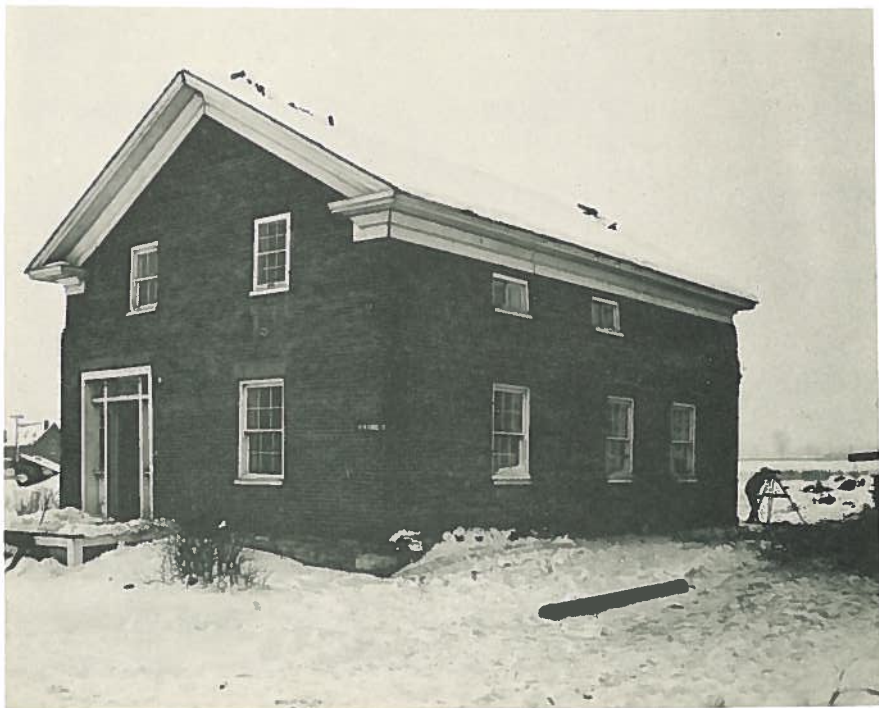
Fig. 2. Building E (after Test E11)

Building E:- Damage first occurred with Test E10 when some vertical and diagonal cracks developed in the basement and upper walls. An original diagonal crack in the front wall was opened up to 1/2 inch in width. Test E11 demolished large sections of the two rear walls and caused the rear upper floor to collapse. The diagonal crack in the front wall opened up to about 1 inch in width.

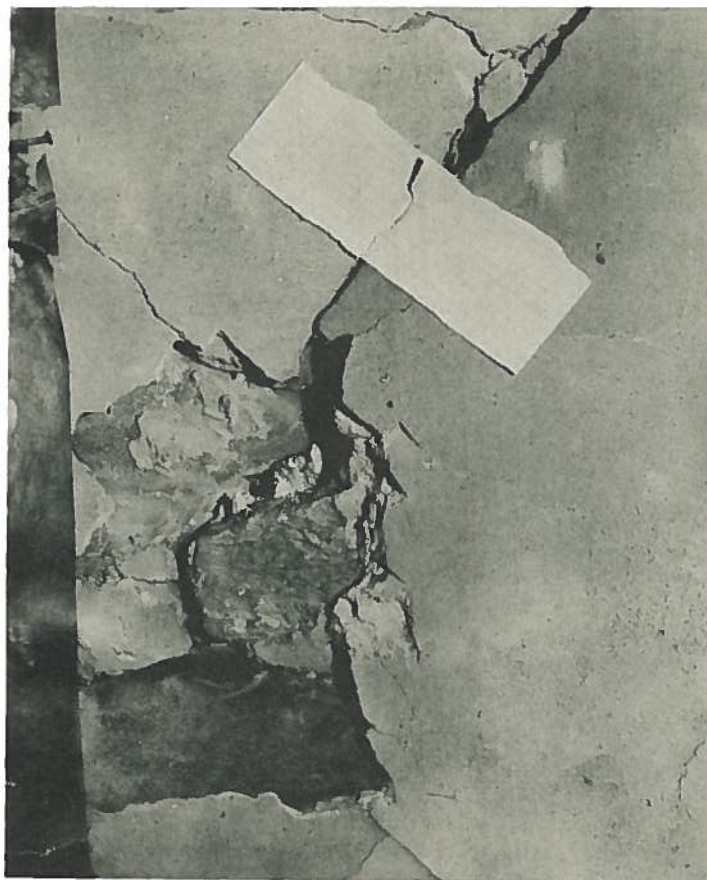
Fig. 5. Showing tell-tale
across an original
crack.

- (a) Tell-tales:- In order to obtain a positive indication of movement in existing cracks in plaster or in basement walls, a sheet of paper was pasted across each crack (See Fig. /5/). The adhesive used was a type that is rigid when dry and thus does not yield under load. Consequently a widening or extension of original cracking produced a tear in the paper.
- (b) Settlement:- Excessive settlement of a structure, which could be the primary cause of damage rather than the building vibration, was measured with a precise level. Reference

Building C:- There was no noticeable damage from Test C4. Damage from C5 was mainly in the form of vertical cracks, from hairline to 1/2 inch in width, in the two walls closest to the blast. One of these (1/4 inch width) extended down through the basement wall. An original crack in the rear basement wall opened up and some pieces of stone forming the wall were dislodged (see Fig. 5).

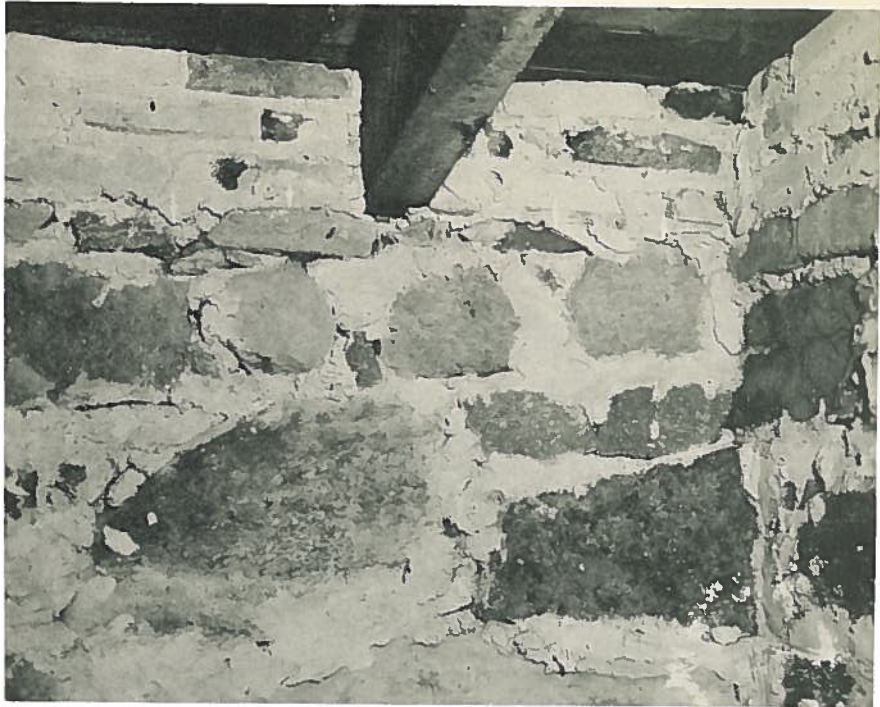
Fig. 8. Horizontal crack - Building T.

Building T:- Test T17 caused a few of the tell-tales across original cracks to break although none opened up. No new plaster cracks were noticed possibly because there were several layers of paper on the walls. A few of the bricks in the chimney became dislodged. Somewhat fewer tell-tales were broken by Test T18. This caused some minor horizontal and vertical cracks in the basement walls - these being generally between courses or associated with windows, etc. Additional bricks were dislodged from the chimney.

In general the type of damage was found to be related to the soil condition. In the sand-clay vertical cracks occurred which were associated with large settlement. Examples of this type of damage are shown in Figs. /6/ and /7/. In the till, damage was more often associated with horizontal cracking and shattering of the basement walls as exemplified by Figs. /8/ and /9/. It was interesting that chimneys are sometimes the first part of a building to show signs of weakness. Figure /10/ shows an example that occurred at Building R.

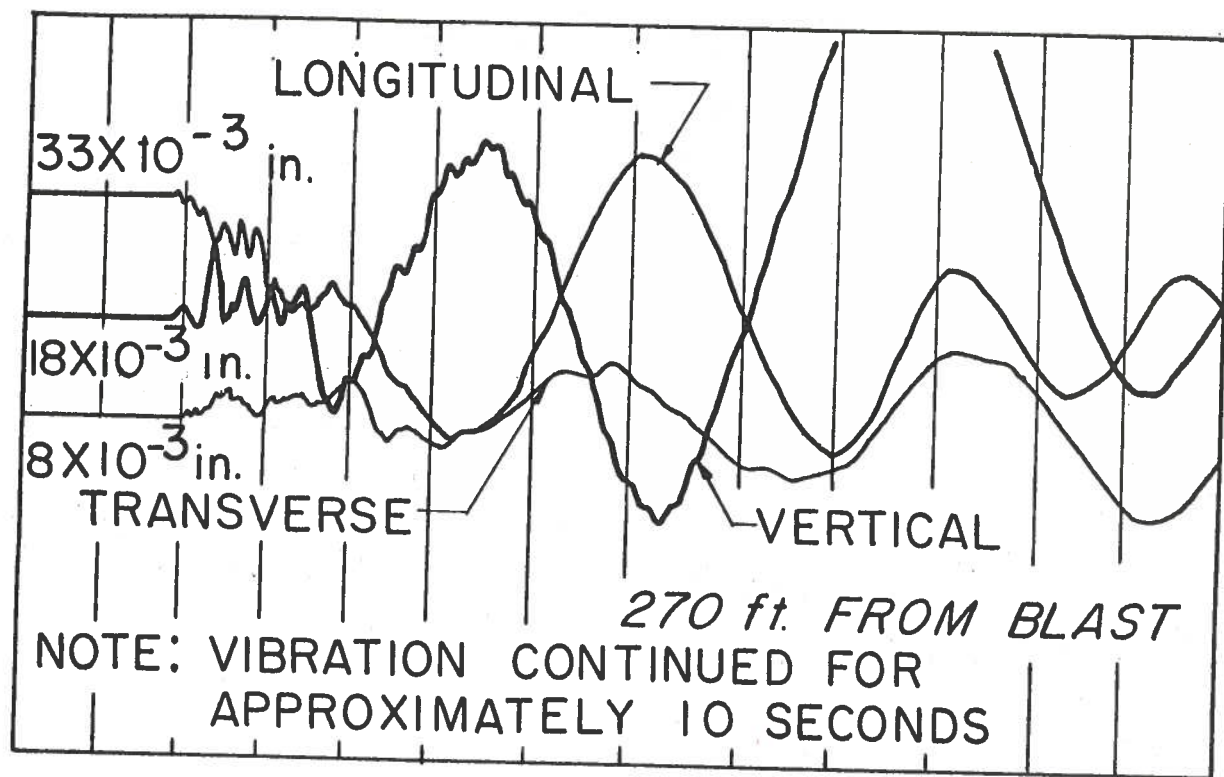
FIGURE II a
TYPICAL SAND CLAY RECORD
(DISPLACEMENT)

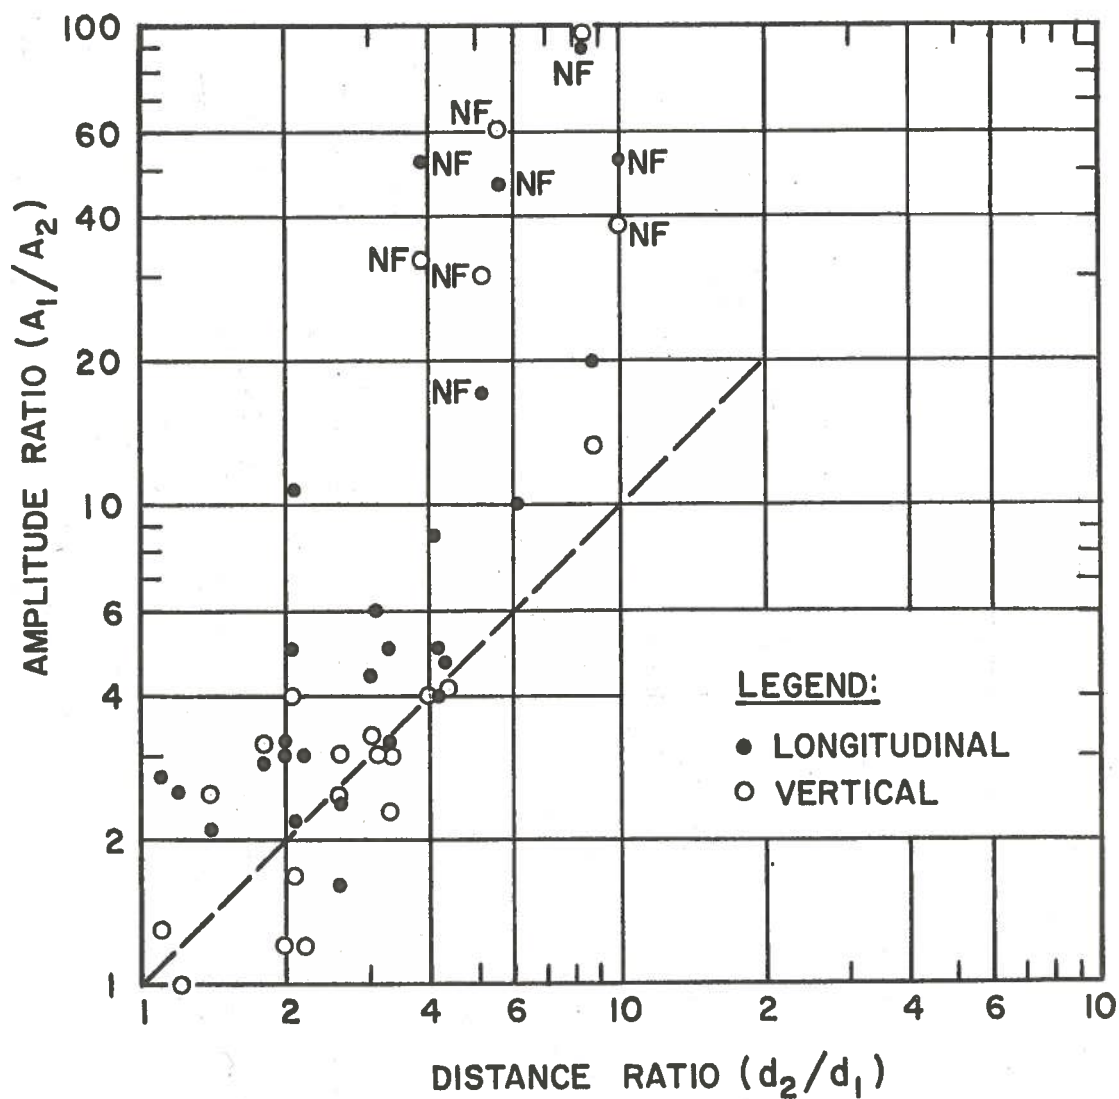
FIGURE 12

SCATTER DIAGRAM OF AMPLITUDE RATIOS VS
DISTANCE RATIOS

As noted previously it was not always possible, especially with the displacement instruments, to observe directly the vibration of the portion of the building nearest to the blast. Hence a preliminary analysis was made to determine a satisfactory means of making corrections to the actual observations to give the vibration levels at the most-stressed portions of the structures. To this end the results were examined to find the variation of amplitude with charge (weight of explosive) and with distance from the source. This was done for the acceleration and displacement records.

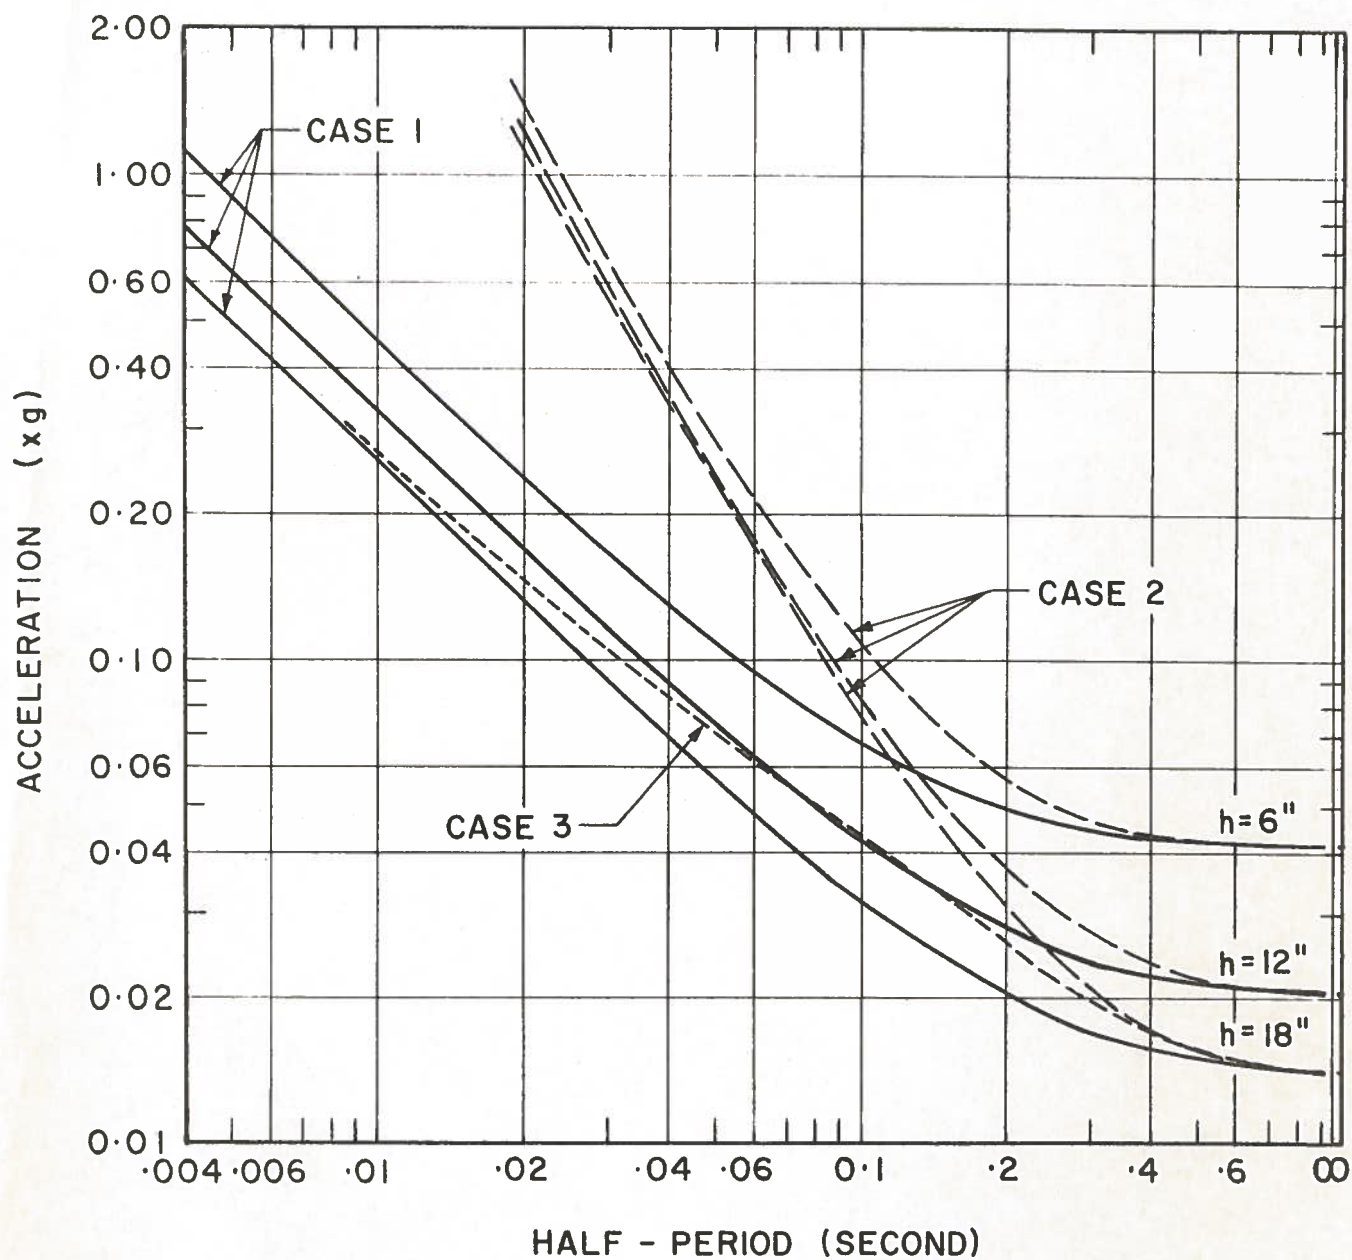
FIGURE 20

AMPLITUDE AND HALF-PERIOD OF ACCELERATIONS RESULT-
ING IN TOPPLING OF PINS OF LENGTH h

Since the maximum velocity of point p is given by $v_1 = \dot{x}_{p1} t_1$, a 45 degree line across Fig. 20 denotes a particular value of maximum velocity. The sloping portion of the solid curves have exactly this slope, and indicate that for the single positive excursion of Case 1 maximum velocities from 1.1 to 1.7 inches per second will topple pins from 6 to 18 inches long. This applies for disturbances with a wide range of periods. For the second case, of an additional negative excursion, a similar result holds but for a limited range of half-periods which depends somewhat on the pin length. The threshold values of velocity range from 3.1 to 3.8 inches per second. Case 3 gives threshold values between those for Case 1 and Case 2.

It is concluded that in actual blasting disturbances the toppling threshold will be somewhere between the results for Case 1 and Case 2, depending on the detailed nature of the disturbance.
