### **Solutions for mid-rise wood construction: apartment fire test with encapsulated cross laminated timber construction: Test APT-CLT: report to Research Consortium for Wood and Wood-Hybrid Mid-Rise Buildings**

## **Solutions for Mid-Rise Wood Construction: Apartment Fire Test with Encapsulated Cross Laminated Timber Construction (Test APT-CLT)**

December 31, 2014

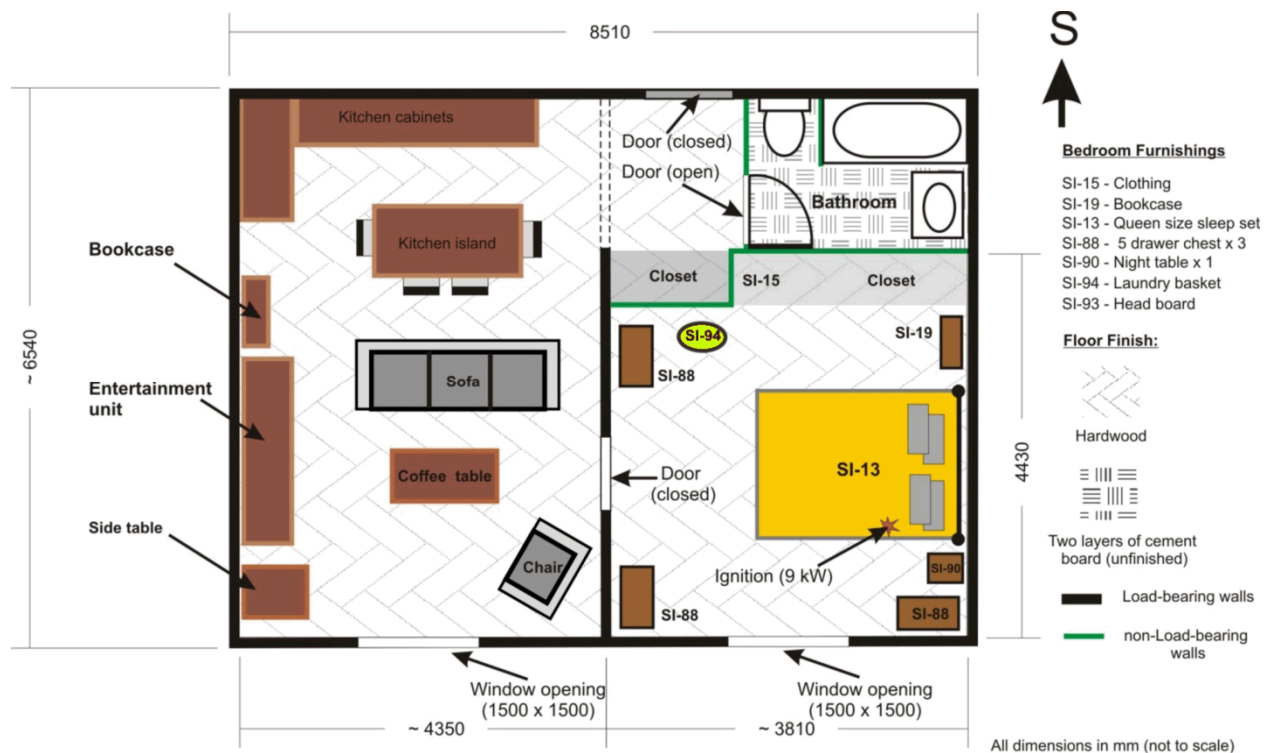
The primary fuel load present within the fire floor (middle storey) was made up of typical furniture and contents found in residential occupancies. The items used in the apartment fire tests were based on previous fire tests conducted as part of a project to develop information to be used as a basis for establishing ‘design fires’ for multi-family occupancies [10]. These fuel loads were based on actual field surveys conducted to determine fuel loads in multi-family dwelling units [11]. The layout of the fuel load in the test area is shown in Figure 6. The labels (e.g. SI-13) on the items used in the bedroom refer to single item tests conducted on the fuel item [12].

In addition to the furniture and contents, fuel was also provided by the hardwood flooring used throughout the test area except the bathroom, the kitchen cabinets and island including counter tops and by the wood framing used for the partition wall between the bedroom and the bathroom/entrance.

Figure 6. Fuel load layout.

The bedding on the bed assembly was the first item ignited. It was ignited using a 9 kW T-burner that was positioned at a distance of 470 mm from the head of the bed (Figure 6). The same ignition scenario was used in the full-scale bedroom fire tests discussed in Reference [10].

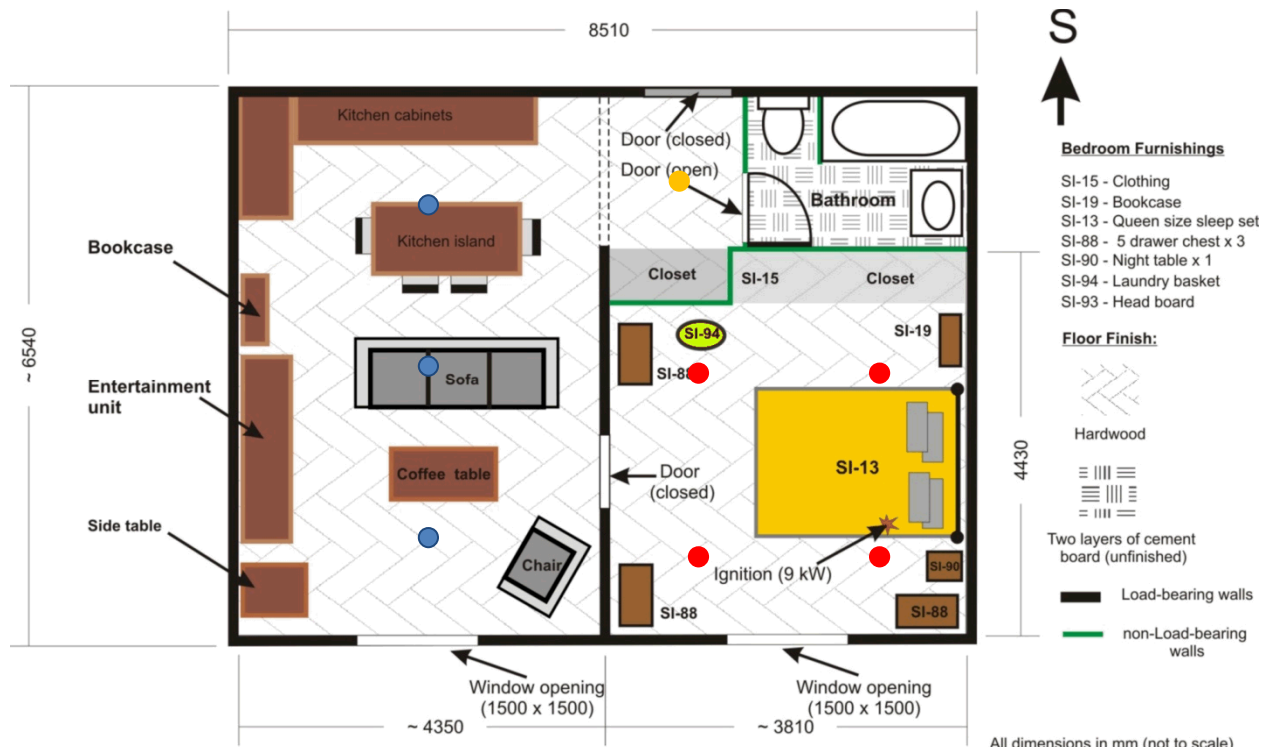
Figure 7. Location of thermocouple trees in the bedroom (●), living room/kitchen (●) and entryway (●).

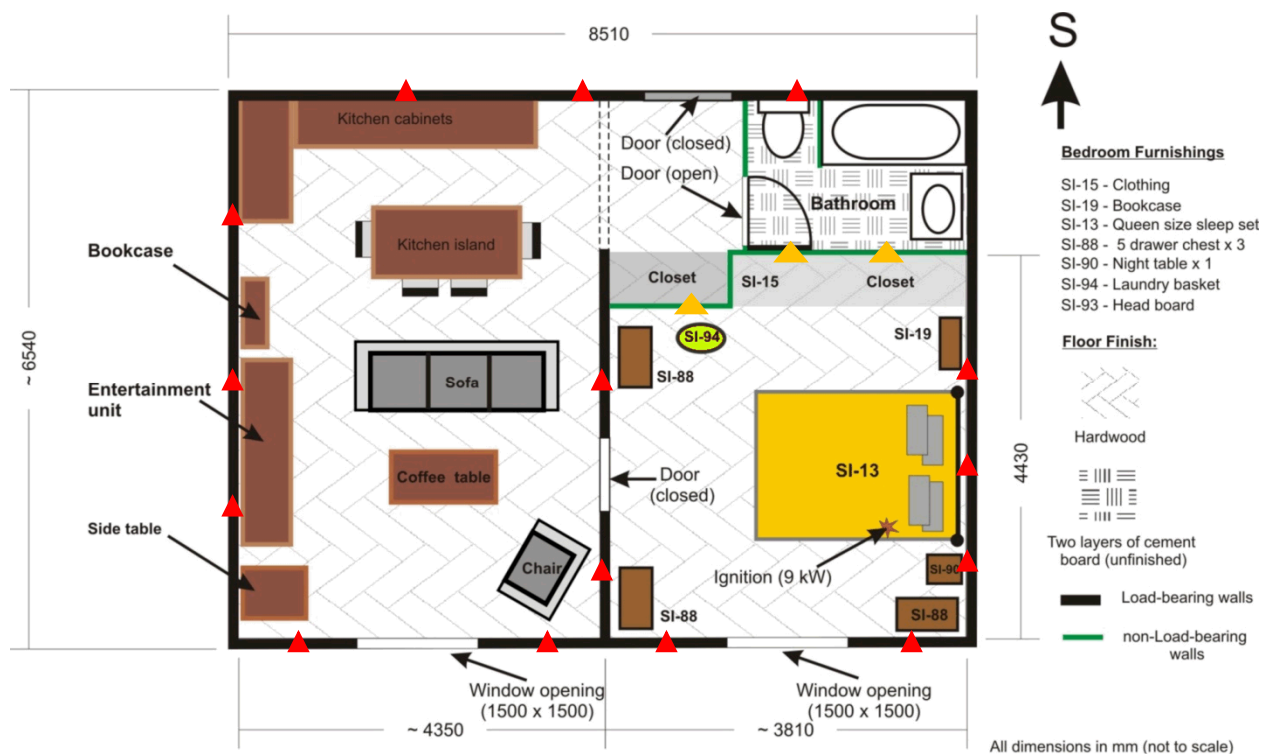
Figure 8. Sketch showing locations of thermocouples in wall assemblies. (The locations indicated by ▲ had thermocouples located at the 0.6, 1.2 and 1.8 m heights. The locations indicated by ▲ had a single thermocouple at the 1.8 m height.)
