NATIONAL RESEARCH COUNCIL  
CANADA  
DIVISION OF BUILDING RESEARCH

ATMOSPHERIC CORROSION BEHAVIOUR OF STAINLESS  
STEELS IN EIGHT CANADIAN ATMOSPHERES -- SUMMARY  
OF TEN YEARS' RESULTS

Internal Report No. 331  
of the  
Division of Building Research

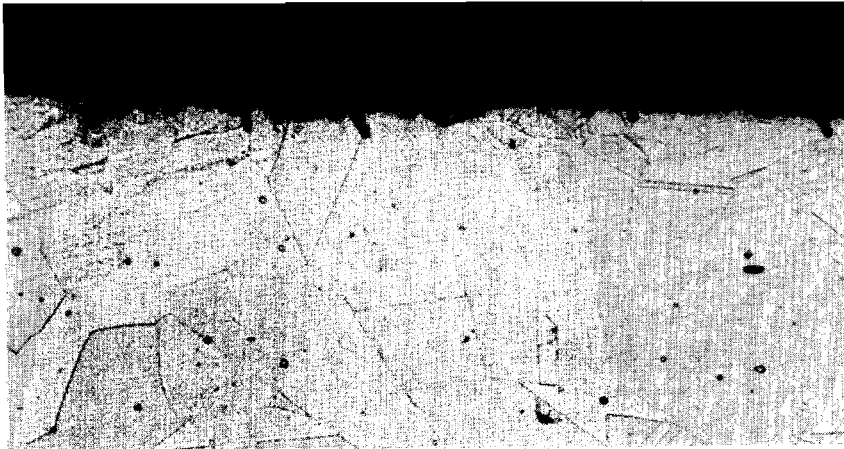
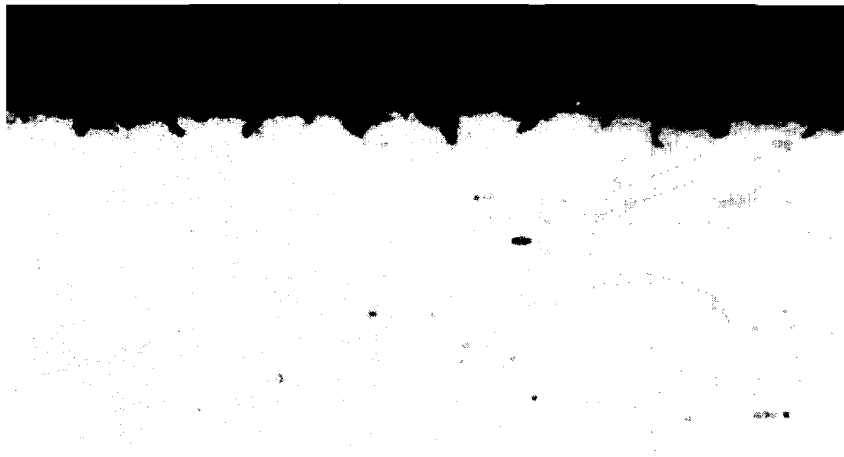
STAINLESS - 302

Samples exposed at sites 4 and 6 were selected from each type of steel after the ten-year exposure period for confirmatory chemical analysis. These results are given in Table 8. There are no significant differences from the original analysis except in the case of stainless 302 from the Halifax industrial site. Here there is a significant drop in the chromium content from 18.78 to 18.21 per cent.

From these results it is seen that the corrosion of the three types of steel is a general corrosion restricted mainly to the surface of the panels. No evidence of intergranular attack was found.

FIGURE 9 - ELECTROLYTIC ETCH, 10% OXALIC ACID, 30 SECONDS, 6 VOLTS

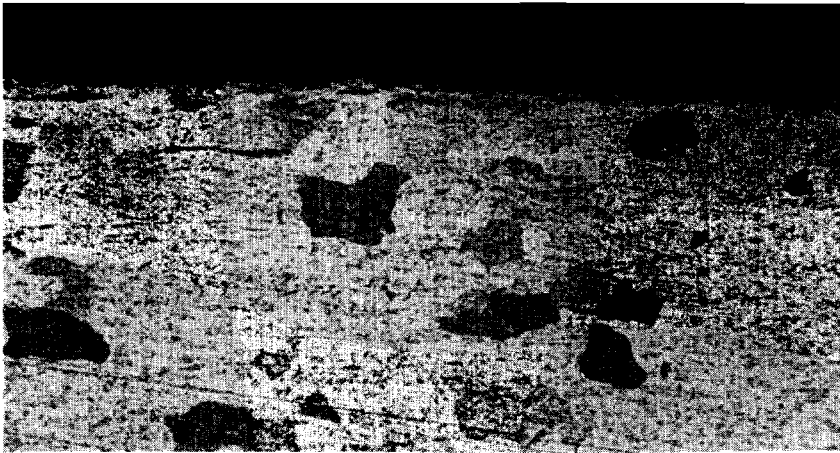
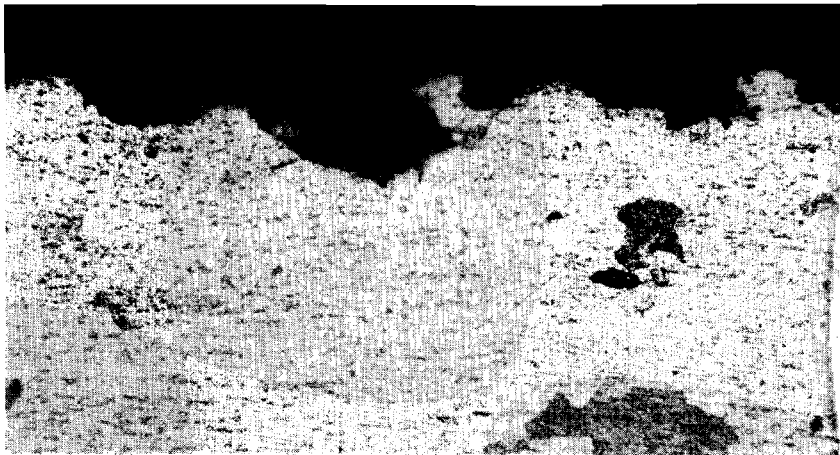
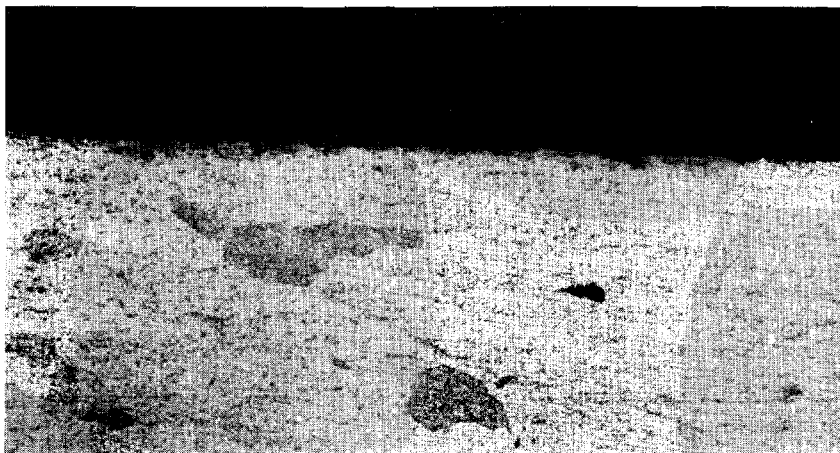
STAINLESS - 430

FIGURE 11 - ELECTROLYTIC ETCH, 10% OXALIC ACID, 30 SECONDS, 6 VOLTS

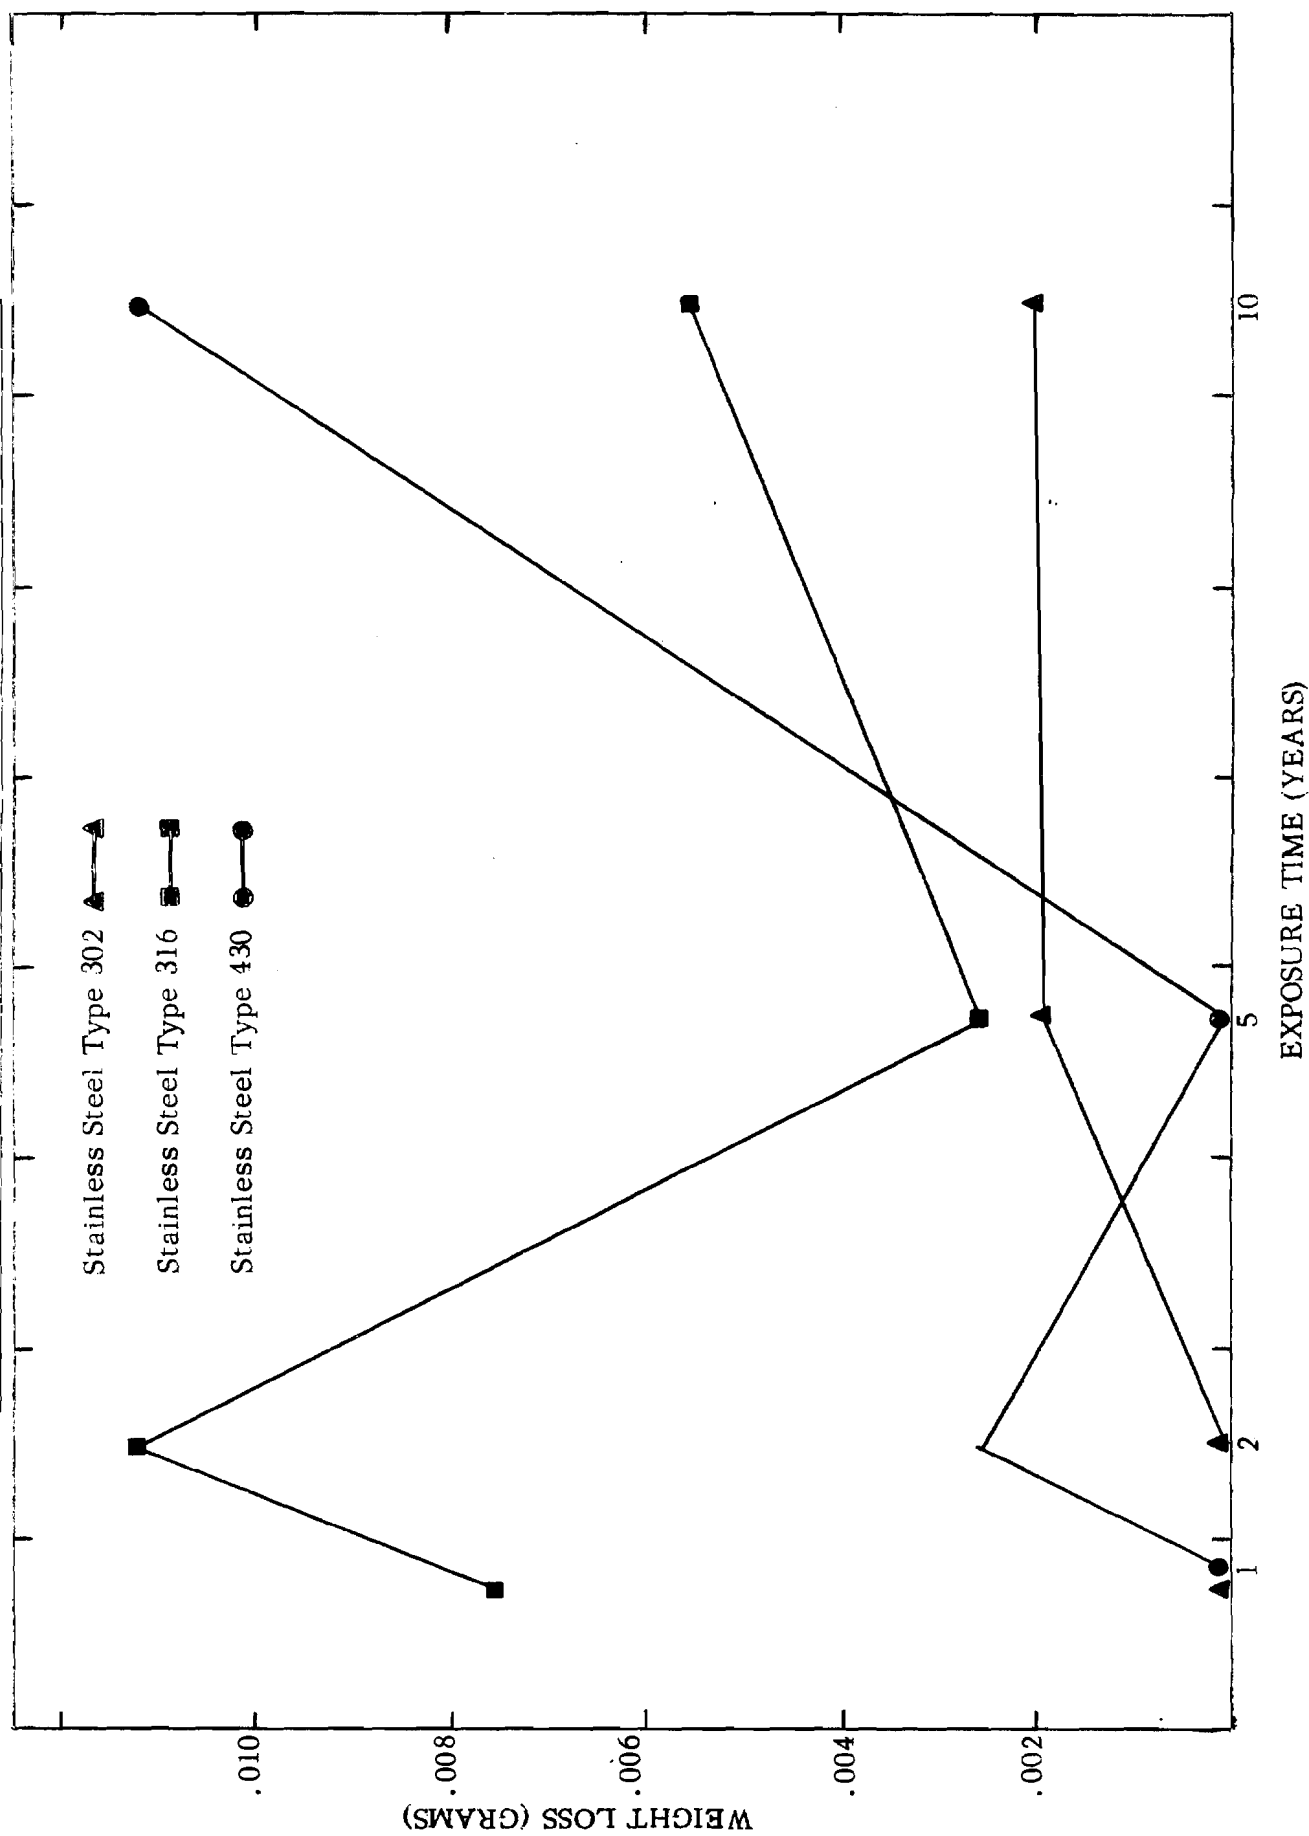
FIGURE 19

Figures 12 to 19 show graphically the corrosion behaviour of the three types of stainless steels versus test site.

ATMOSPHERIC CORROSION OF STAINLESS STEELS AT SITE NO. 8 (TRAIL)
